**FINAL INVESTIGATION REPORT ON  
ACCIDENT TO GOVERNMENT OF  
UTTAR PRADESH PREMIER 1A AIRCRAFT  
VT-UPN AT IGI AIRPORT, NEW DELHI,  
ON 22/09/2012**

**FINAL INVESTIGATION REPORT ON ACCIDENT TO**  
**GOVERNMENT OF UTTAR PRADESH PREMIER 1A AIRCRAFT**  
**VT-UPN AT IGI AIRPORT, NEW DELHI, ON 22/09/2012**

1. Aircraft  
    Type : Premier 1A  
    Nationality : INDIAN  
    Registration : VT - UPN
2. Owner/ Operator : Government of Uttar Pradesh.
3. Pilot – in –Command : ATPL holder (operating aircraft under privileges of open rating below 5700 kg)
4. Extent of injuries : Nil
5. First Officer : ATPL holder (operating aircraft under privileges of open rating below 5700 kg)
6. Extent of injuries : Nil
7. Place of Accident : IGI Airport, New Delhi
8. Date & Time of Accident : 22<sup>nd</sup> Sep 2012 0600 UTC(Approx.)
9. Last point of Departure : Lucknow
10. Point of intended landing : New Delhi
11. Type of operation : Non- Schedule Operation
12. Passengers on Board : 04  
    Extent of injuries : Nil
13. Phase of operation : Landing
14. Type of Accident : Heavy landing and subsequently runway excursion

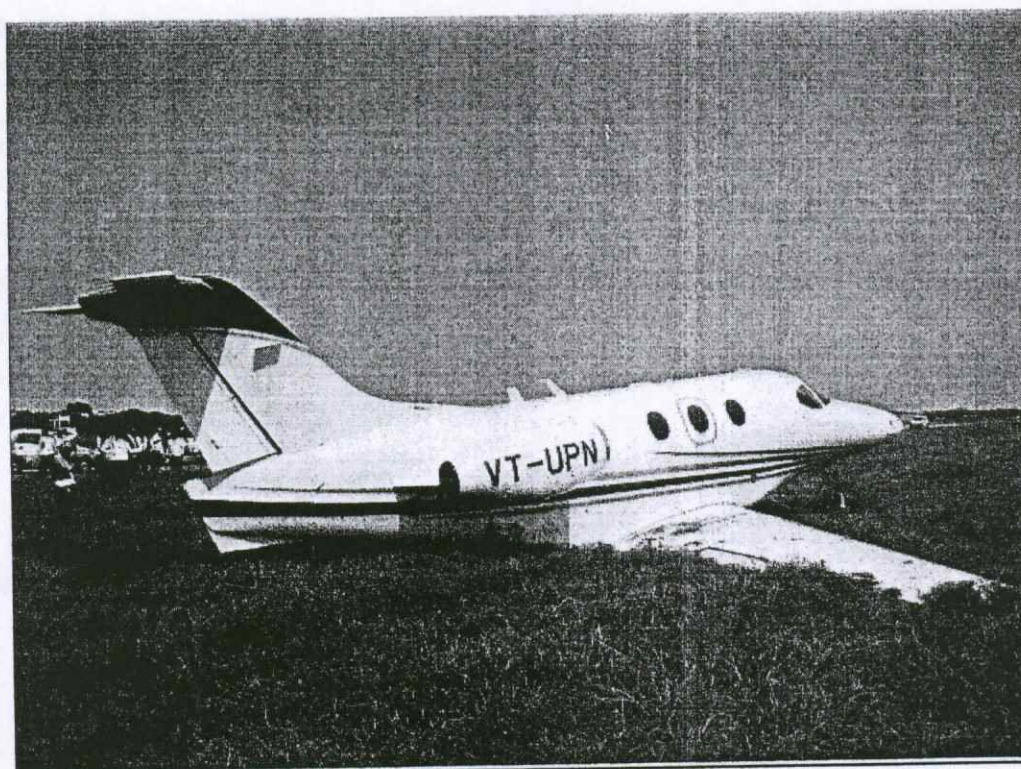
Final rest position of the aircraft in Kutcha (Soft Ground)

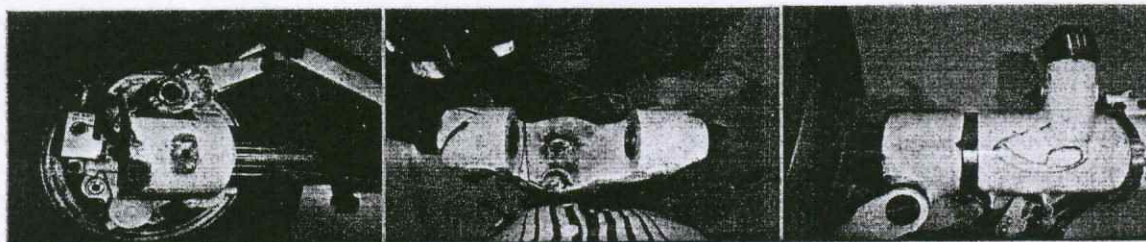
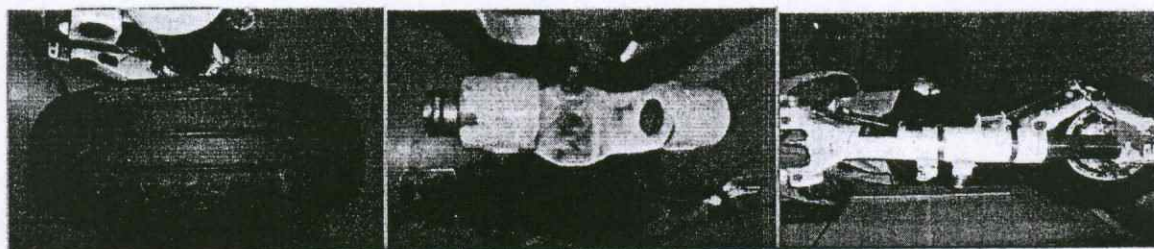
a) Left & Right Landing Gear sheared off due to impact.

- LH Shock strut has deep scratch, rub marks, which appears to be dragged on hard surface like concrete run way (Fig-1),
- Top view of LH & RH oleo- scratches to oleo body and pins (Fig-2,5), it suggests, this gear sheared off and dragged over concrete runway
- Fig-3, oil leak from gland seal, suggests impact;
- Fig-3, shows lower attachment point of LH Main Landing Gear's actuator;
- LH & RH tires are inflated, one cut mark on LH tire and unusual rub mark all around inboard periphery on RH tire-Fig(4)- it seems to be happened consequentially.
- Fig-6, RH full view, unlike LH, no deep scratch/rub marks, no sign of oil leak. It seems like it sheared off when aircraft off of the concrete runway.

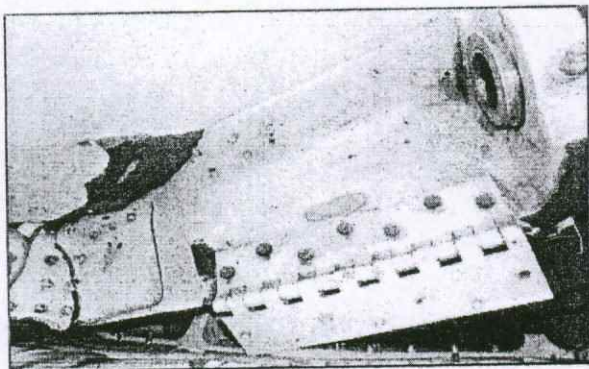
Fig-7(Side View-LH aft)

b) LH Trunnion Support broke in two pieces.

Forward portion broken and separated, aft section (bonded and riveted-as original) with aircraft.

- LH Main Landing Gear fwd attachment, which is part of Trunnion- Fig-11
- Teared (FWD)/isolated portion recovered- Fig-11;
- Aft portion of Trunnion, which is MLG's aft pin attachment- Fig-7, 9, 10;
- Scratch mark over pins.

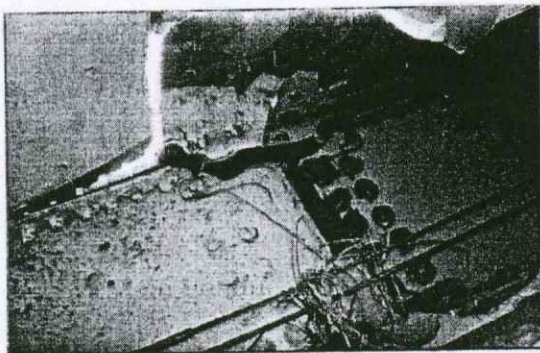
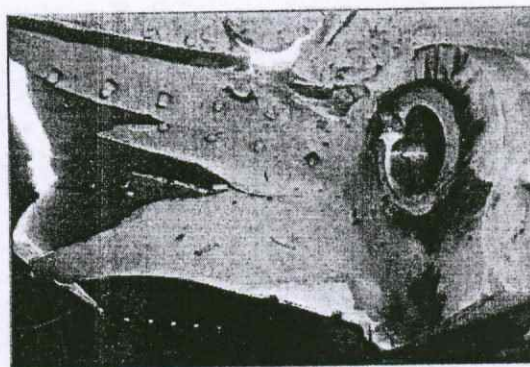
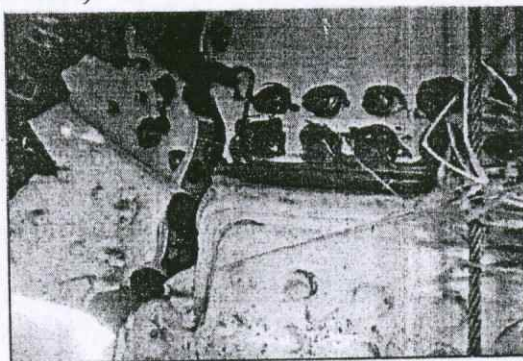
c) RH Trunnion Support broke in two pieces.

Trunnion Aft portion broke and separated, front portion with aircraft

- LH Wing Trunnion teared off in two parts, front one (Front Pin of MLG Pivotal support and bushing) separated and rear one with aircraft as in Picture- Fig-09,10,11
  - Top deep scratch mark over face of bushing of aft part of Trunnion.
- d) Wing Trunnion is bonded and riveted to wing skin and rear spar in which Landing gear's Pins pivot in bushings, since Trunnions are broken in two pieces landing gear sheared off, in turn, which leads to wing skin tearing in the same area where Trunnions are bonded and riveted.

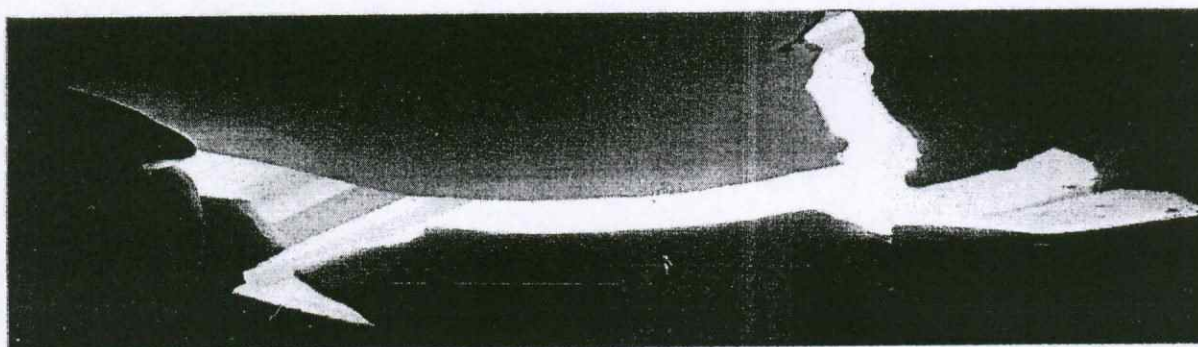
Fig-12(LH Bottom View) – Wing Skin

- Upper wing skin both side LH and RH teared off, exactly in areas, where Trunnions are bonded and riveted to rear spar and skin
- Rivets popped-out (Visible on top surfaces).

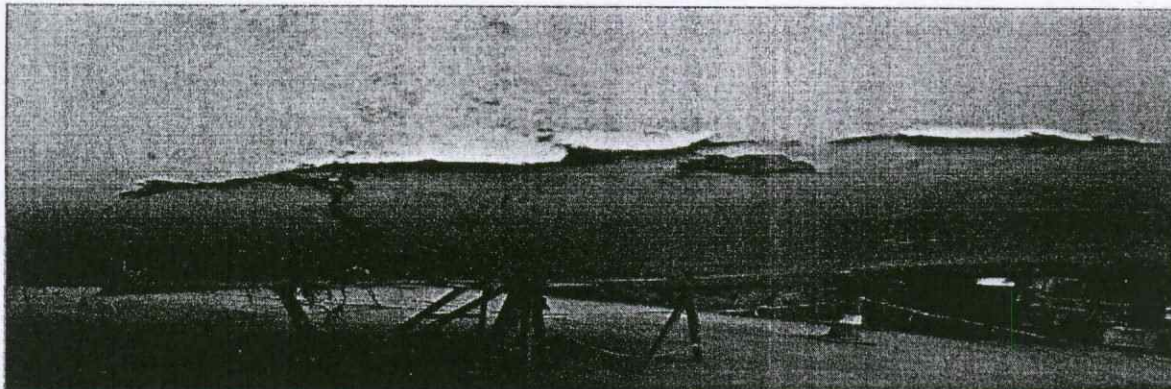
Fig-14 (Side View-LH)

- (30)
- e) Aft Fuselage Shell, LH side, visible fabric clothes/tearing – Damage to Aft fuselage Shell.

- Aft fuselage shell and its front attachment frame, sustained severe damage- Fig-14.
- f) LH and RH inboard and outboard flaps sustained severe damage;

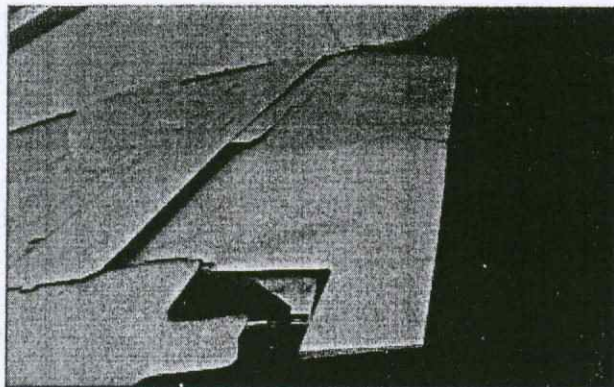
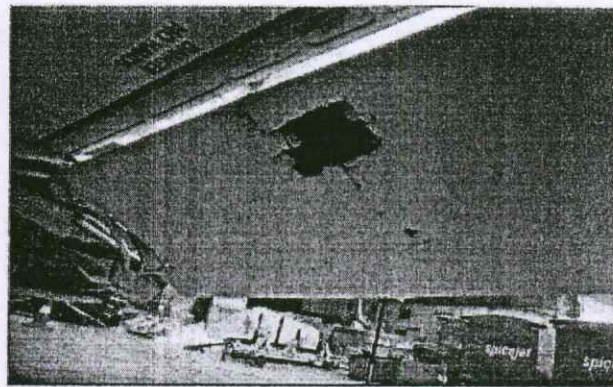
- Flaps are in landing positions i.e.30 degree;
- LH and RH Flaps are heavily damaged, bent, whole mark in lower surface as visible in Fig-15,16;
- Flaps are of composite and damaged.

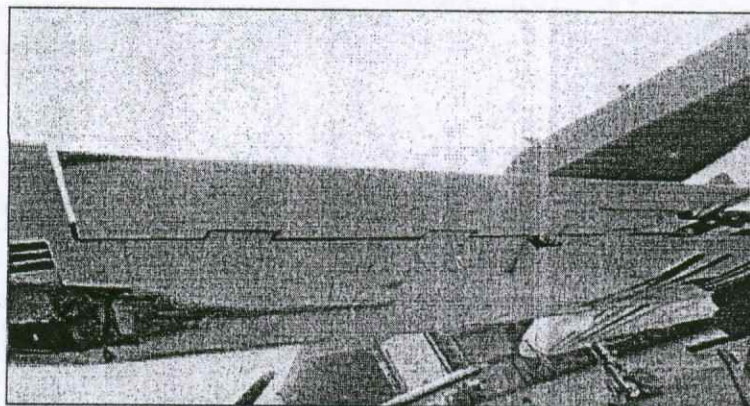
**Fig-17 (LH Aileron-O/B damage)**

g) LH and RH Ailerons sustained damage;

- LH Aileron O/B, in Fig-17, clearly shown damaged;
- RH Aileron sustained damage;
- Both Ailerons heavily damaged.

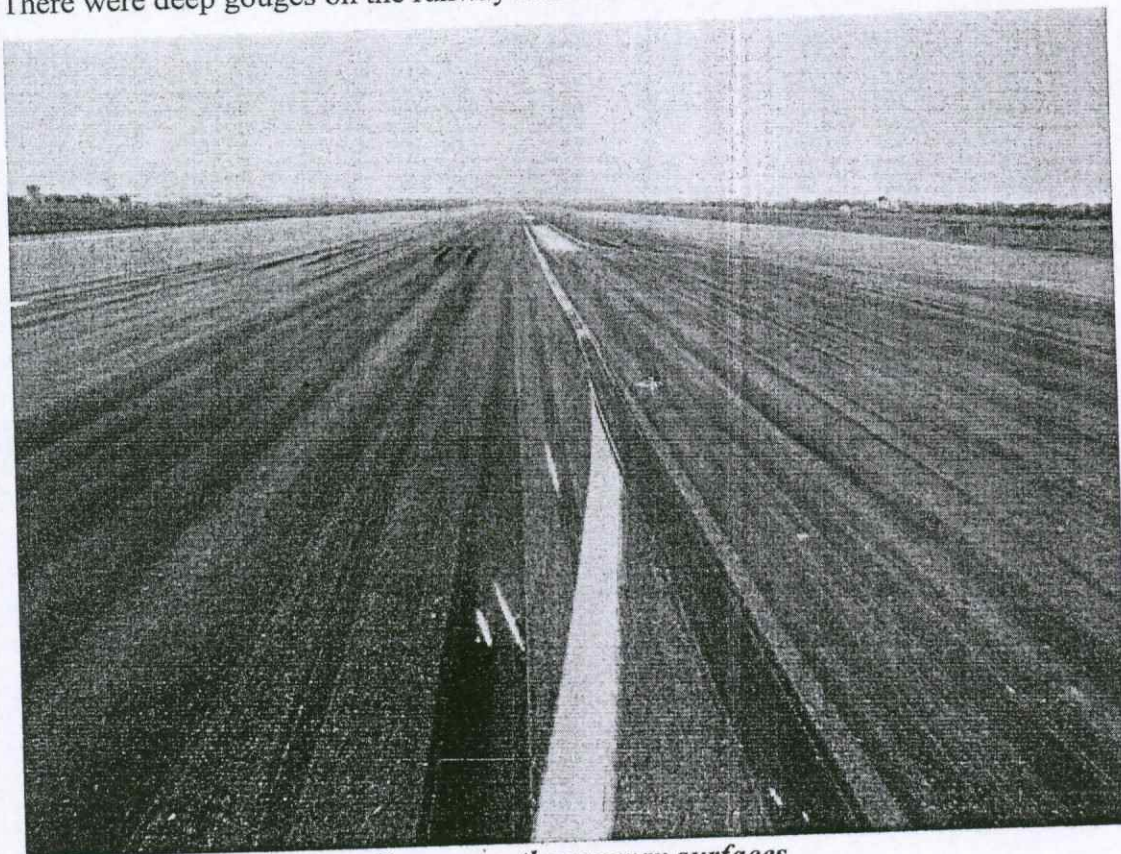
There were deep gouges on the runway surfaces and 01 runway lights were broken.

*Gouges on the runway surfaces*

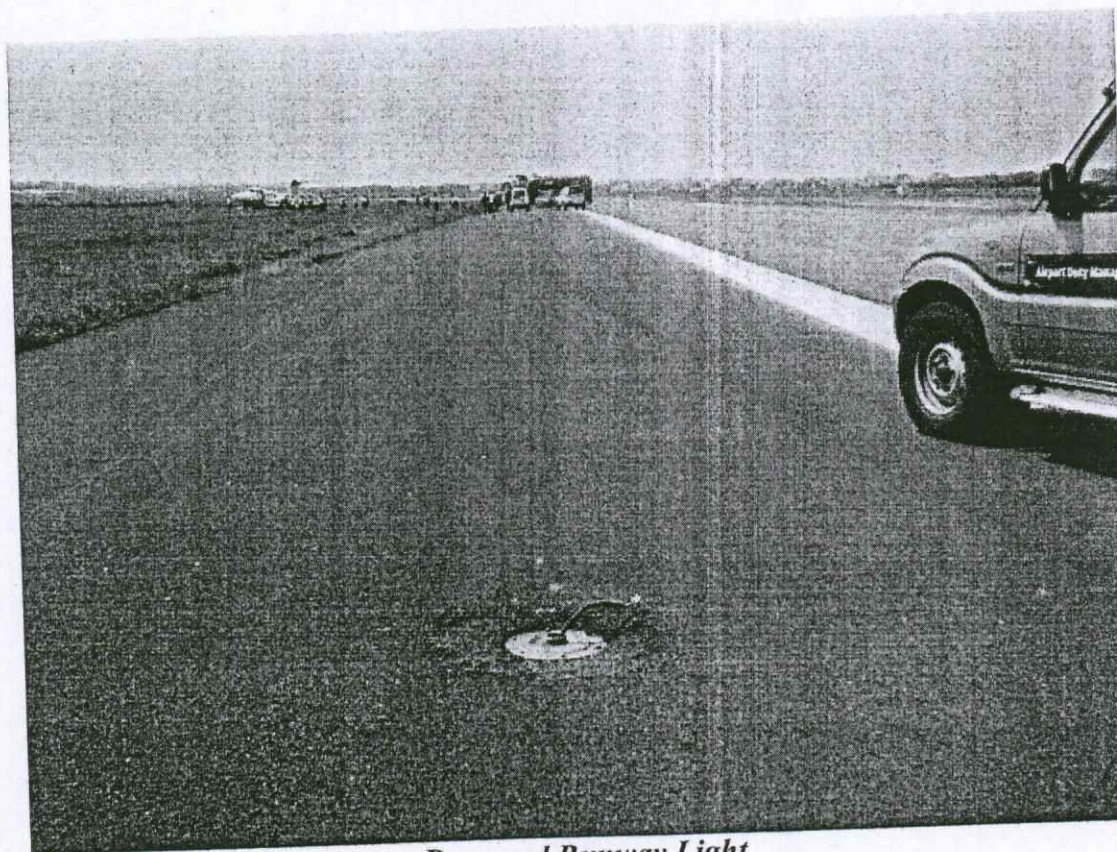
*Damaged Runway Light*

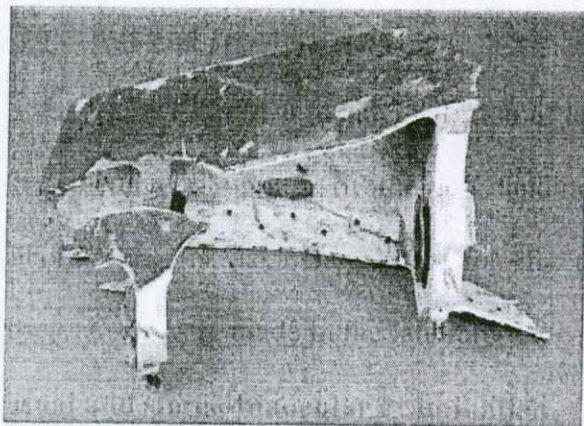
Figure I

The left main gear Trunnion (LH) is shown in Fig.I. Examination revealed that one of the fork arms had fractured close to the eye-end, while the other arm was found intact. In addition to the fracture of the fork arm, the Trunnion had damages in the form of fractures at various attachment points (refer Fig.II).

**Fractographic study confirmed that Trunnion (LH) of the landing gear had fractured under overload.** Presence of Chevron marks on the fracture surfaces indicates fast propagation of cracks during fracturing of the Trunnion. **Hence, it can be concluded that the component experienced sudden overload during landing of the aircraft.**

(a) The fracture of the Trunnion (LH) was a one-time failure and had occurred under sudden overload. There were no evidences of progressive mode of failure such as fatigue and/or stress corrosion cracking.

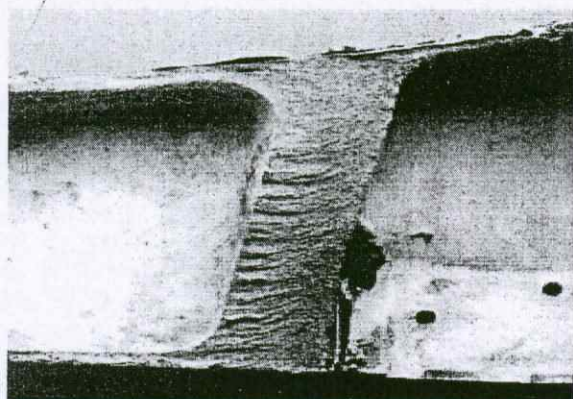
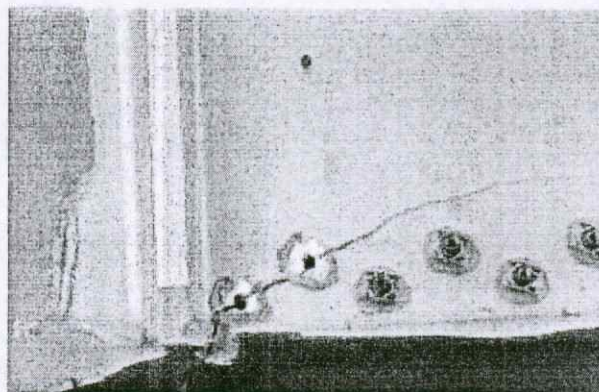
Figure III

A sample containing the fracture initiation region marked in Fig.III was cut, cleaned ultrasonically in ethyl alcohol and examined under a scanning electron microscope (SEM).

The fracture surface showed woody structure interspersed with fine dimples, typical of overload features in wrought Al-alloys.
