**FINAL INVESTIGATION REPORT OF ACCIDENT TO PAWAN
HANS LTD. DAUPHIN AS 365 N3 HELICOPTER VT-PHZ AT
HARSIL HELIPAD UTTARAKHAND ON 28/06/2013.**

- | | |

| Registration | : VT - PHZ |
| 5. Place of Accident | : Harsil Helipad, Uttarakhand |

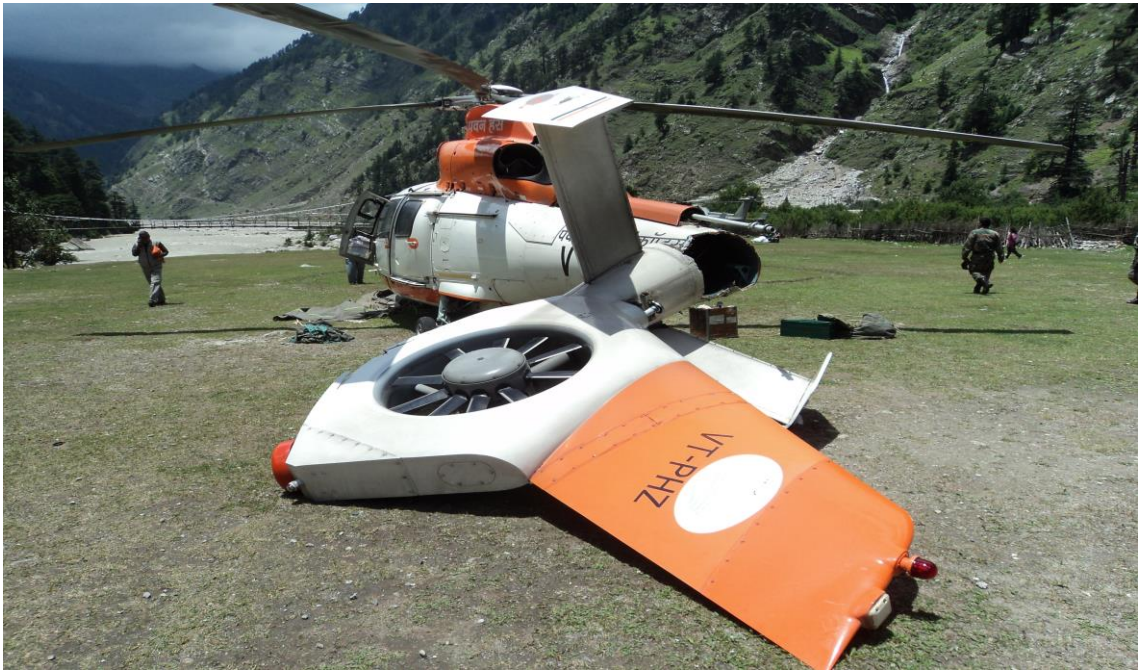
Aft structure of helicopter VT-PHZ was substantially damaged

The helicopter sustained damage mainly on the aft structure. Following damages were observed during inspection.

1. The tail boom had ruptured near stabilizer junction resulting in damage to Tail Boom, Tail rotor (fenestron) and fin. The Horizontal stabilizer on RH side had broken from tail boom attachment junction and also the fin was half broken from the lower end.
2. Internal wiring broken and hydraulic lines inside the horizontal stabilizer was found ruptured.
3. The top cowlings of both MGB and engine showed the tearing marks with exposed honeycomb indicating flapping of rotor head.

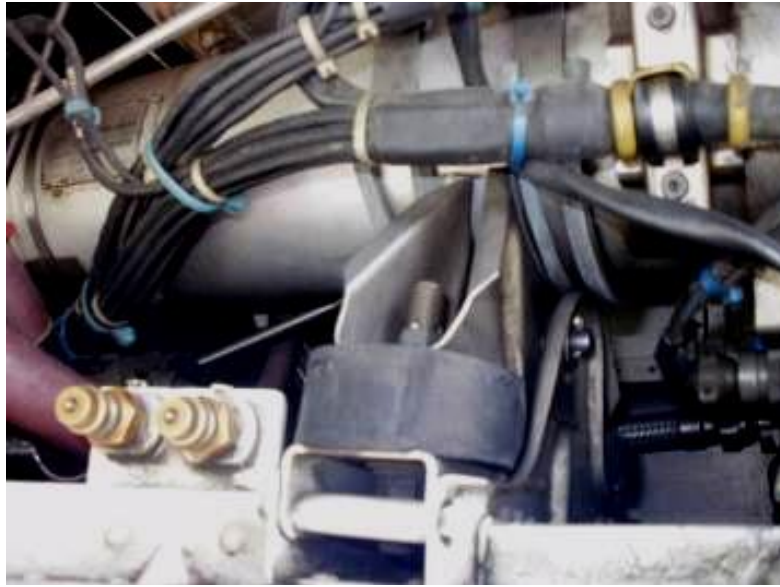
4. The LH engine mounting cradle appeared with converged lips (compression), supporting the tube.

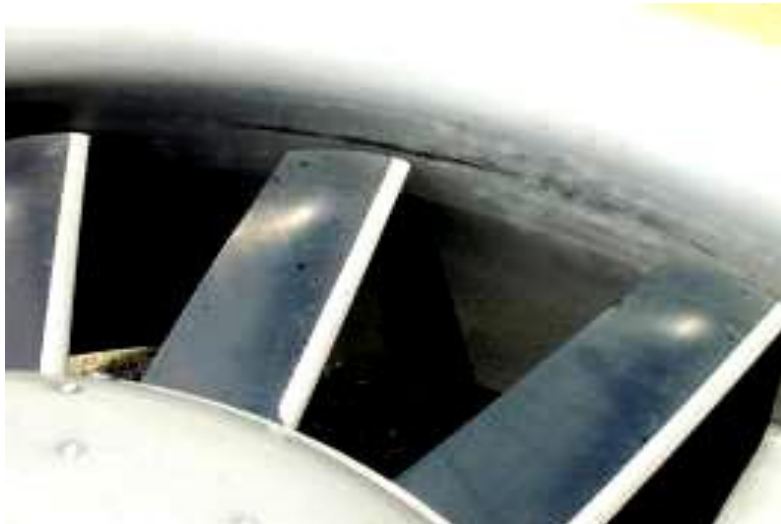
5. The fenestron blades had punctured the inner lip of the structure.

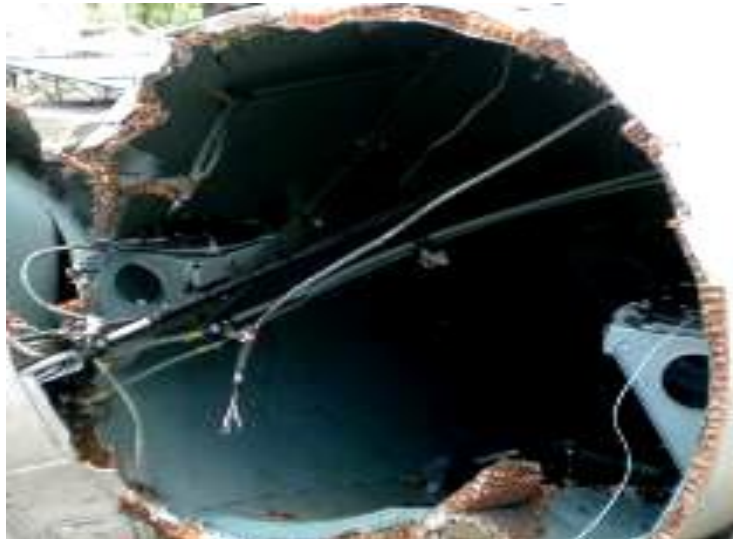
6. The Centre and aft Tail drive shaft were also snapped from the bearing housing on the tail boom and broken near the joint. The yaw control rod joining between tail rotor and tail boom had broken. The tail drive shaft fairing was broken along with the tail boom. Near the tail boom rupture line, the two flux valves were slightly damaged.

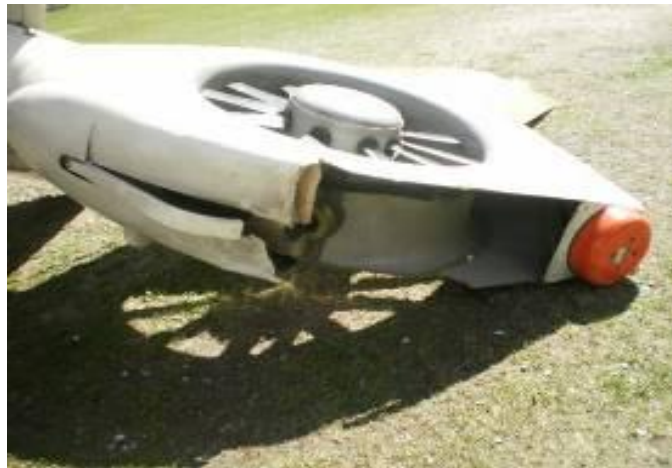
7. Along with the tail skid, the fenestron bottom area near to tail skid was broken. However, the skid plate showed no rubbing marks. The Beacon unit on the tail was in position, however, the fenestron skin was separated due to impact.

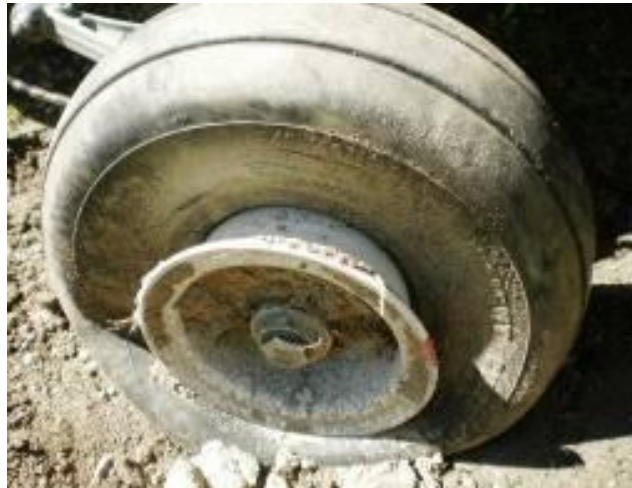
8. The HF antenna near tail boom junction from tubing was dislodged due to impact.
9. The landing gears did not show any evidence of breakage or leakage of fluid etc.. However the RH tyre had deflated and crumpled on rim with ground mud accumulated till centre of hub and this was not evident on LH wheel, which was found intact and without any mud accumulation.

RH- Main wheel deflated and damaged

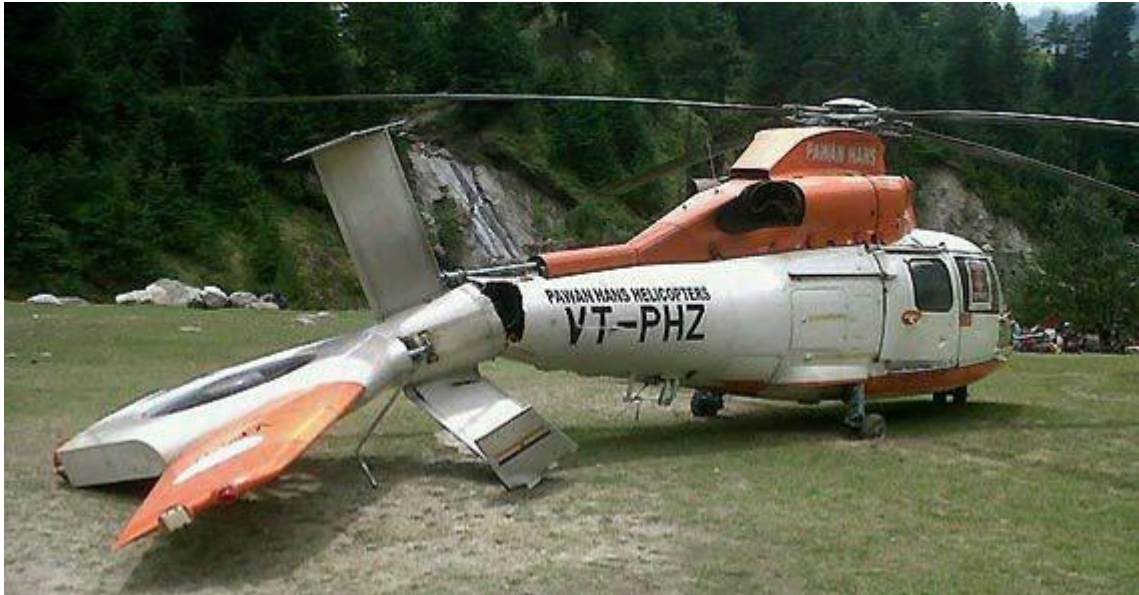
On the top cowlings of both MGB and engine cowling there is an evidence of tearing marks by exposed honeycomb which had occurred due to flapping of rotor head. Due to heavy impact, the left engine mounting cradle had converged lips supporting the tube.

The helicopter made a heavy touchdown as was evident from the wheel marks on the ground. Though the landing gears did not show any evidence of breakage or leakage of fluid etc., the RH tyre had deflated and crumpled on rim and bogged down in mud up to its centre. However, the LH wheel was intact and without mud.
