**FINAL INVESTIGATION REPORT ON
SERIOUS INCIDENT TO M/s. PAWAN HANS
LTD. DAUPHIN SA 365 N HELICOPTER
VT-ELR ON 20.11.2013
NEAR CHOWRA ISLAND.**

FINAL INVESTIGATION REPORT ON SERIOUS INCIDENT TO M/s.PAWAN HANS LTD. DAUPHIN SA 365 N HELICOPTER VT-ELRON 20.11.2013 NEAR CHOWRA ISLAND.			
1	Aircraft		
		Type	DAUPHIN SA 365 N HELICOPTER
		Nationality	Indian
		Registration	VT-ELR
2	Owner		M/s Pawan Hans Ltd.
3	Operator		M/s Pawan Hans Ltd.
4	Pilot – in –Command		Flying under Rule 160
		Extent of injuries	None.
5	Co Pilot		Flying under Rule 160
		Extent of injuries	None.
6	No. of Passengers on board		05
	Extent of Injuries		None
7	Last point of Departure		Kamorta Helipad.
8	Intended landing place		Car Nicobar Helipad.
9	Place of Incident		About 35 NM from Kamorta Helipad.
10	Date & Time of Incident		20.11.2013, 05:55 UTC
11	Type of Incident		Rear Sliding/flap Door Flown off during flight

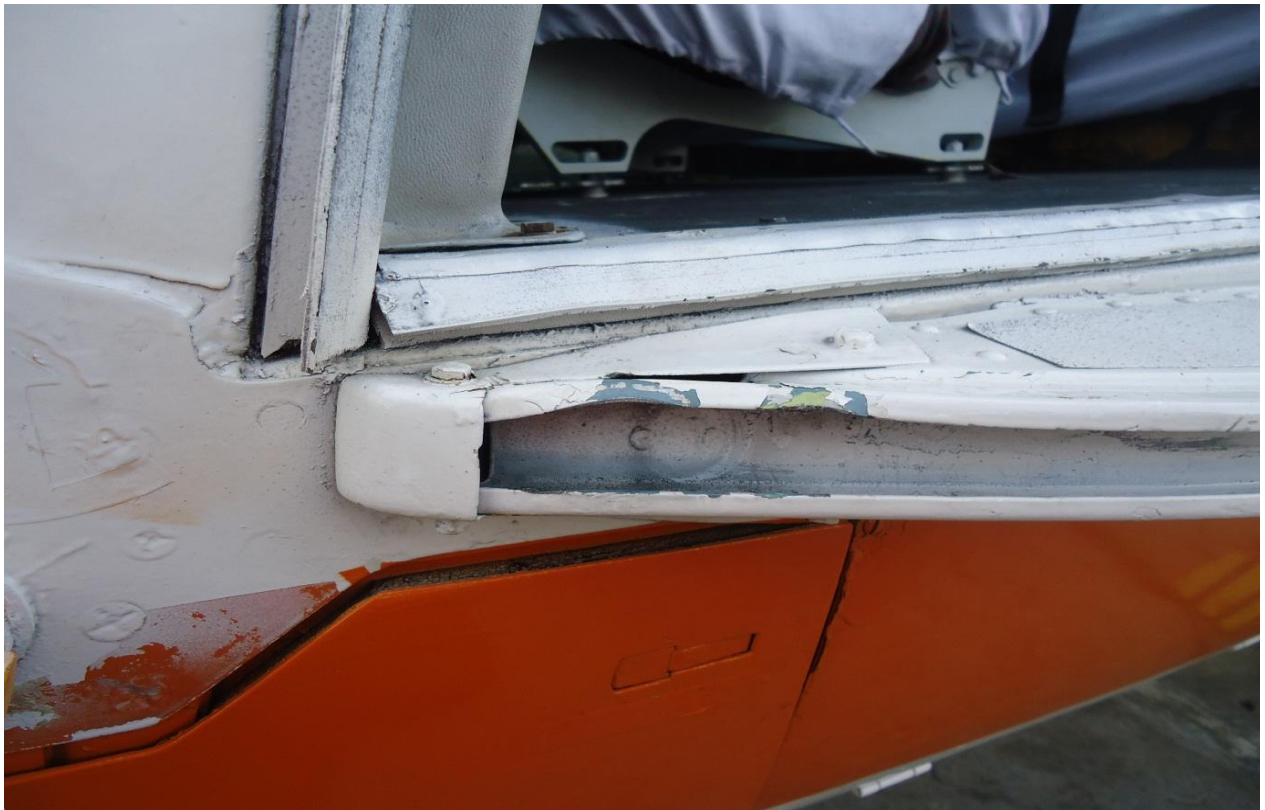
2. LH Sliding door lower rail had two curved displacement of the upper side rail near the forward end due rollers being forced through it.

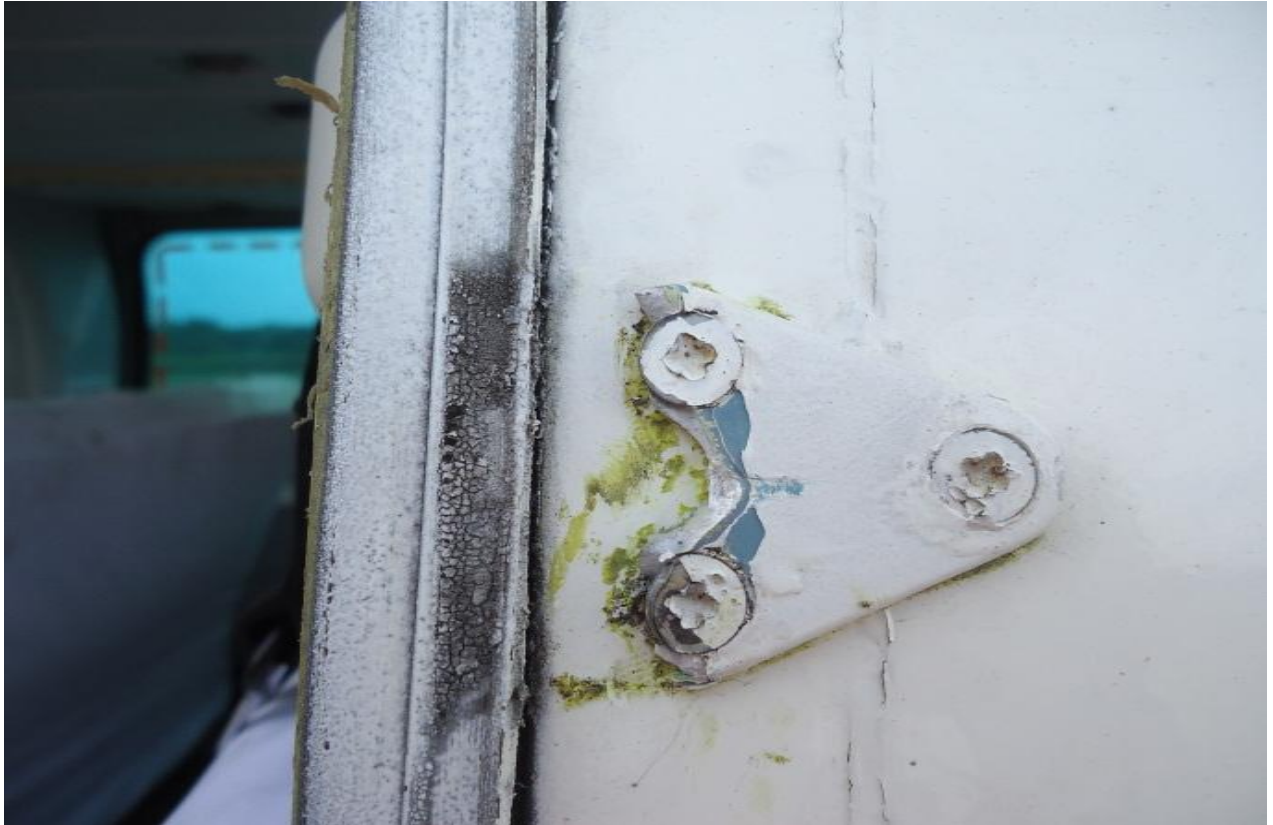
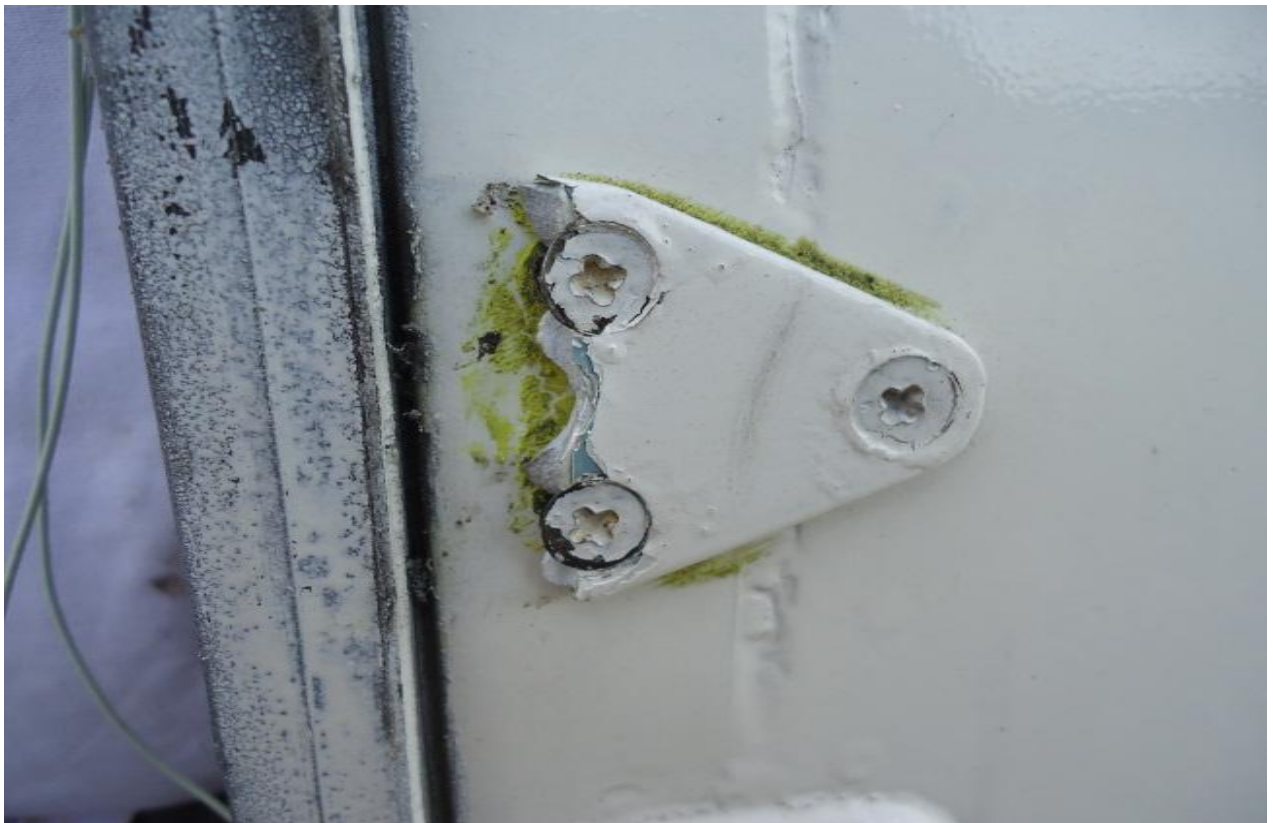
3. Flap door locking plates(upper & lower) were sheared off.

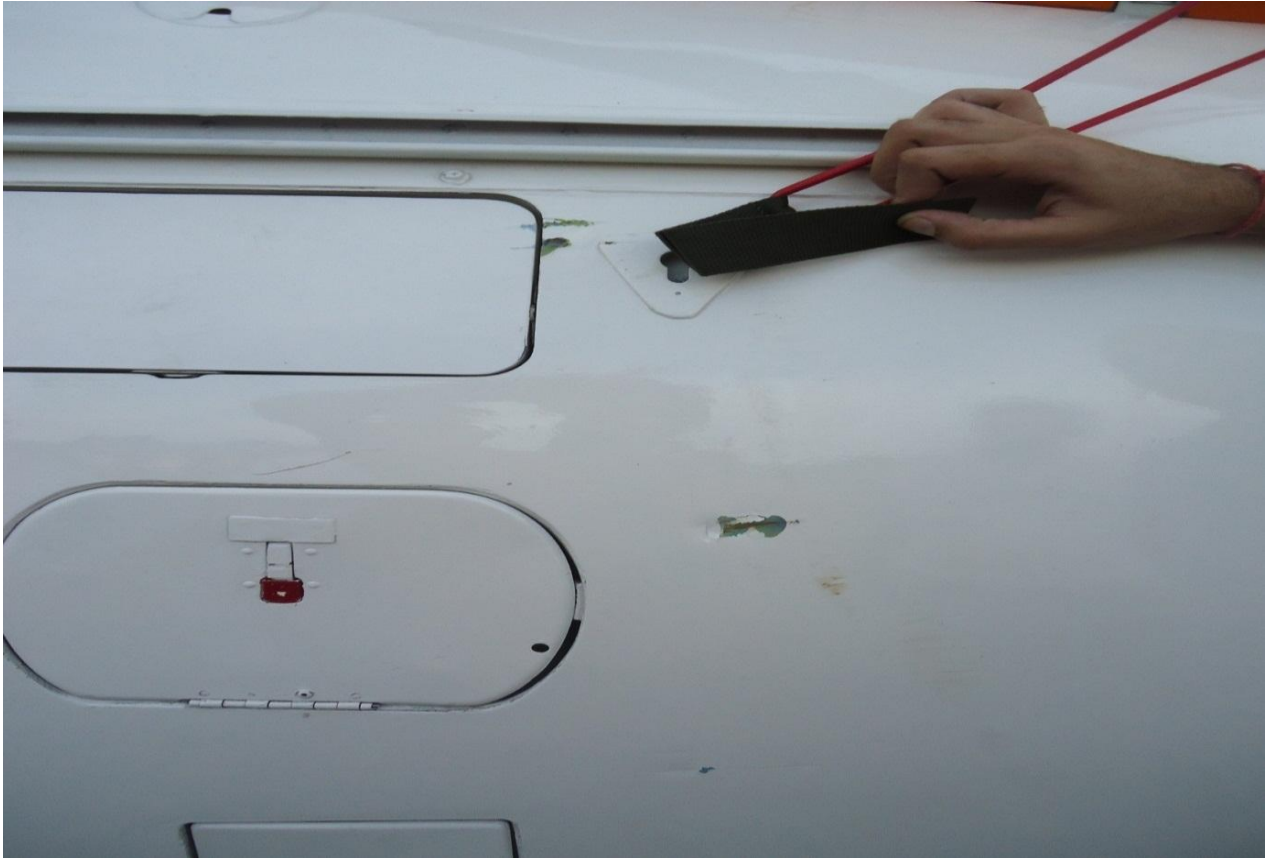
4. Small Dents and marks rear of the refueling point.

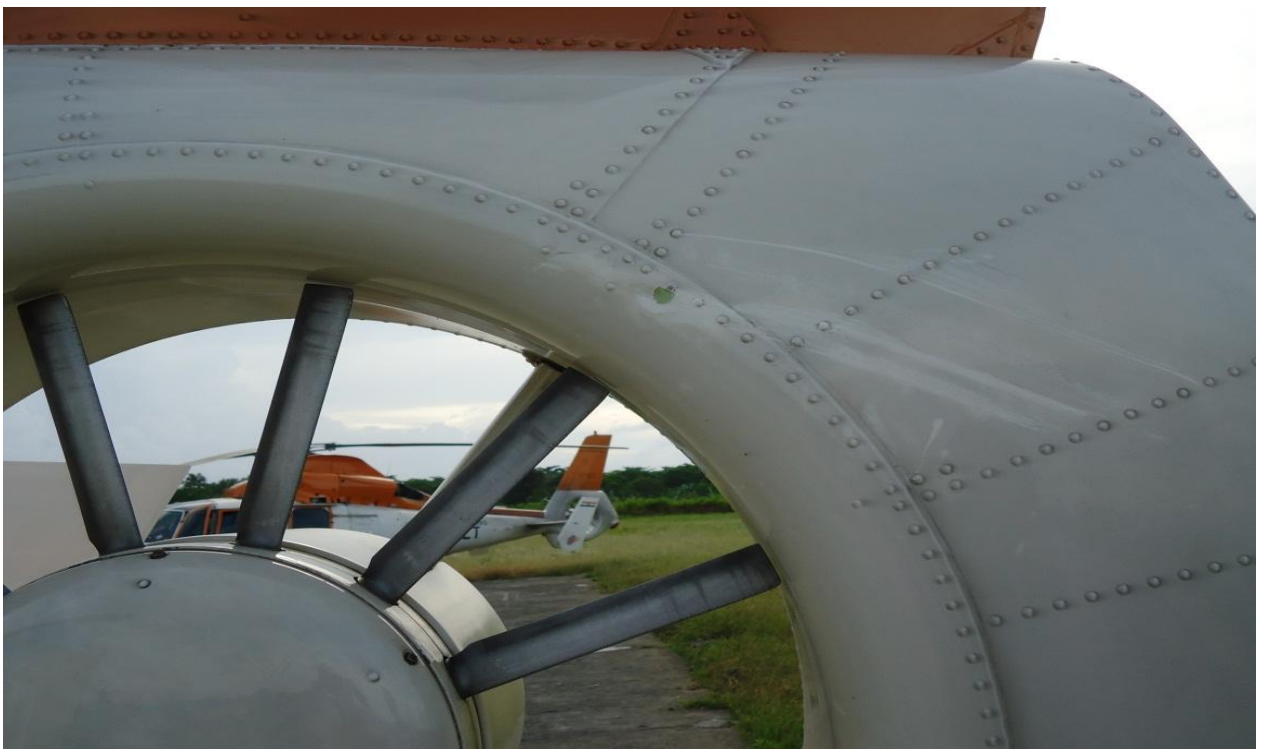
5. Small Dents and Rubbing marks over 2 O’Clock position on the Fenestron.

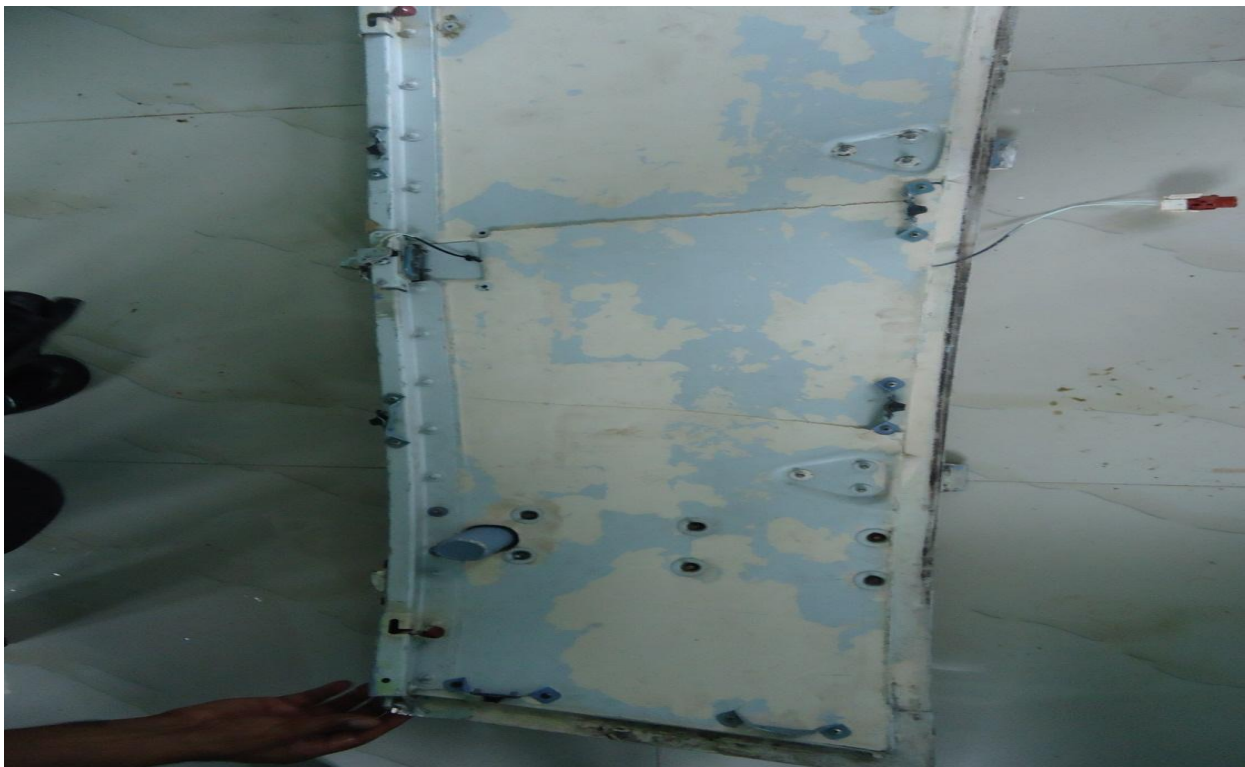
6. Damaged Flap door recovered from the Sea Coast on 22.11.2013.

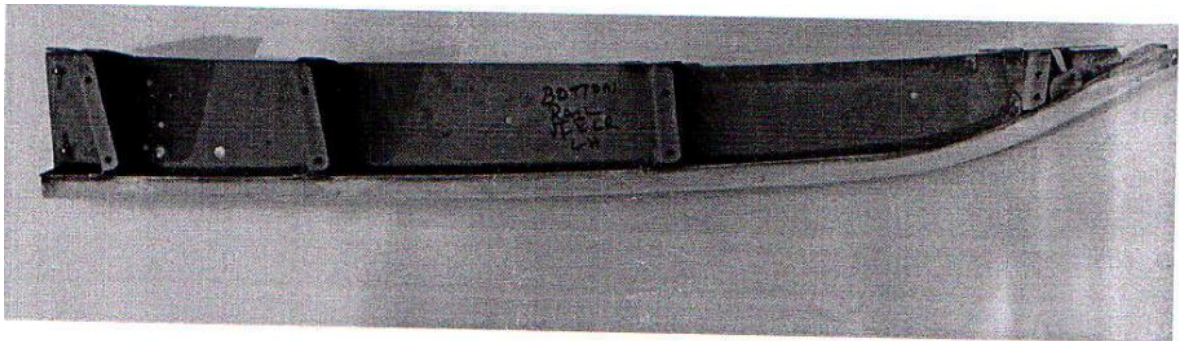
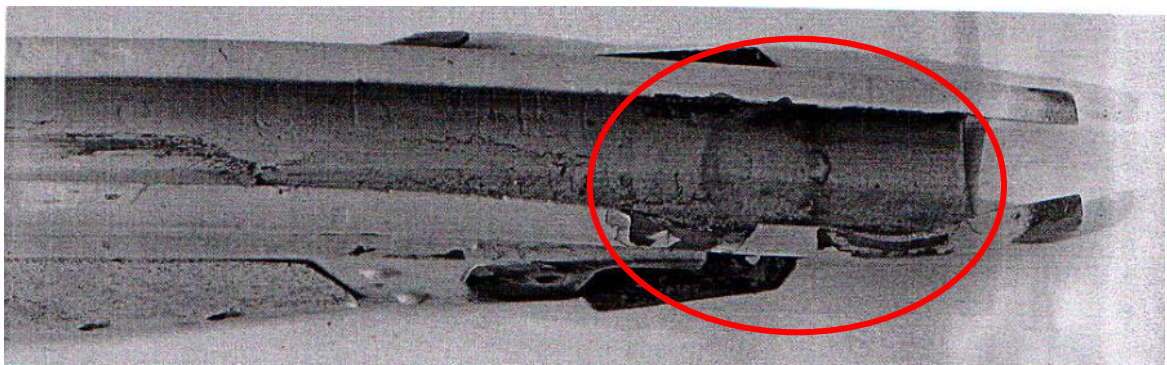
Both ends of the lower rail along with complete rail portion were examined on the microscope as shown in Fig. 1(a) & 1(b). On one end, there is an evidence of excessive load/ oversize marking of the roller as shown in figure:-

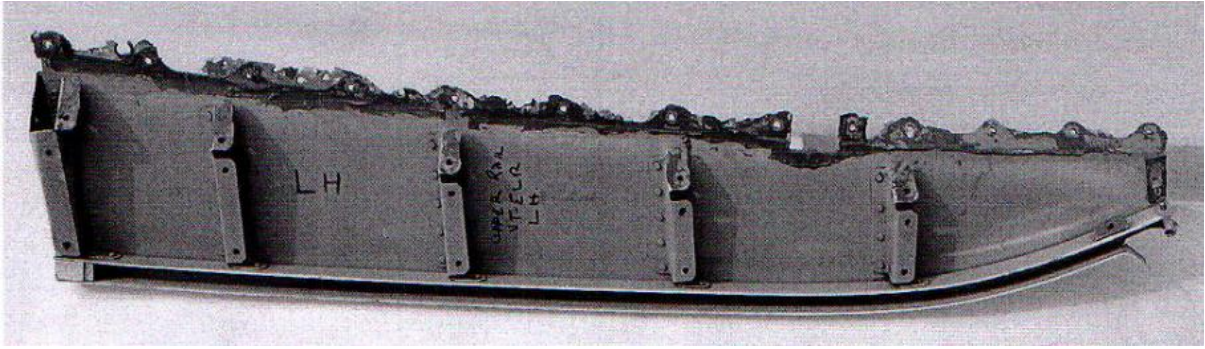
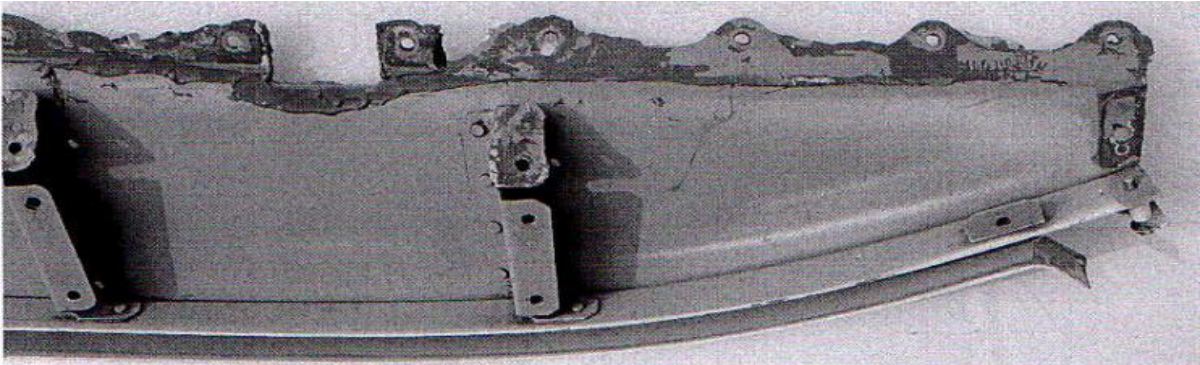
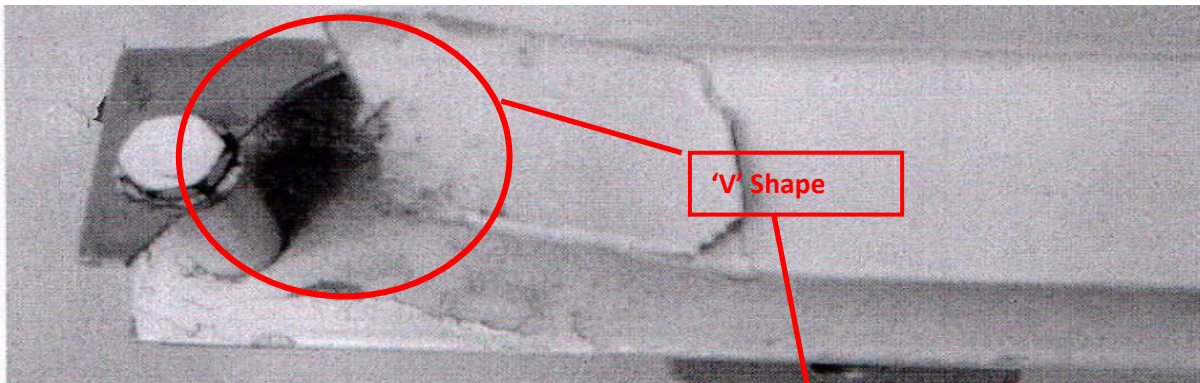
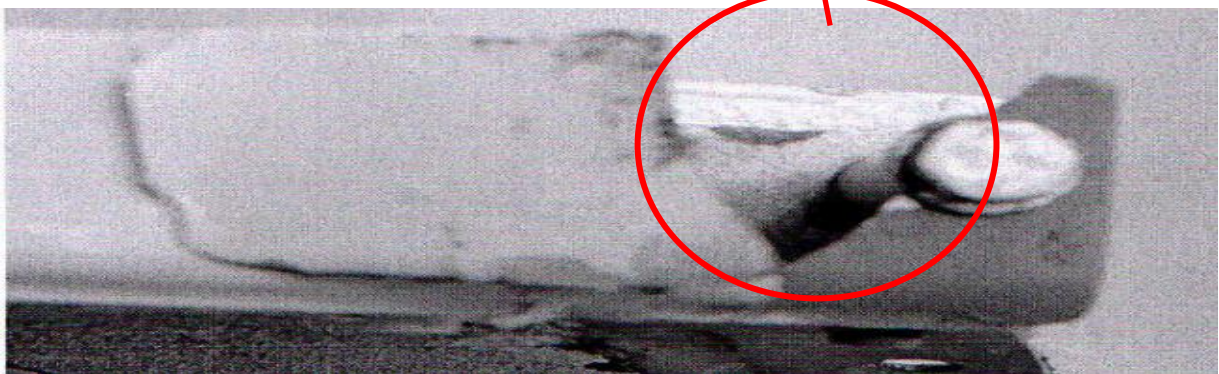
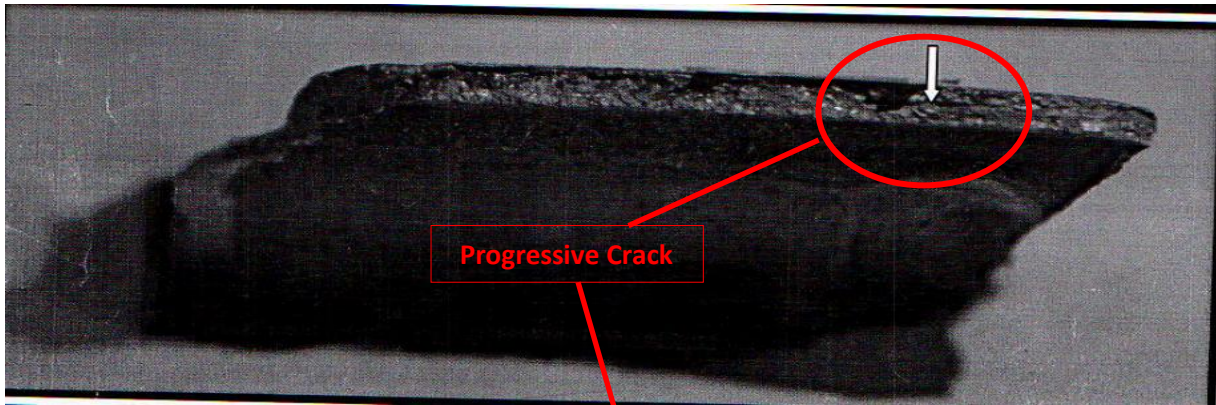
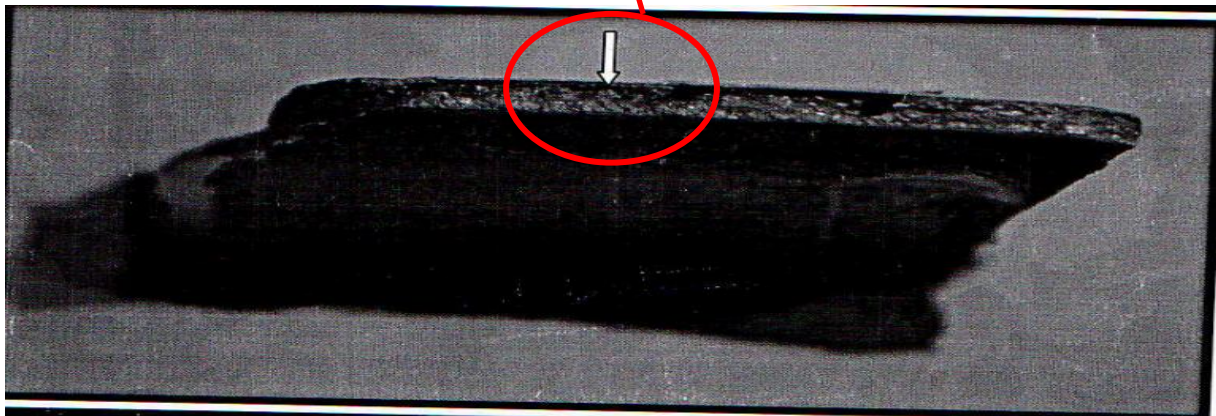
Complete rail portion was examined on the microscope as shown in Fig 2(a) & 2(b). It was noticed that on one end, some portion of the rail was found bent. After straightening the bent portion, it was found that some portion ('V' shape) was missing as shown in Fig 2(c) & Fig 2(d). It appears that this portion might have gone missing after fracture during the helicopter operation, the remaining mating portion of 'V' shape was cut to observe the fracture surface. The same was prepared for detailed examination after cleaning with acetone. Fig. 3(a) 3(b) are the fractographs indicating the slowly developed progressive crack originating from bolt hole followed by final overload fracture.

The missing(V-shape) portion was found to be cracked in a progressive manner as shown by smooth fracture on available fracture surface which has probably initiated from the bolt hole, the bent portion of rail shows that overload might have caused the bend resulting into detachment of V shaped portion.

The probable cause of the incident is due to the progressive failure of upper rail followed by final overload fracture which created excessive air pressure through the partially opened LH door forcing both LH Sliding and flap door to detach from its security of attachment and consequently resulted into the incident.

- 4.1 M/s PHL may review the in-house procedures on frequency of inspection on the door operation including its security of attachment.
- 4.2 M/s PHL may review the in-house procedures for traceability of non-serialized part and shall reflect in the respective log book whenever any such part is replaced/cannibalized.

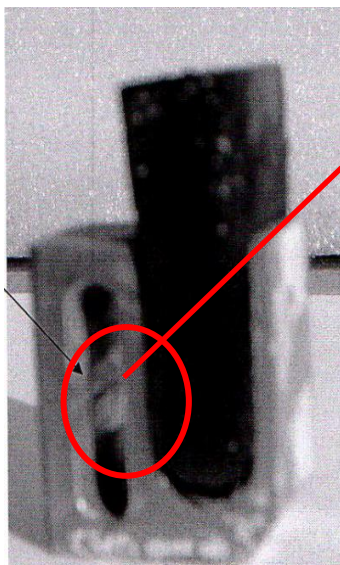
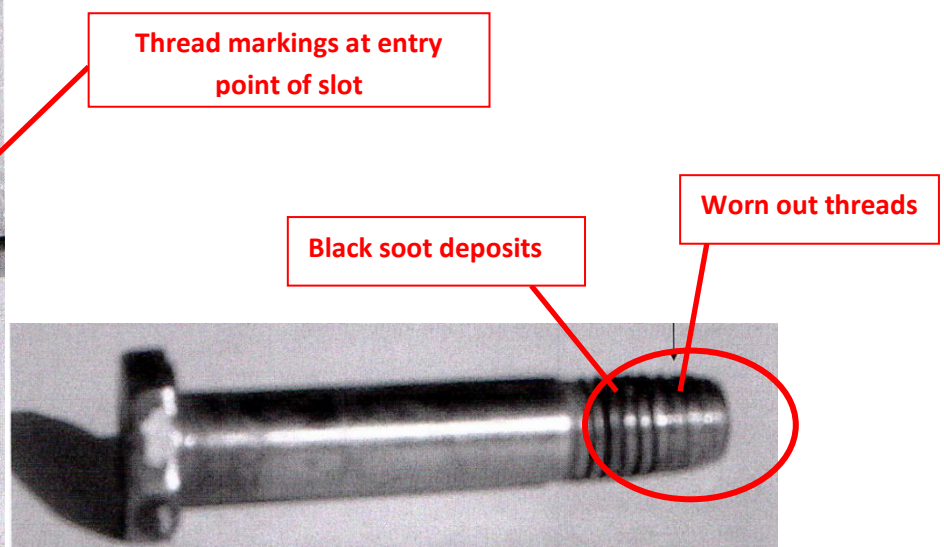
Sliding door stop & screw was studied on the microscope as shown in fig. 4(a) & 4(b). Some threads markings were observed at the entry point of the slot perhaps due to misalignment of stop & screw during the service. Initial portion of the screw threads were found worn out. On the remaining threads, black soot was found deposited.

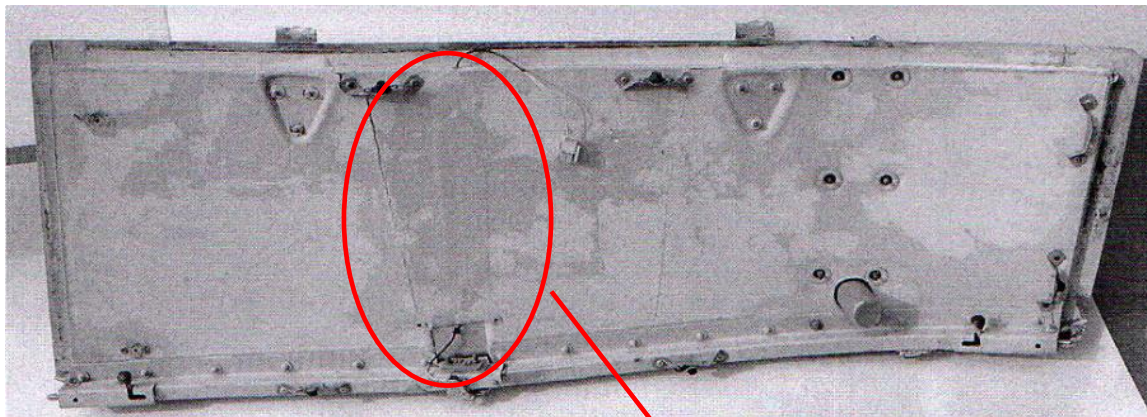
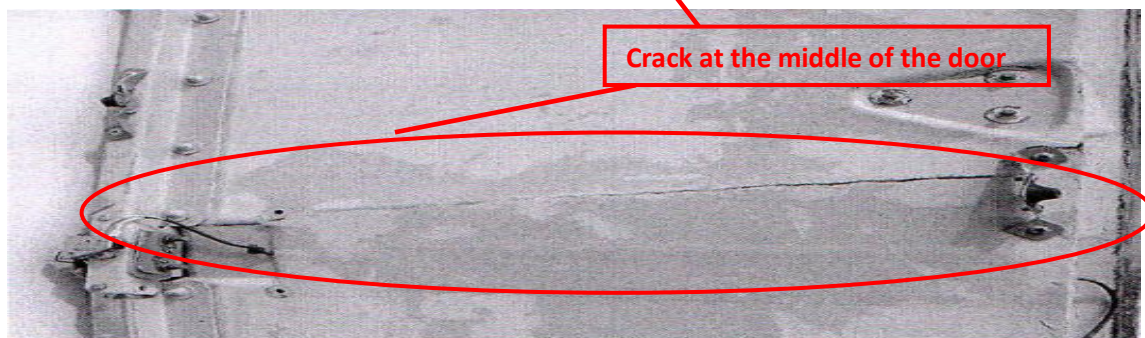
Flapdoor is shown in fig 5(a) & 5(b). After inspection, it was found that door was cracked from the middle (approx.), which is perhaps due to bending of door post incident.

The fixed door and its central lock was found cracked probably due to post failure damage.

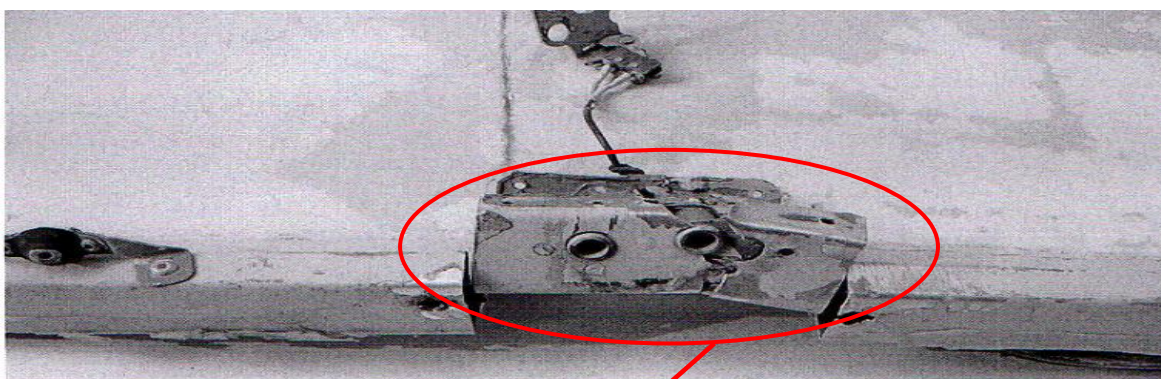
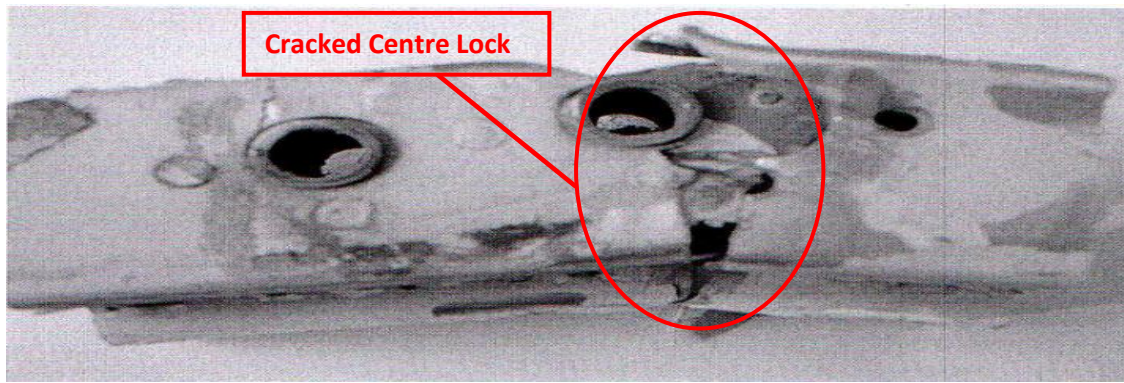
Examination of the centre lock revealed that it has cracked (fig. 5d).

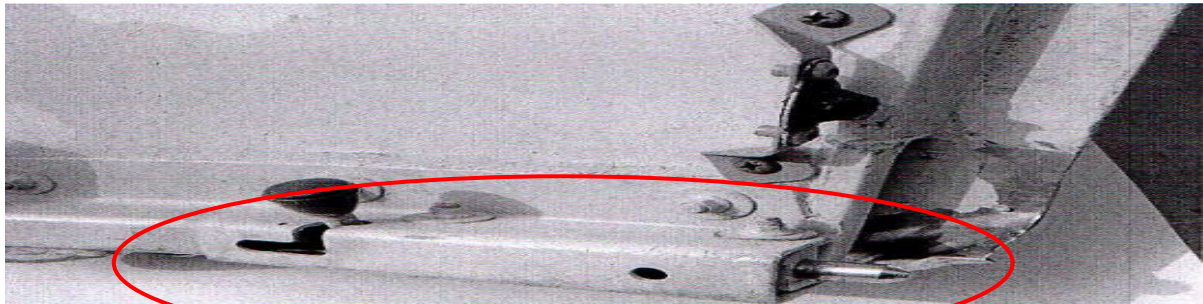
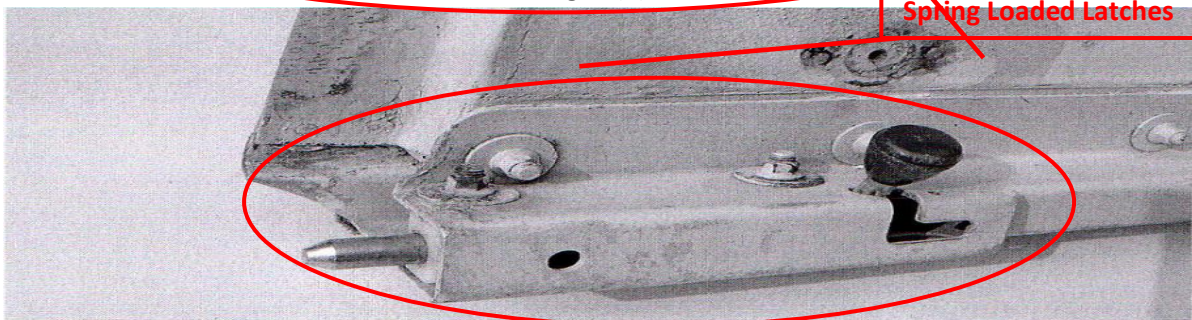
Spring loaded Latches were available on the both sides of the door as shown in fig 5(e) & 5(f). Both latches were found in intact condition as shown in figures.
