**FINAL INVESTIGATION REPORT ON SERIOUS INCIDENT**  
**TO M/s CATHAY PACIFIC LTD. BOEING B747-400**  
**AIRCRAFT REGISTRATION B-HUL AT IGI AIRPORT**  
**DELHI ON 27.07.2015**

**COMMITTEE OF INQUIRY B-HUL**

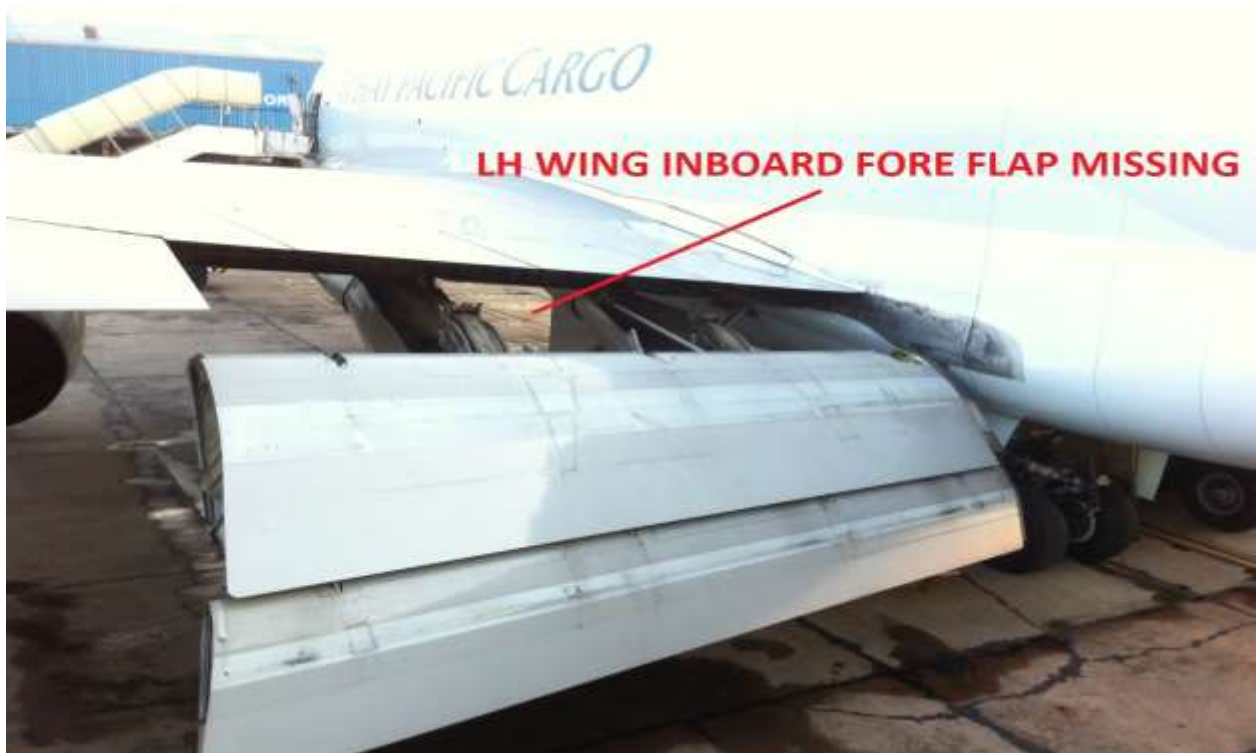
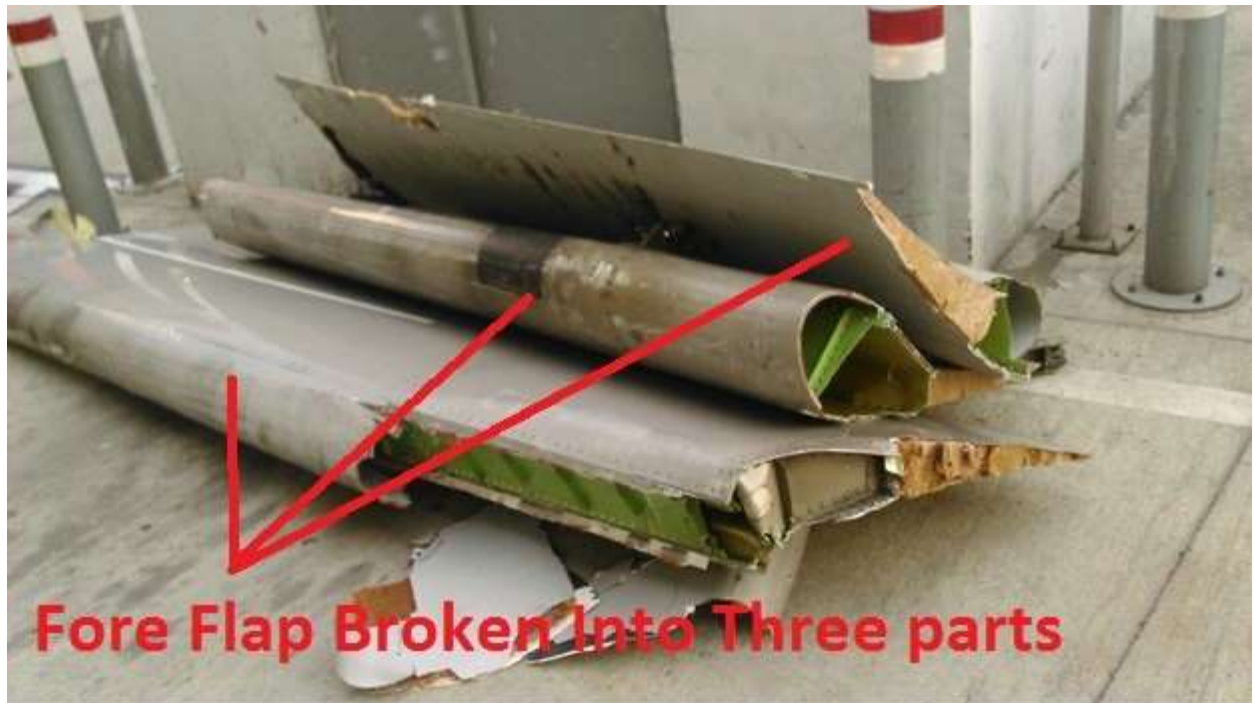
The left wing inboard trailing edge fore-flap detached from its mounting. The fore flap fell on the runway and was broken into three pieces.

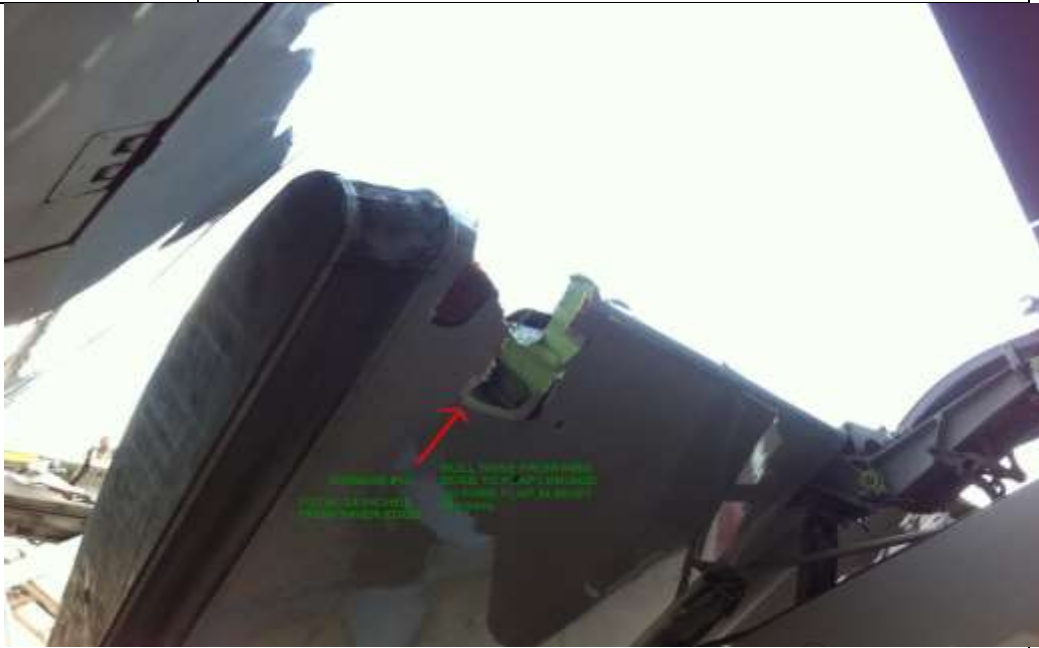
| Damage 1 | Damage 1A | Bull Nose of about 24 Inches from inboard edge was found missing. |

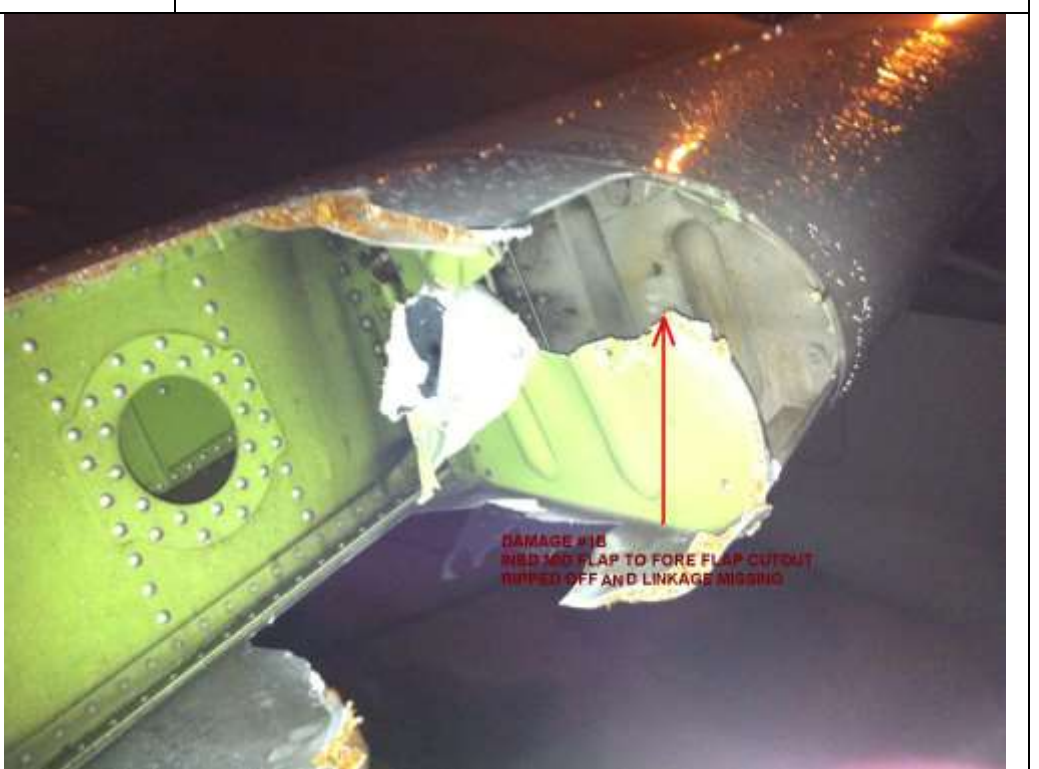
| Damage 1B | | Inboard Mid Flap to foreflap Cut out was found Ripped Off. |

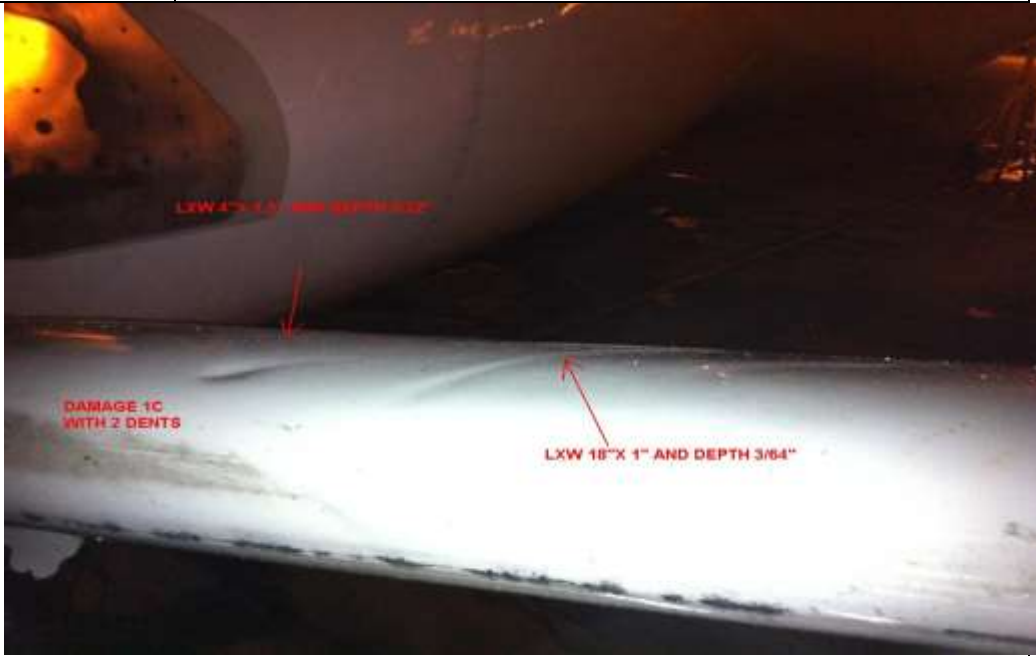
| | Damage<br>1C | 2 Dents Measuring 4" X 1.5" X 3/32" and 18" X 1" X 3/64" were found on the upper surface of the mid flap. |

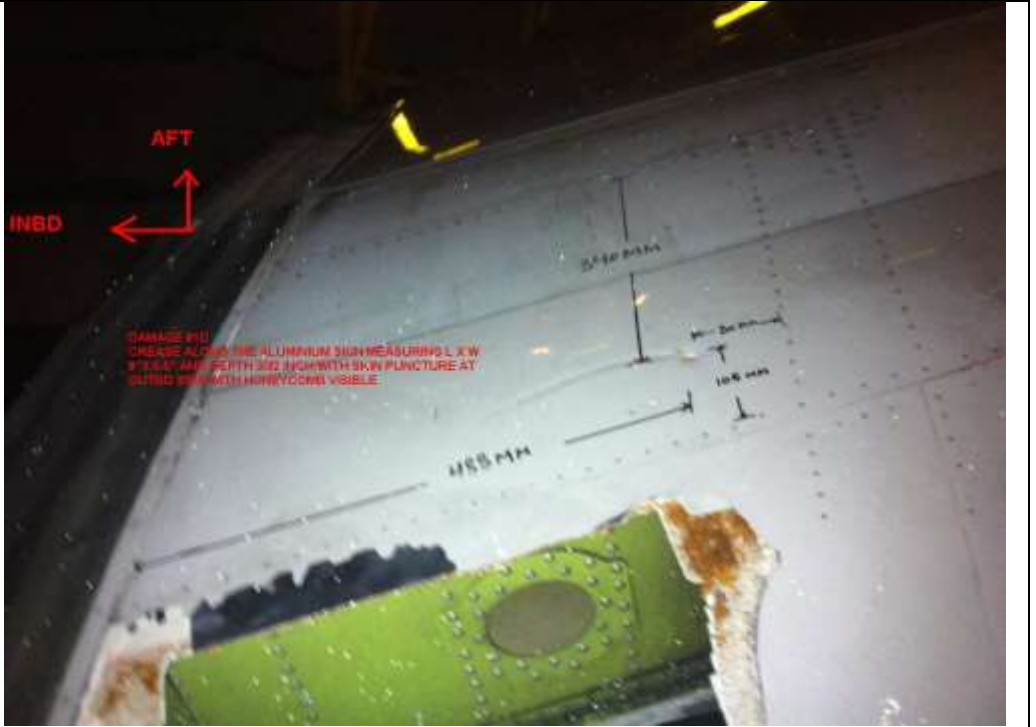
| | Damage<br>1D | Crease along the AL Skin 9" X 0.5" X 3/32" with skin puncture at outboard side and Honeycomb Visible. |

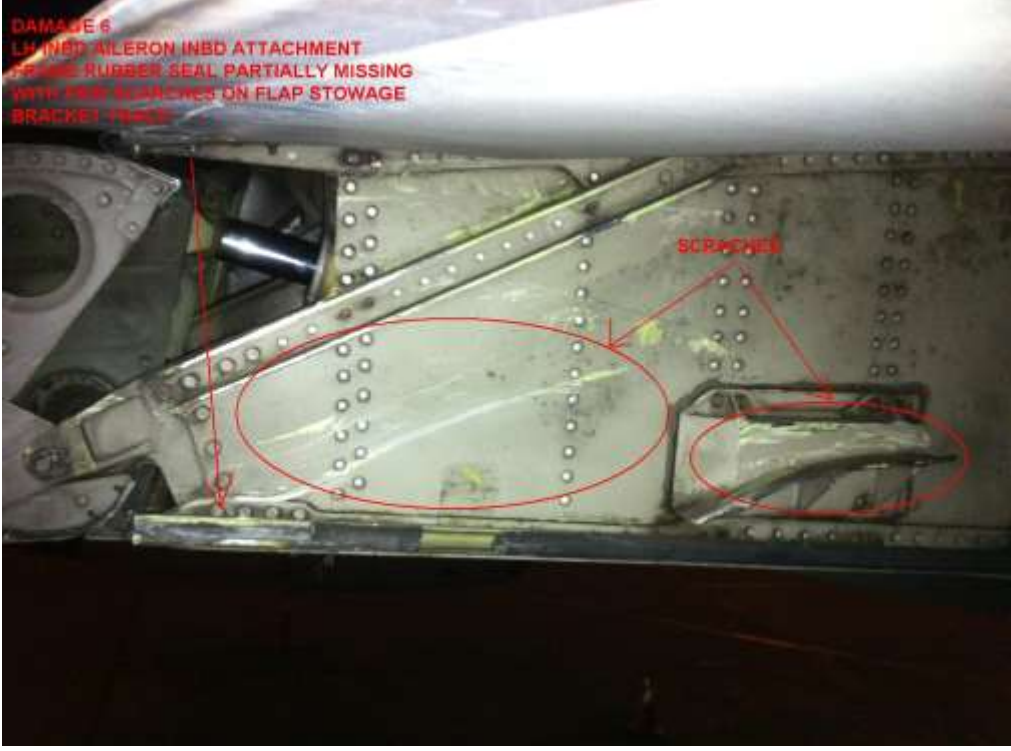
| Damage 6 | LH Inboard Aileron Inboard Attachment Frame rubber seal partially missing with few scratches on Flap Stowage Bracket Track. |
| | <p data-bbox="456 321 860 432">DAMAGE 6<br/>LH INBD AILERON INBD ATTACHMENT<br/>FRAME RUBBER SEAL PARTIALLY MISSING<br/>WITH FEW SCRATCHES ON FLAP STOWAGE<br/>BRACKET TRACK</p> <p data-bbox="1117 537 1224 562">SCRATCHES</p> |

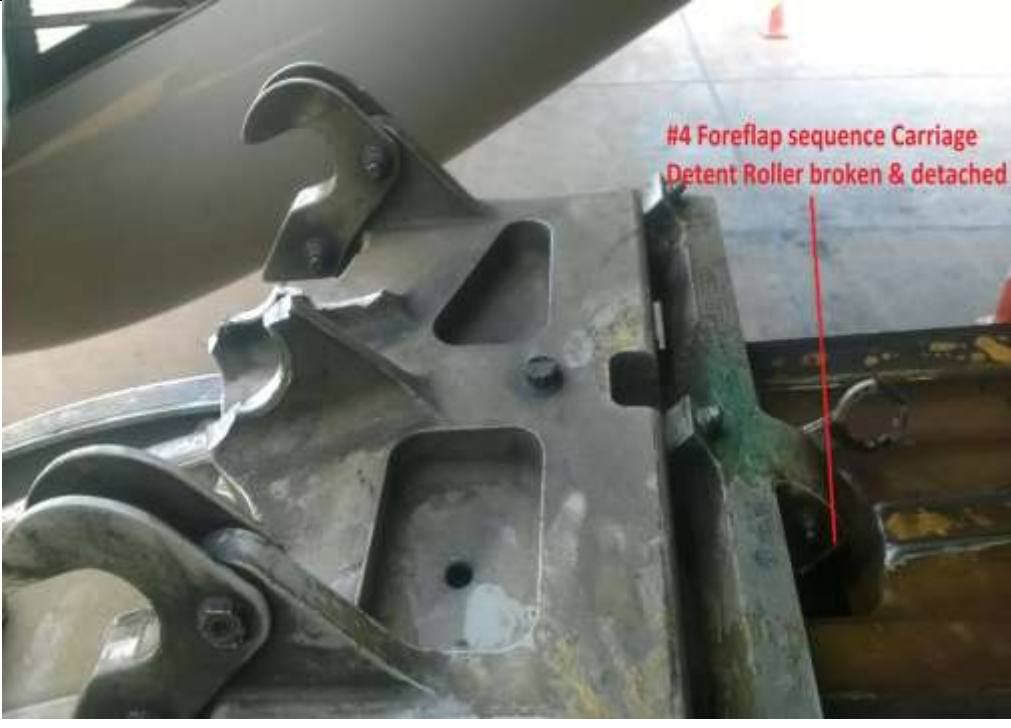
| Damage 7 | Detent roller of #4 sequence carriage was found broken and detached from the carriage. |
| | <p data-bbox="1105 1297 1453 1367">#4 Foreflap sequence Carriage<br/>Detent Roller broken &amp; detached</p> |

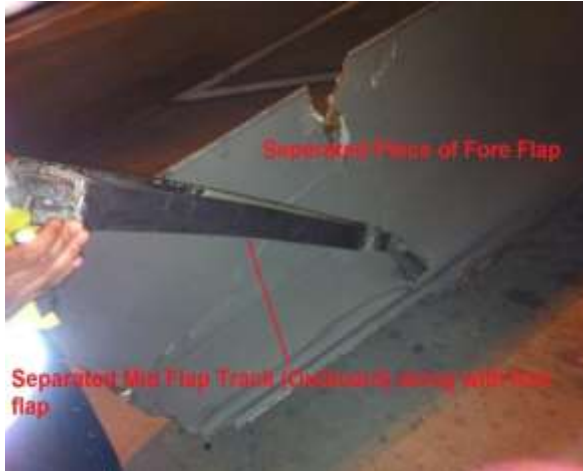
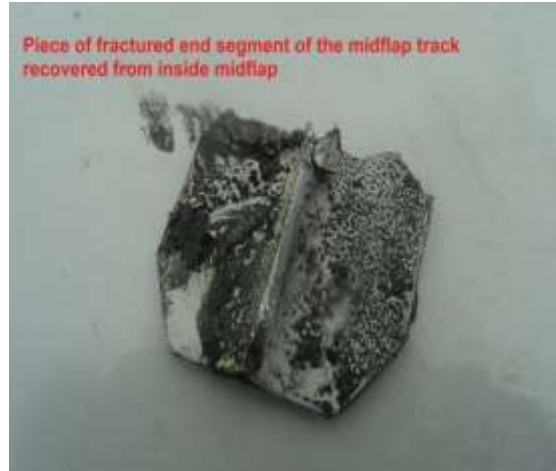
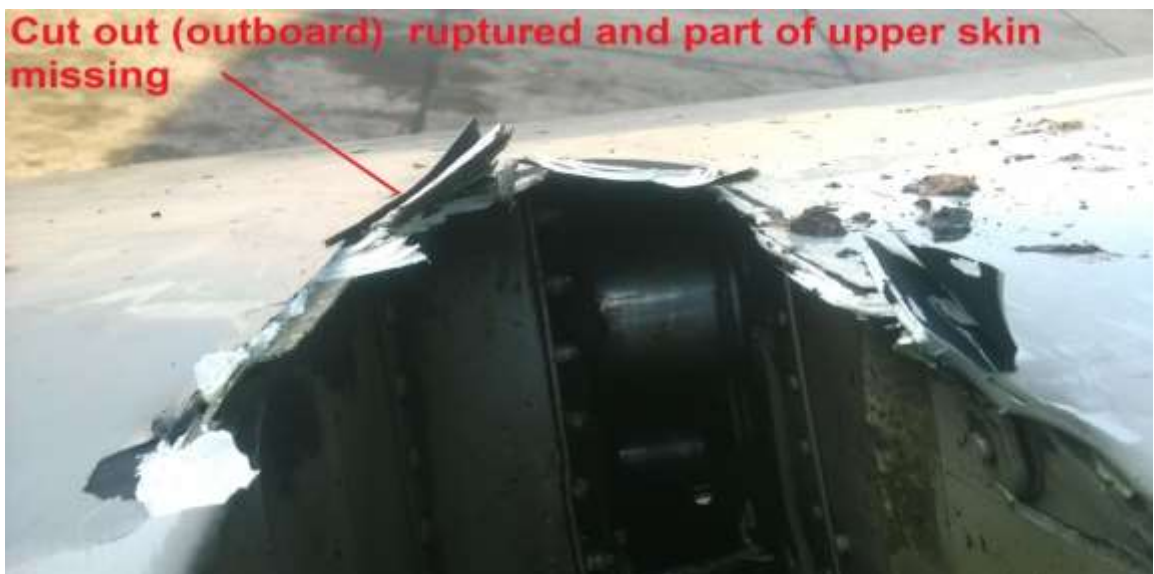
- The fore flap was broken into three span wise pieces after impacting with the runway.
- **Mid flap track & fore flap track (Mid flap track linkage with fore flap)**
  - The outboard mid flap track (which supports the fore flap and extends into the mid flap) was found attached to the fore flap track (which is attached to lower surface of fore flap). The outboard mid flap track was found broken at the aft end (point of attachment with mid flap) which resulted into its separation from the mid flap. Only a piece of fractured end segment of the mid flap track was recovered from inside mid flap. The mid flap cut out (outboard) at leading edge for mid flap – fore flap track was found ruptured and part of upper skin missing.

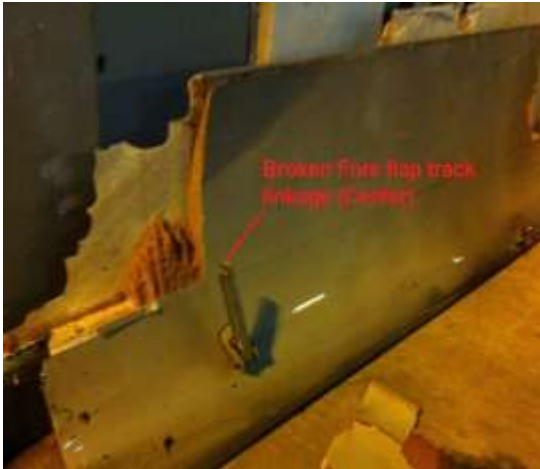
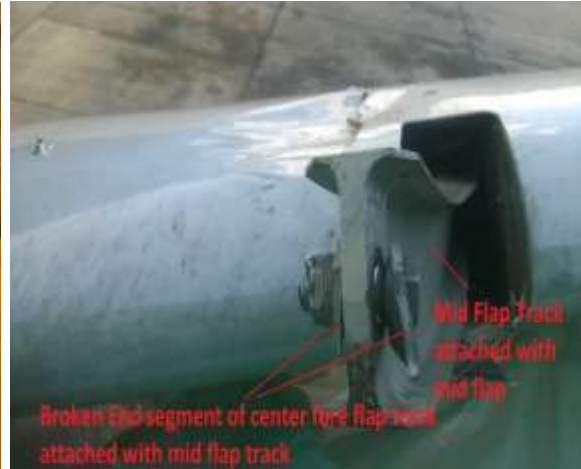
- The centre mid flap track was found attached with the mid flap, however was found slightly bent due to overload. The fore flap track was broken from its aft end (point of attachment with mid flap track). The broken end segment of fore flap track was found attached to the mid flap track along with bolt and nut. The mid flap cut out lower skin was found ruptured.

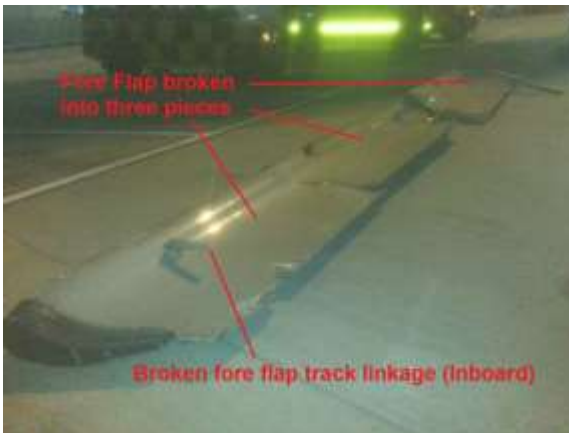
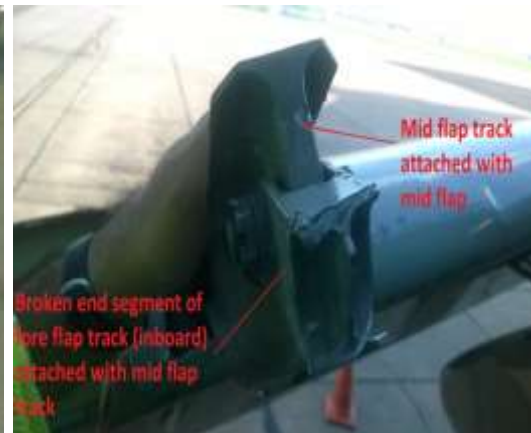
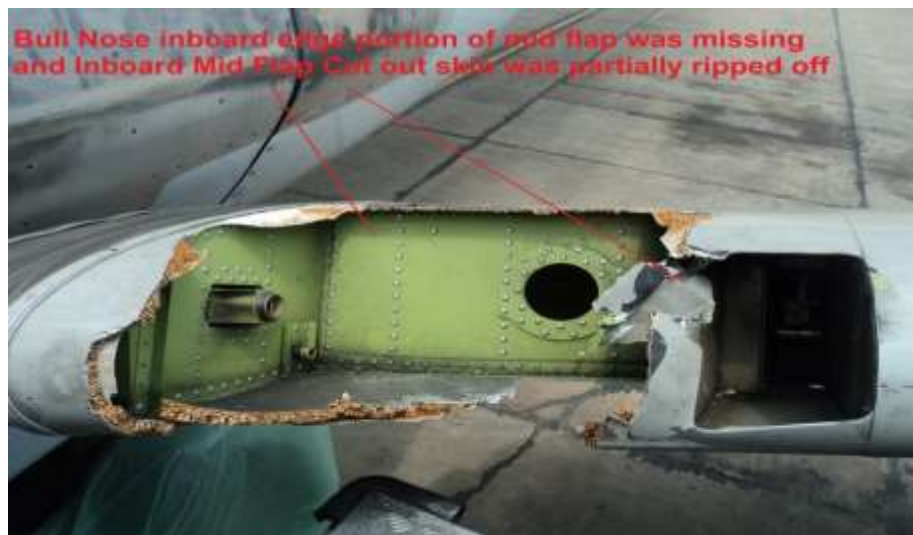
- The inboard mid flap track was also found attached with the mid flap and like centre fore flap track, the inboard fore flap track was found broken from aft end. The broken end segment of fore flap track was found attached to the mid flap track along with bolt and nut. Bull Nose of about 24 Inches from inboard edge was found missing and Inboard Mid Flap Cut out skin was partially ripped off.

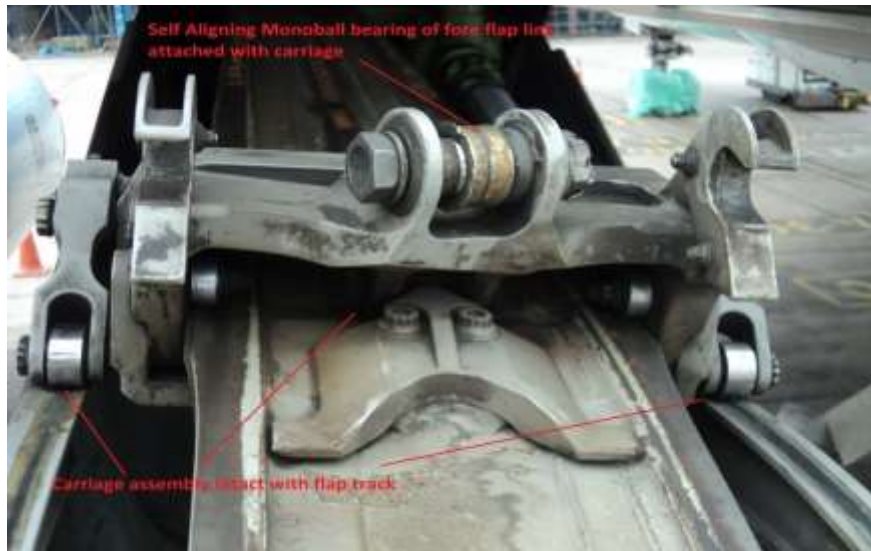
- The # 3 (outboard) sequence carriage assembly was found intact on flap track. The fore flap attachment link (with carriage) was found broken from attachment eye end. The broken end segment of fore flap attachment link was missing. However the self-aligning mono-ball bearing of link was found attached to the sequence carriage.

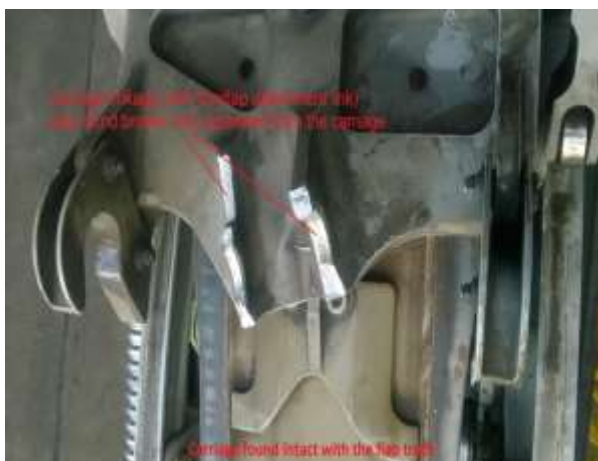
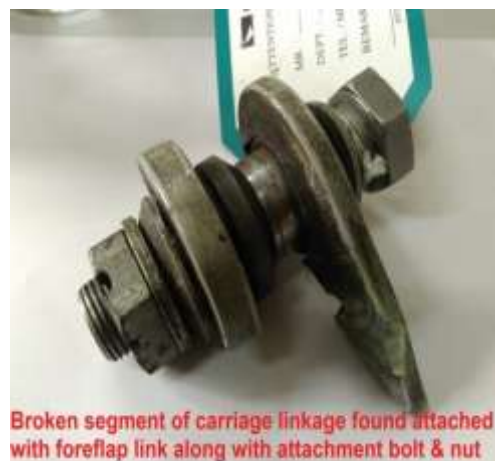
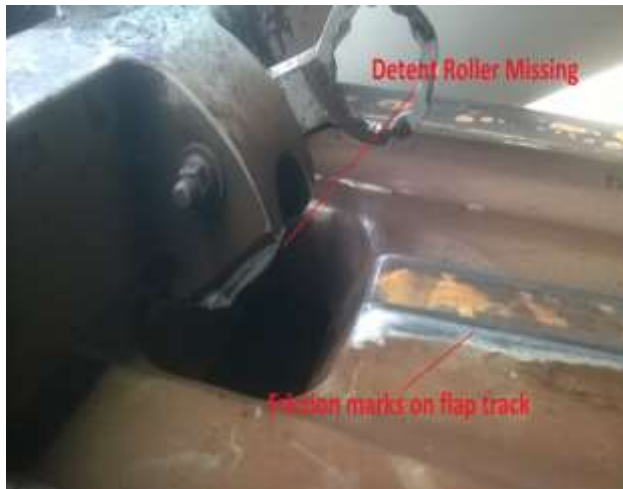
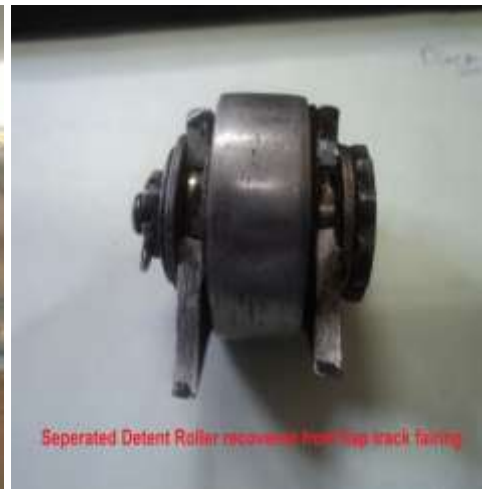
- The # 4 (inboard) sequence carriage was found intact on flap track. However the carriage linkage (with fore flap attachment link) was found broken and separated from the carriage. The broken segment was found attached with fore flap link along with attachment bolt & mono ball bearing. The detent roller was found broken and separated from carriage. The carriage slide on the flap track without roller as evident from the friction marks observed on the upper flange of flap track. The detent roller was recovered from the inner flap track fairing.

The inboard sequence carriage was found intact with the flap track. However while inspecting the carriage it was found that the attachment lug (attachment with fore flap inner link) was fractured and the fractured segment of the lug was

found attached with the fore flap inner link along with bolt, nut, washers and bushings. The detent roller of the carriage was also found sheared and separated from the carriage assembly. Friction marks were observed on the flap track which indicates that when the flaps were extended the sequence carriage moved on the flap track for some distance after the detent roller was separated. This reveals that there may be some anomalies in the inboard sequence carriage assembly thereby resulting in inboard sequence carriage getting out of phase with the other sequence carriage. This may have led to fracture of carriage attachment lug (attachment with fore flap inner link) or the outboard fore flap inner link and subsequently led to failure of other links one after another under severe air loads when the flaps were extended fully for landing. Hence anomalies in sequence carriages may be the primary reason for failure/fracture of carriage attachment lug and fore flap inner attachment link.

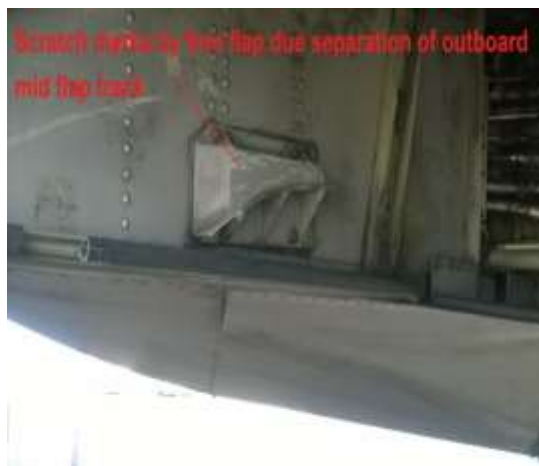
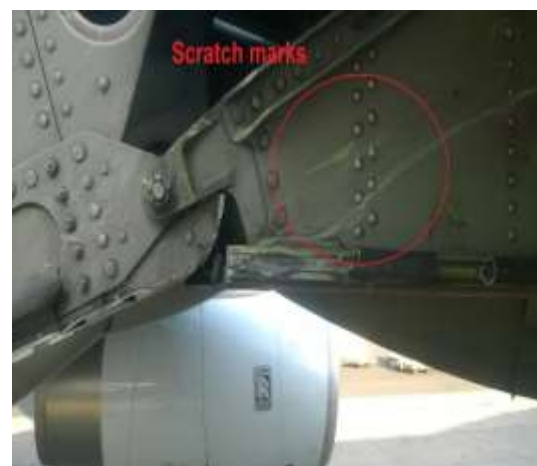
- Scratches were observed on the Flap Stowage Bracket Track probably due to separation of outboard mid flap track from mid flap causing the fore flap to come in contact with adjacent surface.

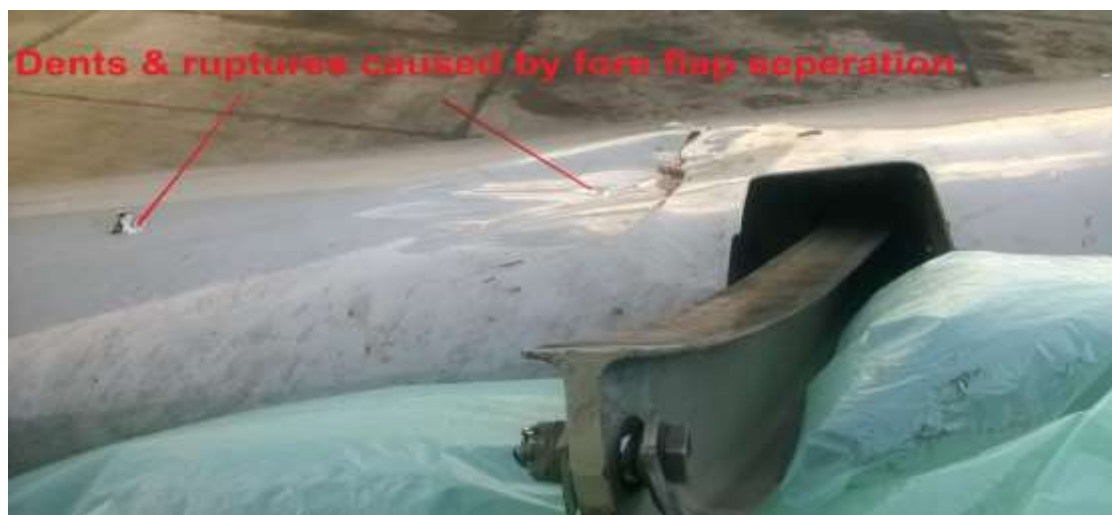
- The fore flap separation caused damage to mid flap skin and honeycomb.

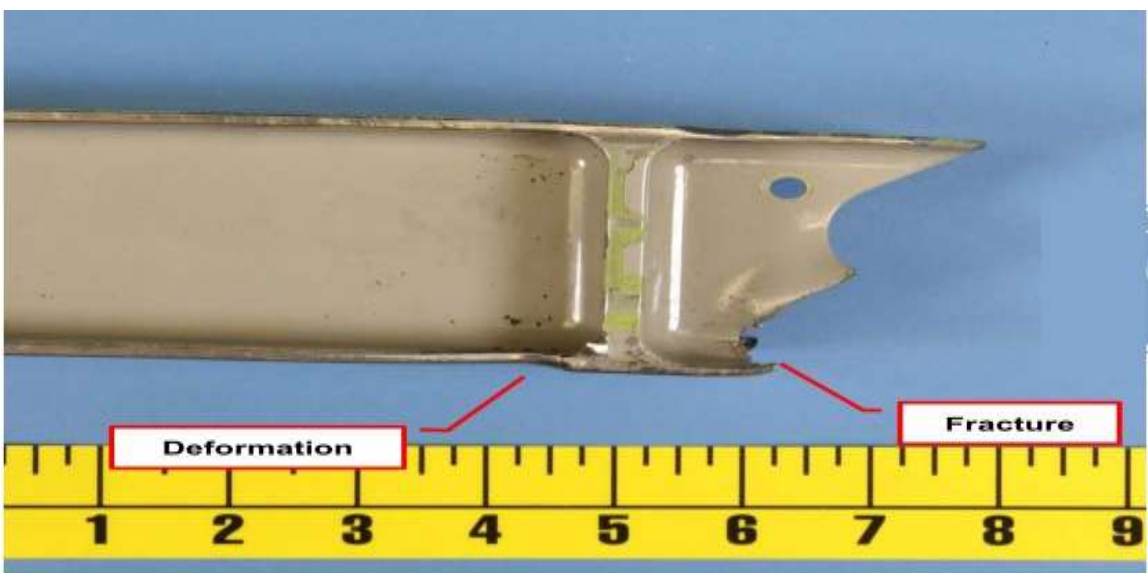
*Close view of the fractured end*
