**FINAL INVESTIGATION REPORT ON ACCIDENT TO
GLIDER CENTRE PUNE L-23 SUPER BLANIK GLIDER
VT-GLK AT GONDHALE NAGAR , PUNE ON
09/03/2016**

SYNOPSIS:

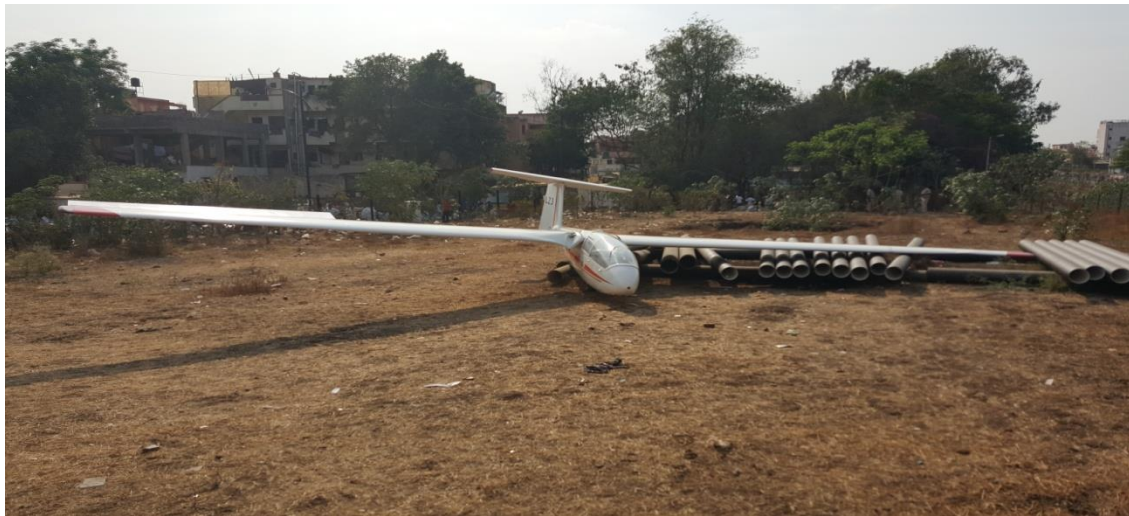
The tailwheel of the glider got entangled with overhead electrical wire which is approximately 25 feet above the ground level and this resulted into lateral spun of glider around 180 degree.

Fig: Final resting position of glider after Outfield landing

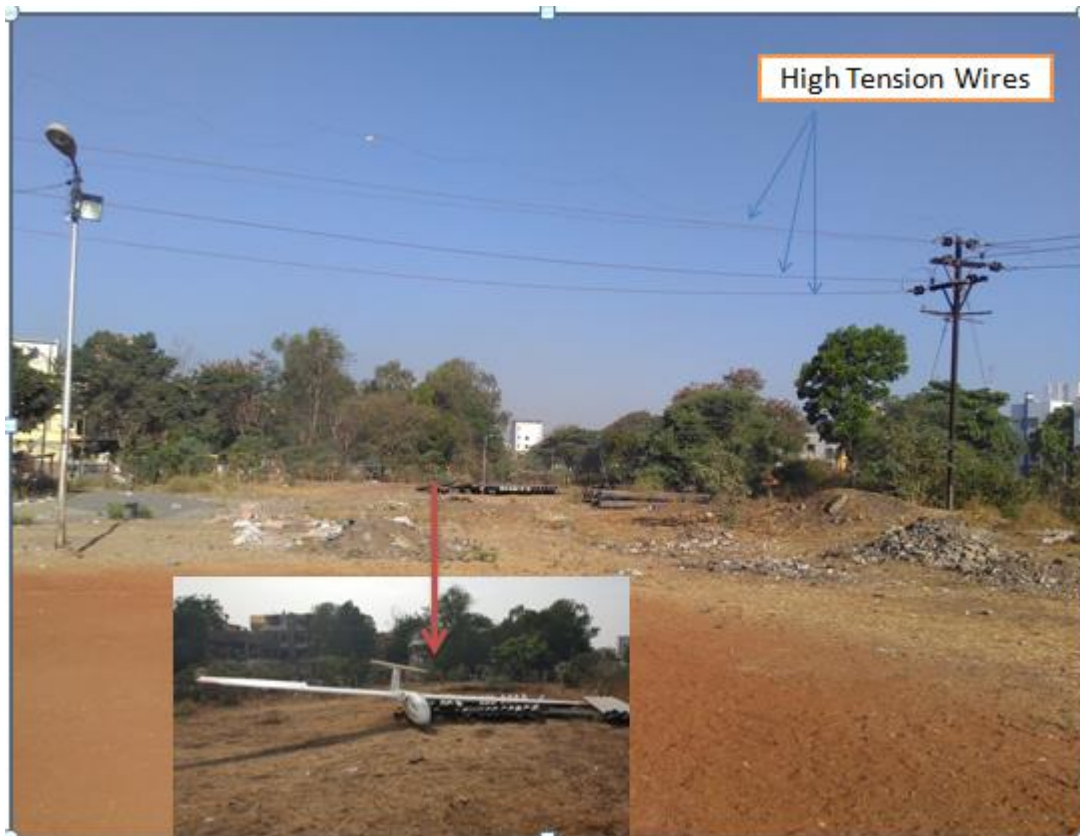
Fig: Location of Electric Wires

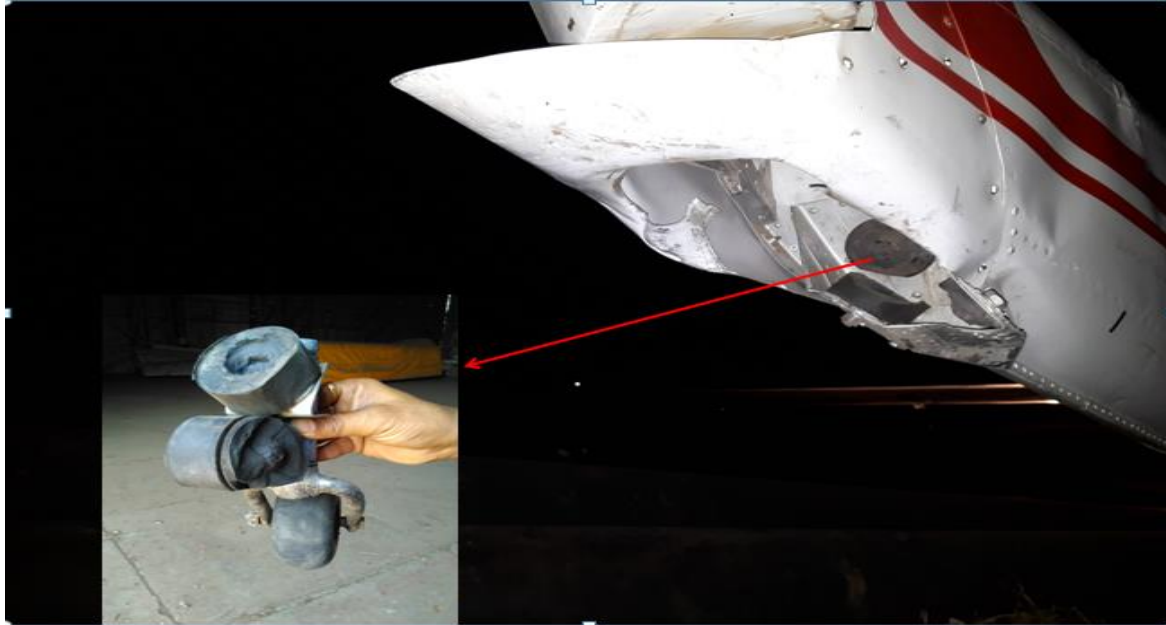
Due to single point impact on tailwheel assembly, tailwheel of the glider disintegrated and was found at a distance of 50 feet from the point of impact with over

head electric wire and subsequently the Left horizontal stabilizer also had hit the electric wire.

Fig: Disintegration of Tailwheel

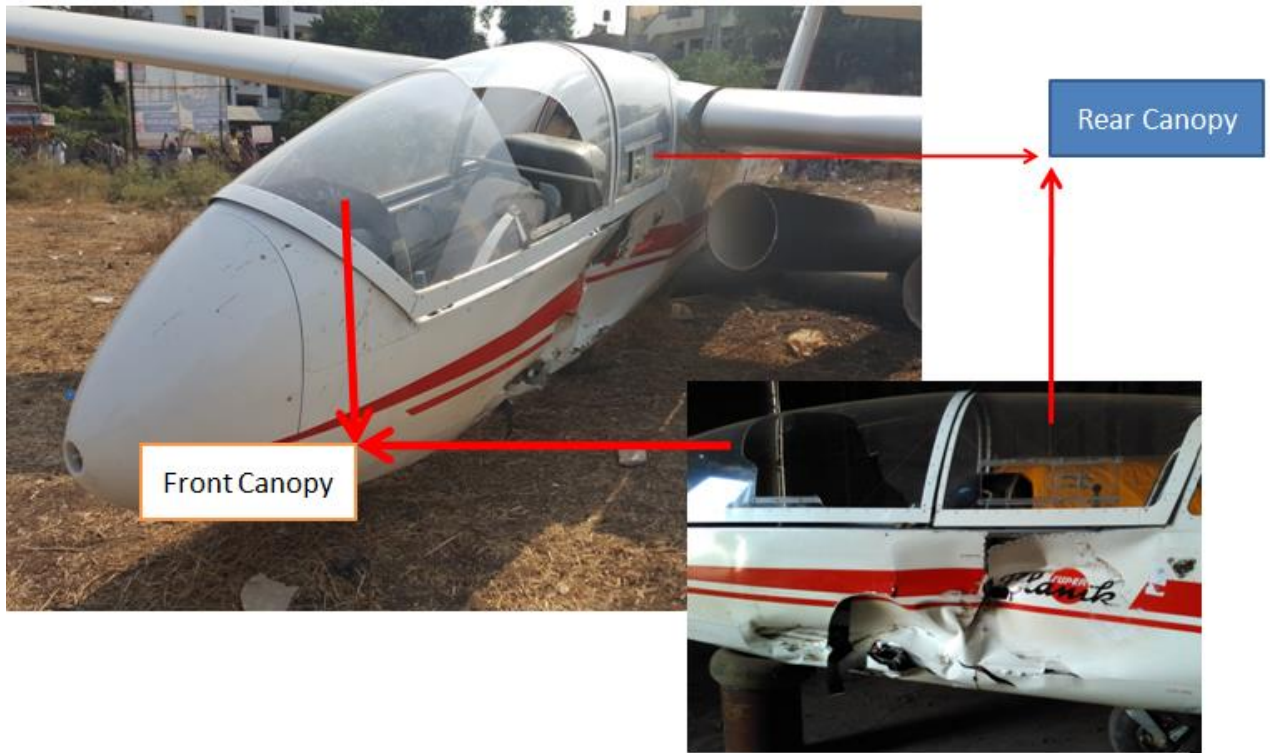
Examination of the wreckage revealed that left side fuselage section 3 to 6 was completely damaged due to the heavy impact on stacked pipes. Belly portion of nose at section 2 – 3 of the fuselage got heavy dent and front canopy cover found broken but operational.

Side View of the Fuselage

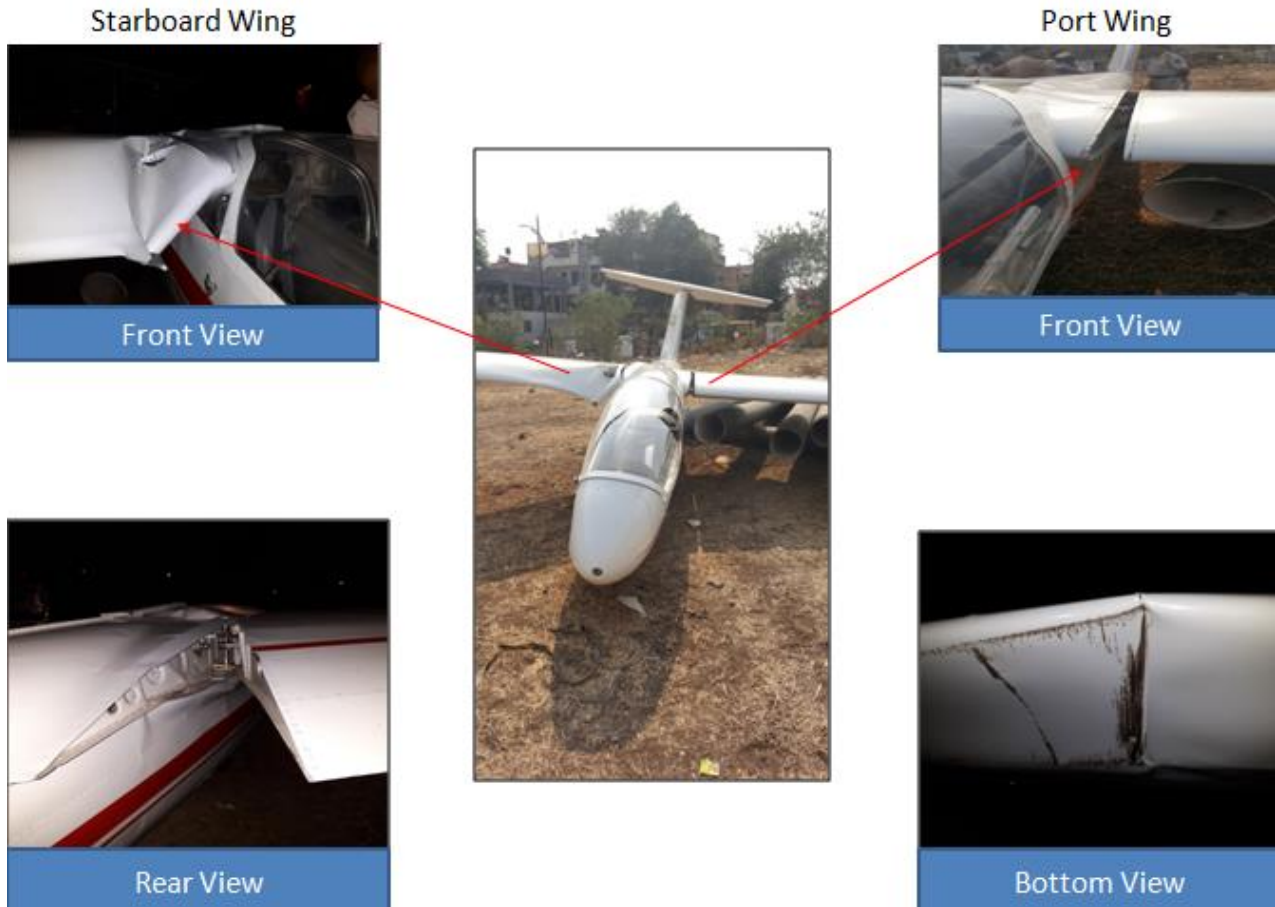
Deformation and metal sheet undulation found at the left wing root section. The left wing lower surface at section 12,13 and 14 also got damaged and the fuselage skin got deformed at section 9,10 and 11. The fuselage tail at section 13 and 14 also damaged and deformed. Due to heavy impact the right wing root got completely deformed and the wing surface got buckled. The right wing – fuselage attachment got deformed and sustained damage.

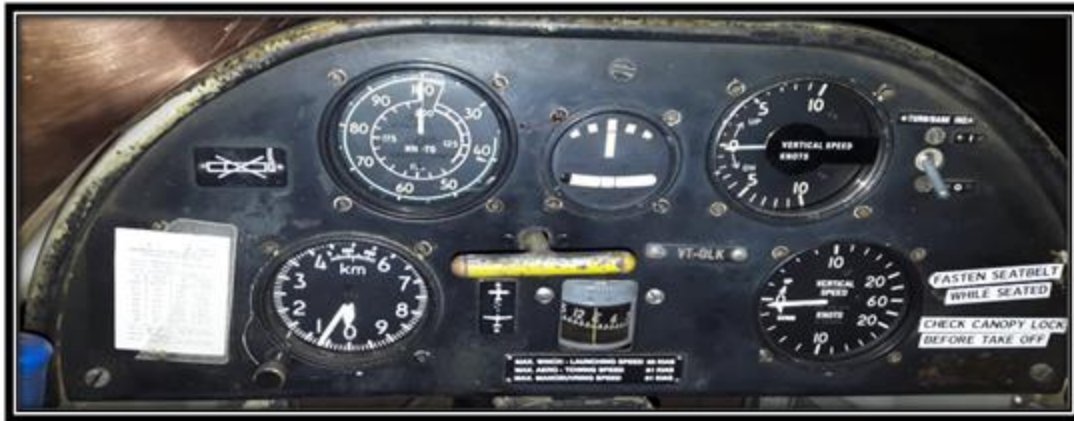
The instrument panel and instruments of both front and rear cockpit were found attached in place without any damage. The safety harness was intact and the main undercarriage was also intact and no damage was observed. All the attachment pins locks and all the control surfaces (Ailerons, Elevators, Rudder, trim tabs and Airbrake) were in place and found intact. However, Starboard side rudder pedal was found damaged. The rear canopy cover found satisfactory and there was no disintegration of any part in air. Altimeter of the rear cockpit was found stuck at max due to the tailwheel impact with the overhead electric wire and other than this all the instruments showing actual reading positions.

Front Cockpit-Instrument Panel

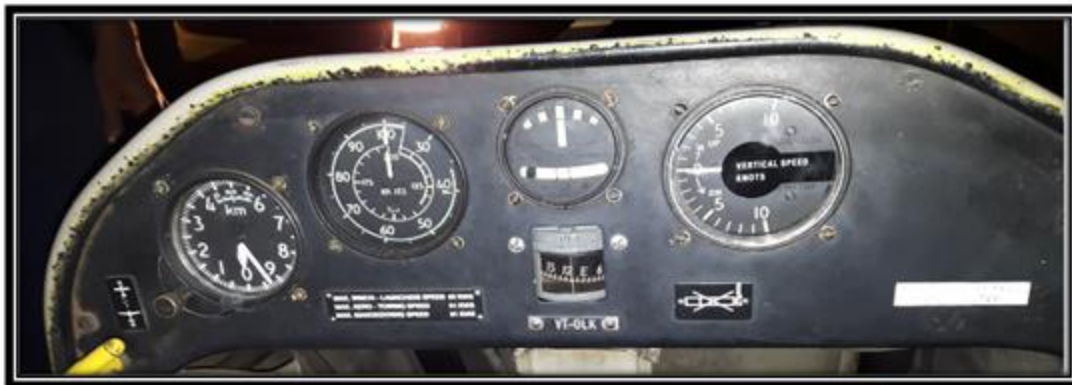
Rear Cockpit-Instrument Panel

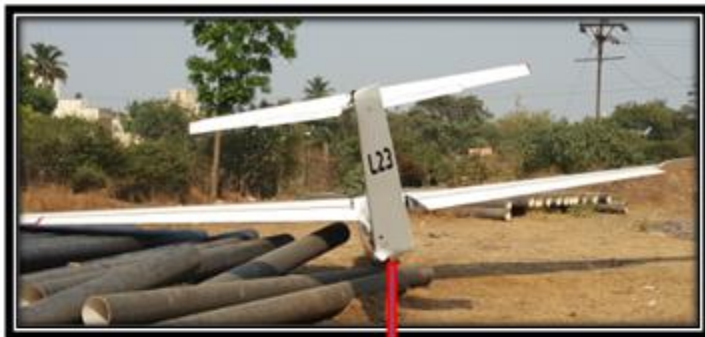
Rudder deflection

Position of damaged rudder pedal and rudder depicts that the rudder was deflected towards the right with a forceful action during the flying and which is in line to final rudder position.

It is evident that excess use of rudder resulted in side slipping and very high drag as the fuselage moved sideways through the air. This acted as an airbrake and inevitably caused a loss of airspeed with a high rate of sink even though the nose had not been raised. There is a tendency for glider to overbank at very low speeds so that a large stick deflection to hold off the bank can also be a warning of a dangerously low speed. In either case, a glider with high glide ratio would have not reached the point of intended landing.

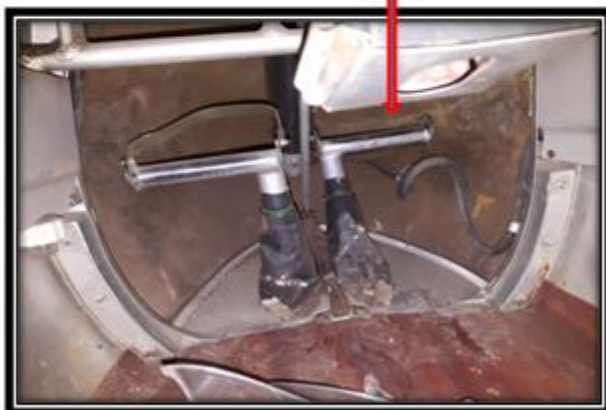
Apart from the damage to the different areas of fuselage, inside the front cockpit, RH side rudder pedal was found damaged as shown in the Fig.

Right side Rudder Pedal damaged
