**FINAL REPORT OF ACCIDENT  
INVOLVING  
M/s JET AIRWAYS ATR 72-500 AIRCRAFT  
VT-JCX  
AT INDORE  
ON 07<sup>TH</sup> MAY 2016**

**FINAL REPORT ON ACCIDENT TO M/s JETAIRWAYS ATR 72-500**

**AIRCRAFT VT-JCX AT INDORE ON 07/05/2016**

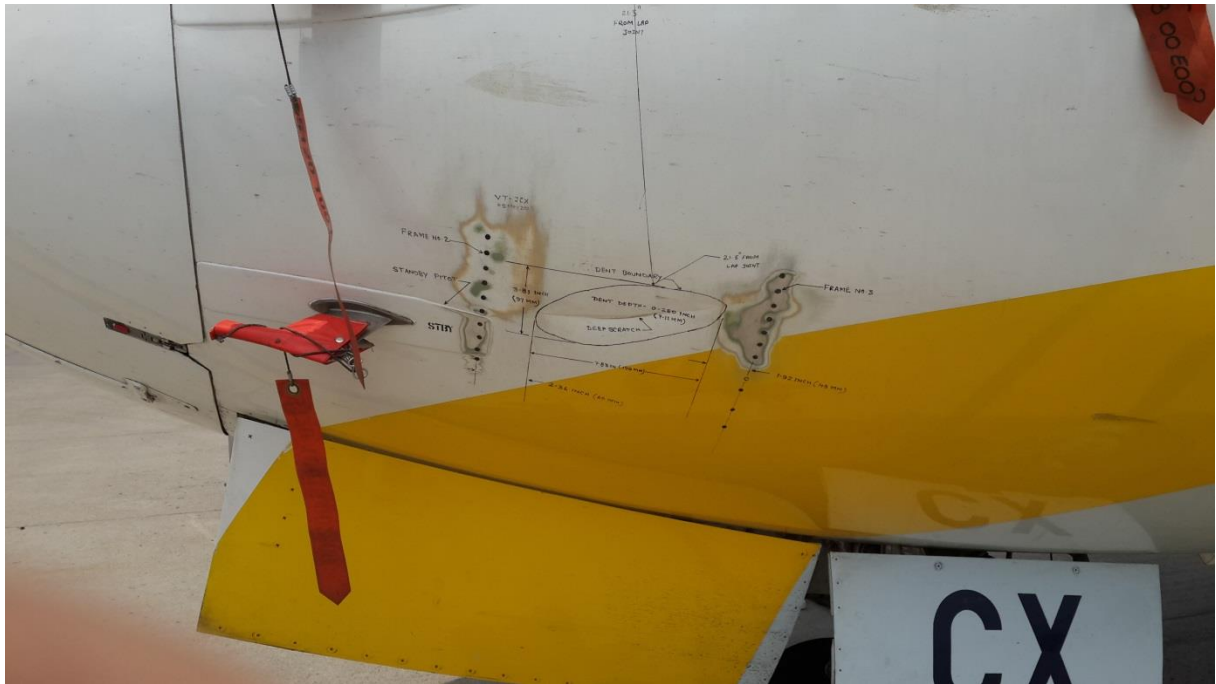
**Fig 1**

Aircraft sustained substantial damage while moving over uneven and unpaved surface and was grounded for necessary repairs and maintenance. Deep scratch and dent was observed near Standby pitot probe SEC 11.

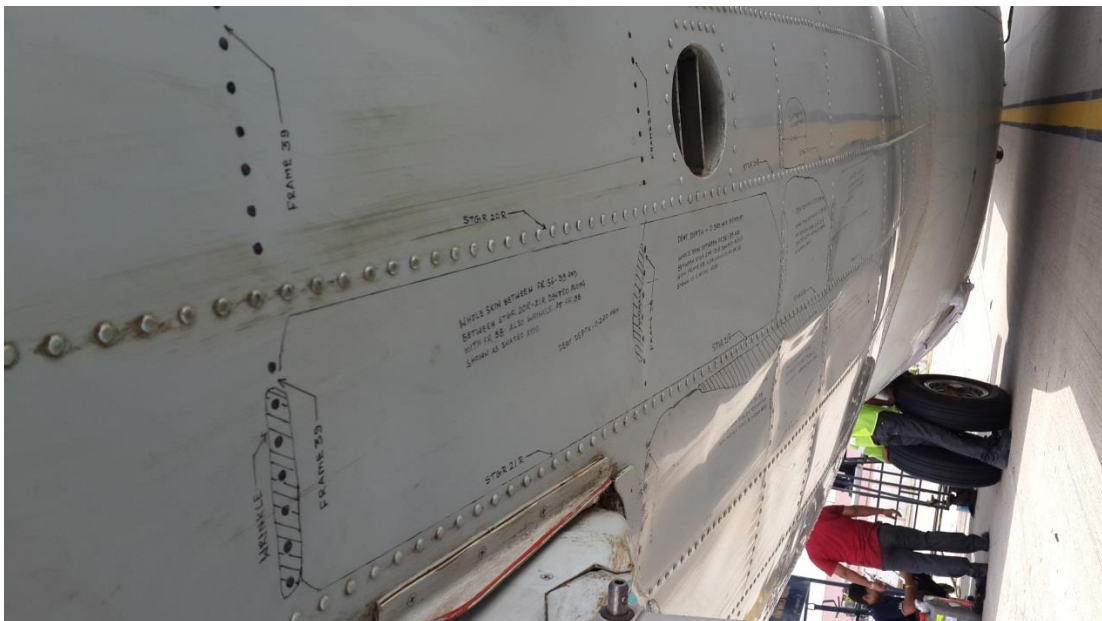
**Fig 2**

Lower fuselage belly skin was scratched, buckled and dented ahead of SEC 16.

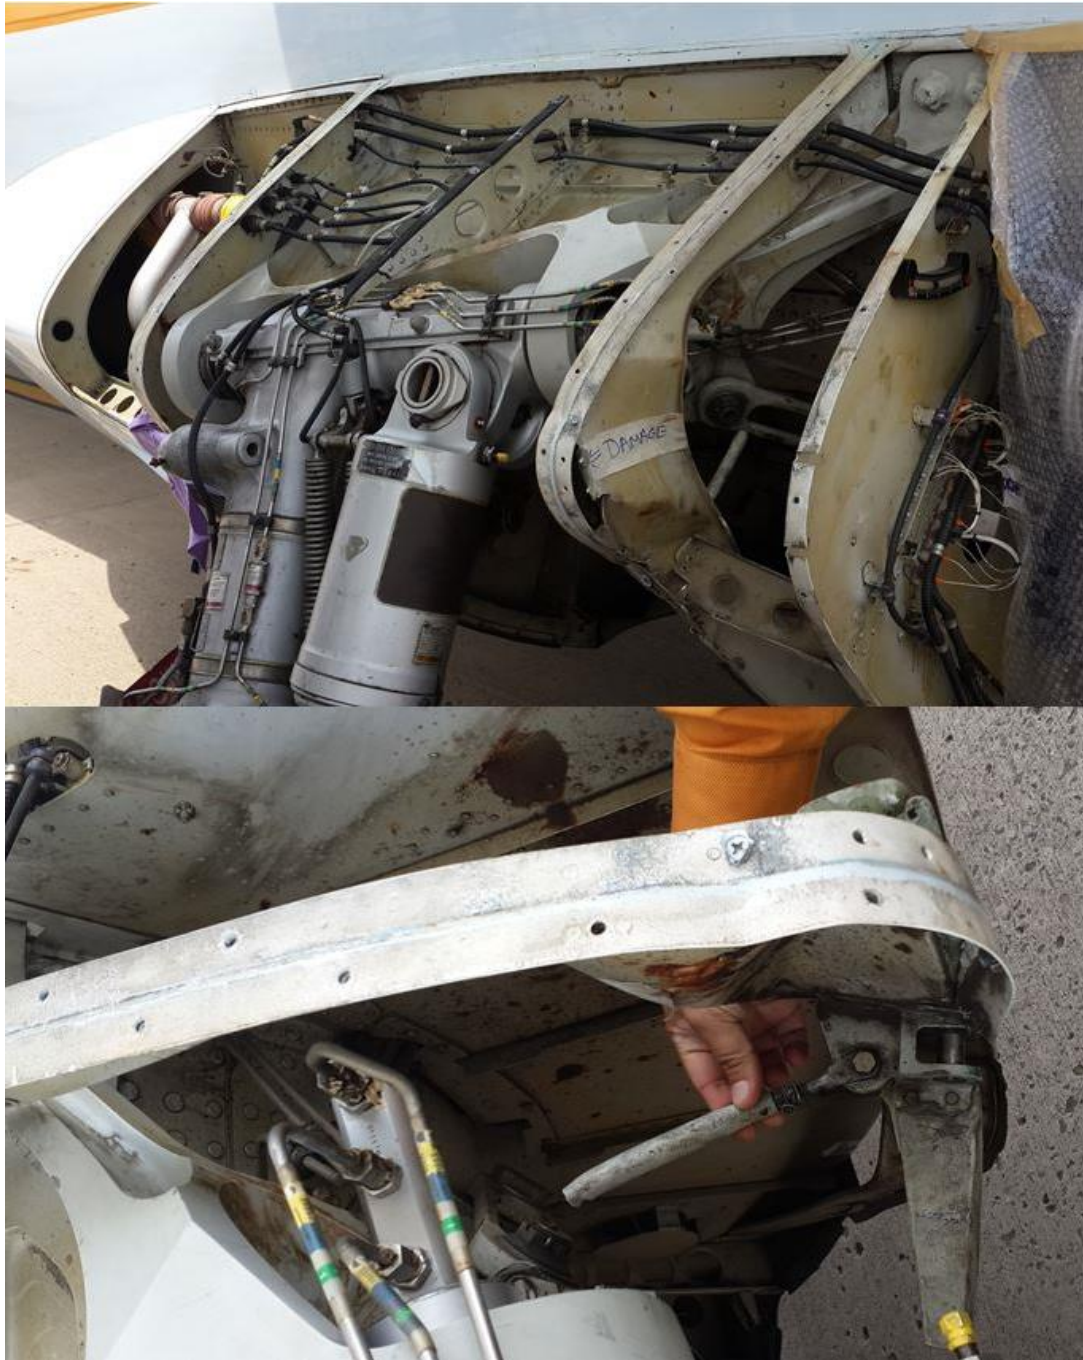
**Fig 3**

Bulkhead frame aft of wheel well was damaged. Damage was also observed on the drain mast, LH Hydraulic Bay access fairing as and the LH engine propeller blades.

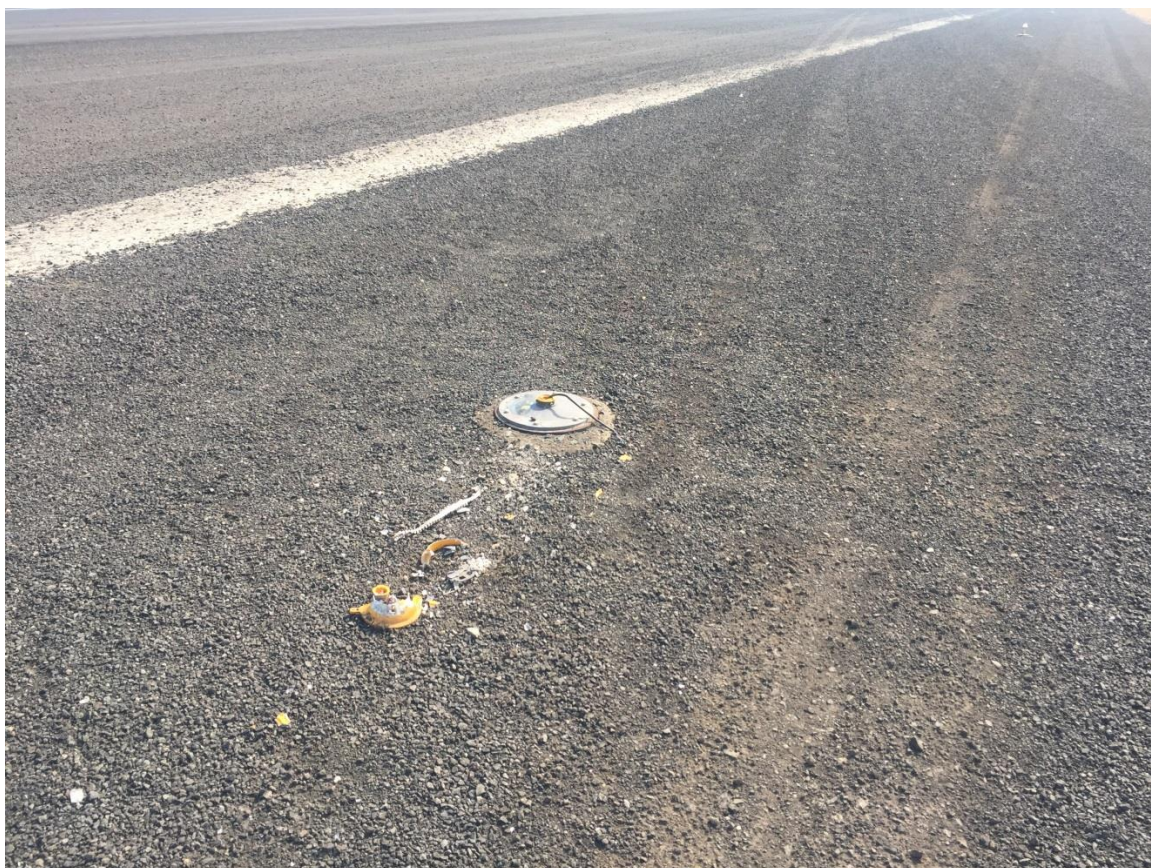
**Fig 7**

The DGCA had conducted last surveillance of Indore Airport on 26.11.2014. As per the non-compliance report *“Surface condition of runway is very bad. Loose pebbles are observed throughout the runway. There are depression and pot holes at many places on the runway, It is safety hazard to aircraft.”* The picture below shows the surface condition of runway near area where aircraft exited the runway

As per the Action Taken Report provided to the COI, both the non-compliances were still open, as on 31.03.2016. The tender for resurfacing was awarded, but the work was under progress, and in the meanwhile regular removal of gravels was being done through runway cleaning contract. The potholes were also being repaired as per operational requirement. The expected date of completion was stated as 30.11.2016.

It is evident that from the photographs, inspection report and statements of pilot that, condition of the runway had deteriorated and was a contributory factor in accident.

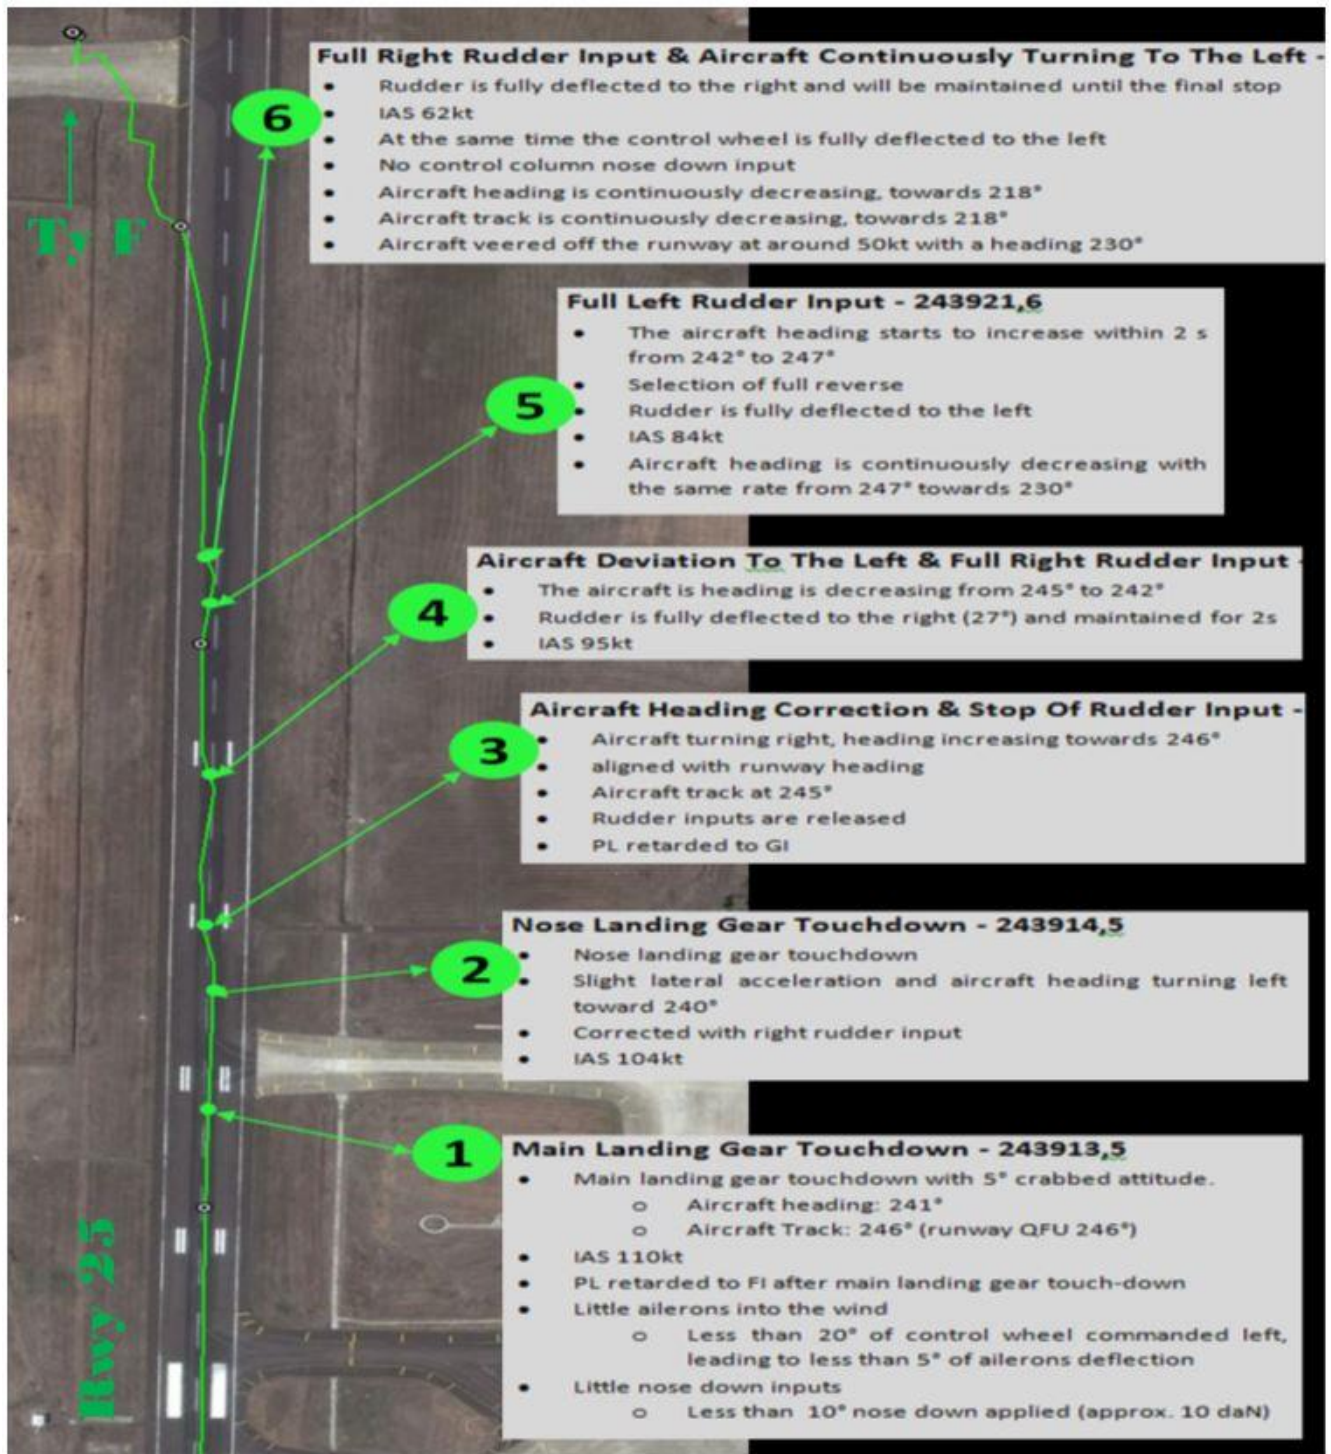
Fig 8

Main events vis-a-vis travel of aircraft on runway and off the runway after landing as per the report provided by BEA, France are appended below.

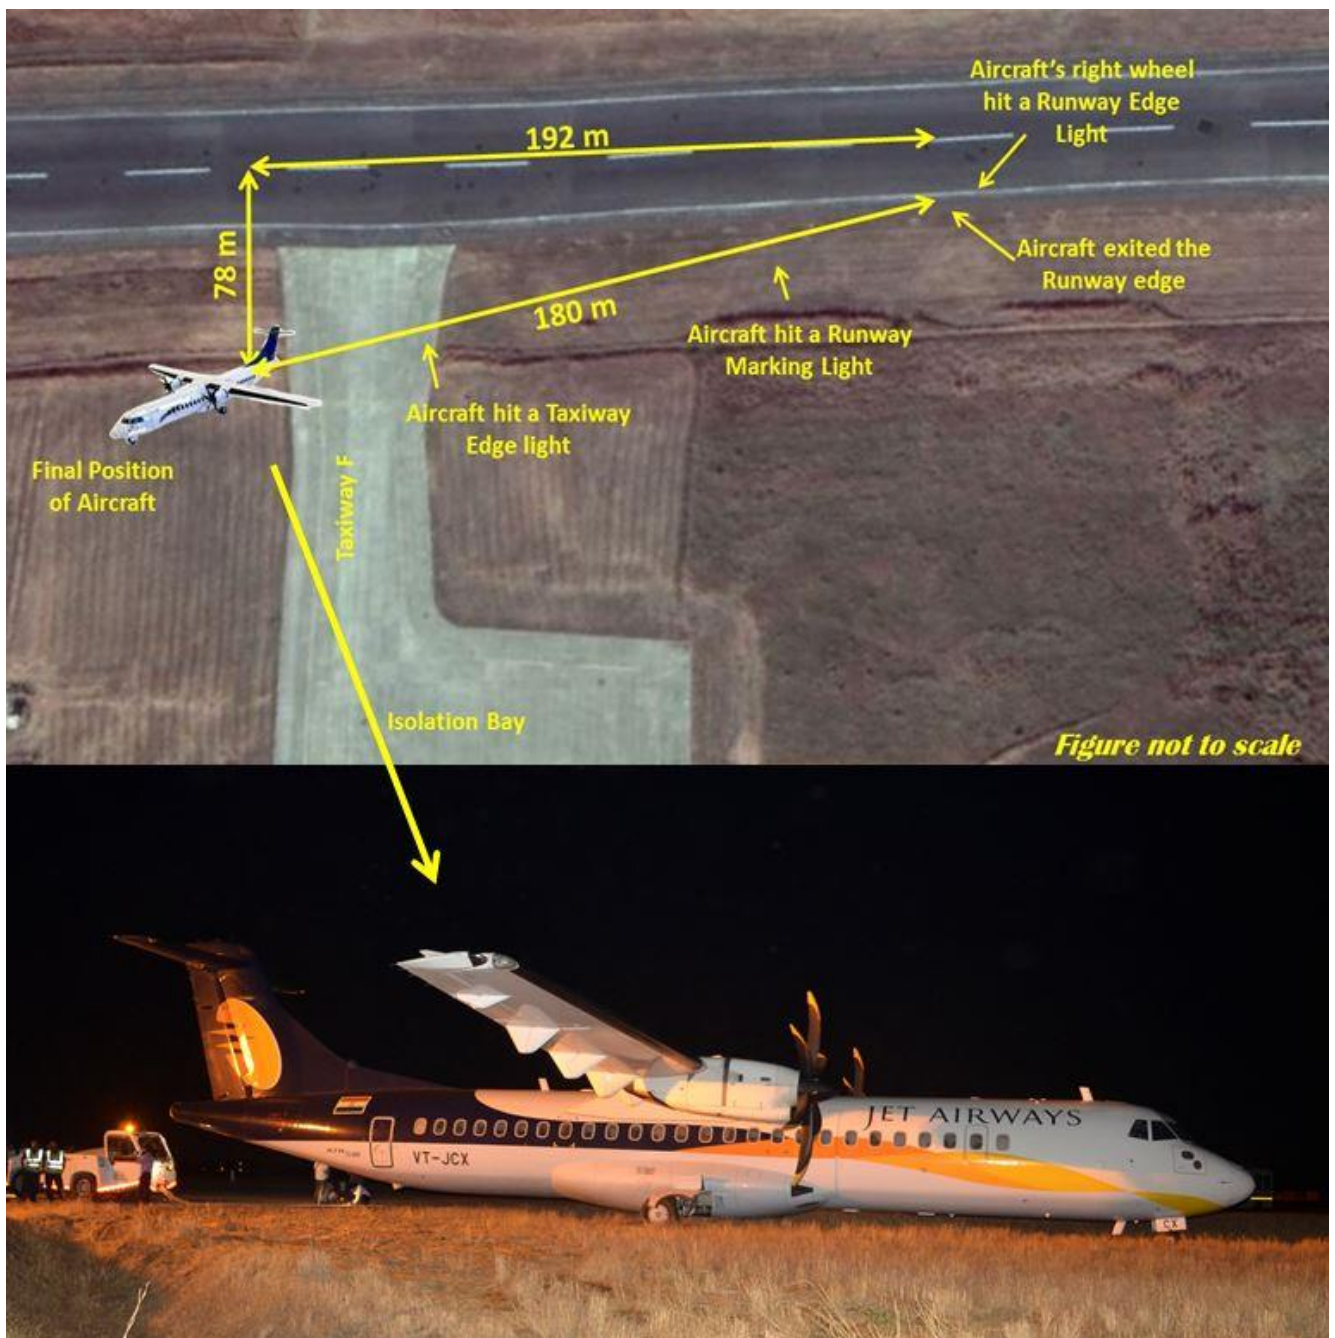
**Fig 9**

The aircraft exited the runway on the right at a distance of approximately 1300m from Rwy 25 threshold.

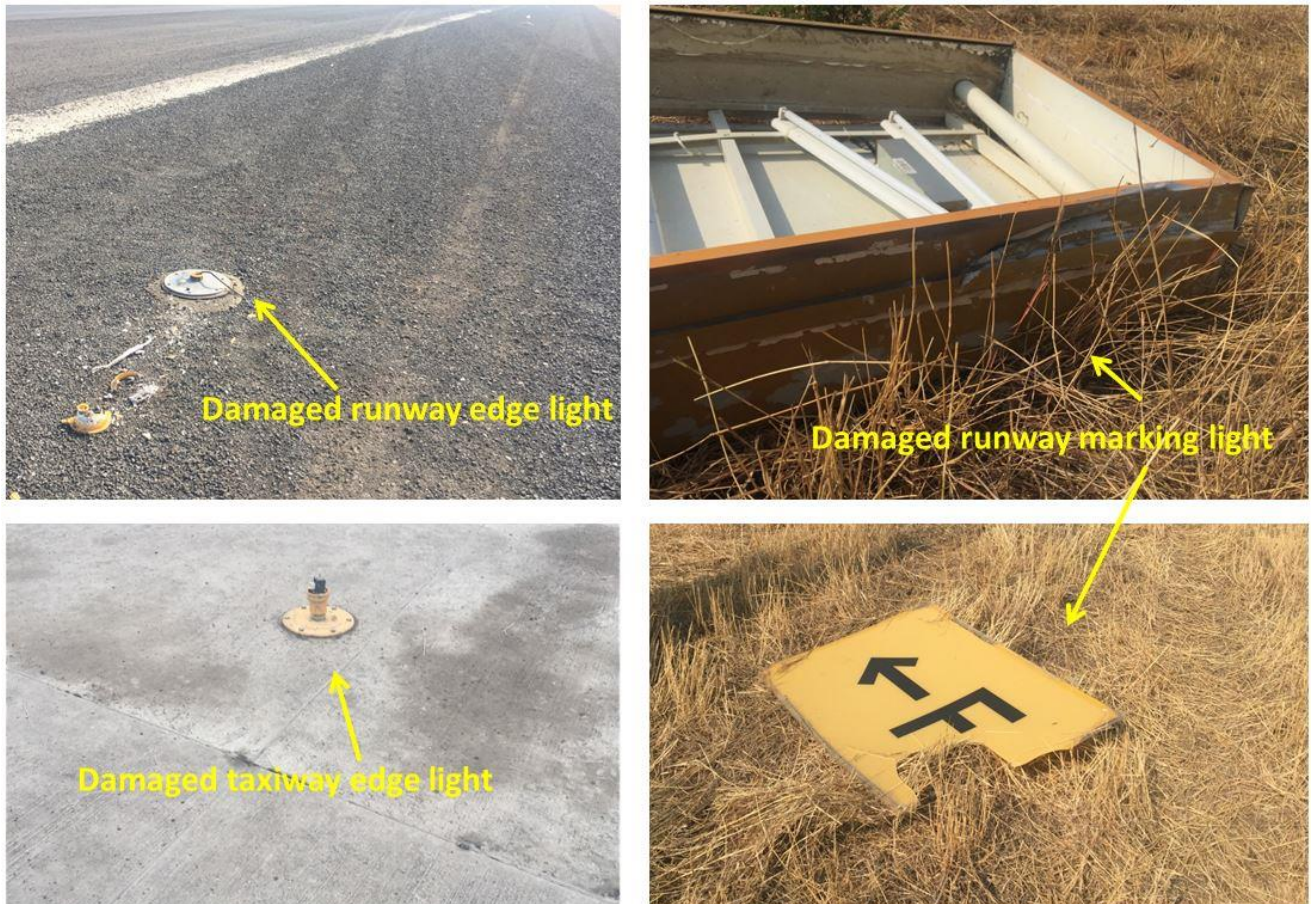
**Fig 10**

Its right wheel hit a Rwy edge light and aircraft travelled around 180 m in unpaved surface while hitting a Rwy marking sign and crossed over the taxiway F, hitting a Twy edge light and came to stop across the Twy. The final position was approximately 78 m from the Rwy edge.
