**FINAL REPORT OF SERIOUS INCIDENT
INVOLVING M/s A R AIRWAYS
CESSNA CITATION 550 S II AIRCRAFT
VT-KMB
AT BANSWARA
ON 27/10/2016**

Jasbir Singh Larhga
Chairman, Committee of Inquiry

**FINAL REPORT ON SERIOUS INCIDENT TO M/s A R AIRWAYS CESSNA
CITATION 550 S II AIRCRAFT VT-KMB AT BANSWARA ON 27/10/2016**

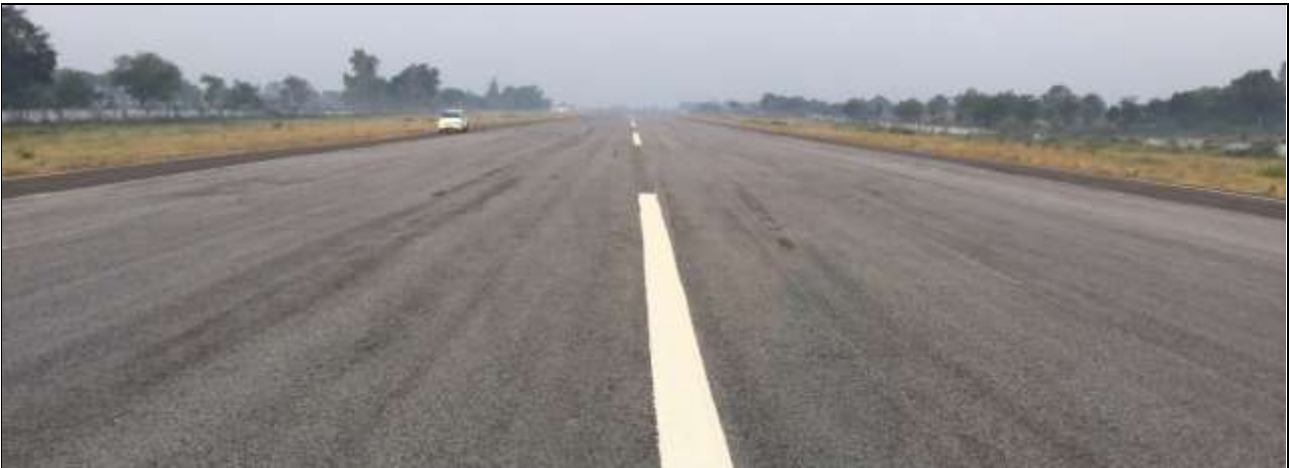
Touchdown point on runway

The aircraft landed at Banswara on Rwy 28 at 0745 UTC and immediately after touchdown, the LH main wheel tyre burst and the wheel hub started scrapping

the runway surface. The crew applied the thrust reversers and speed brakes, however, aircraft continue to roll for about 100 meters, and started deviating to the left.

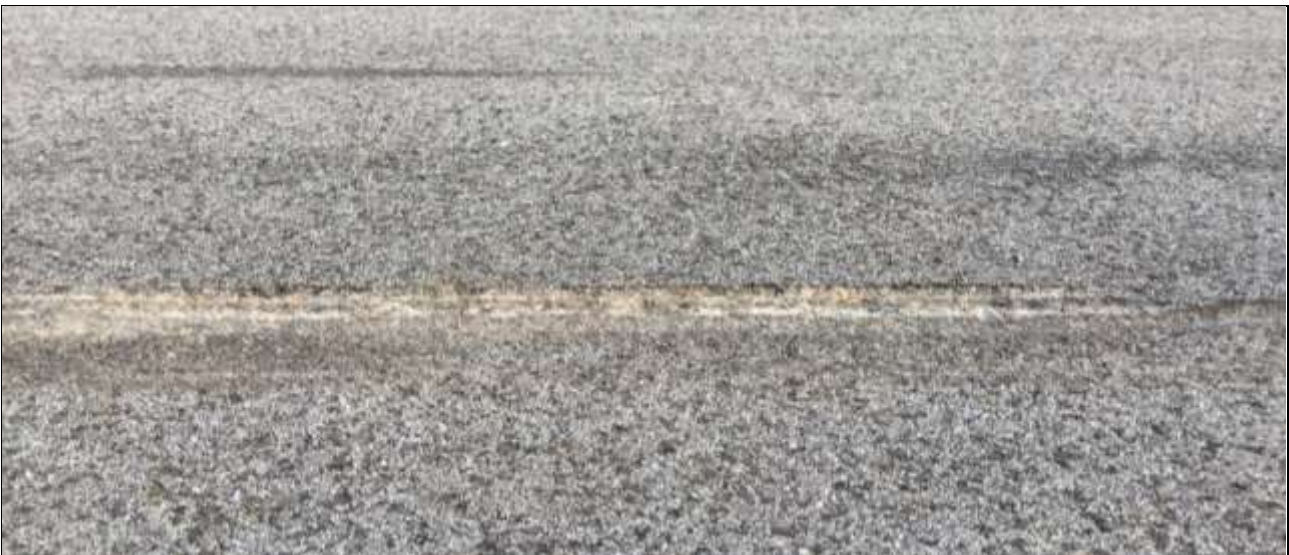
Pilots applied right rudder and attempted to bring the aircraft back to the centreline. However, the aircraft kept deviating to the left and travelled around 200 m before turning slightly towards right. The aircraft travelled to the right i.e. towards runway centreline for 150m before beginning to turn towards left again. Aircraft then continued to deviate toward left till it exited the runway at a distance of 600 m from the threshold.

Runway surface scraped by LH wheel after tyre burst

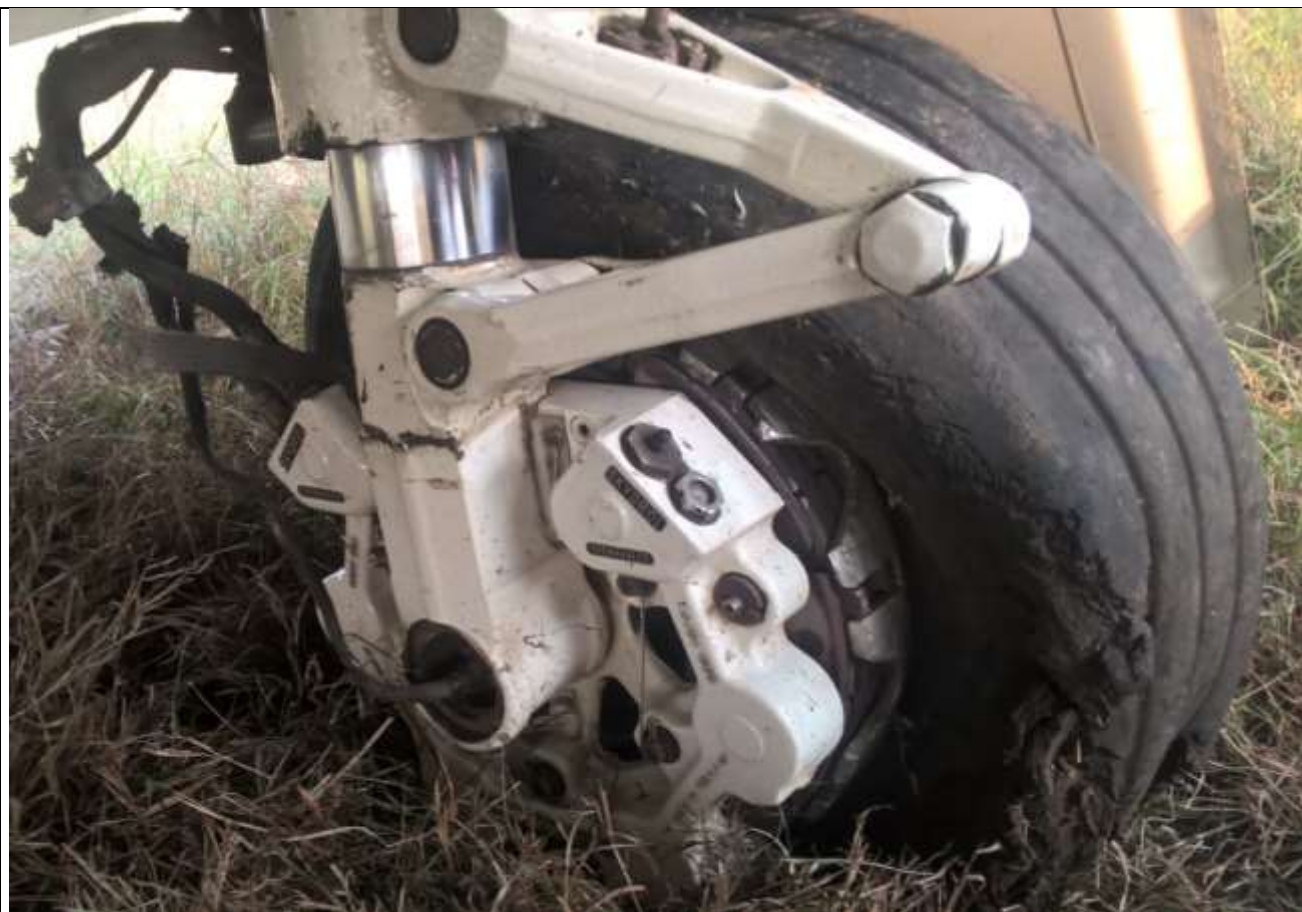
The LH tyre of had burst immediately after landing. The LH wheel hub was damaged due to scraping the runway surface.

LH Wheel of the aircraft after incident

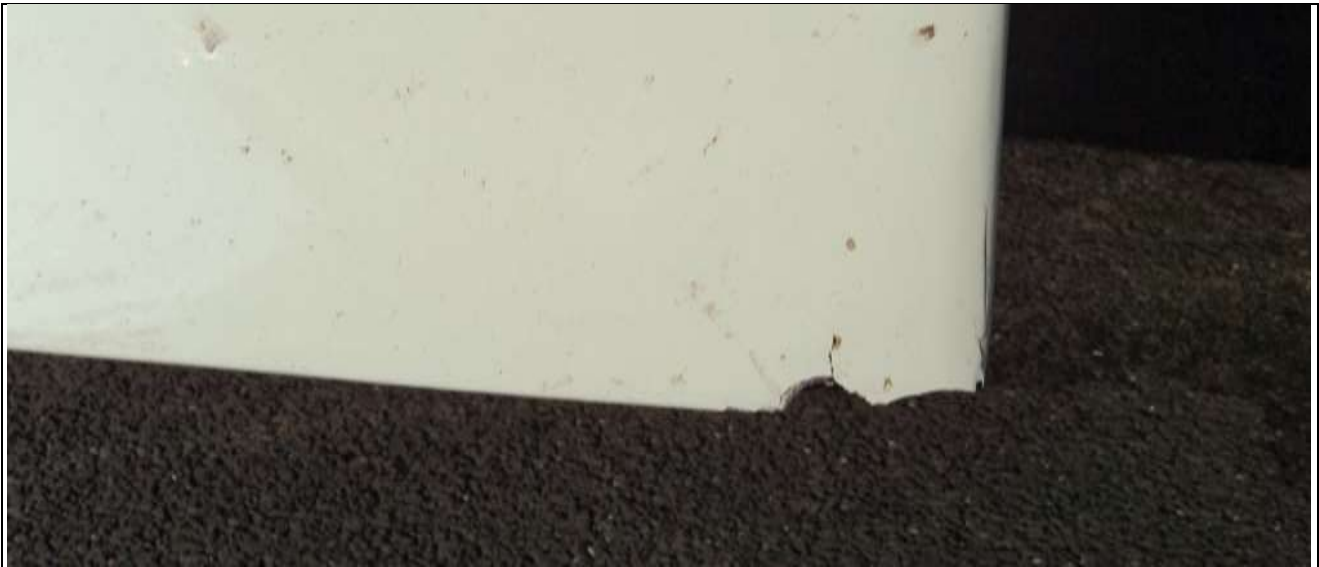
Damage observed on inner edge of the LH flap

LH flap inner trailing edge was found chipped off. The operator carried out hard landing inspection after the incident and no abnormality was observed.

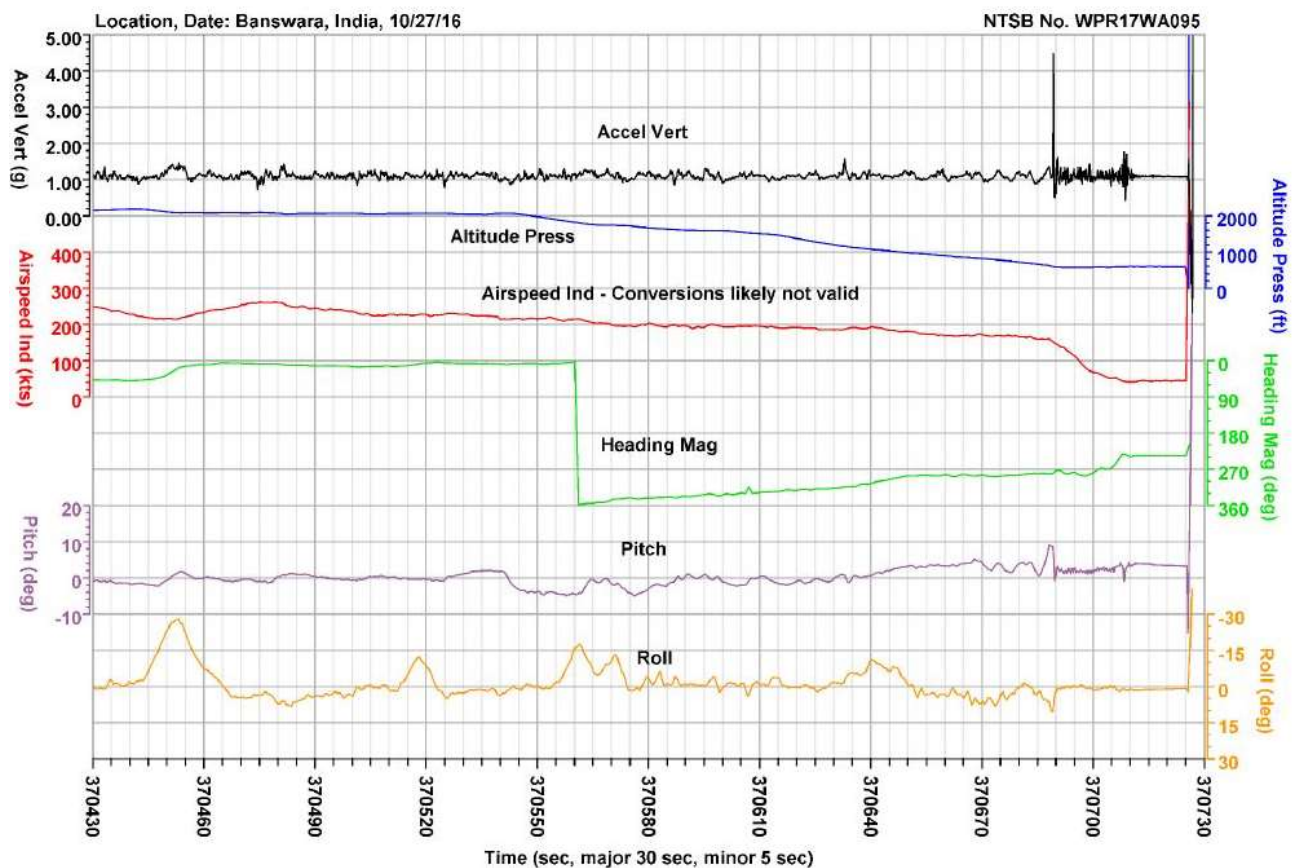
As per the report and plot above, during the final portion of the approach, the aircraft was in a steady left turn until it lined up on the runway heading about 400 ft above the touchdown altitude. Upon touchdown at time 370688 seconds (DFDR Elapsed Time), the aircraft was rolled to the right about 10 degrees. Vertical acceleration reached recorded peaks of 4.47 G and 0.51 G when the aircraft touched down. The aircraft then deviated to the left and the recording ended about 30 seconds after touchdown.

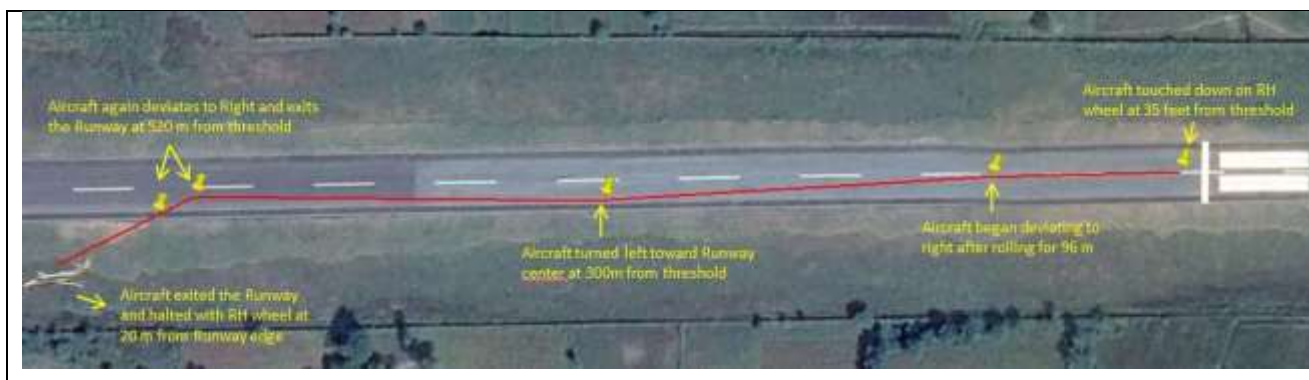
The aircraft touched down on its RH wheel first at a distance 10.7 m from the threshold. The LH wheel touched further 07 m ahead and burst on landing. A deep scrape mark on runway was observed at the point of impact of LH wheel. The aircraft started deviating to left after rolling for about 100 m. The aircraft track after touchdown is reproduced in figure below based on the tyre marks on the runway.

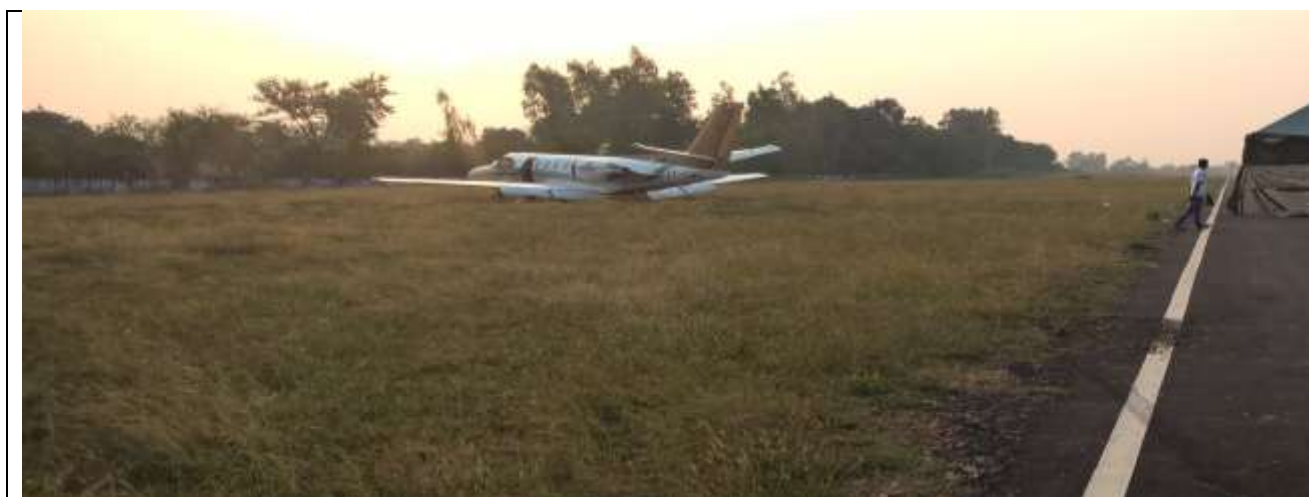
The aircraft exited the runway at an angle of about 20° with runway at a distance of about 500m from the threshold. The RH wheel of aircraft was 20 meters from runway edge when it came to halt and aircraft had travelled around 50 meters on unpaved surface. There was no sign of disintegration of any part of the aircraft in air.

Final resting position of the aircraft

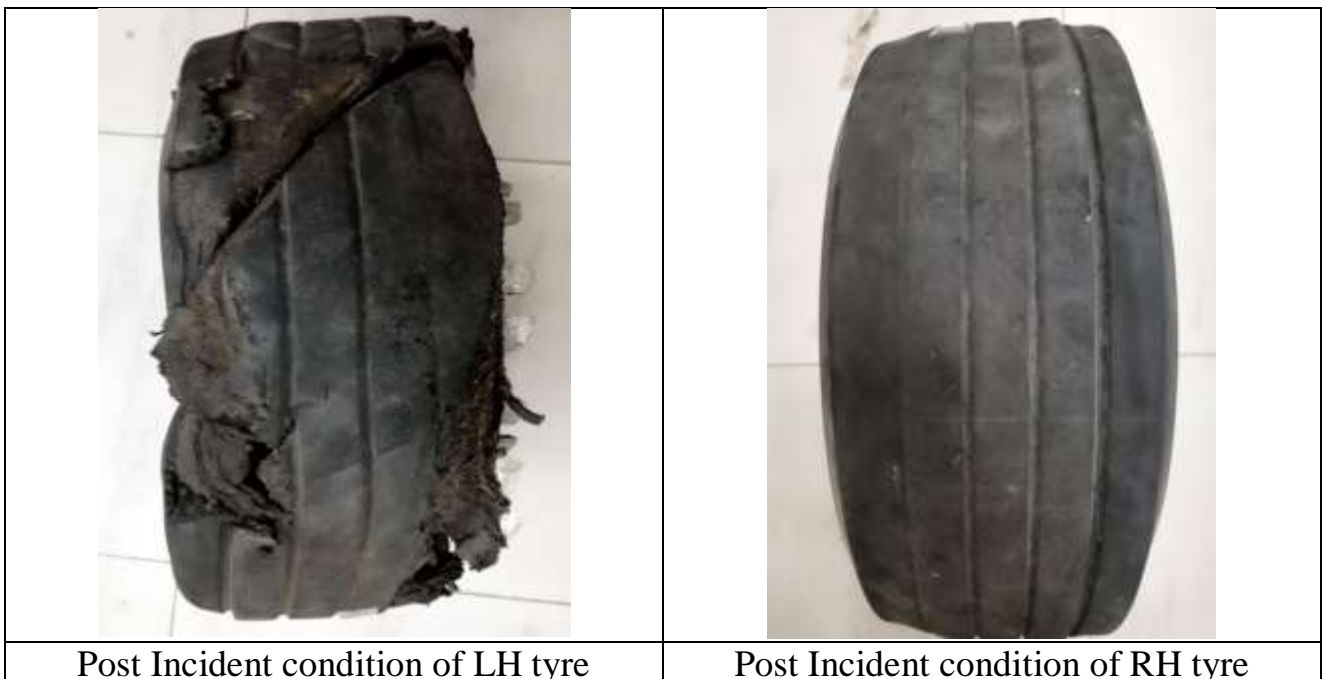
From the above measurements, it is inferred that the tyre was not in good condition before take-off for the incident flight. The tread depth was close to zero at various spots. The treads were significantly worn out, specifically on the inner sides.
