FINAL REPORT ON ACCIDENT

DIAMOND DA-42 AIRCRAFT VT-NFM

NATIONAL FLYING TRAINING INSTITUTE

ON 26/04/2017 AT GONDIA

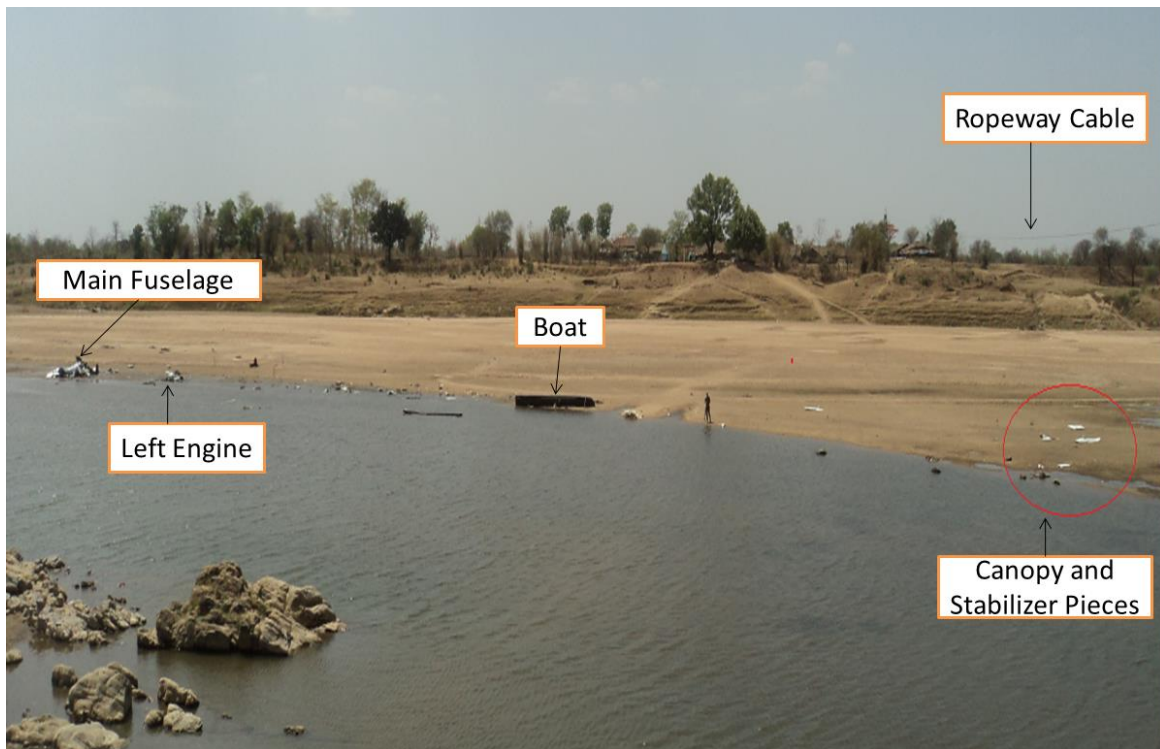
The aircraft's final position was 190 meters away from the point of impact. Before reaching its final position aircraft grazed the base of a boat on the river bed and toppled.

Fig 6: Crash Site

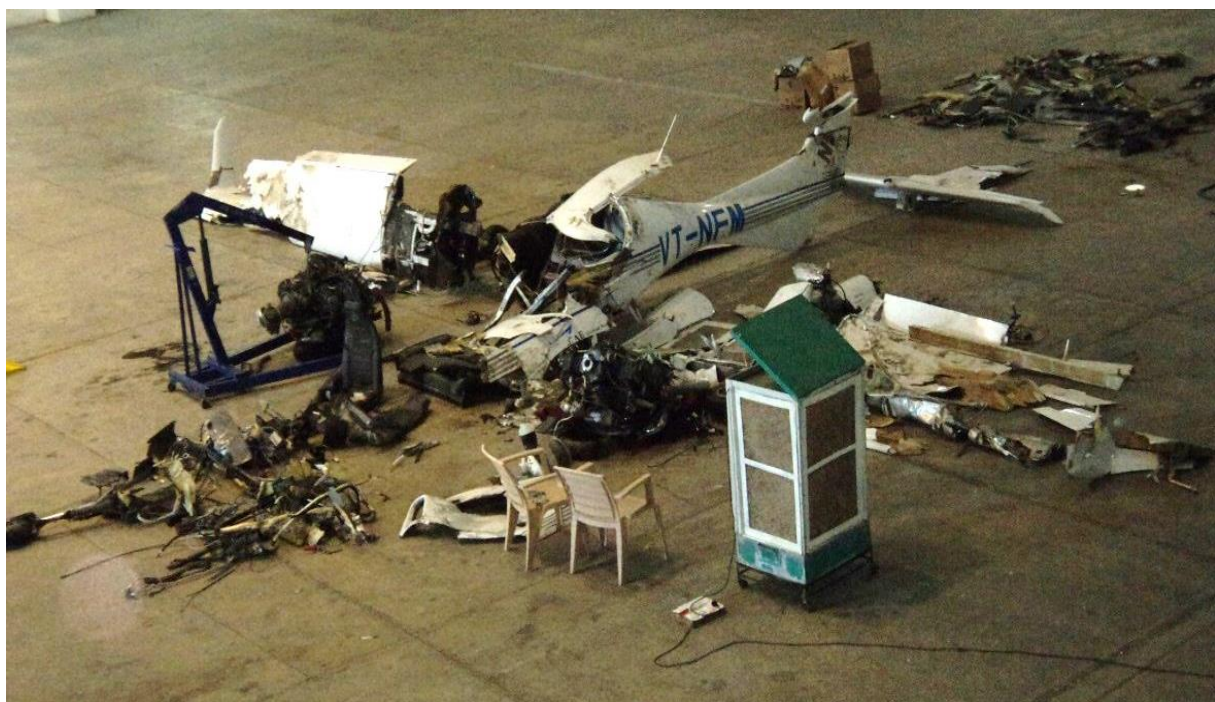
Fig 7: Wreckage Layout at Gondia airport Hangar

After impact the aircraft had disintegrated and scattered into mainly three major sections which were composed of main fuselage, engines and wings. The left wing was completely damaged and only fuel filler section along with fuel tank was recovered.

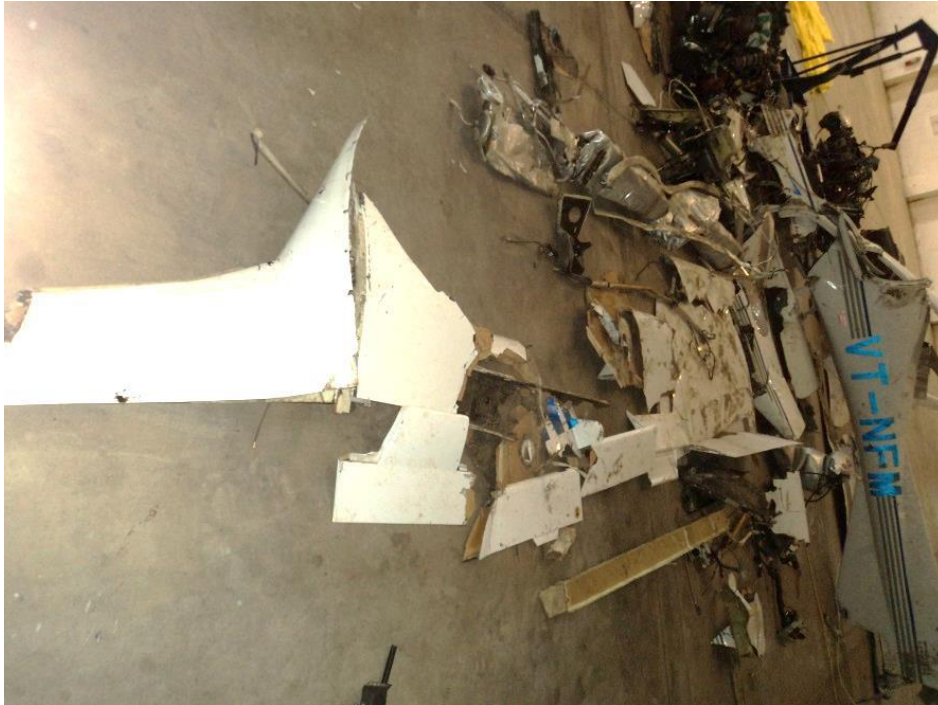
Fig 8: LH wing wreckage after layout

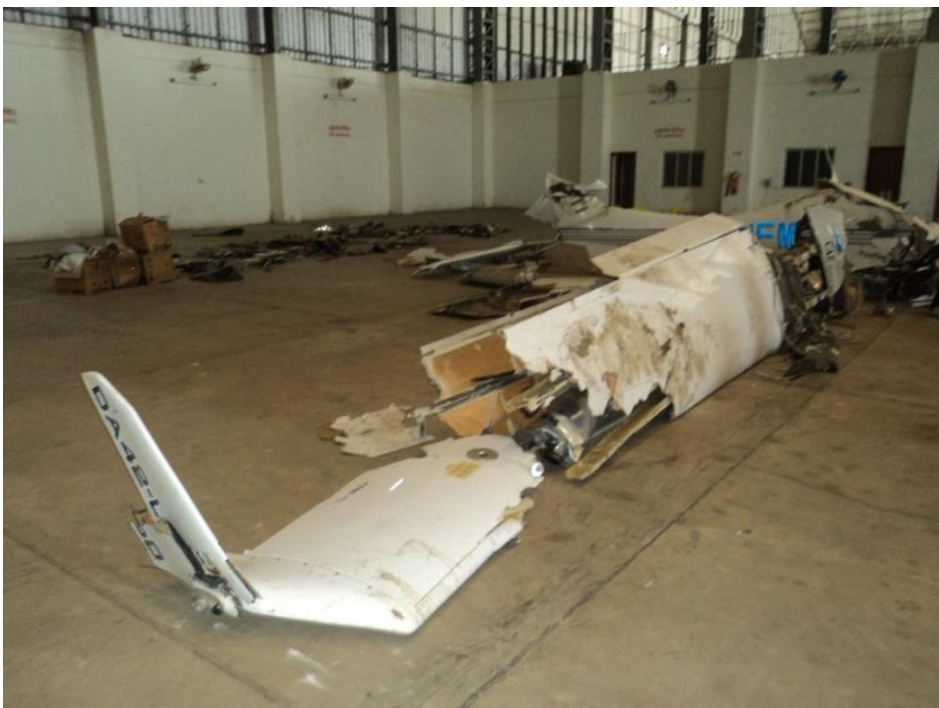
The right wing was also detached but was lying near the fuselage. The fuel tanks were also recovered in damaged condition and wing was broken into two sections.

Fig 9: RH wing wreckage after layout

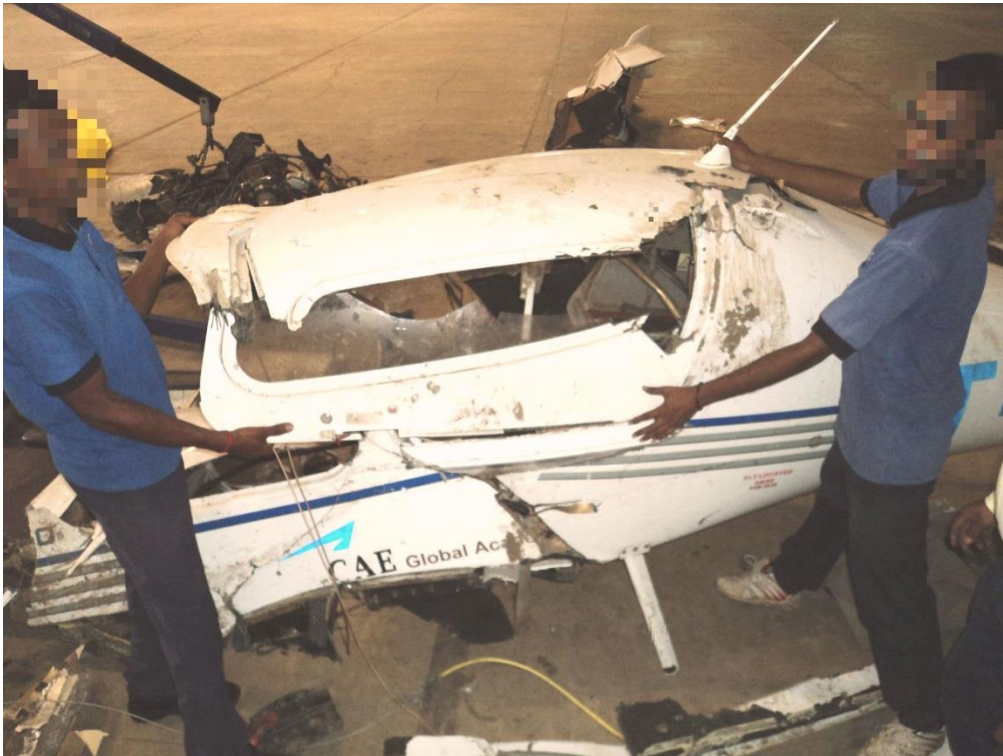
The front portion of fuselage structure was badly damaged due to impact with ground and ropeway cable. The canopy was sliced by the ropeway cable. Front as well as rear seats were detached from the fuselage after impact.

Fig 10: Front Fuselage wreckage

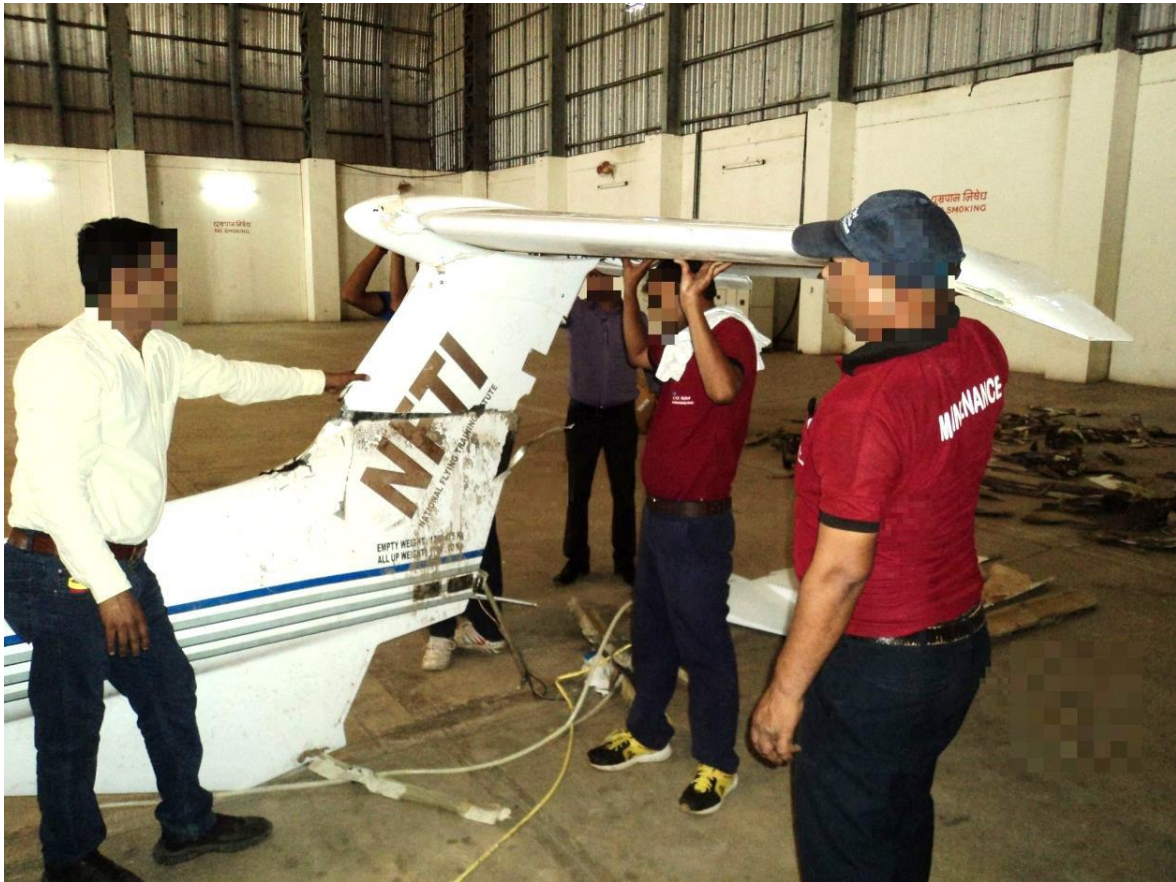
Horizontal stabilizer was found in one piece but detached from the vertical stabilizer. The tail section was found mainly intact with some damages due impact.

Fig 11: Wreckage of vertical stabilizer

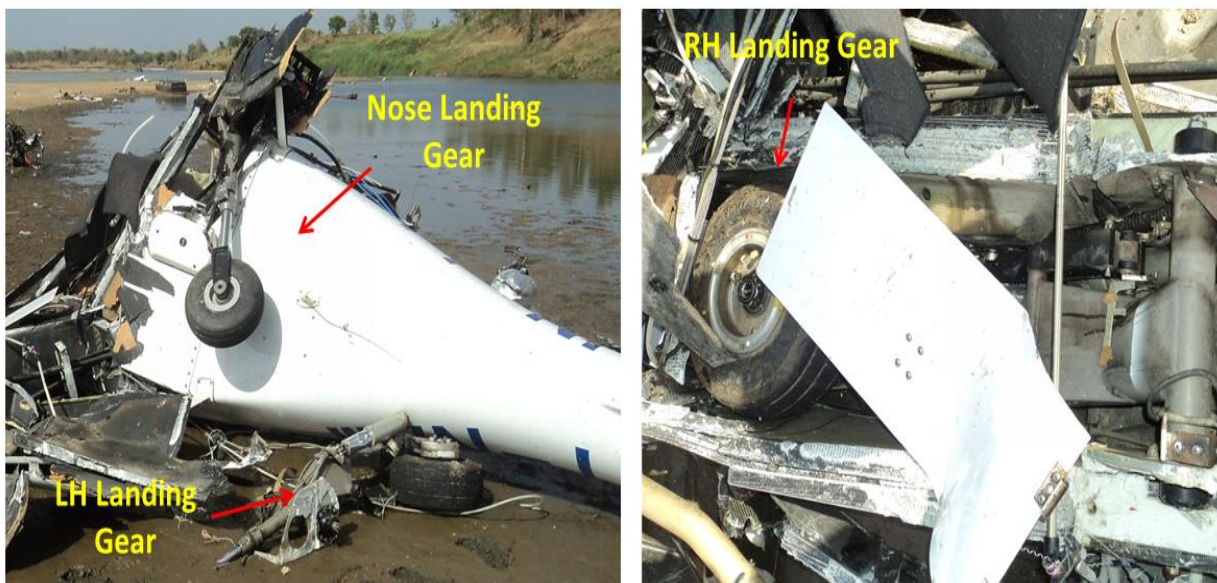
Due to impact the right landing gear was pushed into the wheel well and left gear & nose gear had disengaged from the gear bay and linkages.

Fig 13: Landing gears at crash site

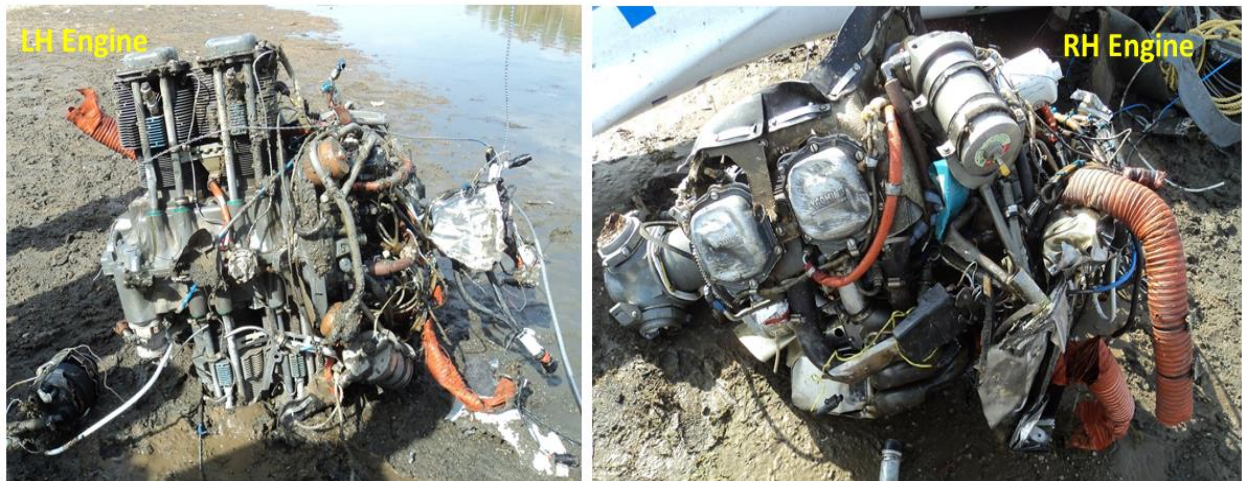
Both the engines completely detached from airframe. The left propeller hub had got disconnected from engine and blades had completely sheared off from the root. The right propeller hub was attached with the engine and blades were sheared off at the root except for one blade which had about one foot blade remaining.

Fig 14: Engines at crash site

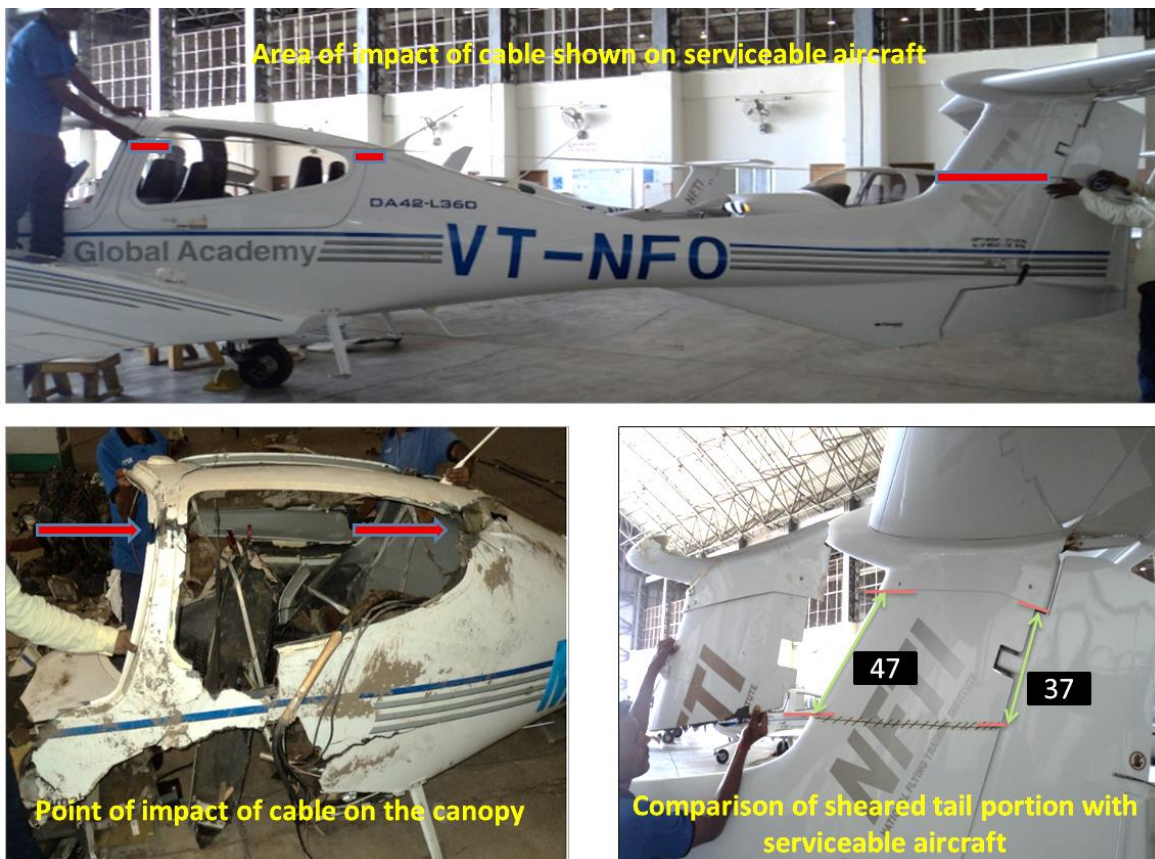
Further comparison of the wreckage was done with the serviceable aircraft and it was seen that, the direction of impact on the canopy was in line with the direction of impact on the vertical stabilizer as seen in the fig below.

Fig 15: Comparison of wreckage with serviceable aircraft

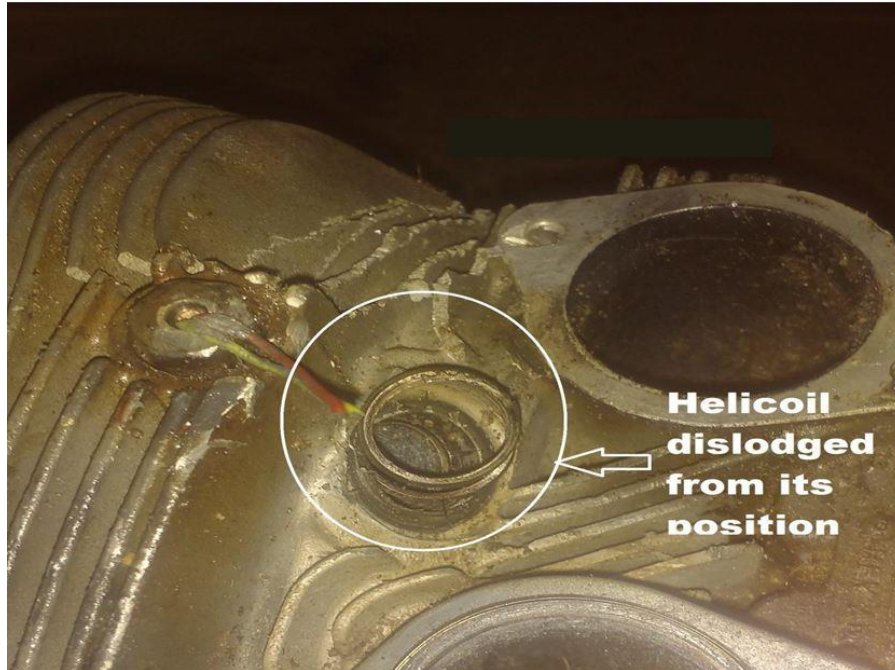
Seven quantities of spark plugs out of eight were retrieved from the wreckage site. The remaining spark plug possibly had dislodged from its position due to impact. The condition of the spark plugs was satisfactory. The helicoil of missing spark plug was found dislodged from its position.

Fig:19: Dislodged Helicoil

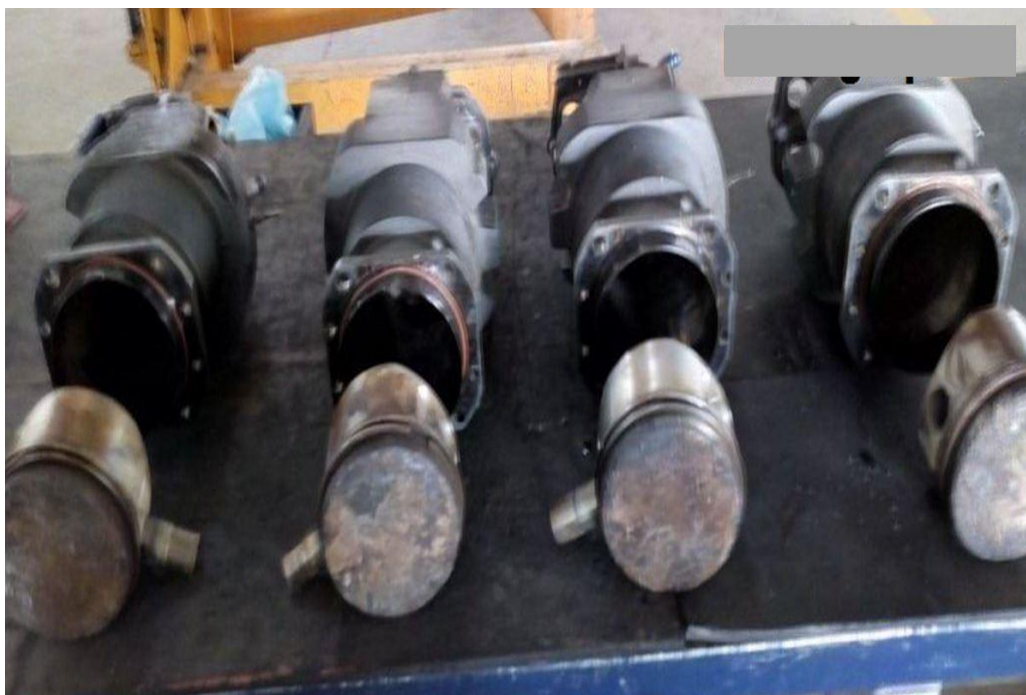
Engine was disassembled for inspection. Carbon deposits were seen on the internal wall of cylinders, no deposits were noticed on Oil screen. High amount of carbon deposit was found in the ring grooves of Pistons. Carbon deposits were also noticed on dome of Piston. Piston rings of all the pistons were found in stuck piston without any movement and were corroded.

Fig 20: Piston and Cylinders

The external damages observed on parts and accessories were resultant of impact on the engine due accident .The carbon deposits noticed on piston were normal and are also normally observed on engines received for overhaul. The bench check of spark plugs was found satisfactory.

The sand particles seen at electrode locations of the spark plugs & internal walls of the cylinders were possibly due to ingestion of sand particles through the broken induction tube at the time of accident. The start of spark of right hand magneto at higher RPM was possibly due to change in time setting because of impact on magneto at the time of accident.

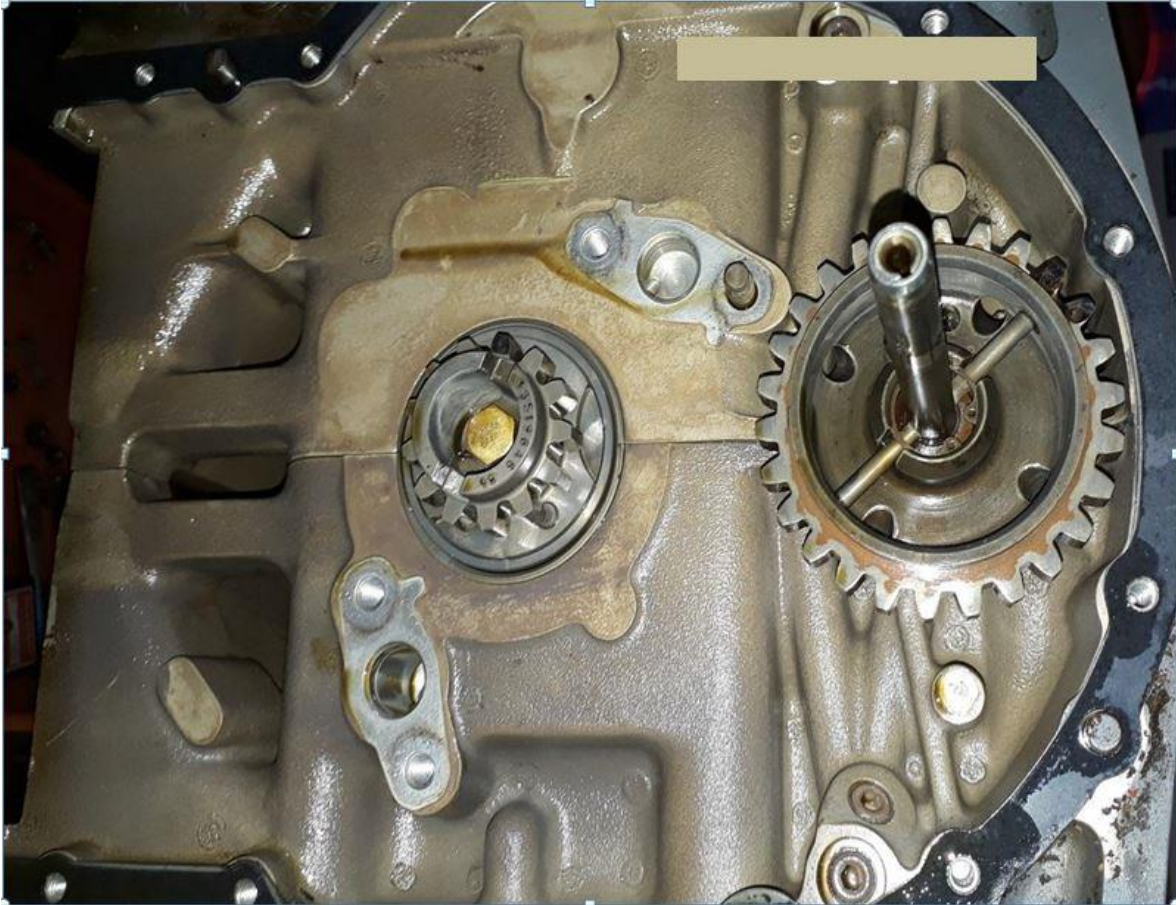
There was no visible damage to the gears.

Fig:21: Gears

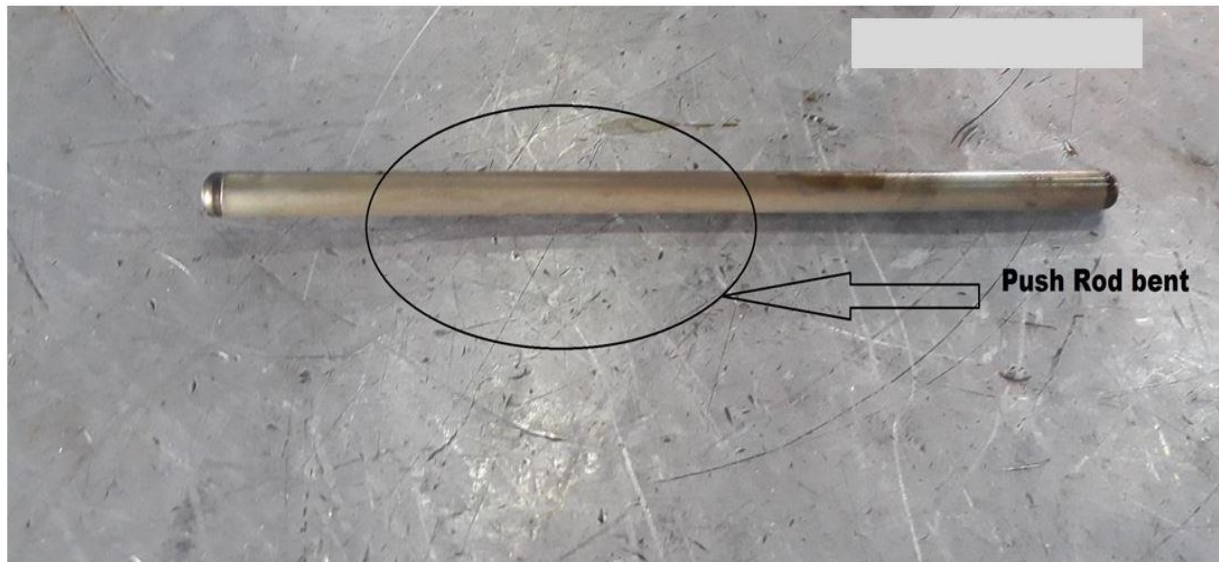
The Pushrods were bent.

Fig: 22: Damaged push rods

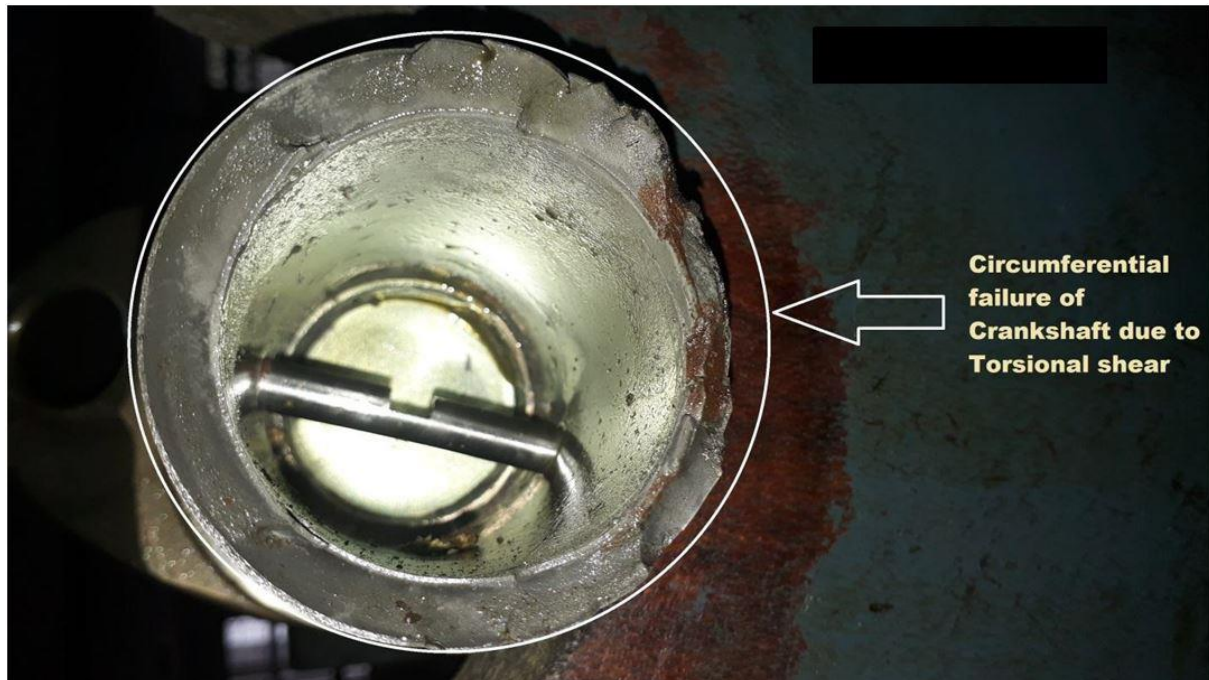
The Crankshaft had sheared behind the flange. The condition of connecting rods with the bearing was satisfactory. No abnormal wear out or scuffing of bearing was found.

Fig: 23: Failed crankshaft

It can be inferred from the failure observed on the crankshaft during detailed examination of the LH engines that the shaft had failed due to torsional

shear indicating the engine was delivering full power at the time of accident. The other damages observed were resultant of impact to the engine at the time of accident.

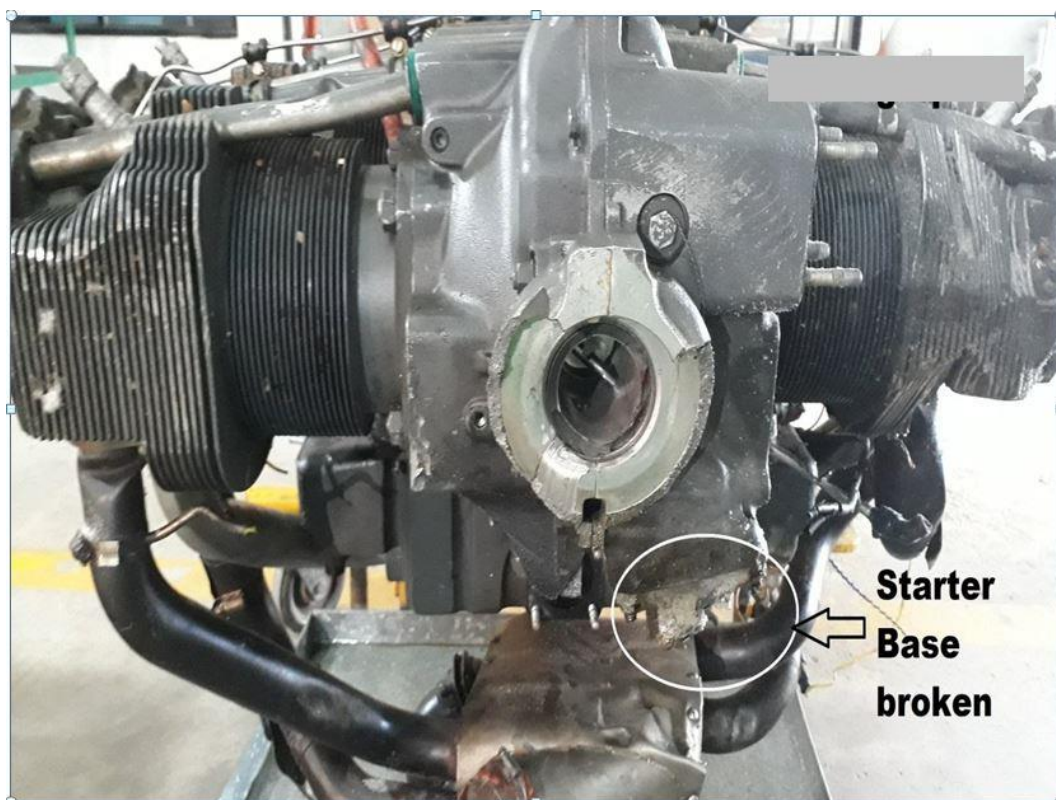
During Inspection of electrical system it was found that Ignition Harness was cut and damaged. Starter was found broken at the base.

Fig: 24: Starter base broken

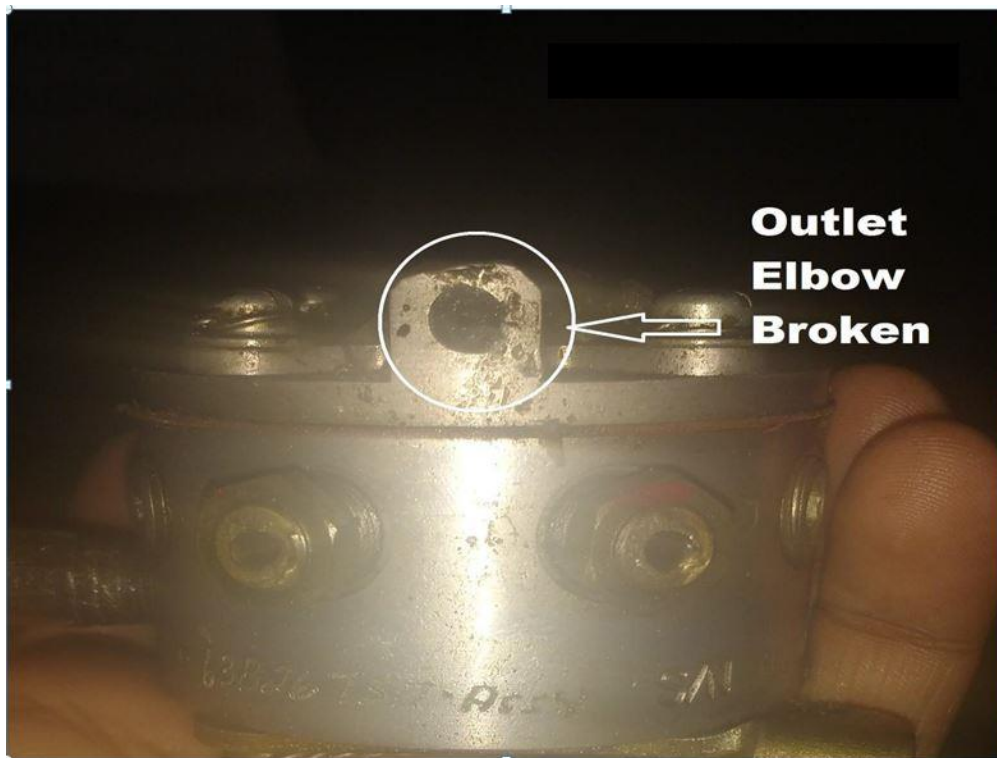
The inspection of fuel system revealed that the external condition of Fuel flow divider was satisfactory. The outlet elbow was broken. The fuel pump was

dislodged from its mounting and broken. Fuel injectors were missing and fuel lines were bent and dry.

Fig: 25: Broken fuel outlet elbow

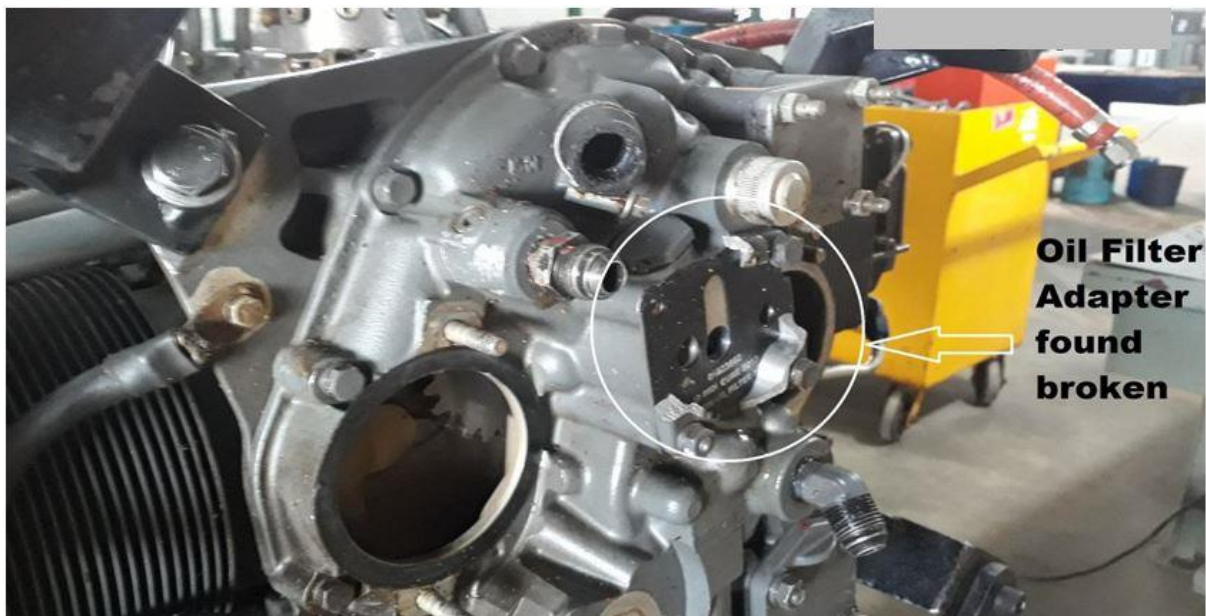
The oil filter adapter was broken and oil filter was missing.

Fig: 26: Broken oil filter adapter

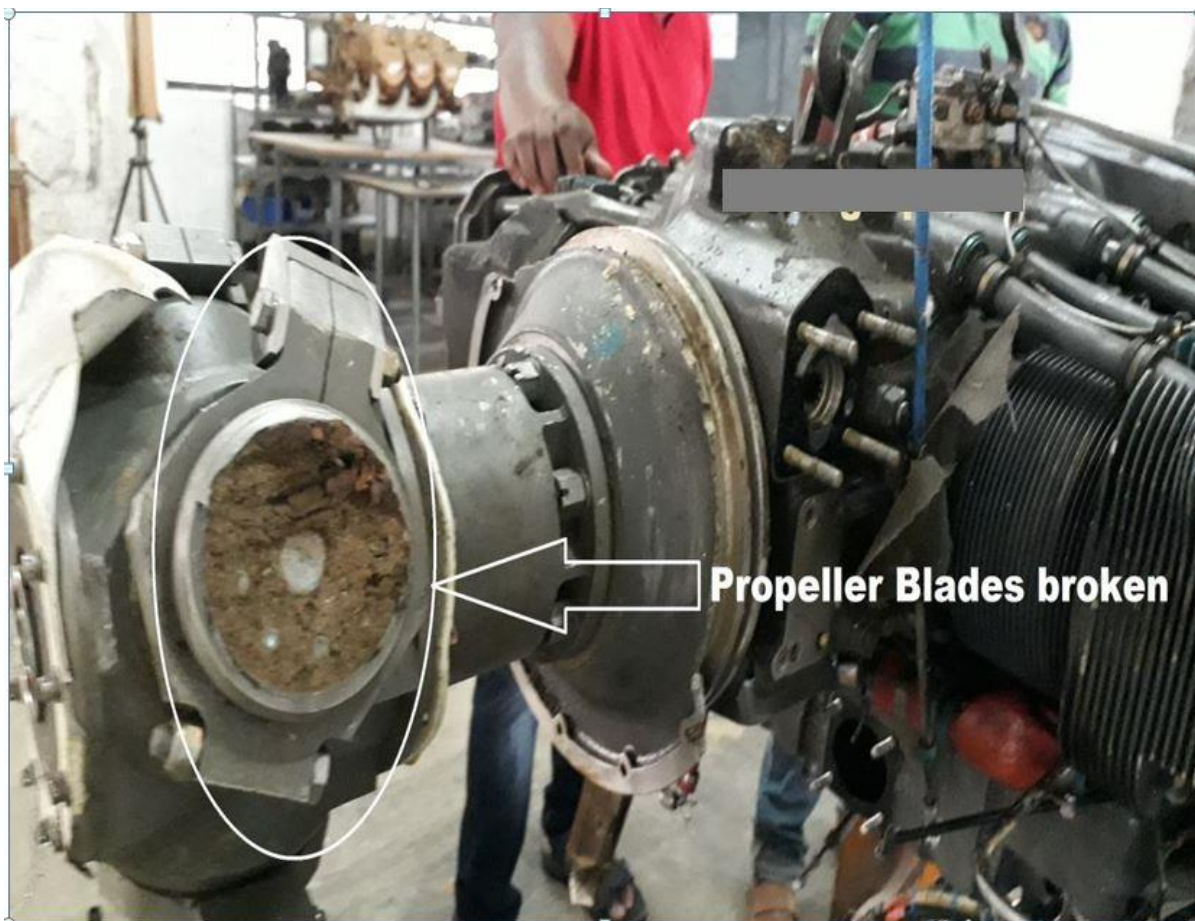
Propeller hub was attached to the flange of crankshaft and root section of propeller blades were stuck in the hub.

Fig: 27: Sheared propeller blade

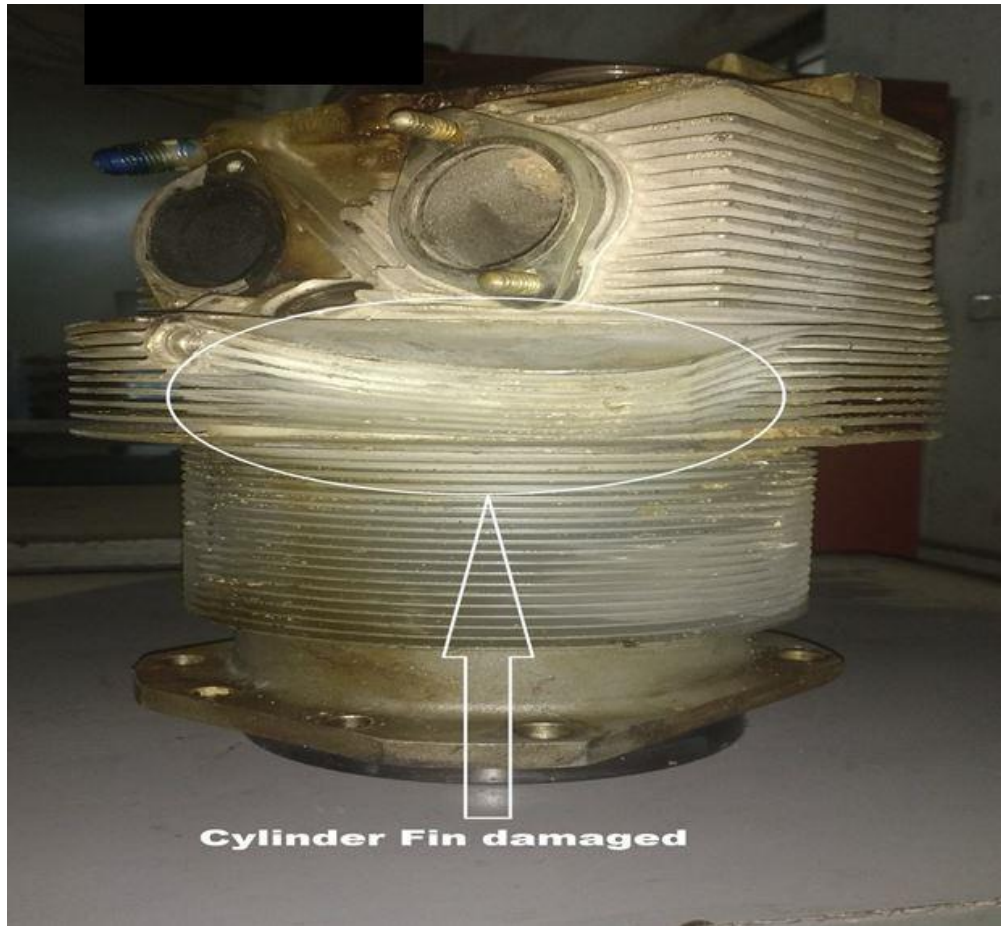
The fins of all the four cylinders were damaged

Fig: 28: Damaged Cylinder Fin

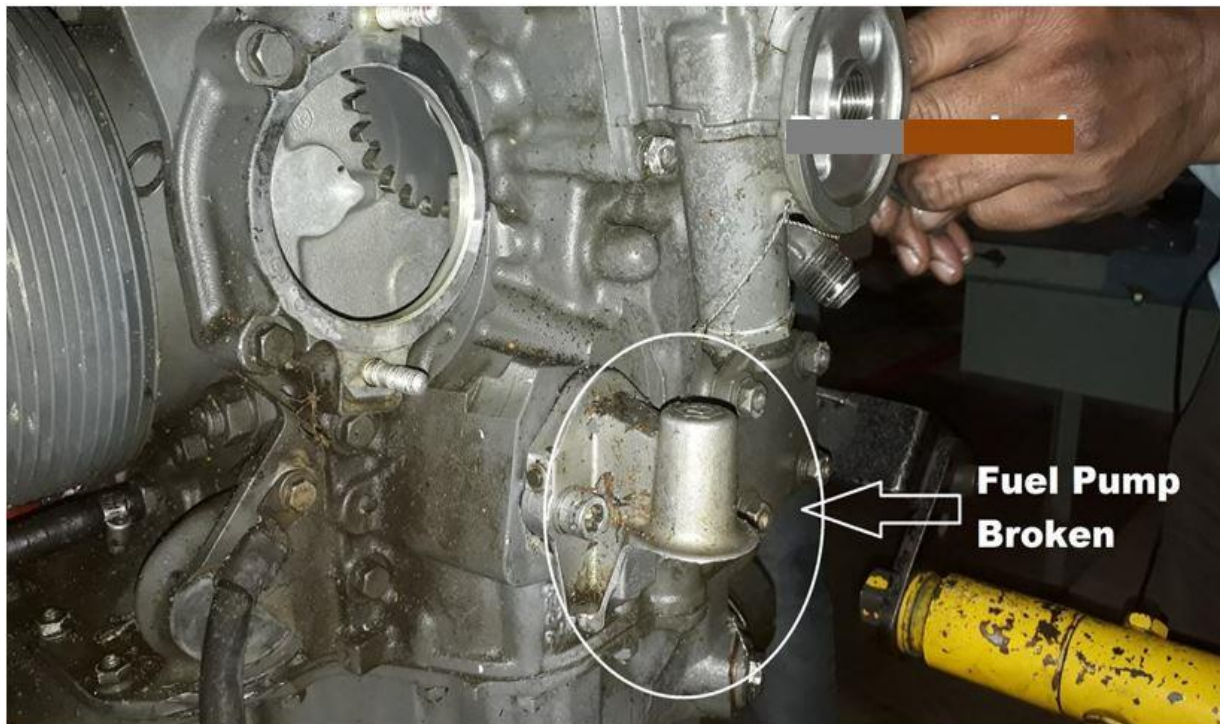
The fuel pump was broken and detached from the engine.

Fig: 29: Broken fuel pump

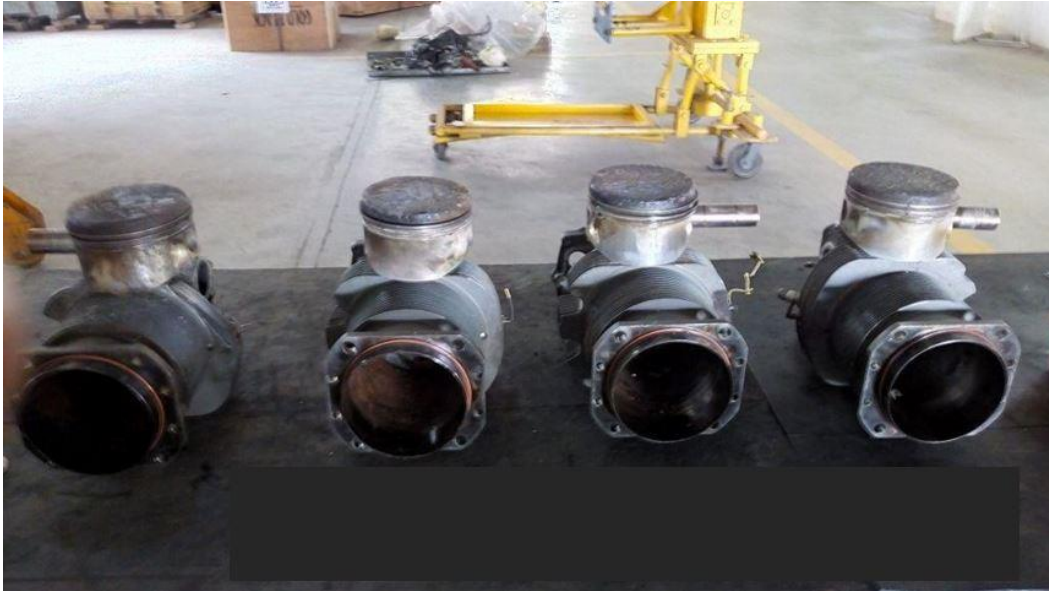
During inspection of the dis-assembled right engine, high amount of carbon deposit was found in the ring grooves of Pistons and carbon deposits were noticed on dome of the Piston. Piston rings of all the pistons were found in stuck piston without any movement and corroded.

Fig: 32: Piston and Cylinders

due to accident. The carbon deposits noticed on piston dome were normal and similar to those observed on engines received for overhaul. Propeller hub was found attached to the flange of crankshaft. The blades of propeller were found stuck in the hub.

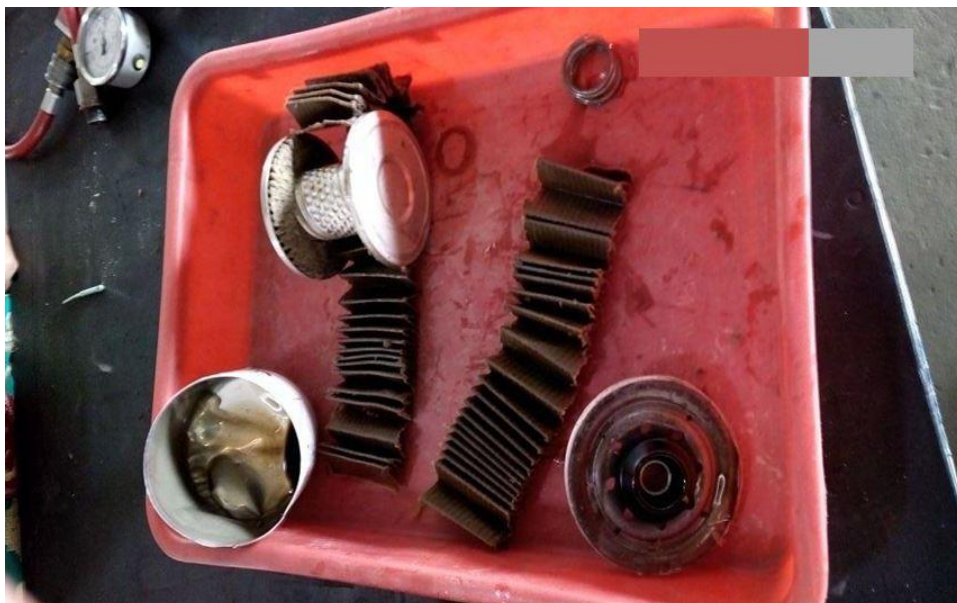
The oil filter was cut opened and no metal particle was found. No internal damages noticed on Crank Case & Oil Sump casings. No deposit was noticed on Oil screen.

Fig: 33: Oil filter cut for inspection

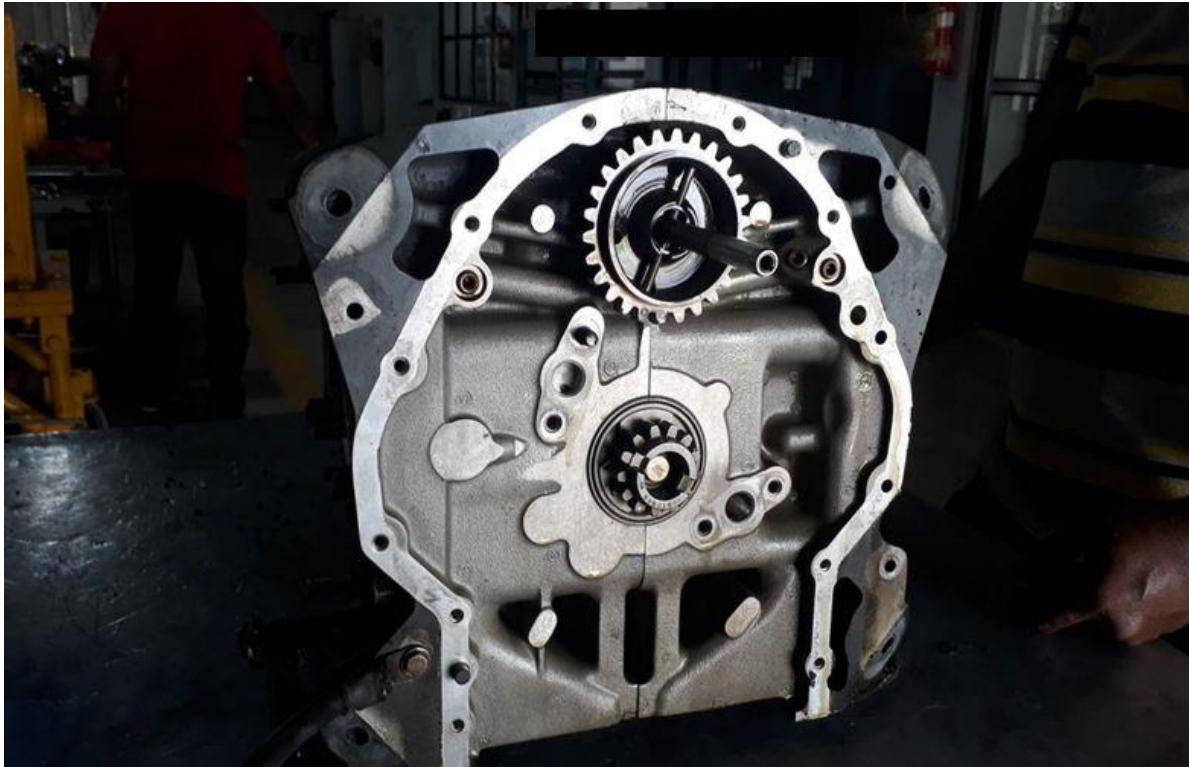
There was no visible sign of damage on the gears.

Fig: 34: Gears

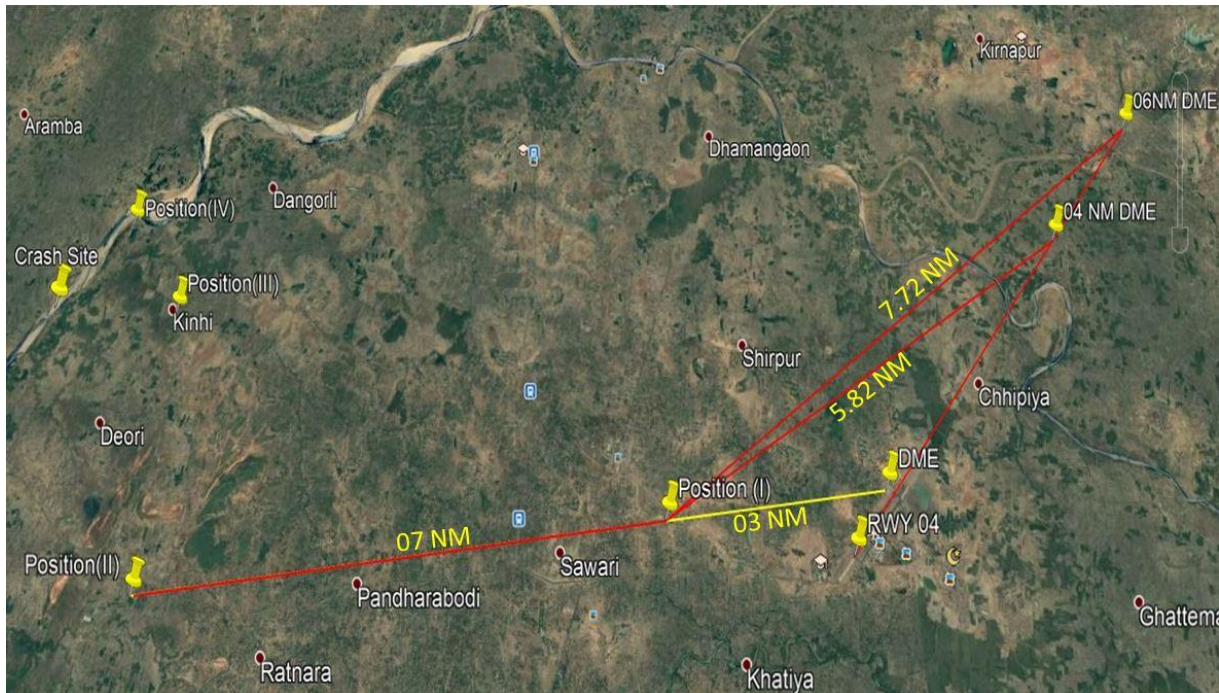
We can see from above table that the aircraft flew distance of 07 NM on radial R265 from Position (I) to Position (II) in 143 seconds. This would require the aircraft to fly at airspeed 176 Kt. This is way above the normal maximum structural cruising speed of 155 Kt.

Further, the aircraft took off from Rwy 04 and was required to continue to 2500 feet before turning left as per instructions of ATC. Assuming that the SOP was followed, aircraft would have turned left to intercept R265 between 04-06 NM from runway.

Fig 40: Possible route as per ATC conversation (Depicted in red)

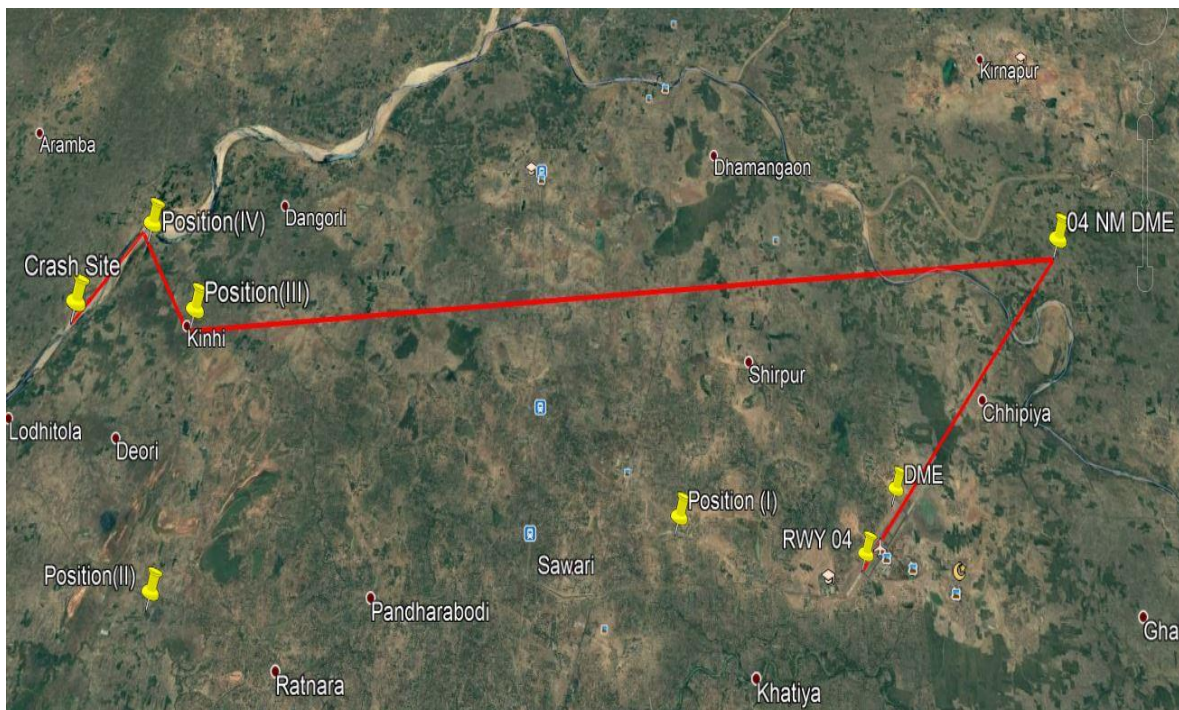
Possible route followed by the aircraft when plotted on the map based on the sightings by the witnesses is given below.

Fig 41: Possible route as per witness and aircraft performance limits
