**Final Report on Serious Incident between M/s Jet Airways
Ltd. B737-800 & M/s Tata Singapore Ltd. A320-232 at Delhi
on 21.04.2017.**

6. Date & Time of Incident : 21st April 2017, 01:20 UTC

13. Type of Occurrence : Air Proximity

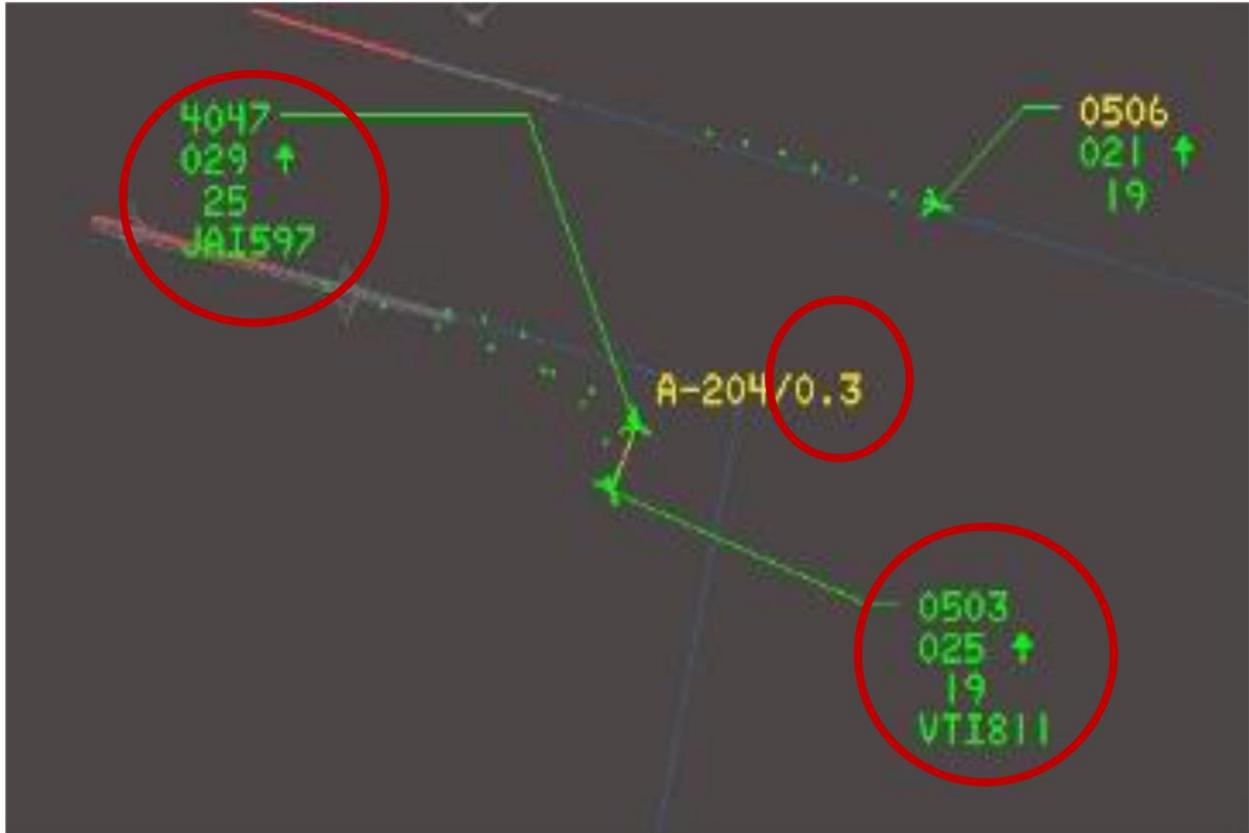
Figure 1: Airprox between JAI597 and VTI811 with vertical and lateral separation as 400 feet and 0.3 NM

2.8 The minimum lateral and vertical separation reduced to 0.3 NM and 400 feet respectively.

- 3.1.11 The simultaneous go around of high speed JAI597 and departure of VTI811 led to breach of separation/ airprox incident. The lateral separation between JAI597 and VTI811 was reduced to 0.3 NM when the vertical separation was 400 feet.

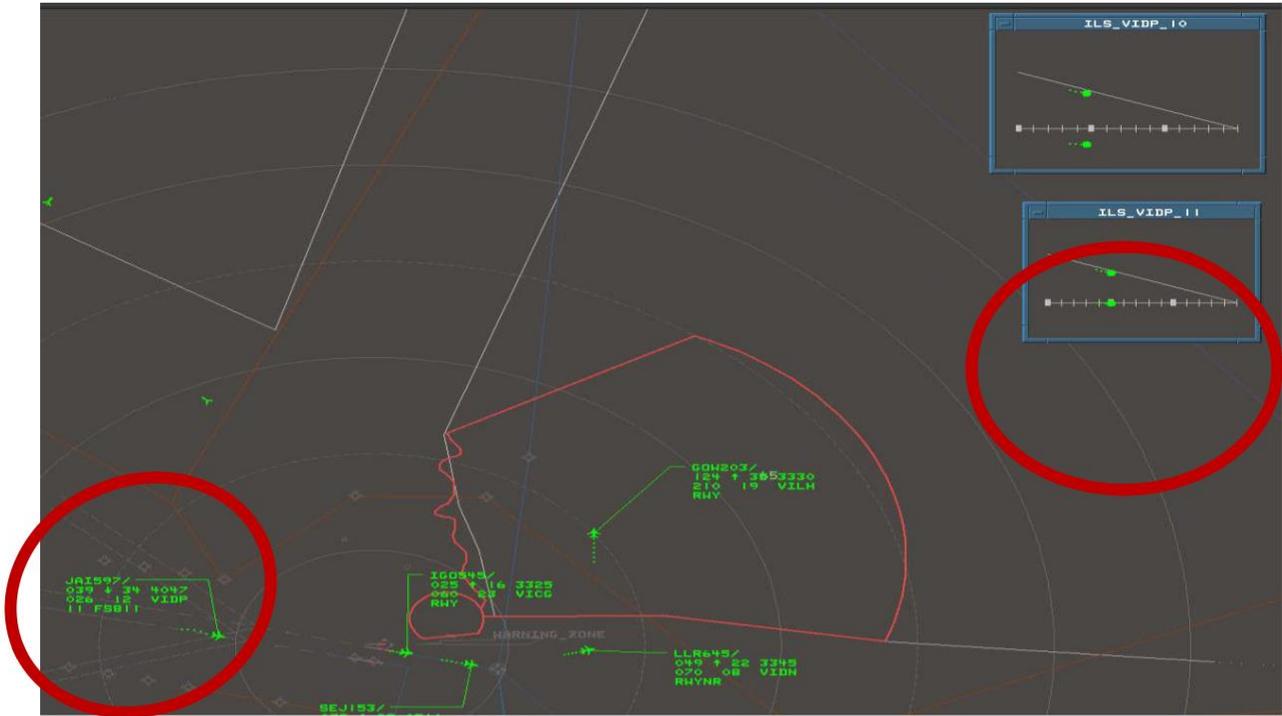
Figure 2: At 011902 UTC, JAI597 10 miles from touchdown, on ILS RWY 11, passing 3900 feet , 340 kts.

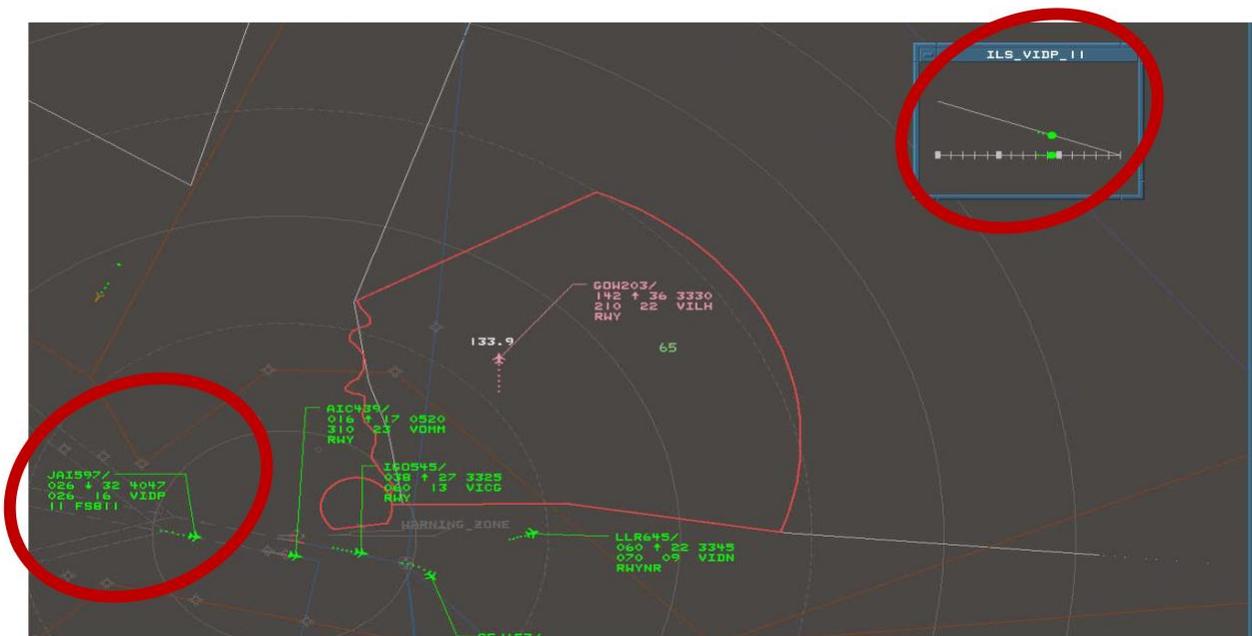
- 1.1.6 At time 011954 UTC *when JAI597 was five and half miles from touchdown the ground speed of aircraft was 320 knots* (as observed on radar label of flight). At this time, the controller again enquired from Crew of JAI597 *“Will you be able to make landing with this speed”* to which the Crew of JAI597 replied *“affirm”*.

Figure 3: At 011954 UTC, JAI597 5.5 miles from touchdown, on ILS RWY 11, passing 2600 feet, 320 kts.

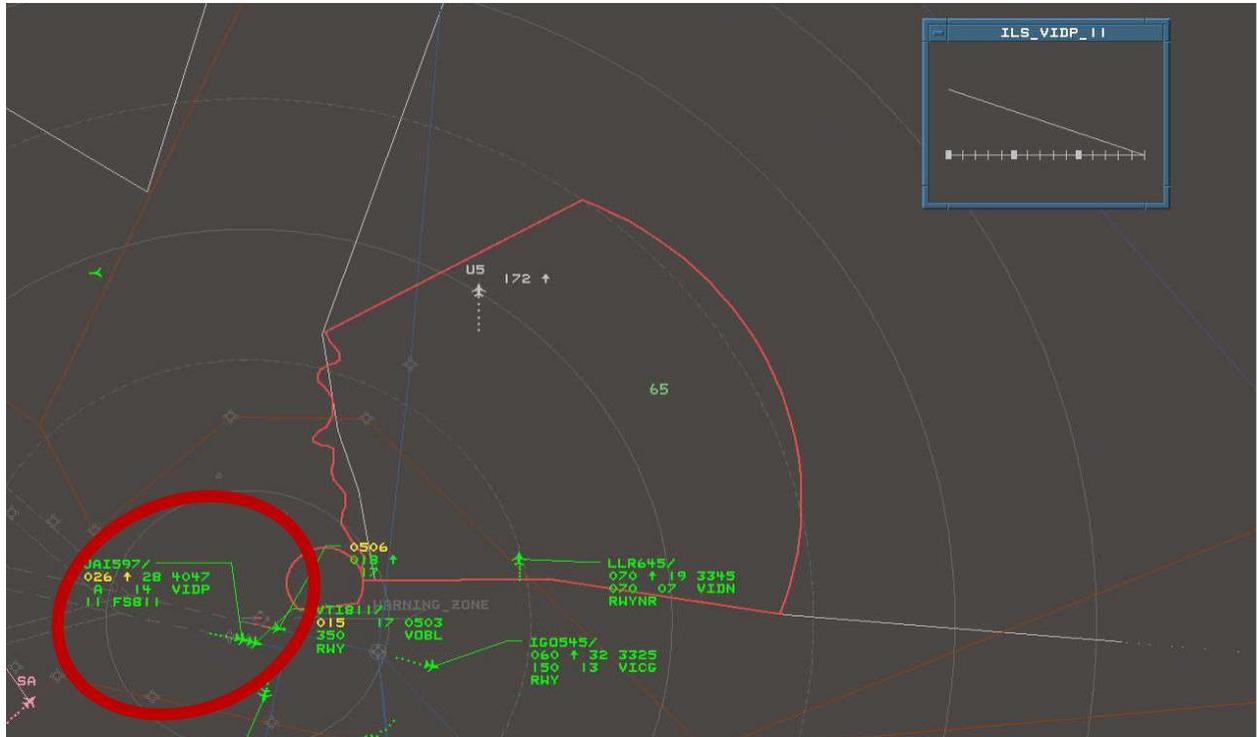
Figure 4: At 012027 UTC, JAI597 going around RWY 11, passing 2600 feet.

1.1.8 At time, 012027 UTC, the Crew of JAI597 informed Approach Radar Controller that they are going around runway11 ***“Sir Request Go around JAI597 Going around.”***

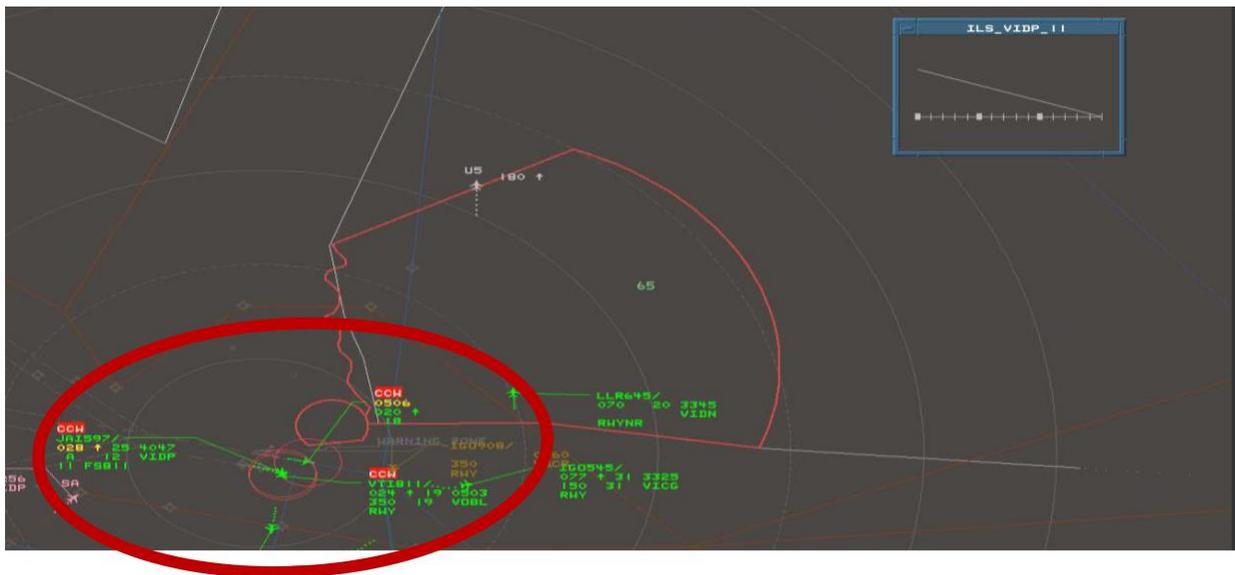
Figure 5: At 012144 UTC, JAI597 after high speed approach, going around RWY 11, airprox with VTI811
