**INVESTIGATION REPORT ON SERIOUS INCIDENT OF  
AIRPROX BETWEEN M/s JET AIRWAYS ,JAI426 (B737-800  
AIRCRAFT VT-JBE )AND M/s AIR INDIA Ltd, AIC696 (A321  
AIRCRAFT VT-PPL) AT CSI AIRPORT, MUMBAI, ON 21/08/2017**

**KUNJ LATA**  
**INVESTIGATOR-IN-CHARGE**

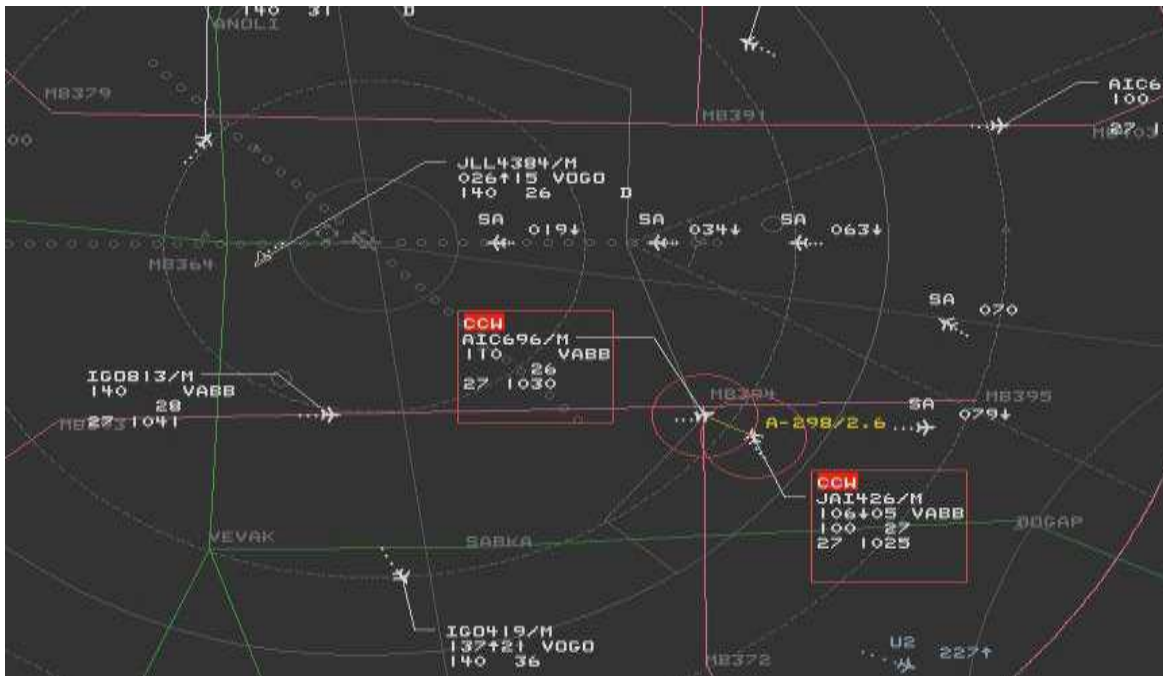
While descending a PCW (Predicted Conflict Warning) was generated. During the warning, Approach Radar Controller didn't initiate corrective action in time. Later, AIC696 flying on heading H090 was given an avoidance heading to turn left H360 and JAI426 was instructed to turn right heading H090 by Approach Radar Controller. JAI426 was also asked to expedite descent. The Approach Radar Controller tried to combine descent clearance with orbiting instruction. At 10:08:22 UTC, PCW converted to CCW (Current Conflict Warning).

**FIGURE: RADAR SNAPSHOT SHOWING CCW WARNING**

JAI426 received TCAS RA at 10:08:22 UTC while passing FL107 (10707 feet) with “DESCEND” advisory followed by “Don’t Climb Advisory”. AIC696 reported TCAS Advisory. The minimum lateral separation was reduced to 2.3 NM and vertical separation was 400 feet.

3. AIC696 and JAI426 was almost on opposite direction. After PCW generation, there was a delay in detecting the conflict. There was no transmission between controller and the concerned aircraft till it was converted to CCW.

3. Training section may sensitize all controllers to be vigilant while PCW system alerts and take the corrective action on time.
