FINAL REPORT ON ACCIDENT INVOLVING CESSNA 152 AIRCRAFT
VT-PTD OPERATED BY M/s FALCON AVIATION ACADEMY, FAIZABAD
ON 26/04/2018 AT FAIZABAD

SUMMARY

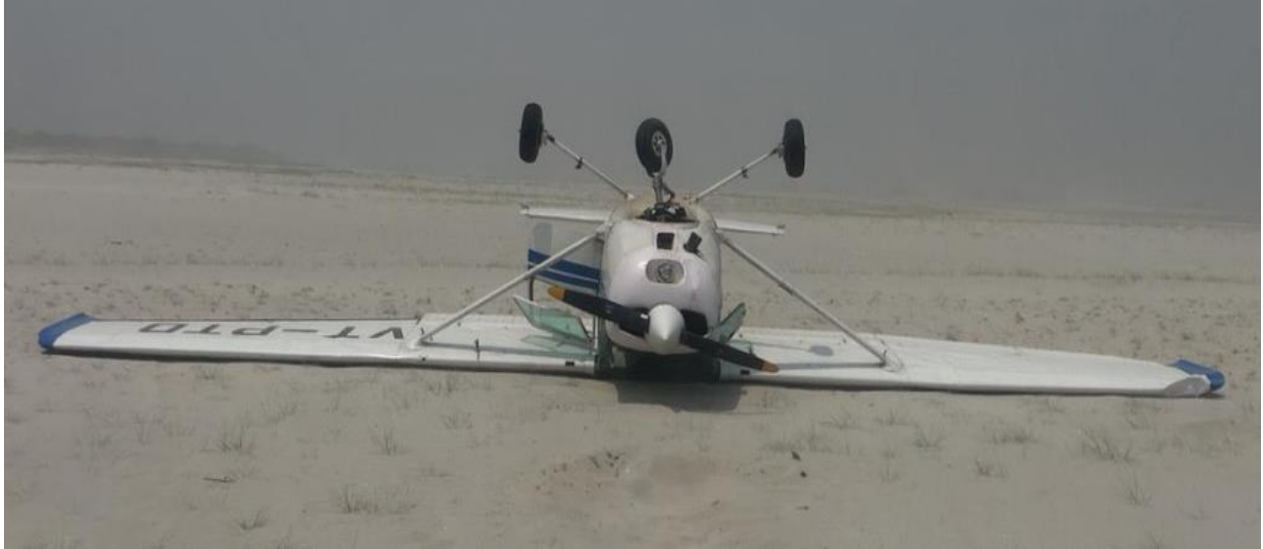
rear wheels touching the sandy ground first. Aircraft kept rolling in this attitude for about 213 feet. As the aircraft lost speed and aircraft weight fell on its wheels, nose wheel also touched the sandy ground. The nose wheel started sinking in the sand which caused the aircraft to topple. Thereafter, the aircraft came to a halt.

Fig 1: Aircraft lying toppled at crash site

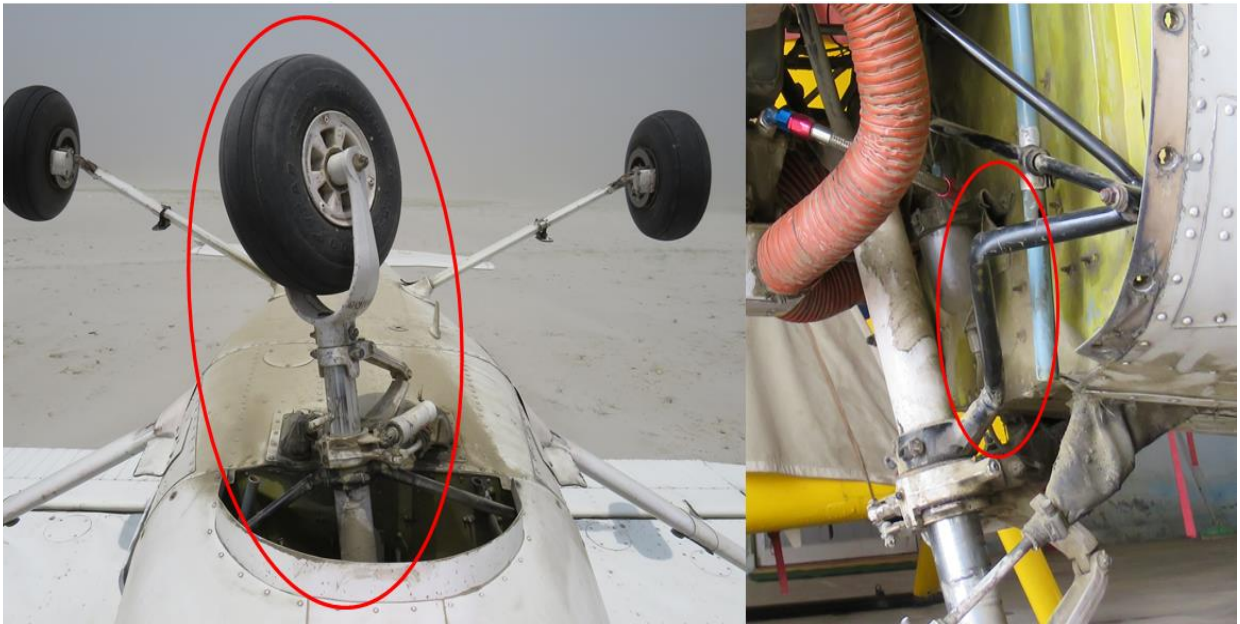
Fig 2: Nose Landing gear bent due to bending of its mounting

Nose cowling of the aircraft received dents and Nose Landing Gear had tilted to one side due to bending of its mounting. Nose wheel right hand steering rod was also broken.

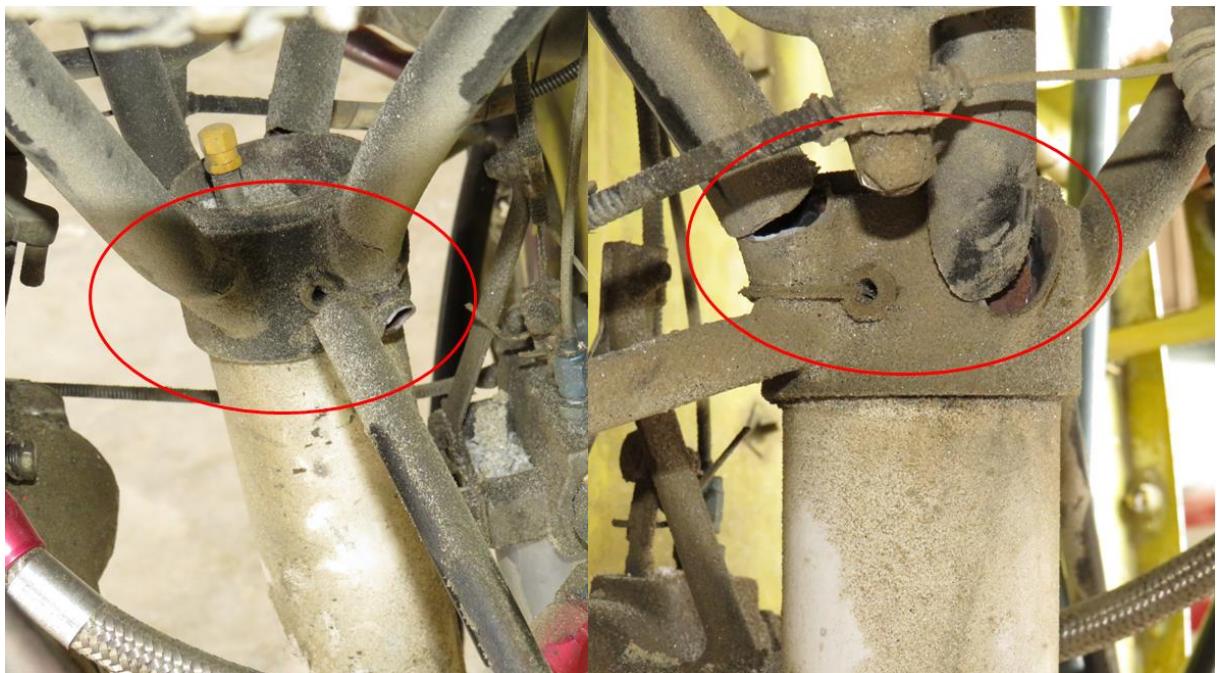
Fig 3: Engine Mounts broken

The engine mount assembly was found broken at three points.

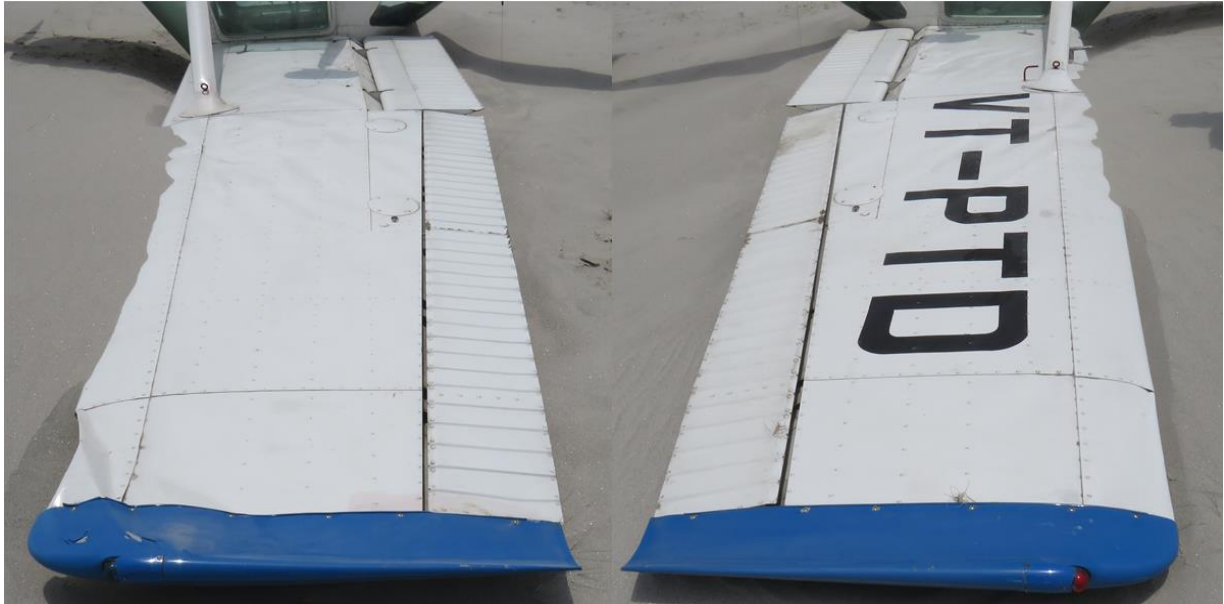
Fig 4: Damages to LH and RH wing

Starboard wing had bulged at L.E near to the tip. Multiple wrinkles were observed on both starboard & port wing on upper as well as lower surface.

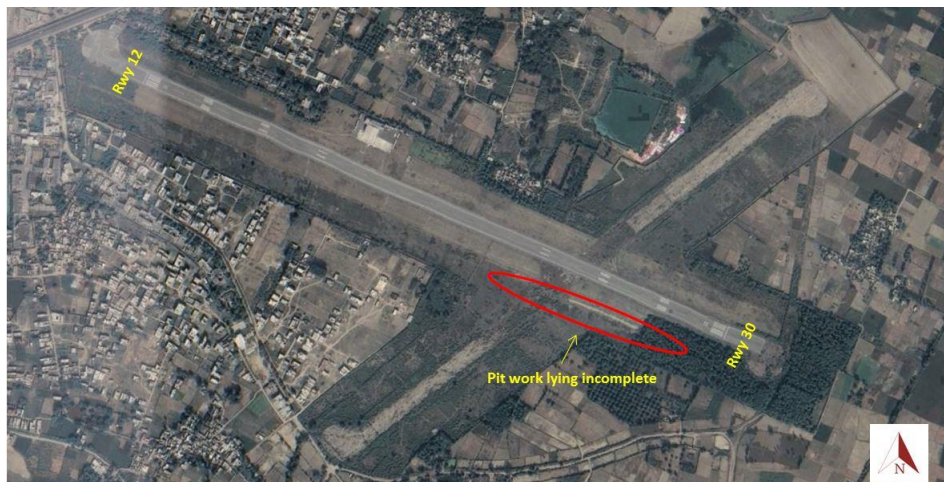
Fig 7: Layout of Faizabad Airport with incomplete mud pit highlighted

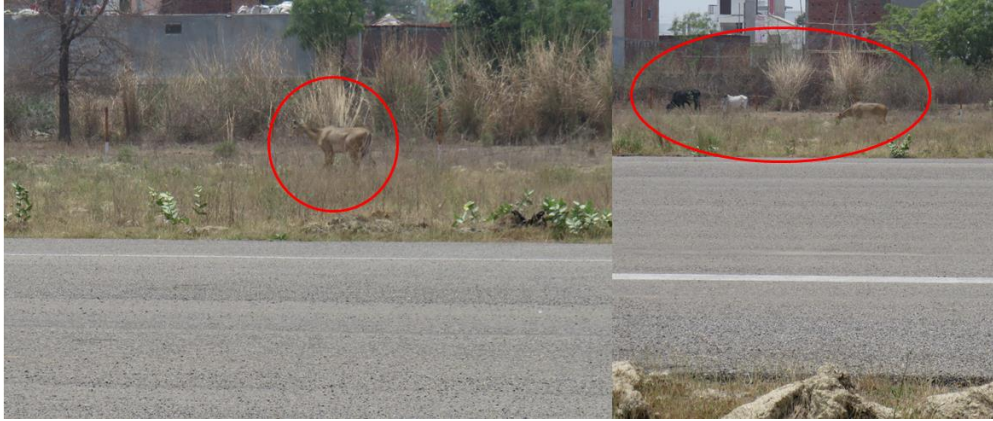
Fig 8: Incursion of stray cattle and wild animals on the Runway

During visit of Investigation team to Faizabad airport, it was observed that the airport premises is not properly secured. Stray cattle and wild animals were seen grazing in the vicinity of the runway. A barbed wire had been put up on both sides of the runway strip to prevent incursion by the cattle and wild animals, but had proven adequate as is evident from the pictures above (Fig 8). Alternately, a pit was being dug on the side of runway to prevent stray cattle from approaching the runway, but the work was lying incomplete.

The airport premises is not properly secured and stray cattle and wild animals are able to approach the runway. A barbed wire fence installed by the operator was not an adequate deterrent and could be crossed by the cattle and wild animals. The work for a pit to prevent animals from approaching the runway was lying incomplete. The hazards present at airport were not a contributory factor in the accident but could pose a serious threat to flights operating from the Faizabad airport.

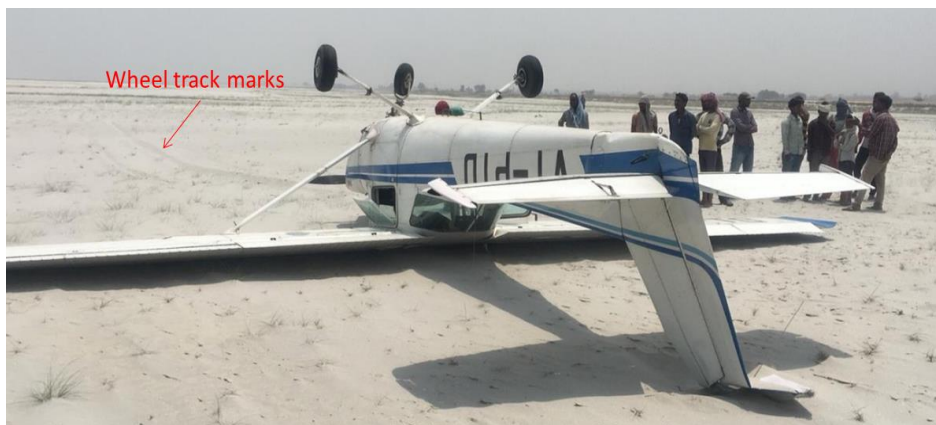
Aircraft forced landed on the bed of Saryu river and had travelled a distance of 213 feet approximately on main landing gear before it got toppled. The marks of tyre track could be seen in the picture taken immediately after the accident.

Fig 9: Wheel track marks

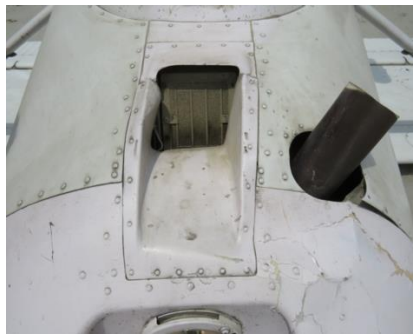
1. Dent was found on the engine cowling near nose section. One rivet of cowling at nose section was found missing.
2. Exhaust stag was found damaged. (Figure10)

Fig 10: Damage to the nose cowling and exhaust stag

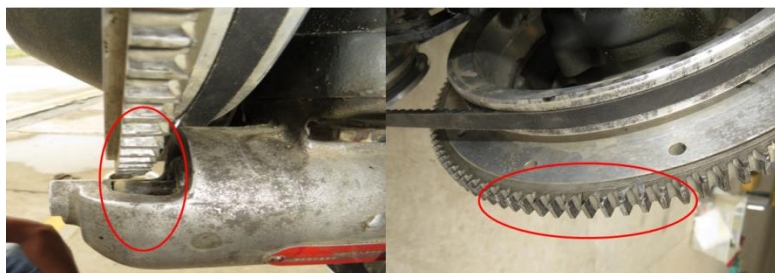
3. Starter drive gear was found broken. (Figure 11)

Fig 11: Broken Starter Gear and Ring Gear teeth

4. Starter ring gear teeth were found damaged at different places and rubbing marks were present on the back of the ring gear. (Figure 11)
5. Air intake filter was found clogged with sand. (Figure 12)

The condition of Starter Motor and Spark plugs hinted at poor maintenance practices. The vibrations and loss of power during the accident flight was caused by fouling of the spark plugs. Crew was unable to re-start the engine as the starter gear teeth had broken possibly during last start up on ground.

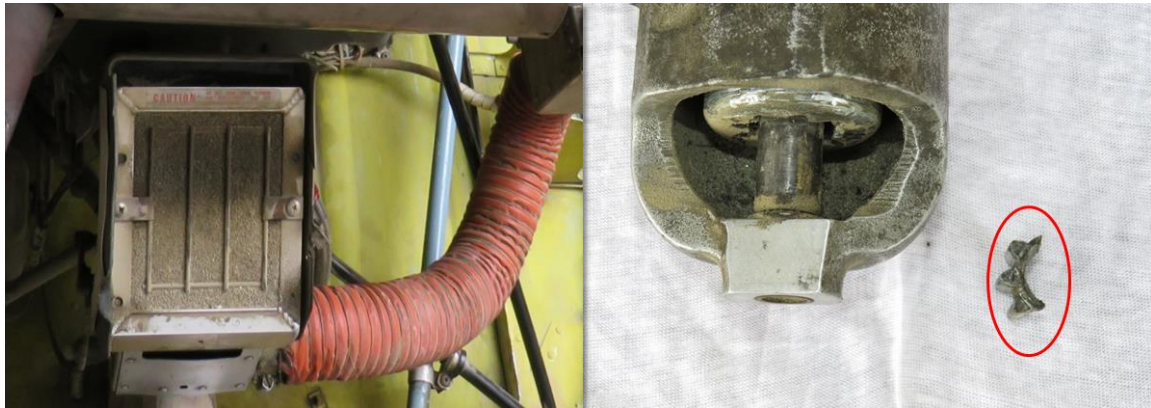
Fig 12: Air intake filter and broken piece of starter gear

6. All gears of the starter were found broken and only one fourth of gear was present. (Figure 12)
7. Cracks were found on both sides of starter mounting points. (Figure 17)
8. All sparks plug from all the Cylinder heads were uninstalled for inspection and found intact. Blue colour deposit was observed on electrodes of top spark plug for Cylinder No. 1 and 3. Bottom spark plugs of cylinder No. 1 & 2 had yellow colour deposits on its electrodes. (Figure 13)

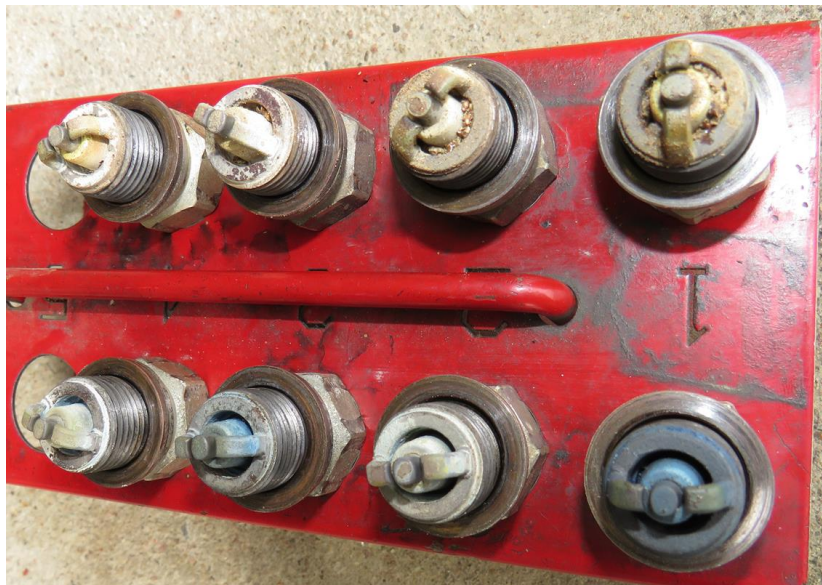
Fig 13: Spark Plugs

The blue coloured deposit on piston heads and spark plug electrode was due to non-combustion of fuel in the cylinder. It can be safely presumed that the top spark plugs of Cylinder no.1 and 3 having blue deposit were not firing. Bottom Spark plugs of Cylinder no. 1 and 2 too were in poor condition due to excessive lead deposit on its electrodes.

The yellow coloured deposit observed on piston heads is a sign of lead deposit which is normally observed on engines received for overhaul with approximately 700 to 800 Hrs of running. Spark plugs too were found with high content of lead deposit which was indicating towards lack of maintenance during

scheduled inspections. Quantitatively that amount of deposit could not have accumulated in just 32 Hrs of engine running had 200 hrs inspection been properly carried out on 18.04.2018. Alternatively, such high deposits could also be caused because the aircraft was carrying out maximum of flying at low altitude (in local flying area) with rich mixture.

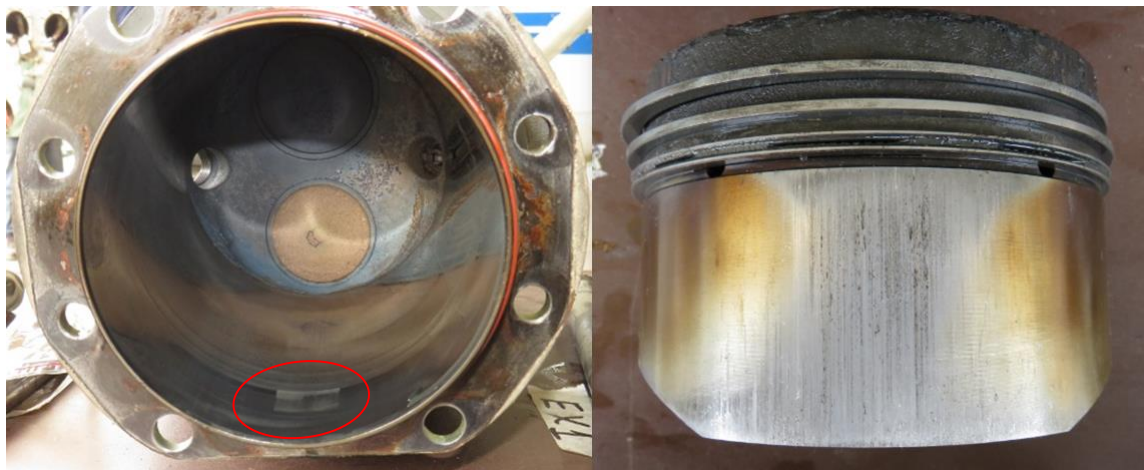
1. Both magnetos, oil filter, R.P.M drive gear and ignition harness were uninstalled from the engine and found satisfactory.
2. Accessory cover was removed and found satisfactory.
3. All induction pipes, oil return lines and oil sump removed and found satisfactory.
4. All cylinders including pistons and connecting rods were dismantled. Scoring marks were observed on cylinder No. 1 inner wall as well as on piston. Rest all the three cylinders were found satisfactory. (Figure 14)

Fig 14: Scoring marks on Cylinder No 1 and its Piston

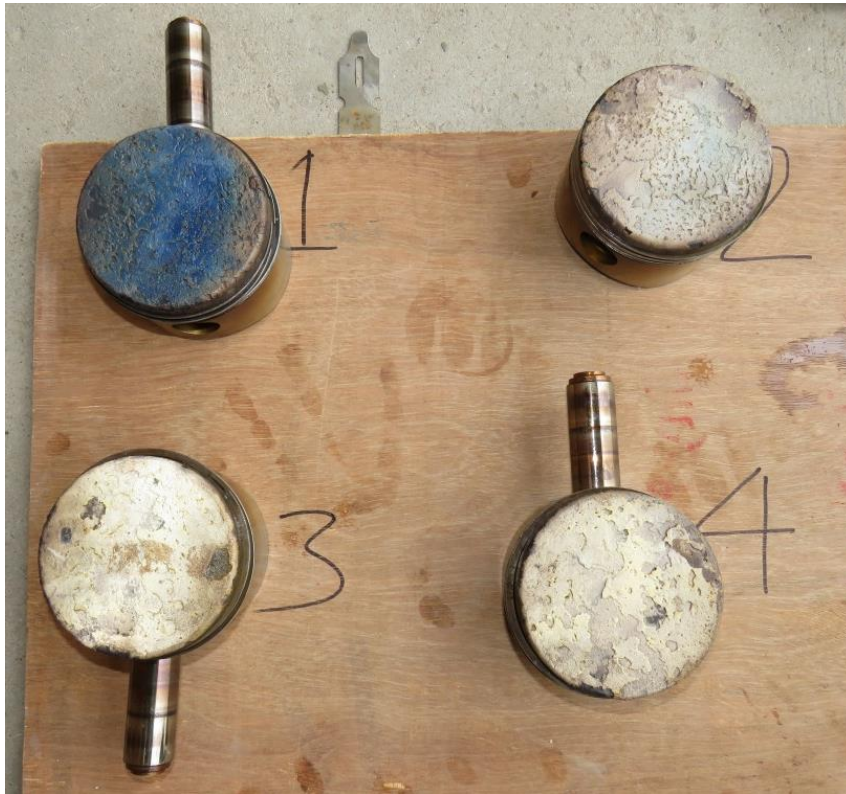
5. Bluish deposit was found on Cylinder no.1 piston head and heavy amount of lead deposit was observed on all the piston heads. (Figure 15) Piston rings, Push rods and connecting rods were dismantled from all cylinders and found satisfactory.

Fig 15: Blue Colour deposit and Lead deposit on the pistons

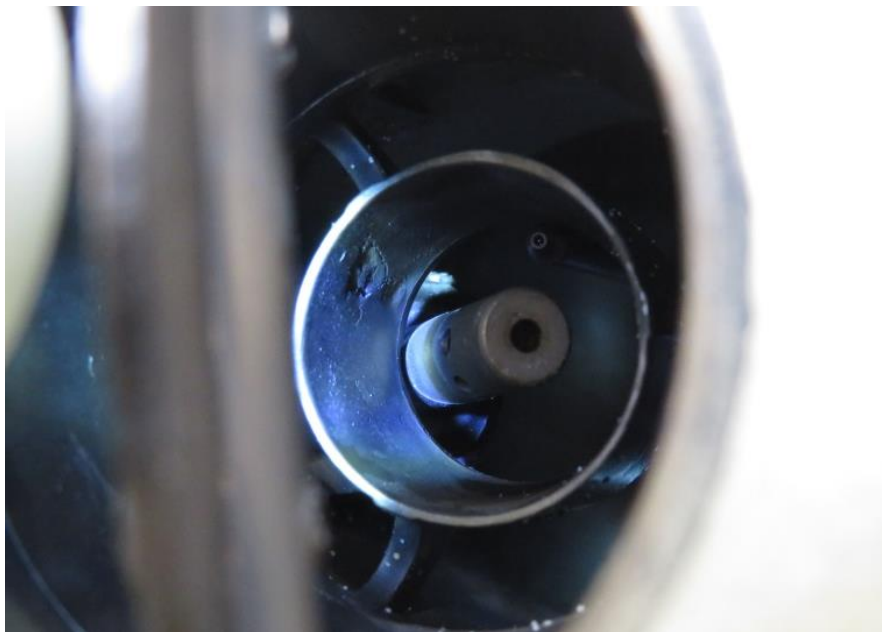
6. Carburettor was removed and inspected. It was found that fuel accelerating jet nozzle was not properly installed in the carburettor which would result into a lower jet pressure than the standard pressure. (Fig 16). The jet nozzle was fitted during the last overhaul and is not inspected in any schedule maintenance checks.

Fig 16: Fuel Accelerating Jet Nozzle

The accelerating fuel jet nozzle was not installed properly at its position which resulted into improper fuel discharge into the venturi and subsequent improper fuel air mixture composition. The effect would have amplified in case of slam opening of throttle.

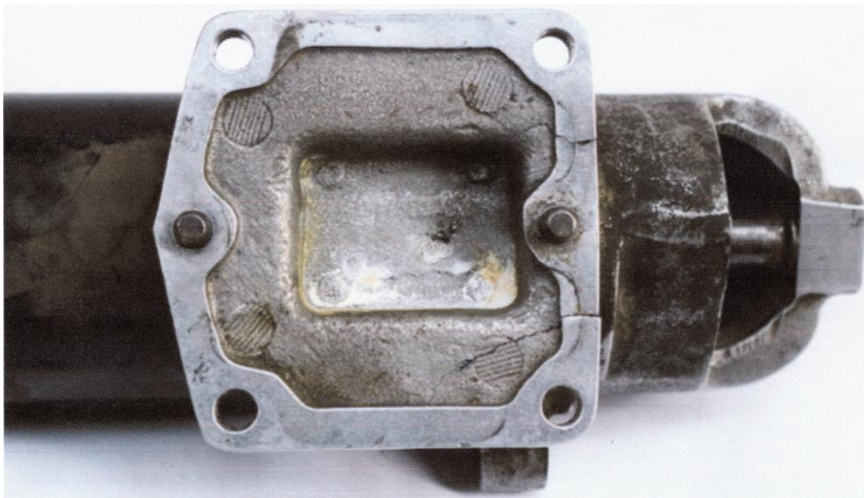
The drive end head assembly removed from the aircraft had visible cracks as is shown in Figure 17.

Fig 17: Drive end head assembly

From the above observations, it is inferred that the base of the assembly had cracked due to corrosion fatigue which resulted from fluctuating load caused by vibration.

The damaged starter and its broken gear were sent to DGCA Lab for examination and as per the result of examination, the base of the assembly had cracked due to corrosion fatigue which resulted from fluctuating load caused by vibration. The vibrational loads were possibly caused due to bending of shaft and improper engagement with the ring drive. It is evident that the crack had progressed over time and was not result of any impact during the accident.

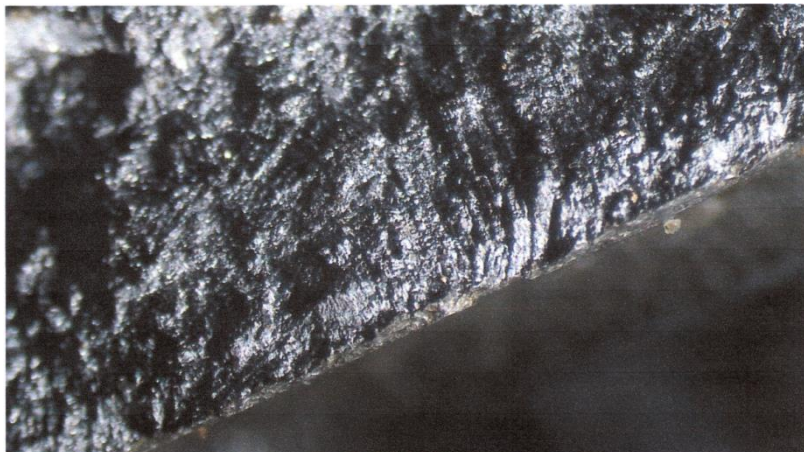
Fig 18: Beach marks on cracked surface

Light beach marks were noticed on the fracture surface. Rubbing Marks were noticed on the fracture surface. Rubbing marks were also noticed on the mounting holes of the head assembly as shown in Figure 19

The presence of light beach marks on the fractured surface and rubbing marks on the holes of head assembly indicated presence of cyclic load due to vibrational stress. Bending of the shaft and signature of corrosion on it indicates that there was some restriction in rotation.

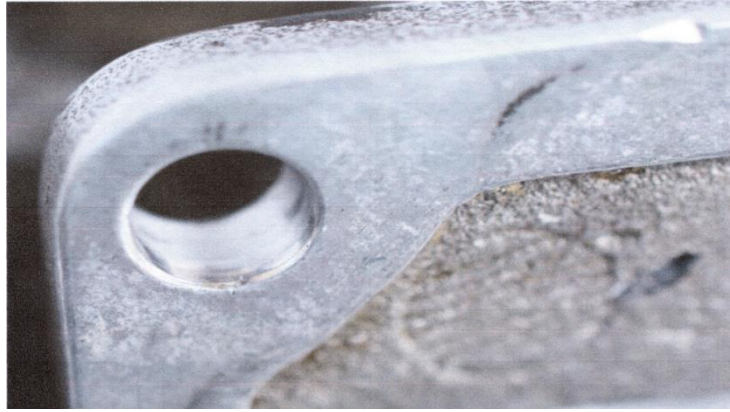
Fig 19: Rubbing marks on mounting holes

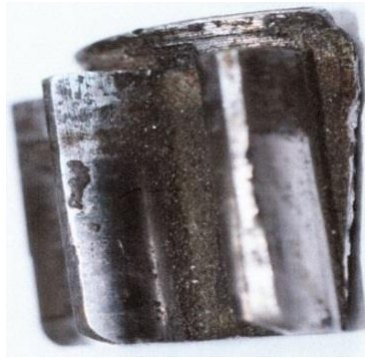
Only small portion of the gear was available for examination. Rest of the portion could have fallen during take-off or in air, after the gear was broken during engine start-up. Pitting was noticed on the gear flank as shown in Fig 20.

Fig 20: Pitting on the gear
