**AIRCRAFT ACCIDENT INVESTIGATION BUREAU
GOVERNMENT OF INDIA**

**FINAL REPORT ON SERIOUS INCIDENT INVOLVING
AIRPROX THAT OCCURRED IN DELHI AREA
BETWEEN NCR840, KLM875 AND EVA061
ON 22.12.2018**

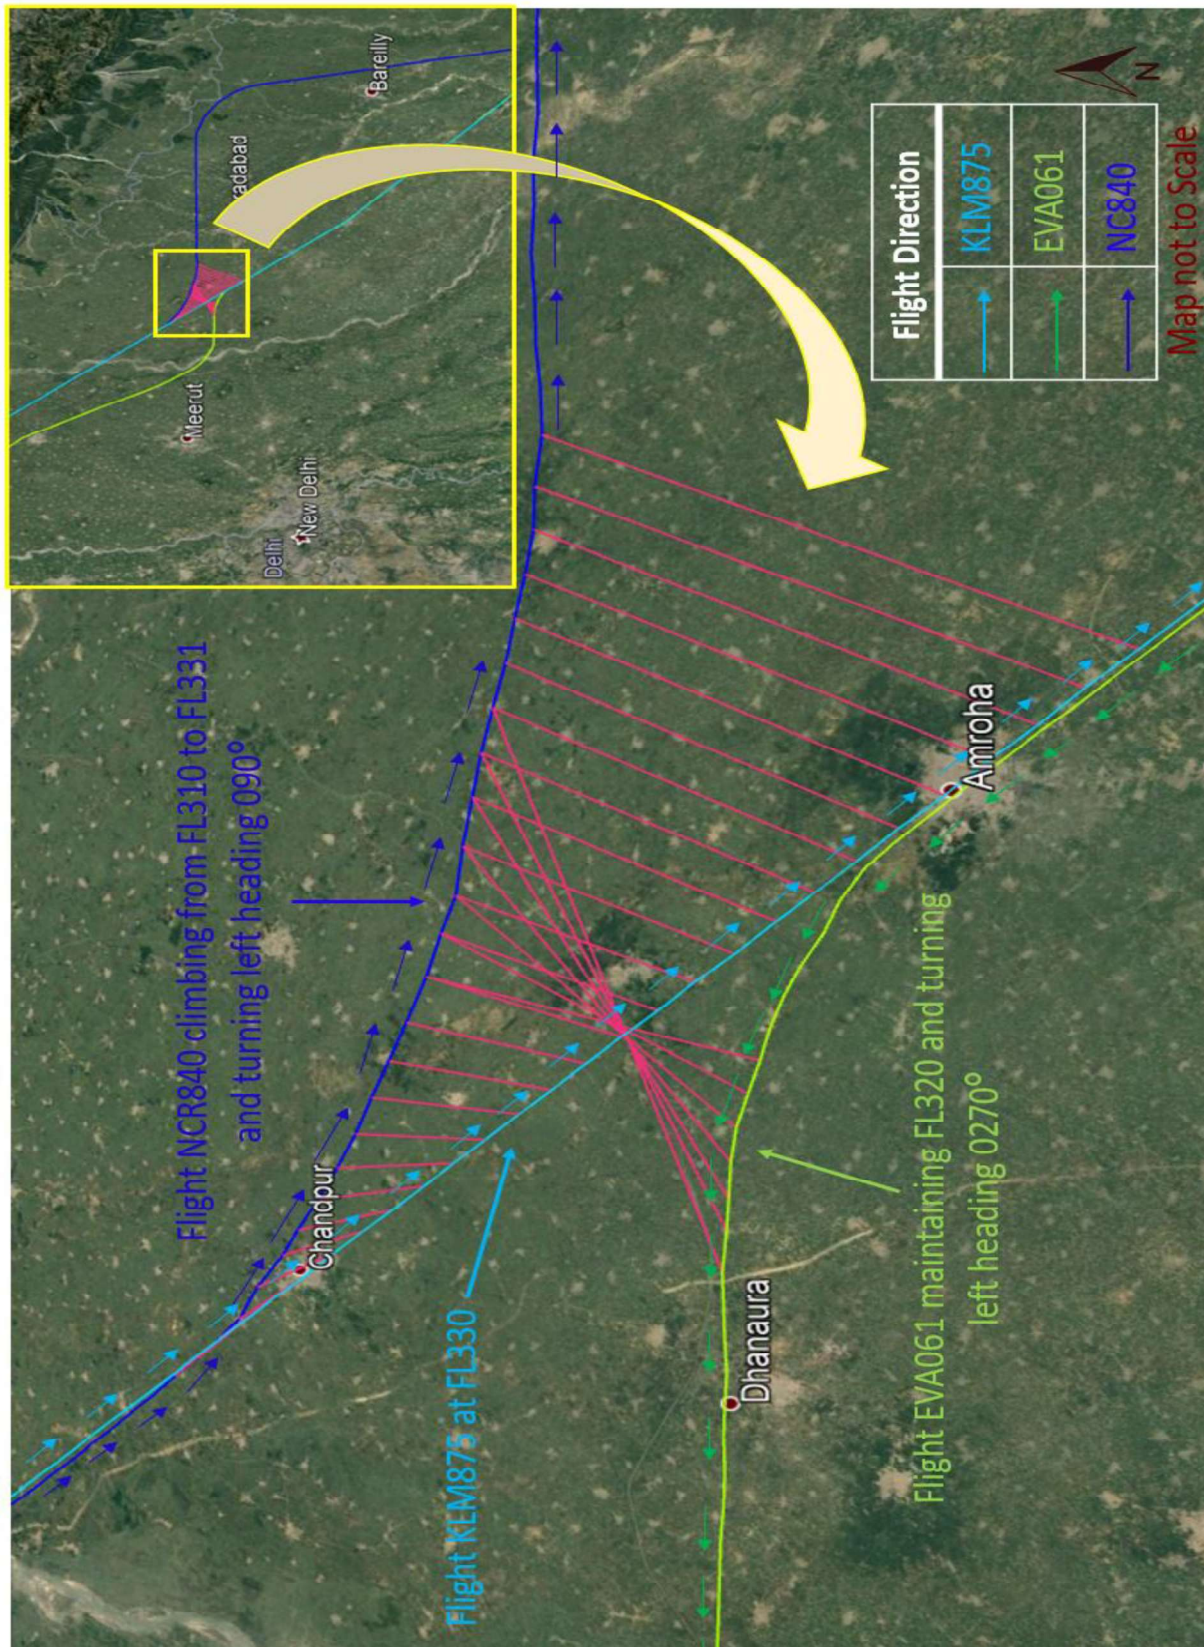
Figure 1: Flight Track superimposed on map.

Flight Tracks were plotted using data from the Delhi Radar. The tracks can be seen in the figure below: -

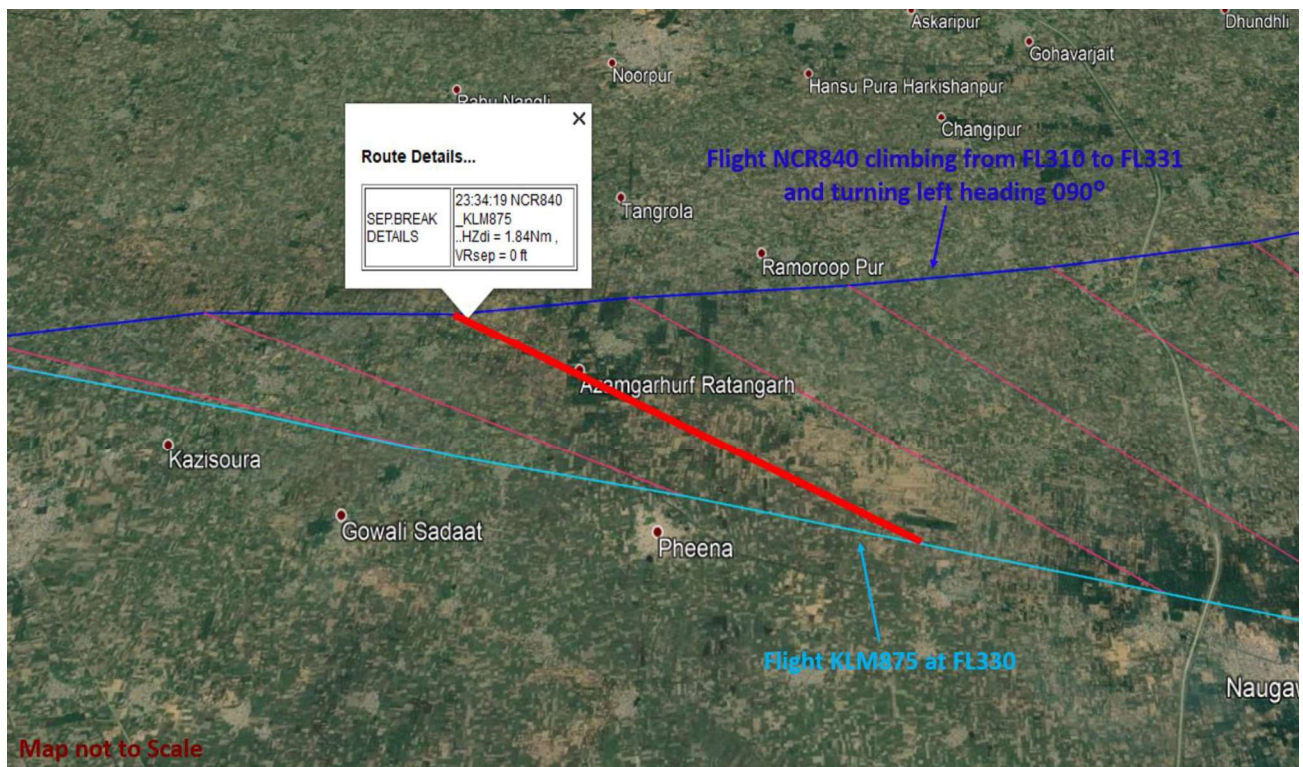
Figure 2: Separation between NCR840 and KLM875

The Lateral Separation between NCR840 and KLM875 at 23:34:19 UTC can be seen as 1.84 Nm while Vertical Separation was 0 Feet, in the Figure 2 below: -

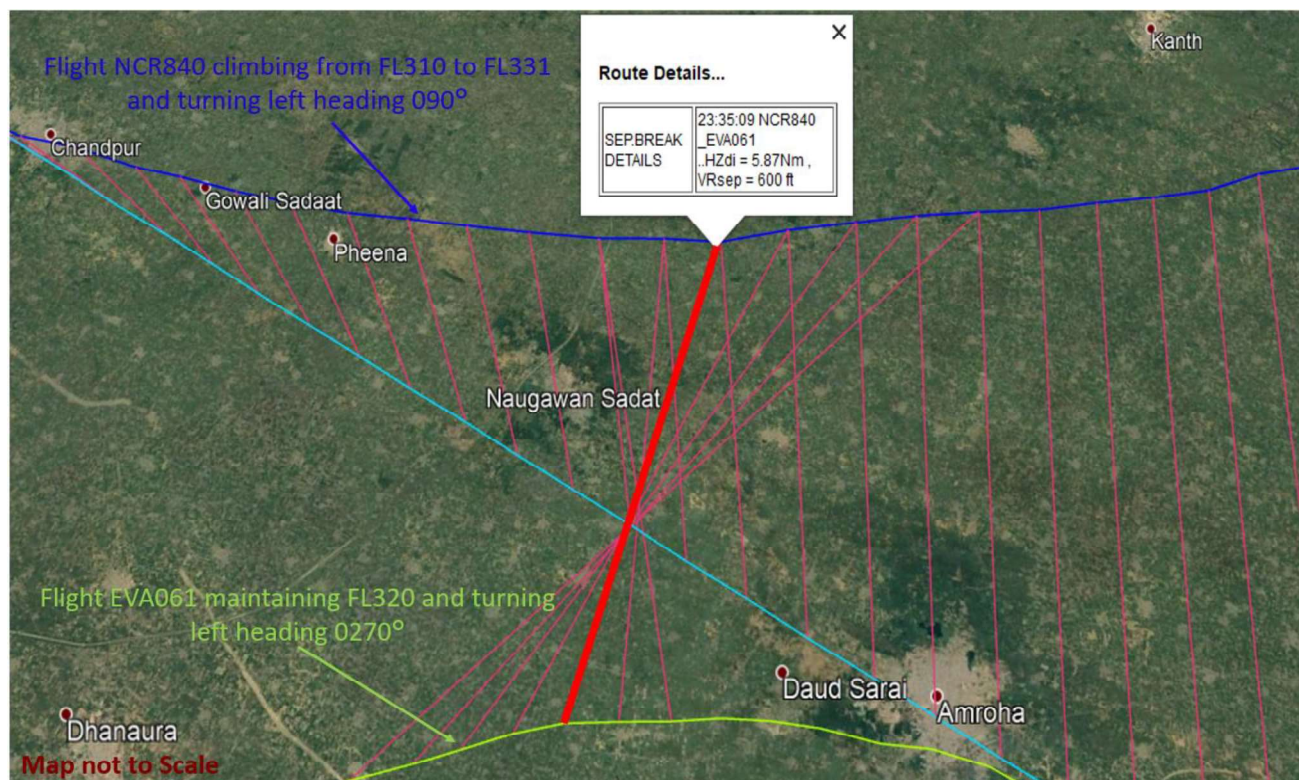
Figure 3: Separation between NCR840 and KLM875

The Lateral Separation between NCR840 and EVA061 at 23:35:09 UTC can be seen as 5.87 Nm while Vertical Separation was 600 Feet, in the Figure 3 below: -

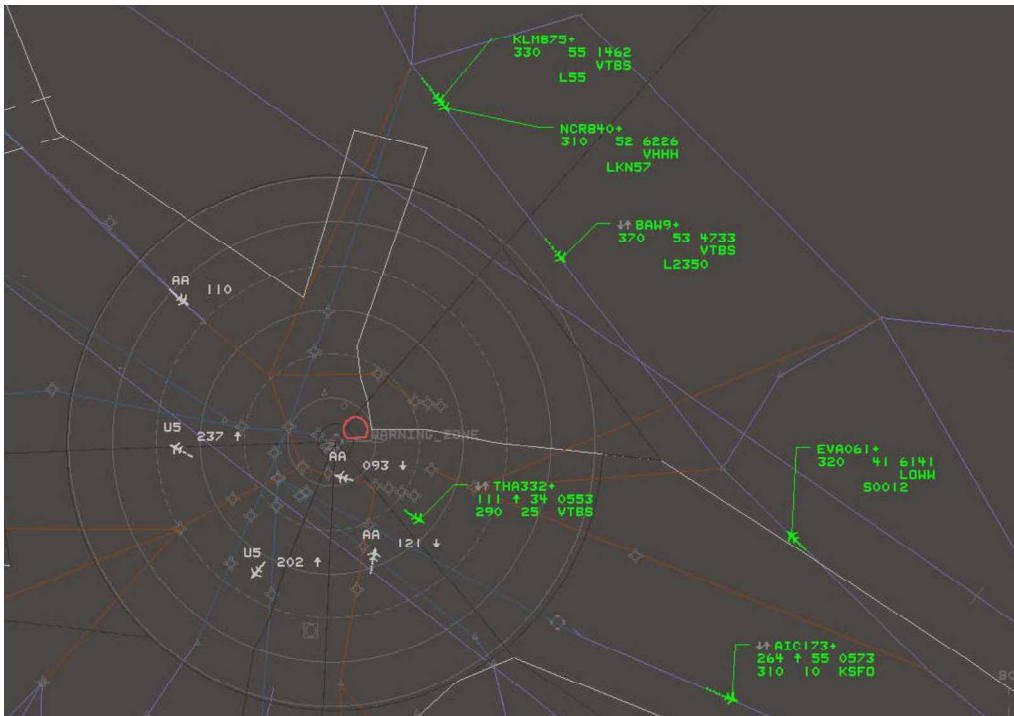
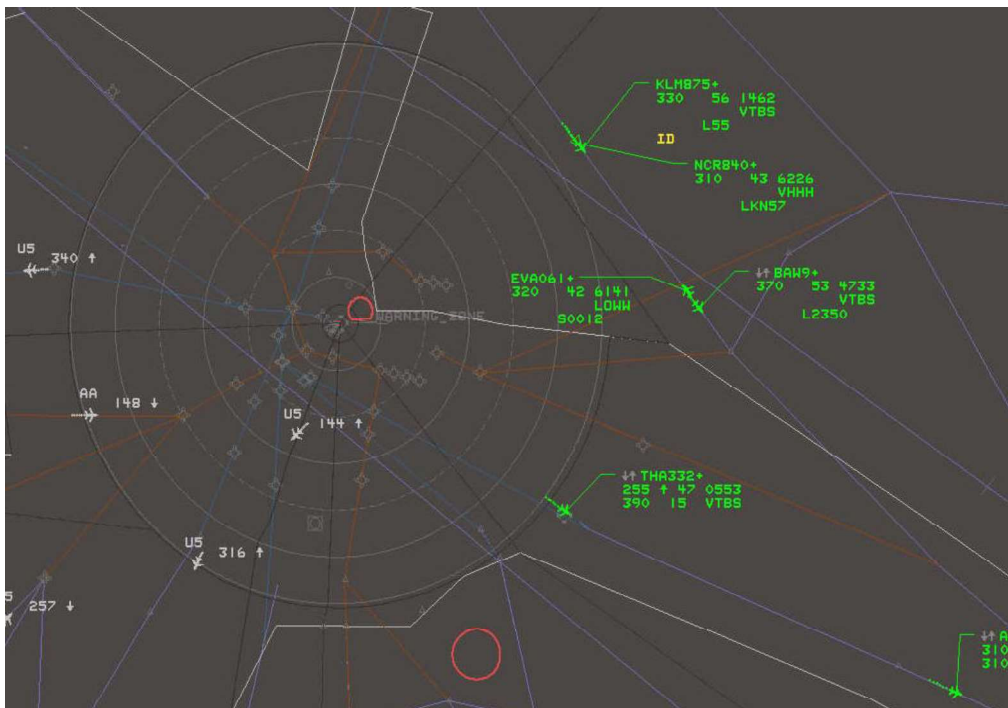
The radar snapshot of time 23:27:11 UTC and 23:32:41 UTC shown in Figure 4 and 5, shows NCR840 maintaining FL310 and KLM875 maintaining FL330. EVA061 is maintaining FL320 flying in reciprocal direction to NCR840 and KLM875.

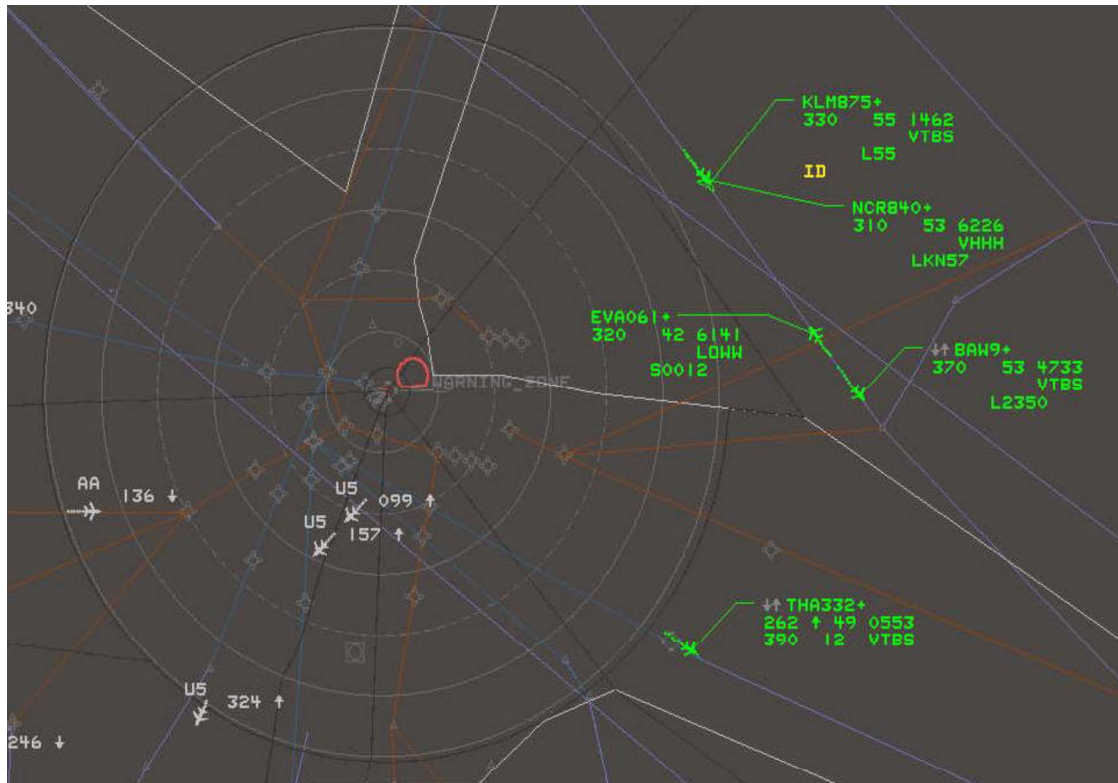
Figure 6: 23:33:12 UTC

At 23:33:12 UTC, KLM875 was just above NCR840 at FL 330 and FL310 respectively, as per the radar snapshot shown in Figure 6.

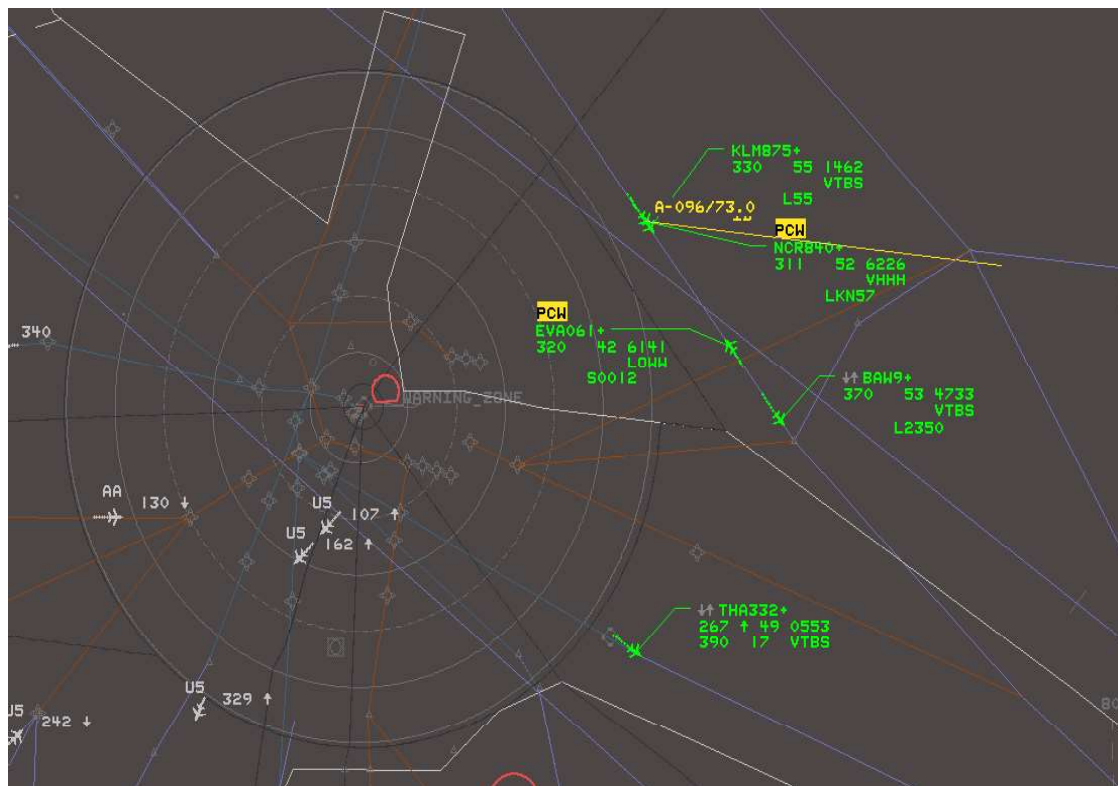
Figure 7: 23:33:28 UTC

In radar snapshot of time 23:33:28 UTC shown in Figure 7, NCR840 can be seen commencing climb. PCW is generated between NCR840 and EVA061.

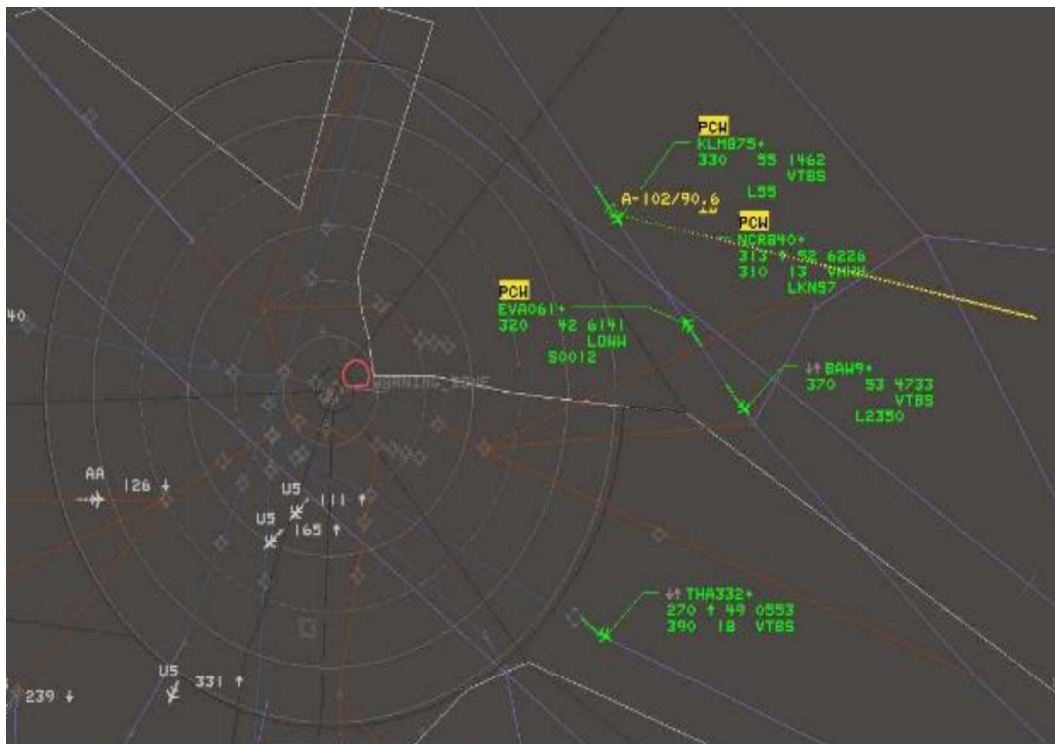
Figure 8: 23:33:38 UTC

In radar snapshot of time 23:33:38 UTC shown in Figure 8, NCR840 can be seen as climbing and having reached FL313. PCW is also seen generated between NCR840 and KLM875.

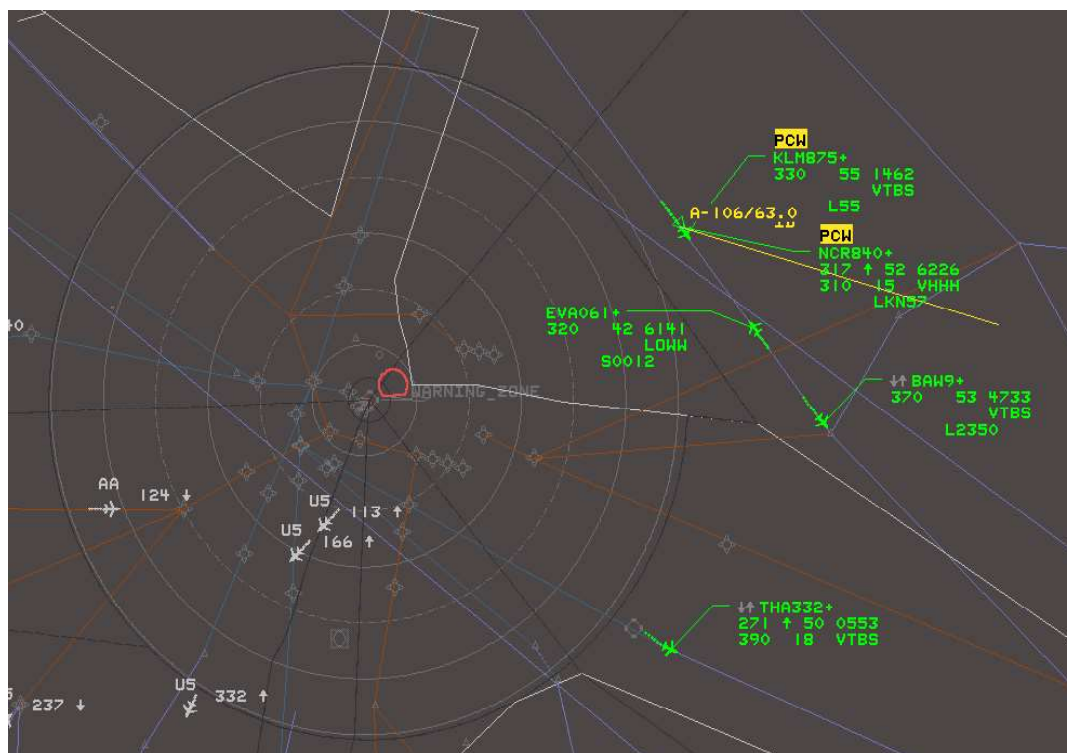
Figure 9: 23:33:44 UTC

In radar snapshot of time 23:33:44 UTC shown in Figure 9, NCR840 can be seen as climbing and having reached FL317. PCW between NCR840 and EVA061 is not seen any more.

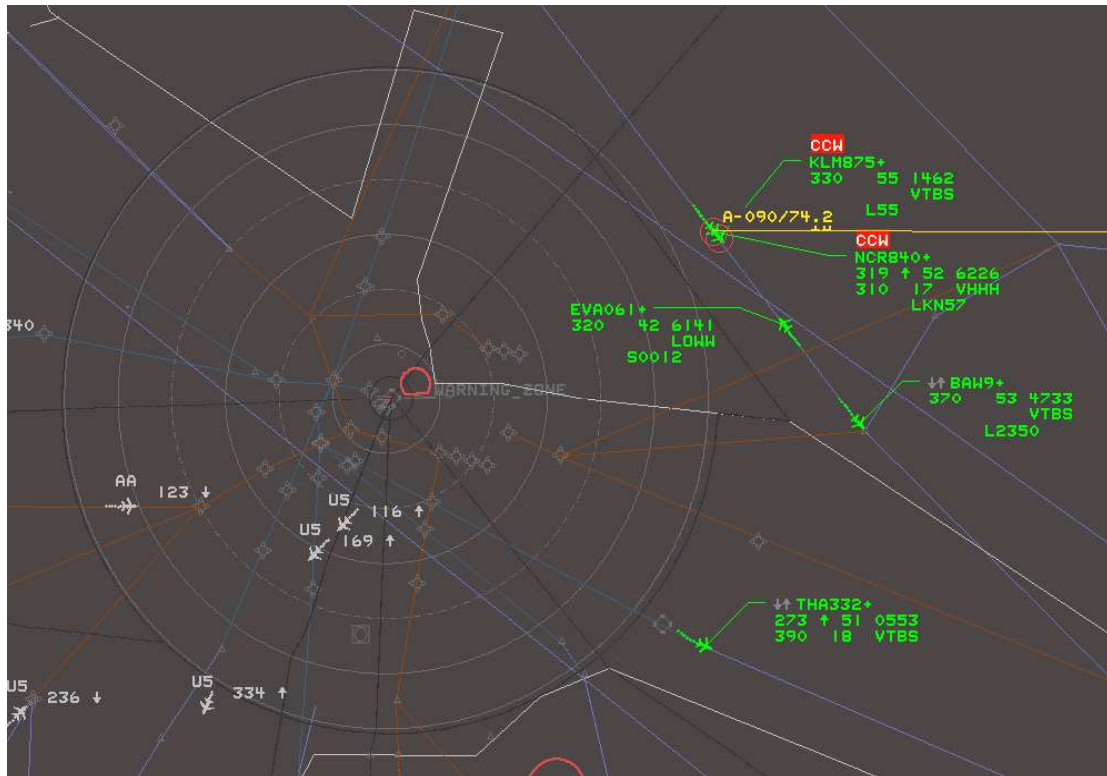
Figure 10: 23:33:50 UTC

In radar snapshot of time 23:33:50 UTC shown in Figure 10, NCR840 can be seen as climbing and having reached FL319. CCW is seen generated between NCR840 and KLM875.

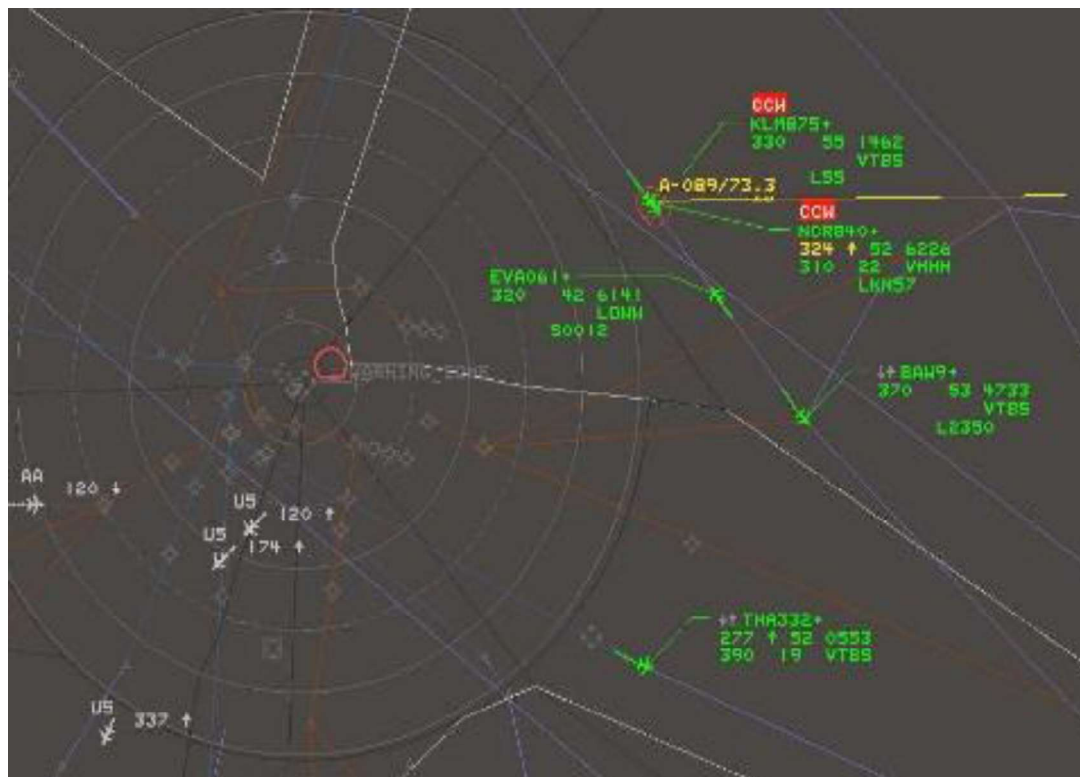
Figure 11: 23:34:01 UTC

In radar snapshot of time 23:34:01 UTC shown in Figure 11, NCR840 can be seen as climbing and having reached FL324. CCW continues between NCR840 and KLM875.

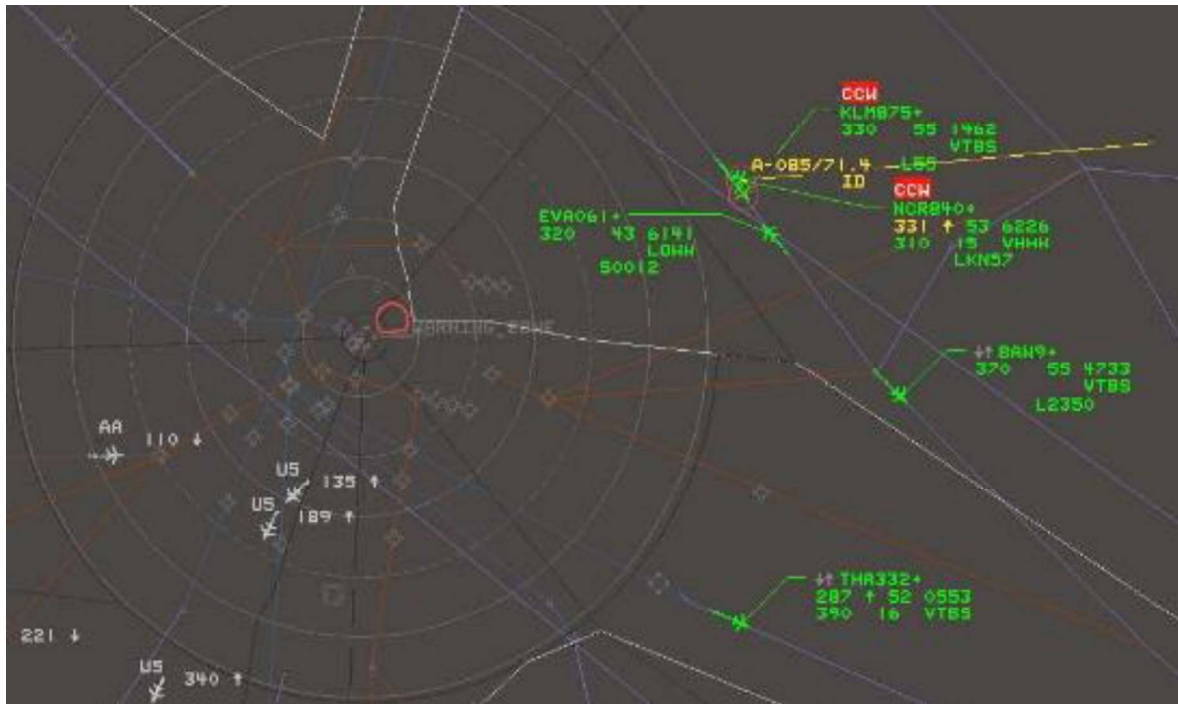
Figure 12: 23:34:38 UTC

In radar snapshot of time 23:34:38 UTC shown in Figure 12, NCR840 can be seen as climbing and having reached FL331, but visibly turning left. CCW continues between NCR840 and KLM875.

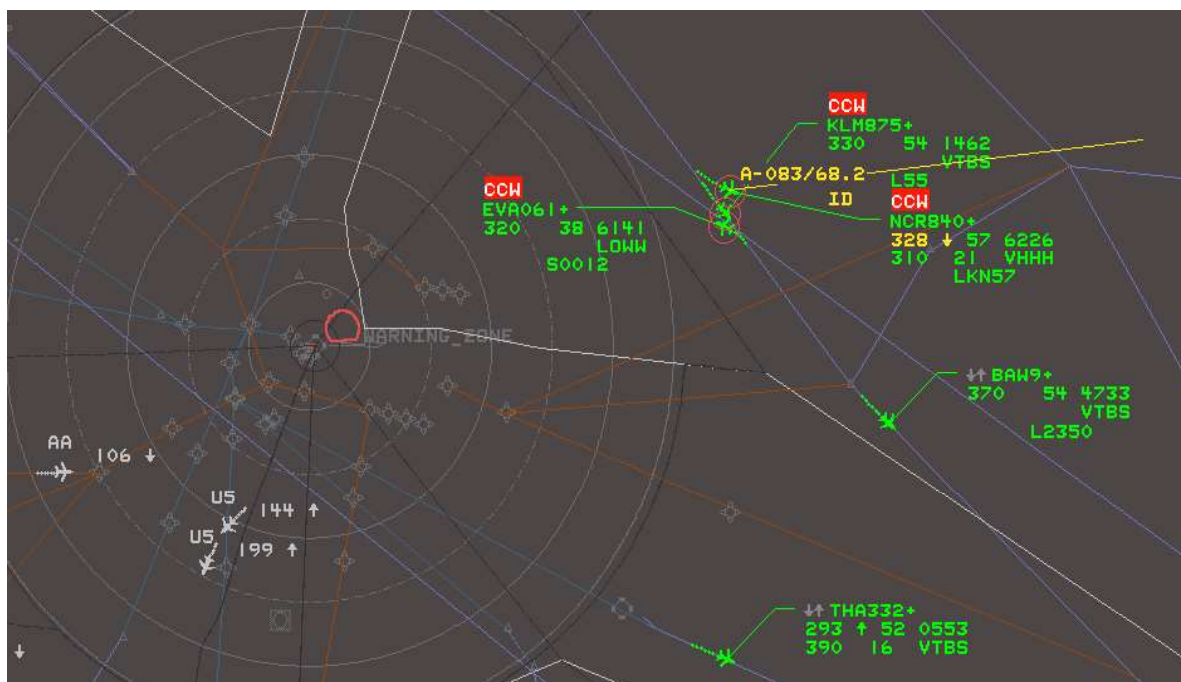
Figure 13: 23:35:00 UTC

In radar snapshot of time 23:35:00 UTC shown in Figure 13, NCR840 can be seen having descended to FL328 and maintaining heading 090°. EVA061 is also seen turning left to maintain heading 0270°. CCW continues between NCR840 and KLM875 and is also generated for NCR840 and EVA061.

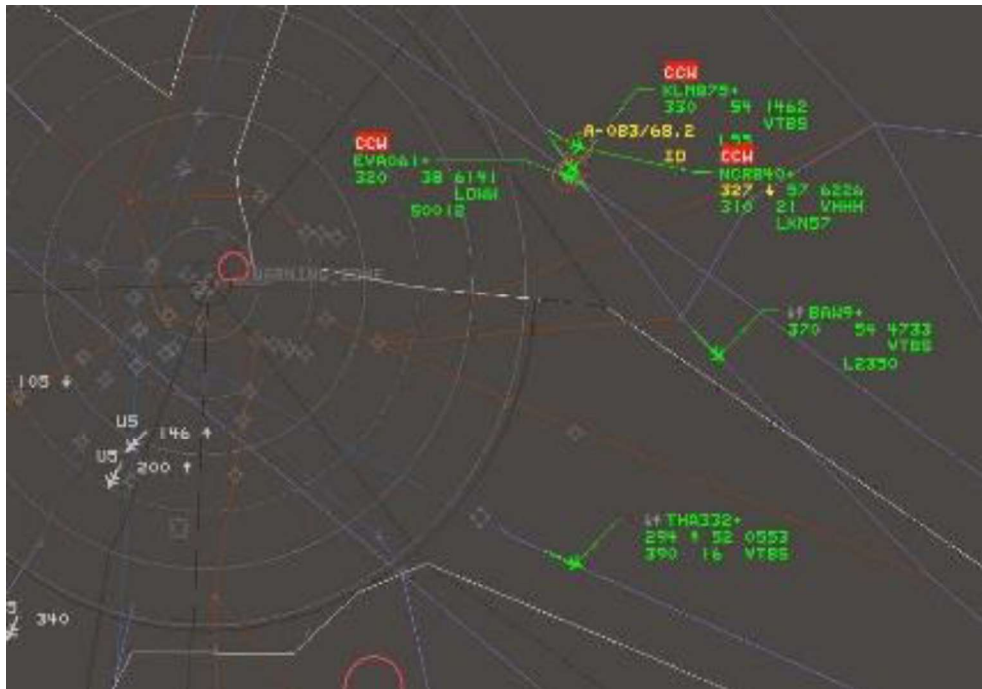
Figure 14: 23:35:03 UTC

In radar snapshot of time 23:35:03 UTC shown in Figure 14, CCW between NCR840 and KLM875 as well as CCW between NCR840 and EVA061 persists. NCR840 can be seen having descended to FL327 and both NCR840 and EVA061 continue left heading.

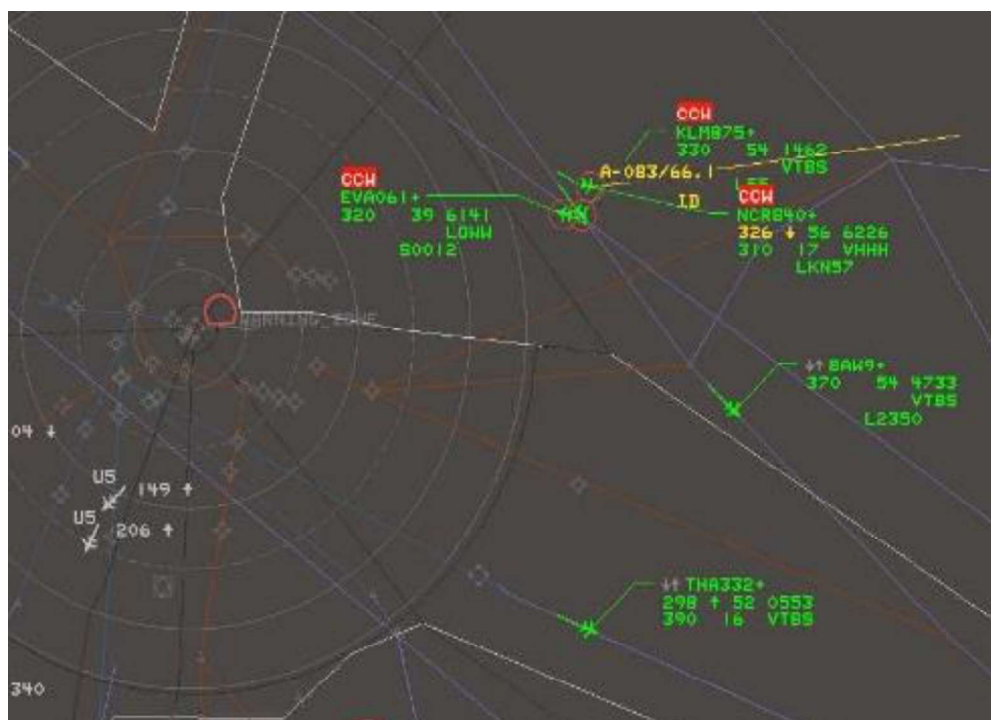
Figure 15: 23:35:16 UTC

In radar snapshot of time 23:35:16 UTC shown in Figure 15, CCW between NCR840 and KLM875 as well as CCW between NCR840 and EVA061 persists. NCR840 can be seen having descended to FL326 and both NCR840 and EVA061 continue left heading.

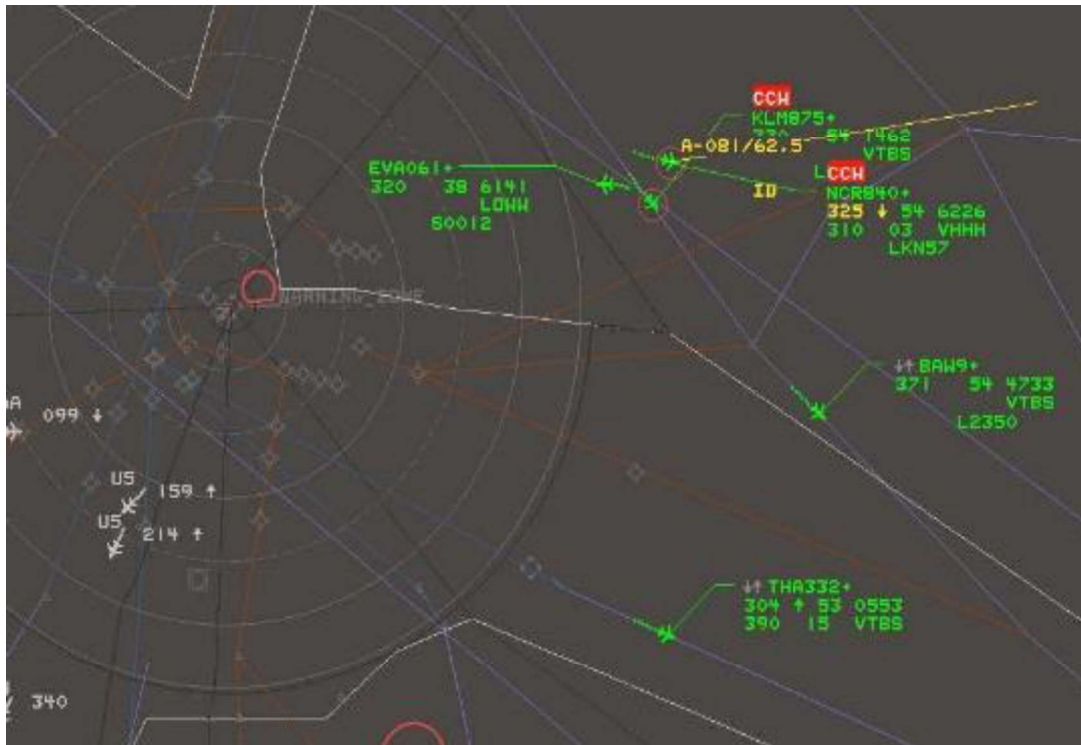
Figure 16: 23:35:43 UTC

In radar snapshot of time 23:35:43 UTC shown in Figure 16, CCW between NCR840 and KLM875 persists but CCW between NCR840 and EVA061 is resolved. NCR840 can be seen having descended to FL325 and both NCR840 and EVA061 continue with left heading. CCW had ceased when standard separation of 10 NM was re-established between EVA061 and NCR845.
