**INVESTIGATION REPORT ON SERIOUS INCIDENT BETWEEN VISTARA,
VTI997 AND AIR INDIA, AIC631 AT CSI AIRPORT, MUMBAI, ON
07/02/2018**

KUNJ LATA
INVESTIGATOR-IN-CHARGE

DINESH KUMAR
INVESTIGATOR

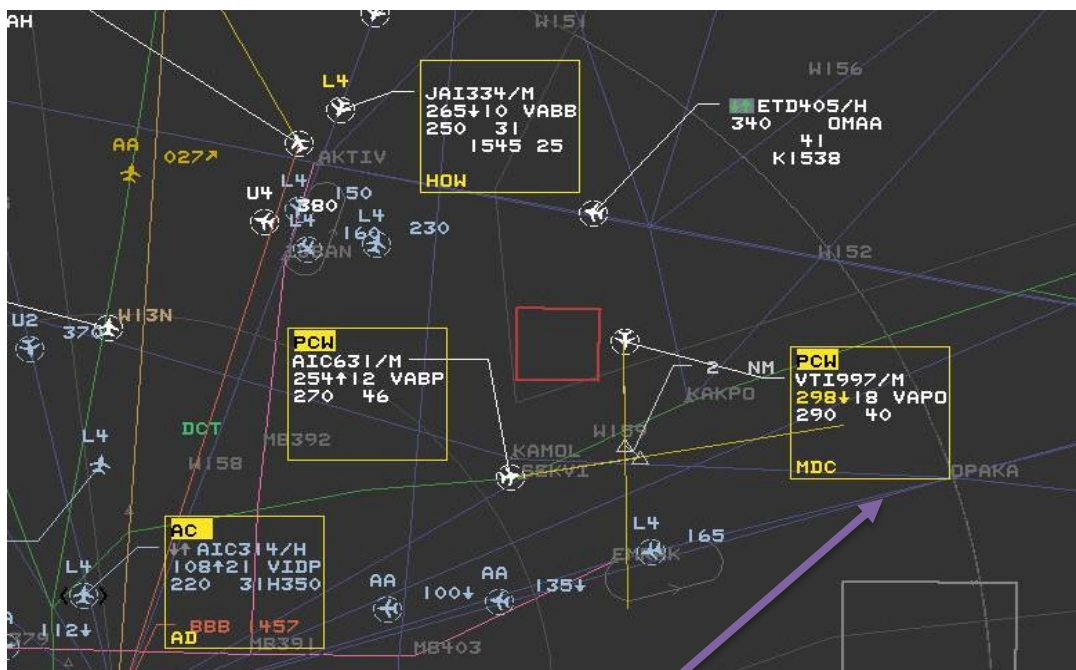
It has an inbuilt feature of change in color of level indicator if there is a mismatch of level assigned and the level updated by the crew in the system of aircraft. Whenever there is a mismatch of level selected by the pilot, then after passing 300 feet it will change its color from white (normal) to yellow color. It is the first indication to resolve the traffic conflict which appears on the radar screen.

Level mismatch shown by the system(it shall be white instead of yellow)

At 14:59, PCW was generated when VTI997 was passing FL298 in descending phase and AIC631 was passing FL254 in climbing phase. **Radar controller did not respond in time, when the PCW was generated.** Indication of wrong flight level feed in aircraft system was being indicated as the colour of the level entered in VTI997 was yellow in colour. Colour change from white to

yellow is a safety feature of the Automation System. This indication was neglected by the Radar Controller. As per the controller's statement, this feature was not taught to him or he doesn't remember. Later CCW alert came on Radar.

- (a) The controller took over the navigation of the aircraft by issuing direct routing.
- (b) Controller failed to identify the mismatch of the level assigned and level entered by the crew.

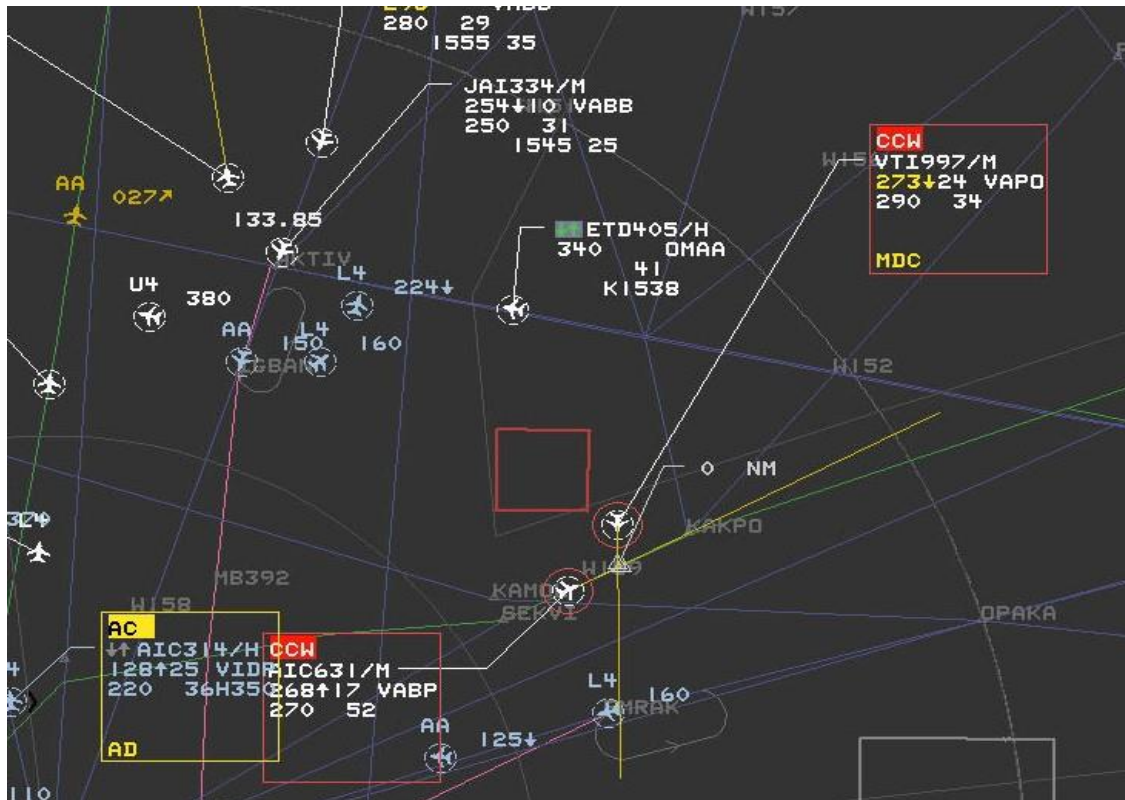
System showing Current conflict warning (CCW)

At time 15:00:39 UTC, CCW was generated by Automation System. Both aircraft got TCAS RA and followed RA maneuvers . TCAS RA for VTI997 was active for 36 second with an instruction of “Descend” and then “Don't climb” instruction. TCAS RA for AIC631 was active for 34 sec with an instruction of “Climb” and then “Don't Climb” instruction. VTI997 and AIC631 reported clear of conflict at time 15:01:26 UTC.

- (a) Controller failed to identify the traffic.
- (b) Controller failed to maintain proper surveillance of the conflicts in his jurisdiction.
- (c) Controller failed to acknowledge the PCW and CCW alerts in time.
- (d) Flight crew entered pre assumed level i.e. FL270.
- (e) Flight crew failed to monitor instructions communicated by controller.
