FINAL REPORT ON ACCIDENT TO
M/s ACADEMY OF AVIATIONCESSNA
172R AIRCRAFT VT-HRP ON 4th OCT
2019 AT SHIRPUR AIRFIELD,
MAHARASHTRA

On 04.10.2019, Cessna 172 R aircraft VT-HRP belonging to M/sAcademy of Aviation while operating a local training flight was involved in an accident at 1200 IST at Shirpur Airfield, Maharashtra.

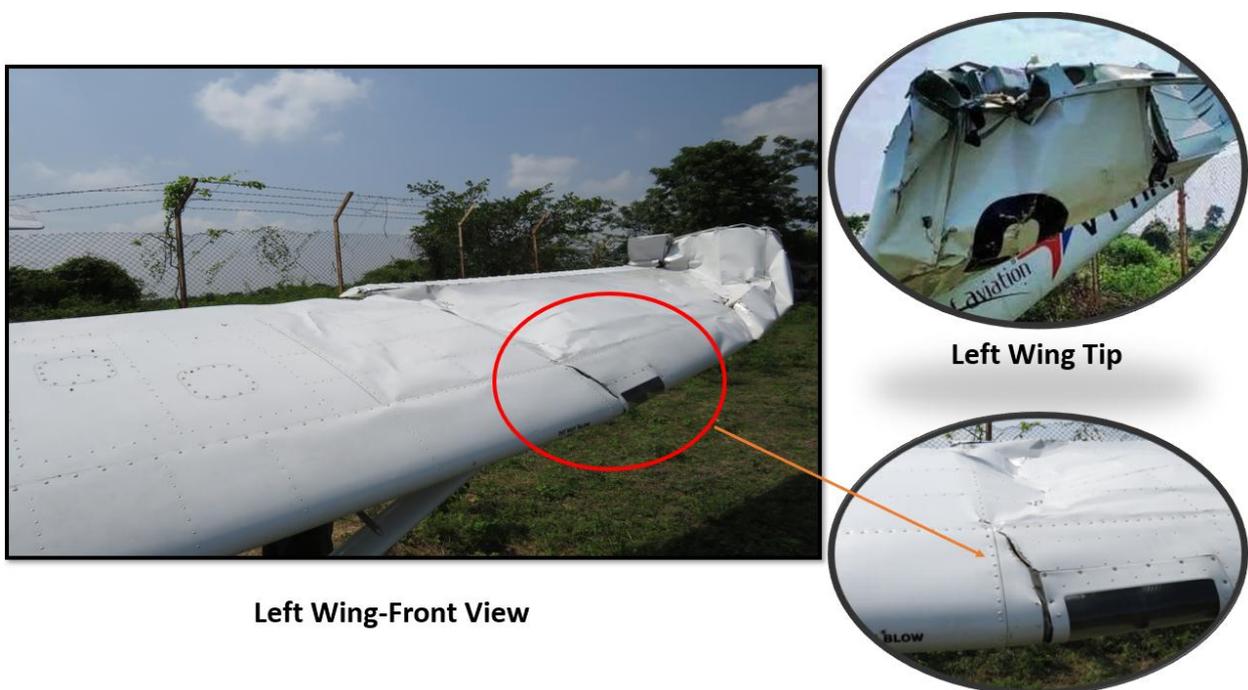
1.3.1 Left Wing

- (a) Wing bent upwards & aileron found damaged. Wing tip was missing & pieces were recovered from the site.
- (b) Leading edge skin of wing found damaged.
- (c) Wing upper skin wrinkled & deformed from wing strut attachment point.
- (d) Wing lower skin found deformed from wing strut attachment point to tip. Wrinkles were observed from strut attachment point to integral fuel tank.

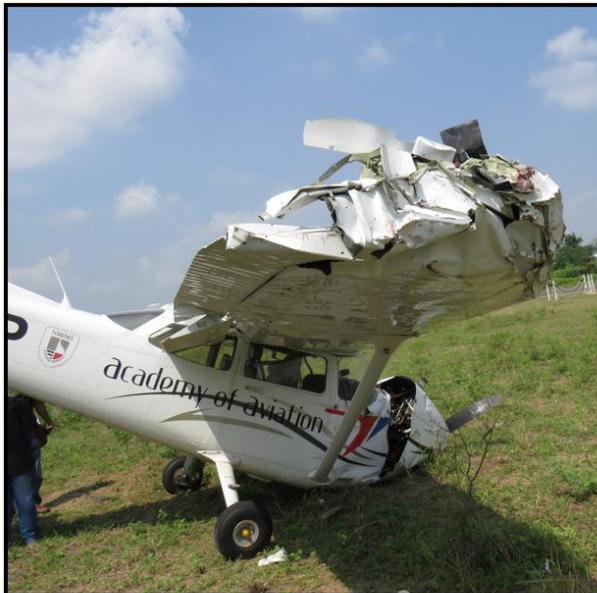
Damages on Right Wing

- (a) Wing tip found bent upwards. Wing tip found attached to the wing with tip broken.
- (b) Wing leading edge found crushed from station 140 to Station 208.
- (c) Wing lower skin found wrinkled and graze marks were observed on bottom skin below leading edge.

- (d) The aileron was found to be bent.
- (e) Wing Upper Skin found deformed from Station 140 to Station 208, wrinkled between Station 100 to Station 140 & Crushed between Station 71 to Station 100.

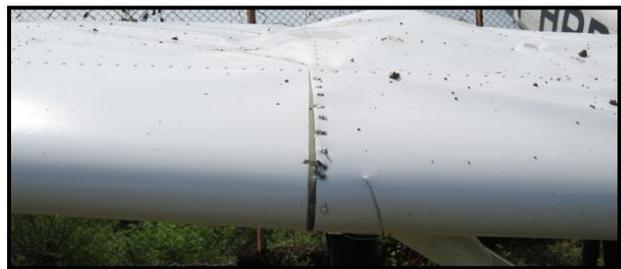
Damage on Leading edge

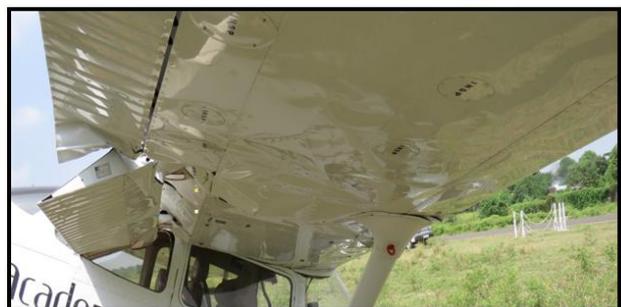
Right Wing Lower Surface

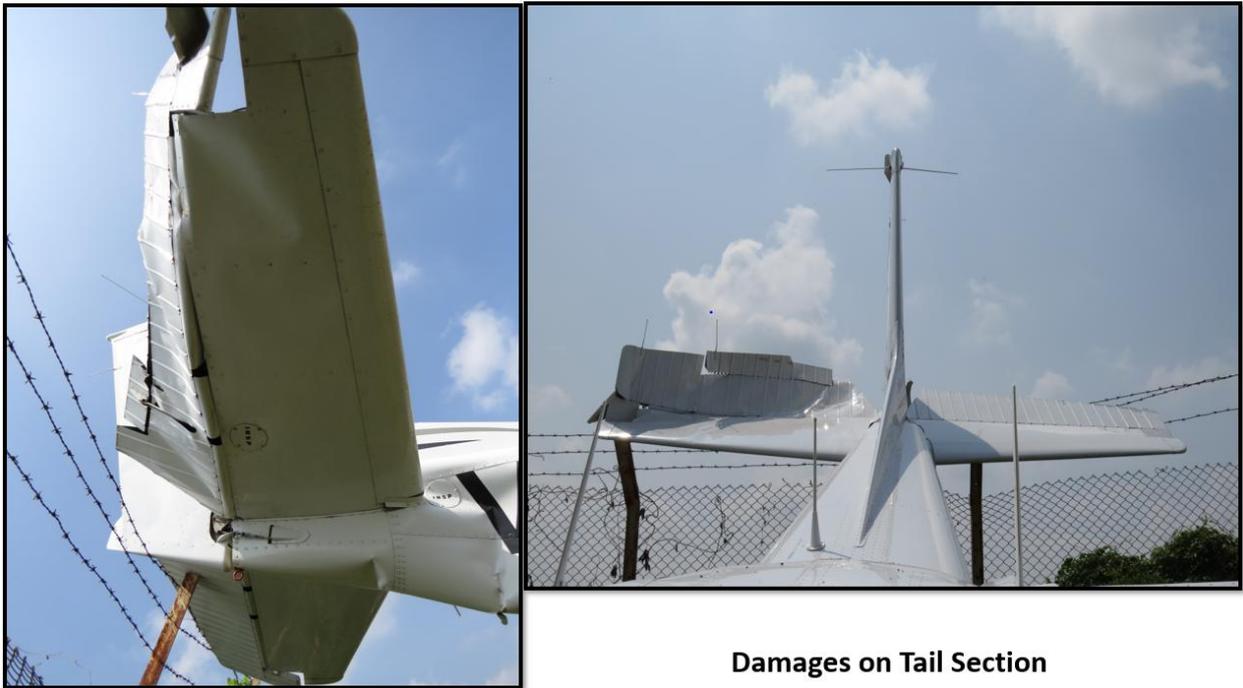
1.3.3 Tail Section

- (a) Rudder fixed trim tab damaged (bent and top two rivets missing).
- (b) Rudder bottom static wick broken & missing.
- (c) Rudder fairing broken (Fin to Fuselage).
- (d) Tail plane starboard side – multiple dents and bent.
- (e) Elevator starboard completely damaged.
- (f) Elevator trim tab completely damaged.
- (g) Tail plane attachment at fuselage - compressed and damaged.

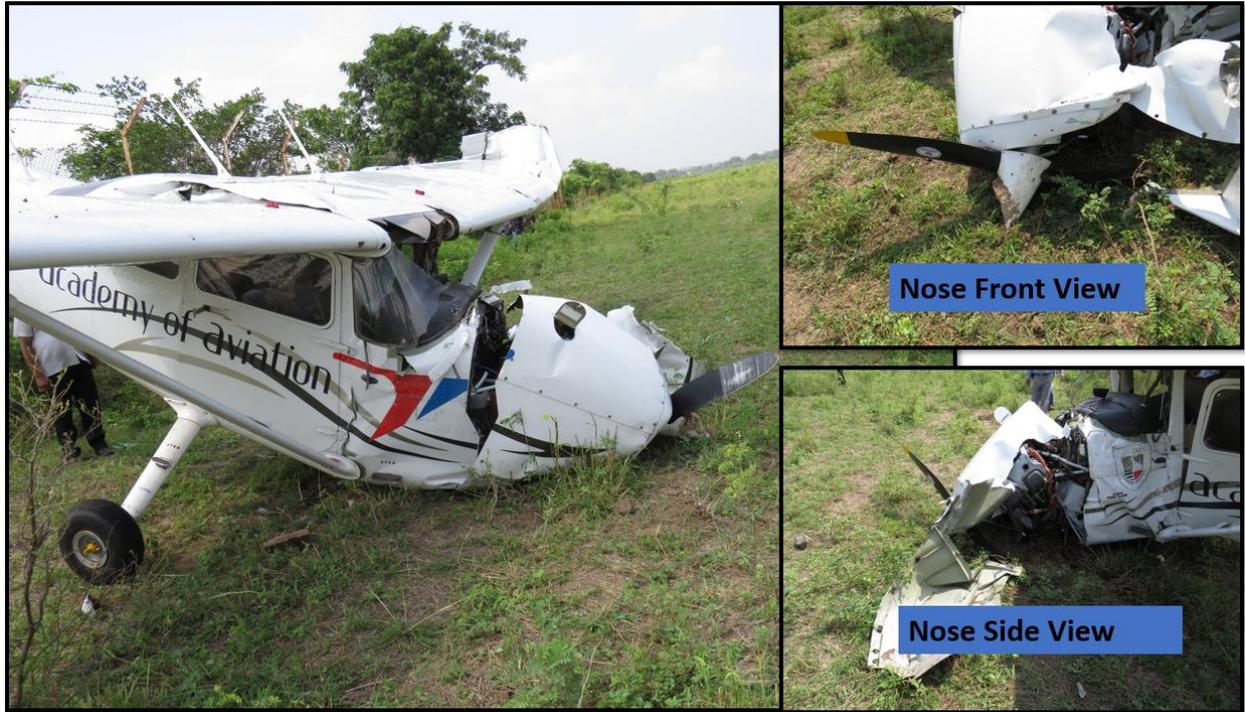
1.3.4 Nose section

- (a) Nose section as a whole severely damaged.
- (b) LH lower cowling separated at mount section, the attachment rivets found sheared off.
- (c) All anti shock cowl mounts found sheared off.

- (d) The fuel filter bowl found opened and fuel return hose pipe found to be sheared off.
- (e) Nose landing gear sheared off from attachment.
- (f) Firewall found crushed & buckled.

- (g) The main electronic junction box found bent with cover broken. All internal components CB's panel found sheared off. Battery found damaged with deformation, no evidence of acid leakage were observed.

- (h) Lower portion of forward fuselage crushed. LH & RH Steering Rod found bent with part of steering arm attached on it. Upper Nose gear mound found missing and lower nose gear mount sheared and attached to fuselage.

- (i) Engine mount found to be broken at all four mounting points towards engine. The shock mounts & frame found attached to the engine. The mount structure at fuselage found attached to firewall at all four points.

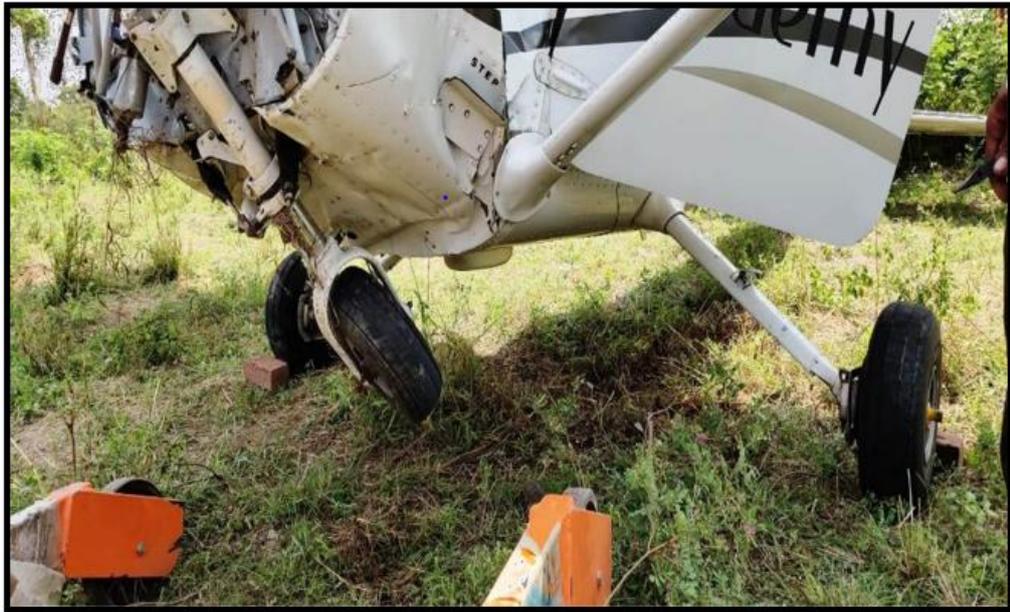
1.3.9 Nose Landing Gear

- (a) Landing gear sheared off.
- (b) Upper torque link attachment bolts found sheared at both points.
- (c) Shimmy dampener rear attachment point found sheared and shimmy dampener found attached to gear at front attach point.
- (d) Shock strut upper barrel found dented near upper attachment point. Upper attachment point found intact & attached to gear upper strut.

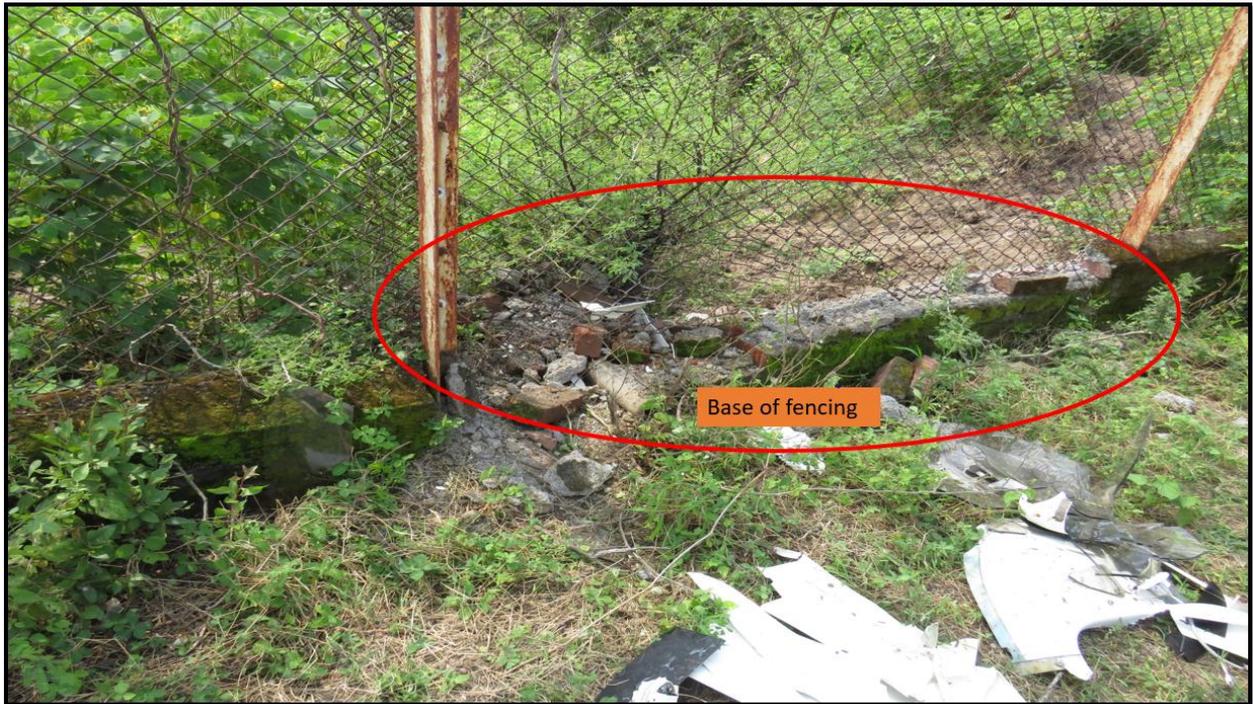
Due to impact of the right wing with the base of the boundary fencing, a small portion of the base was damaged.

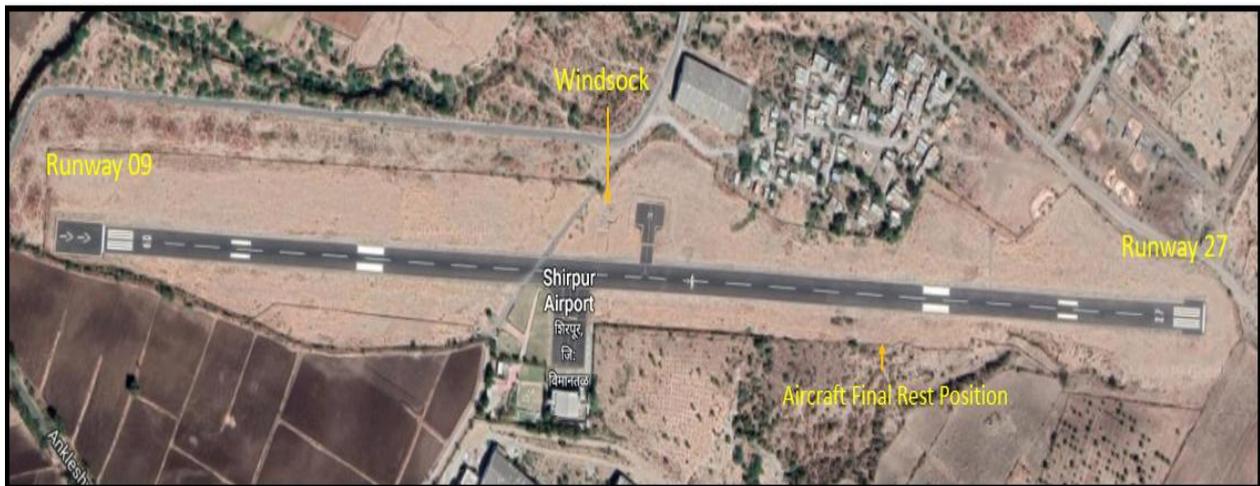
Fig: Aircraft Final Rest position at Shirpur Airfield

Based on the meteorological condition, runway 27 was preferred for flying operation on the day of accident. When the aircraft was at 800' AGL, student pilot called the ATC for landing clearance. Subsequently, the local ATC gave permission to land on runway 27. While the aircraft was at second touchdown point, aircraft speed was approximately 50 Knots and height was about 30 to 40 feet. The pilot planned for go-around as per the SOP but as the aircraft was flying in stall envelope, it could not go around.

To initiate a go around, student pilot pushed the throttle lever fully inside and pitched down the nose of the aircraft to recover from the approached stall condition. Suddenly, aircraft turned and banked towards left. Aircraft then lost height and the left wing tip initially hit the ground at approximately 50 feet from the runway edge and 376 feet from the threshold of runway 27. Thereafter, student pilot lost control of the aircraft and aircraft nose had hit the ground due to which nose landing gear collapsed.

Aircraft engine was on full power and propeller blades struck three times on the ground. Due to this, Aircraft kept on changing its position. Further, aircraft drifted and right wing of the aircraft hit the base of boundary wall. At this very juncture, right wing acted as pivot due to which aircraft heading changed again. Finally, the empennage of the aircraft went up and aircraft came to a halt near the boundary fencing in a nose down attitude.

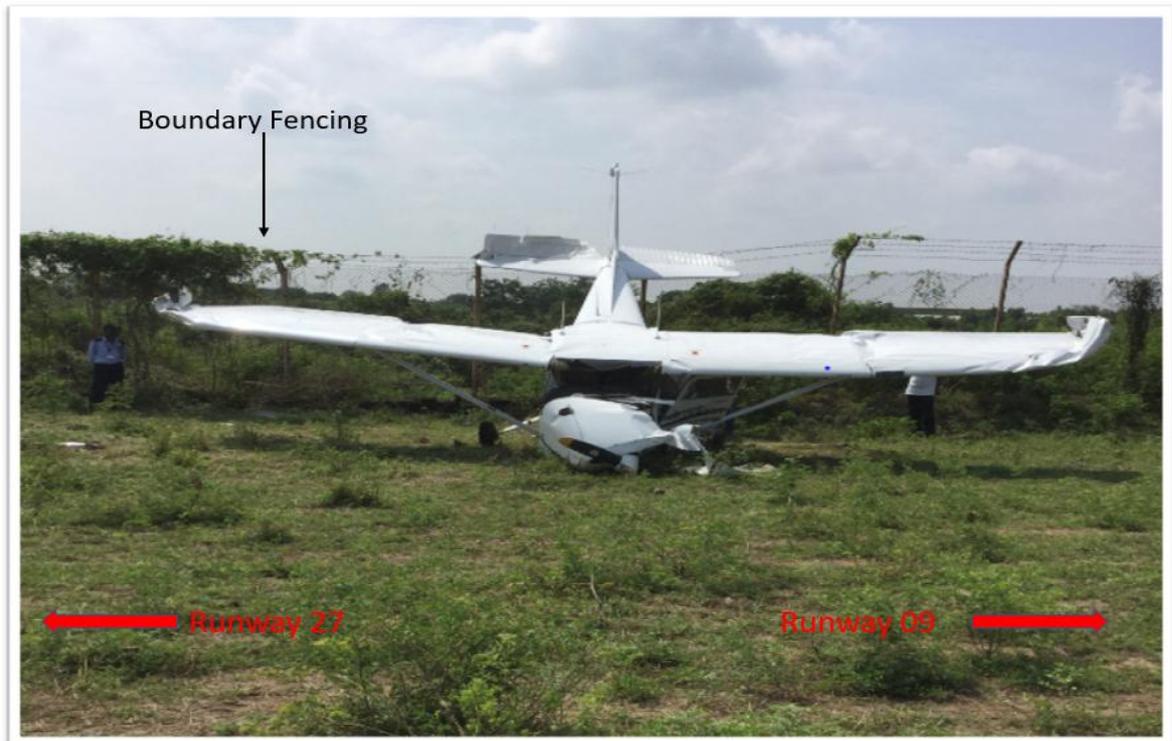
Fig: Final Rest position and damages on VT-HRP

Aircraft was severely damaged in nose section & wing tips. The propeller was twisted and both tips were sheared off. Engine Mount was found broken & nose landing gear found sheared off from its attachments due to impact. Both wings were bent upward at wing tip area. Firewall was found buckled and moved slightly inwards. Cabin & rear section were intact with minor buckling at some places and both main landing gears were intact. The airbag (AMSAFE) assembly was found inflated on pilot seat.
