**AIRCRAFT ACCIDENT INVESTIGATION BUREAU**  
**MINISTRY OF CIVIL AVIATION**  
**GOVERNMENT OF INDIA**

**FINAL INVESTIGATION REPORT ON SERIOUS INCIDENT INVOLVING M/S GO AIR**  
**AIRBUS A320 (NEO) AIRCRAFT VT-WGT ON 07/03/2019**

| 13. | <b>Type of Occurrence</b> | : | Diversion due to Engine Failure (Commanded In-Flight Shut Down). |

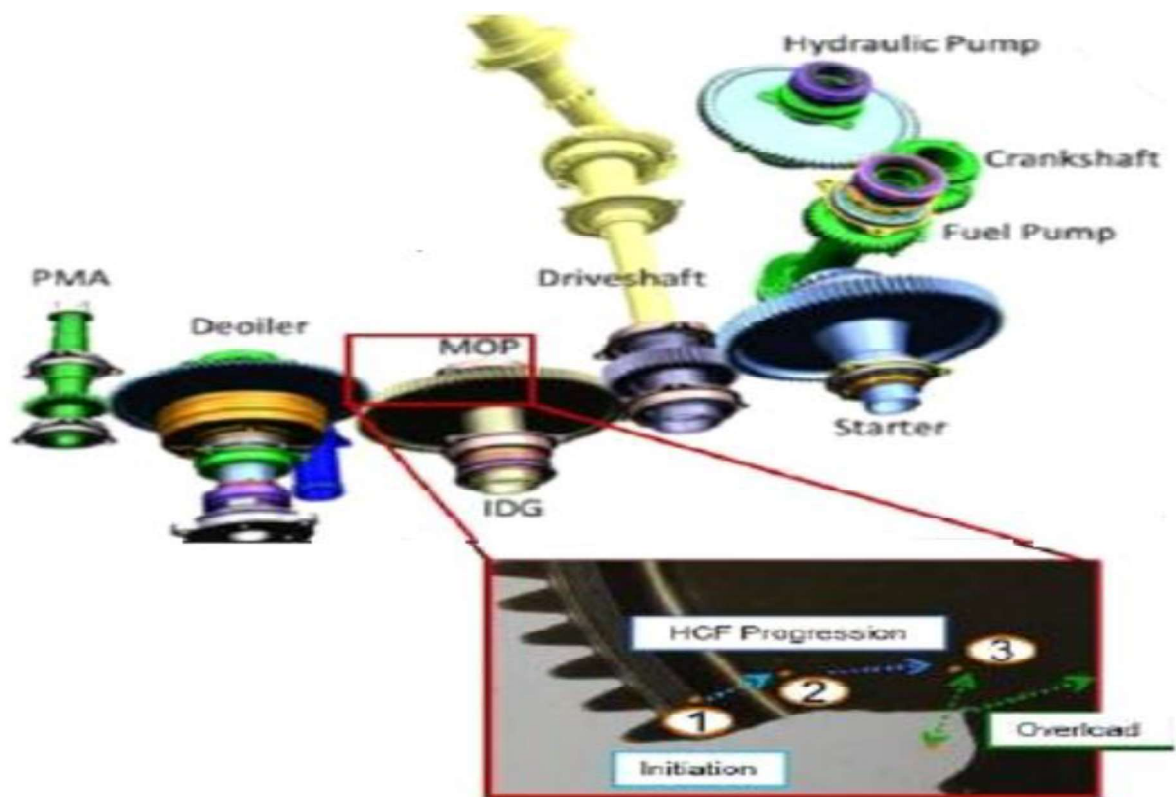
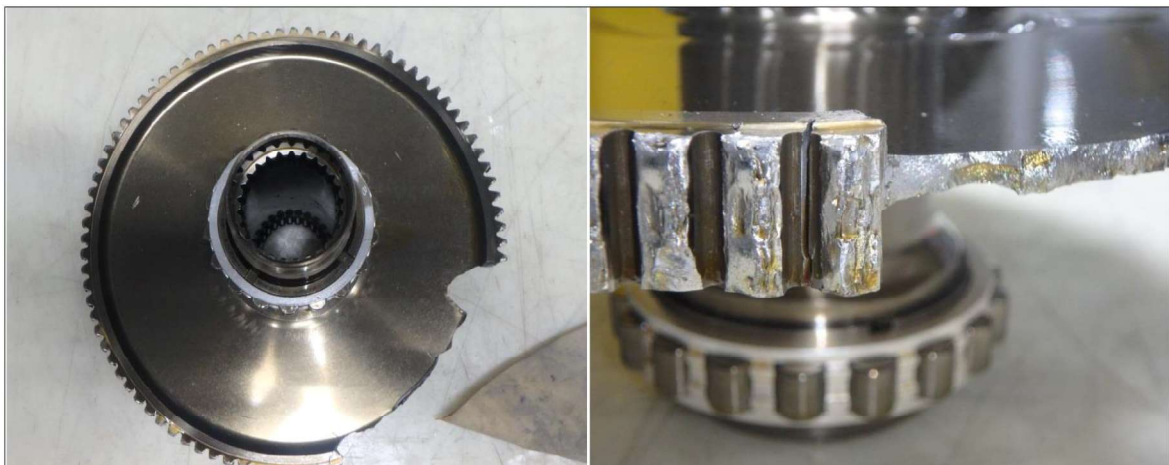
**Figure 5 : Fractured MOP/IDG Gear**

Engine Sr No. 770792 was inducted at OEM facility for disassembly, inspection and repair. The IDG gear shaft was found fractured with secondary damage throughout the Main Gearbox. The Main Gearbox was found with the MOP/IDG Gear fractured. The Main Gearbox was rebuilt to incorporate SB 72-00-0129 in order to address this failure mode.

opined by the OEM that the resonance response of some IDG oil pump drive gear shaft assemblies to certain engine operating conditions can result in a high cycle fatigue fracture.

This fracture of IDG oil pump drive gear shaft assembly and consequent damages to other MGB components like PMA, Starter Drive, Deoiler, Hydraulic pump etc. led to improper scavenging and insufficient air sealing. This resulted in various ECAM fault including Engine Oil low pressure and subsequently to engine failure and IFSD (Commanded).

It was observed that the failure of MOP/IDG gear was because of its resonance response to certain engine operating conditions which resulted in a high cycle fatigue fracture.

Service Bulletin (PW SB 72-00-0129) on “Engine – Gear shaft, Integrated Drive Generator (IDG), Oil Pump Drive, Assembly - Replace the IDG Oil Pump Drive Gear shaft Assembly to Improve Main Gearbox Durability” was issued, to eliminate the re-occurrence of IFSD events and obviate fracture of MOP/IDG gear fracture. The reason for issue of this SB was given as “The IDG oil pump drive gear shaft assembly can fracture during engine operation resulting in an IFSD. The cause of failure was given as “Resonance response of some IDG oil pump drive gear shaft assemblies to certain engine operating conditions result in a high cycle fatigue fracture.”

The SB required to replace the IDG oil pump drive gear shaft assembly with an improved IDG oil pump drive gear shaft assembly with an axially thicker gear web, a radially thicker gear rim, and improved tooth tip relief to eliminate the resonance response of the IDG oil pump drive gear shaft assembly during engine operation. It was also mentioned that the subject SB was the terminating action for the problem.

The OEM came up with an immediate as well as long-term corrective action plan to arrest such failing. To eliminate the re-occurrence of IFSD events and obviate fracture of MOP/IDG gear fracture, Service Bulletin (PW SB 72-00-0129) on “Engine – Gear shaft, Integrated Drive Generator (IDG), Oil Pump Drive, Assembly - Replace the IDG Oil Pump Drive Gear shaft Assembly to Improve Main Gearbox Durability” was also issued. The SB required to replace the IDG oil pump drive gear shaft assembly with an improved IDG oil pump drive gear shaft assembly.

The new and improved IDG oil pump drive gear shaft assembly has an axially thicker gear web, a radially thicker gear rim, and improved tooth tip relief to eliminate the resonance response of the IDG oil pump drive gear shaft assembly during engine operation. It was also mentioned that the subject SB was the terminating action for the problem.
