FINAL INVESTIGATION REPORT
ON
SERIOUS INCIDENT INVOLVING
M/S INDIGO
AIRBUS A320 (NEO) AIRCRAFT VT-ITW
ON 03.01.2019

AIRCRAFT ACCIDENT INVESTIGATION BUREAU
MINISTRY OF CIVIL AVIATION
GOVERNMENT OF INDIA

| 13. | Type of Occurrence | : | Air Turn Back due to Engine Stall. |

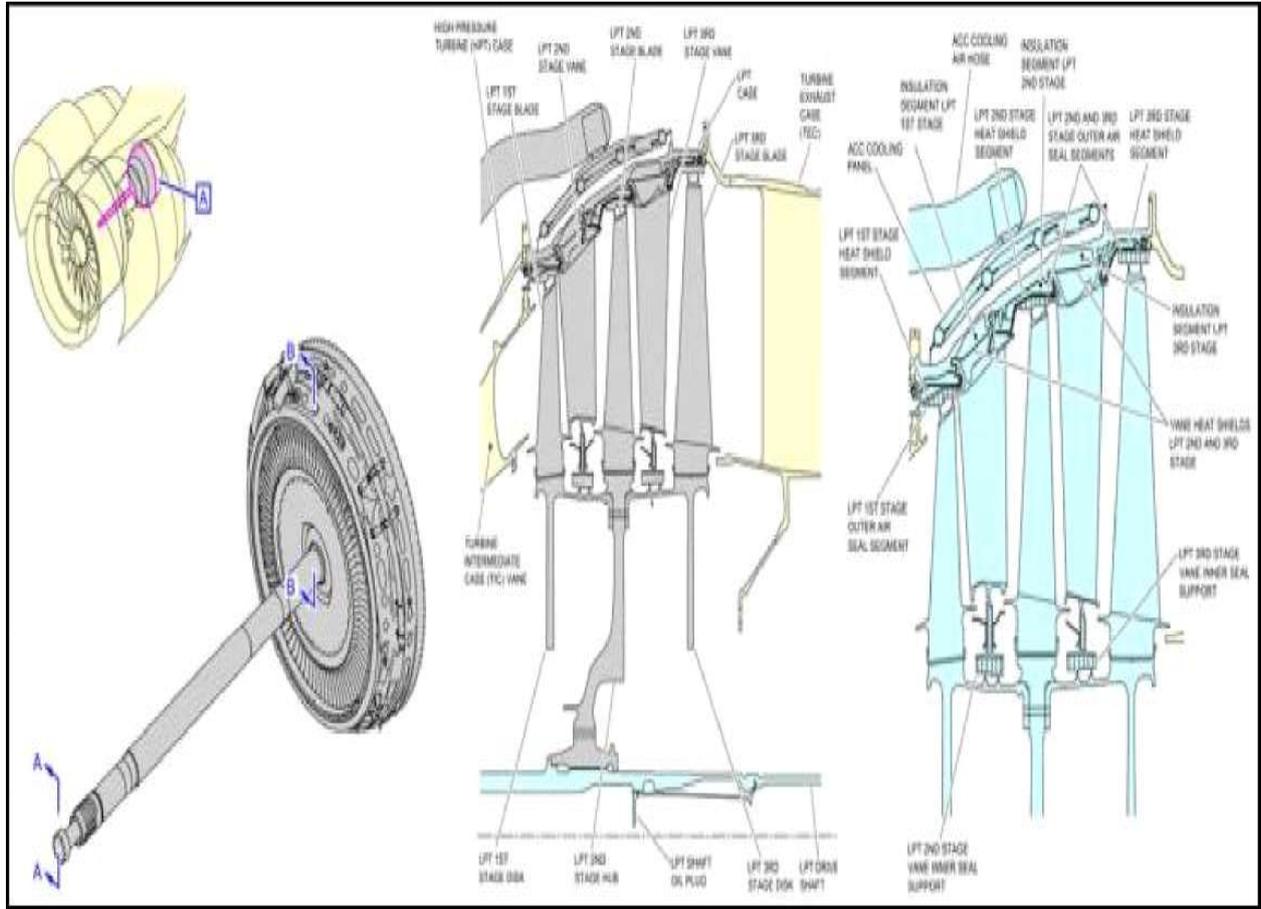
Figure 4 : LTM – LOW TURBINE MODULE

12. LPT Case was found damaged.
13. All LPT Stage 3 blades were found damaged (Fractured from Tip). The Seal Segment was also missing between NGV # 3 and ROW # 3 rotor blade area at multiple places.

17. LPT Stage 2 Disk was observed to have impact damage.
18. LPT Stage 3 Vanes were observed to have impact damage.
19. All LPT Stage 3 blades were found damaged (Fractured).

- Examination revealed that all 78 LPT 3rd stage blades had fractured in the airfoil at varying heights from the blade root platform.
- Impact damages were found present predominantly along trailing edge (TE) of the available part of the airfoil.
- Fracture surfaces of the blades showed a flat appearance with vaguely delineated chevron marks emanating from the crack origins in many occasions.

The incident was caused by failure of LPT 3rd stage blades in flight as the blade material lacked crack growth resistance and damage tolerance to withstand any impact from material that may have liberated upstream.

The SB required that the LPT 3rd stage disk, blades, locking plates, and shroud segments be replaced by the new set made of different material.

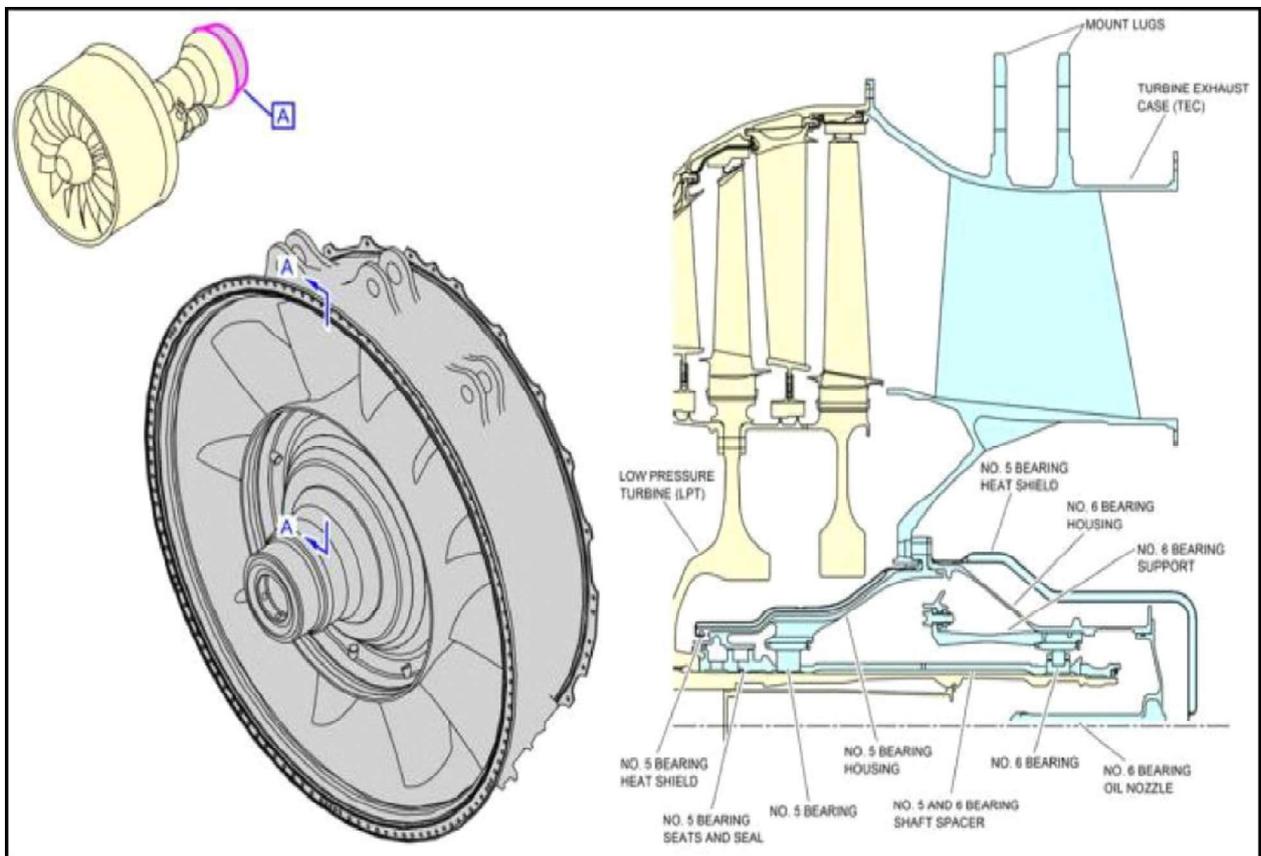
Figure 5: TECM - TURBINE EXHAUST CASE MODULE

20. Turbine Exhaust Case was found to have impact damage.
