FINAL INVESTIGATION REPORT
ON
SERIOUS INCIDENT INVOLVING
M/S INDIGO
AIRBUS A320 (NEO) AIRCRAFT VT-IVB
ON 01.04.2019

AIRCRAFT ACCIDENT INVESTIGATION BUREAU
MINISTRY OF CIVIL AVIATION
GOVERNMENT OF INDIA

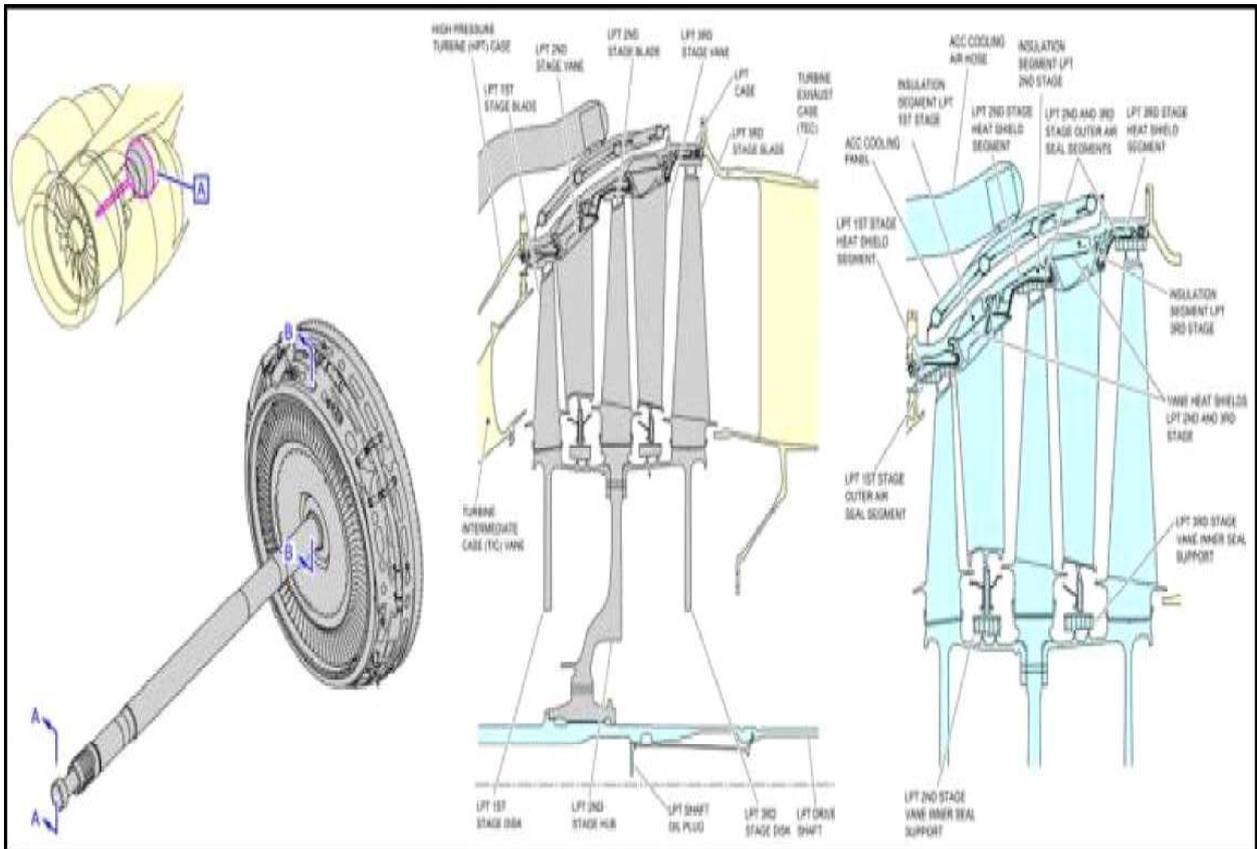
Figure 4 : LTM – LOW TURBINE MODULE

Based on the analysis by NAL, Bengaluru to study Material of Construction (MoC) it was determined that the pre-modified LPT stage 3 blades are made of gamma-based Titanium Aluminide (TiAl) which is, in general, brittle in nature having low fracture toughness. Although, the alloy used for LPT blades 3rd stage blades is an improved version of TiAl alloys with engineered microstructure, the material still lacked adequate damage tolerance properties. It was confirmed during the fractography study conducted by NAL, Bengaluru that LPT 3rd stage blades of the Engine ESN 770187, 770530 and 770516 had fractured instantaneously in a brittle manner and none of the blades showed presence of any signatures of progressive failure such as fatigue.

The fatigue test further confirmed that the material does not have enough crack growth resistance and after initiation, the crack propagated instantaneously leading to fracture. It is, therefore, evident that the LPT stage 3 blades failed in flight as these blades could not withstand possible impact from material liberated upstream and got fractured instantaneously. This led to engine high vibration and EGT overlimit.

The SB required that the LPT 3rd stage disk, blades, locking plates, and shroud segments be replaced by the new set made of different material.
