**FINAL REPORT OF SERIOUS INCIDENT INVOLVING AIRBUS A320 (NEO) AIRCRAFT
VT-WGLOPERATED BY M/s GO AIRLINES (INDIA) LIMITED
ON 23RD DECEMBER 2019.**

SYNOPSIS

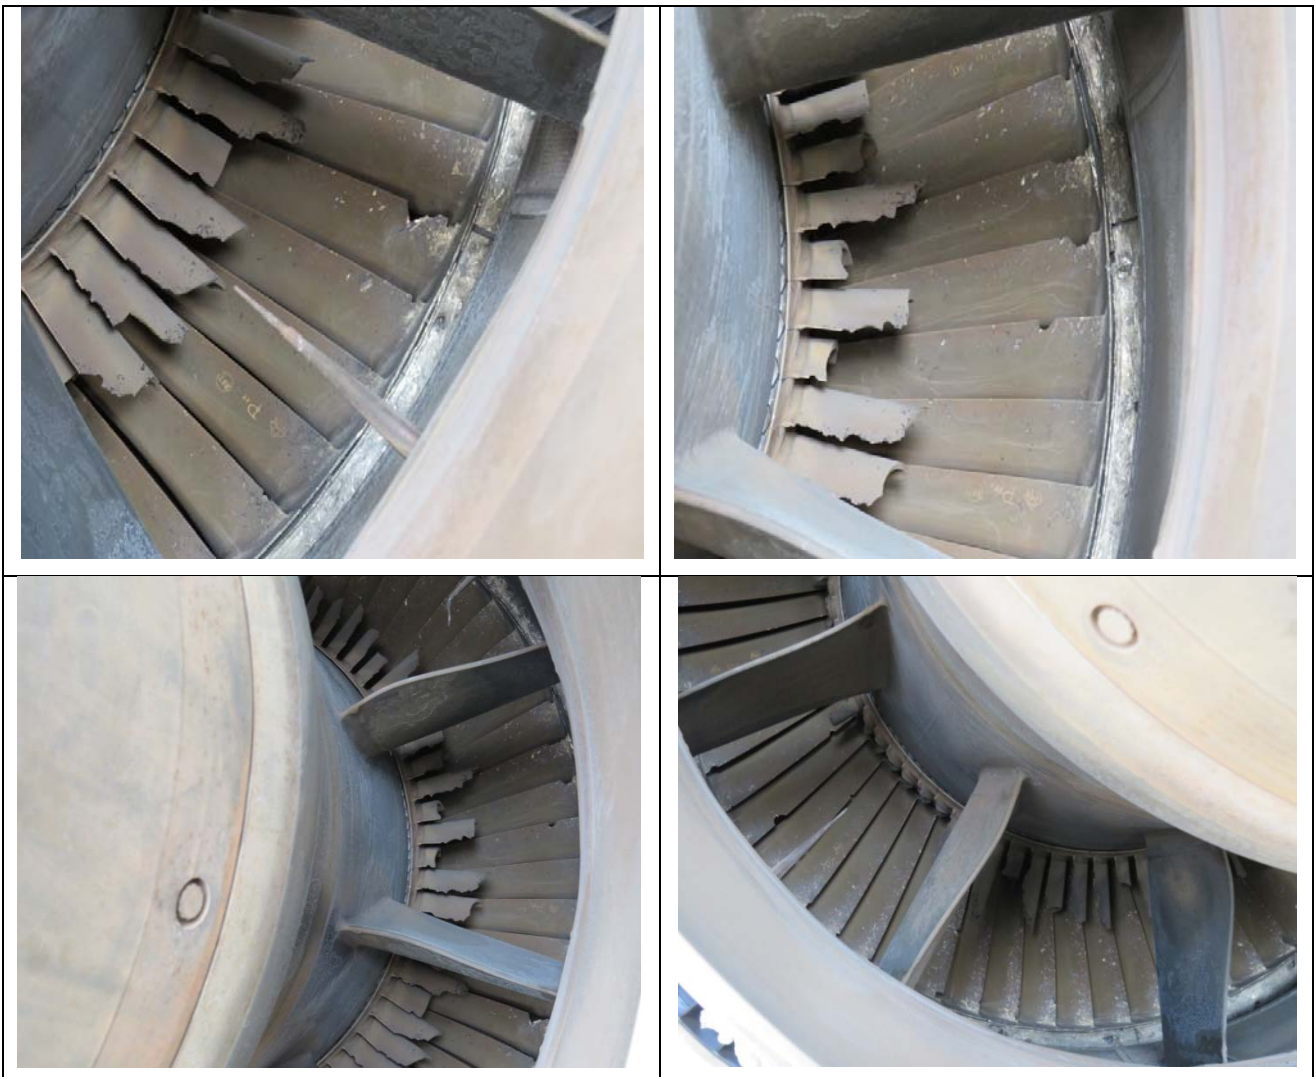
Post landing during visual inspection of the engine exhaust area all blades of Low-Pressure Turbine (LPT) 3rd stage were found damaged.

The aircraft damages due to the incident was limited to its left engine. The LPT 3rd Stage blades of left engine were found broken during inspection. The images of damaged blades is shown below:-

Figure 1: Engine LPT 3rd Stage blades were found damaged during inspection.

Engine ESN 770398 was inducted into the shop for stall and high vibration issues. The LPT Stage 3 was found with several broken blades. The discs and blades of LPT Stage 1 and 2, along with the 2nd stage support and 3rd stage vanes were replaced due to wear / damage. The Low Turbine module had the LPT 3 blades, shrouds, and disc replaced as per SB 72- 00-0111 in accordance with the work scope requirements. HPC IBRs were replaced to combat vibration issues and all HPC seals were repaired to address stalling problems. The Diffuser Case Group had the combustion chamber and additional parts replaced / modified to a block D configuration. The High Turbine Case Module was upgraded to a block D configuration and had the T1 and T2 blades replaced. All unserviceable parts were repaired or replaced as per EM specifications. The engine was tested as per IAW Test # 9 and passed successfully.

- Examination revealed that all 78 LPT 3rd stage blades had fractured in the airfoil at varying heights from the blade root platform.
- Impact damages were found present predominantly along trailing edge (TE) of the available part of the airfoil.

- Fracture surfaces of the blades showed a flat appearance with vaguely delineated chevron marks emanating from the crack origins in many occasions.
- Fractography study confirmed that LPT 3rd stage blades had fractured instantaneously in a brittle manner. None of the blades showed presence of any signatures of progressive failure such as fatigue.

The incident was caused by failure of LPT 3rd stage blades in flight as the blade material lacked crack growth resistance and damage tolerance to withstand any impact from material that may have liberated upstream.

The SB required that the LPT 3rd stage disk, blades, locking plates, and shroud segments be replaced by the new set made of different material.

M/s Go Airlines (India) Ltd complied with SB 72-00-0111 i.e., all its NEO fleet were installed with LPT modified engines by 31st Aug 2020.
