**FINAL REPORT OF SERIOUS INCIDENT INVOLVING AIRBUS A320 (NEO) AIRCRAFT
VT-WJEOPERATED BY M/s GO AIRLINES (INDIA) LIMITED
ON 22ND DECEMBER 2019.**

**Jasbir Singh Larhga
Investigator -In- charge**

**Amit Kumar
Investigator**

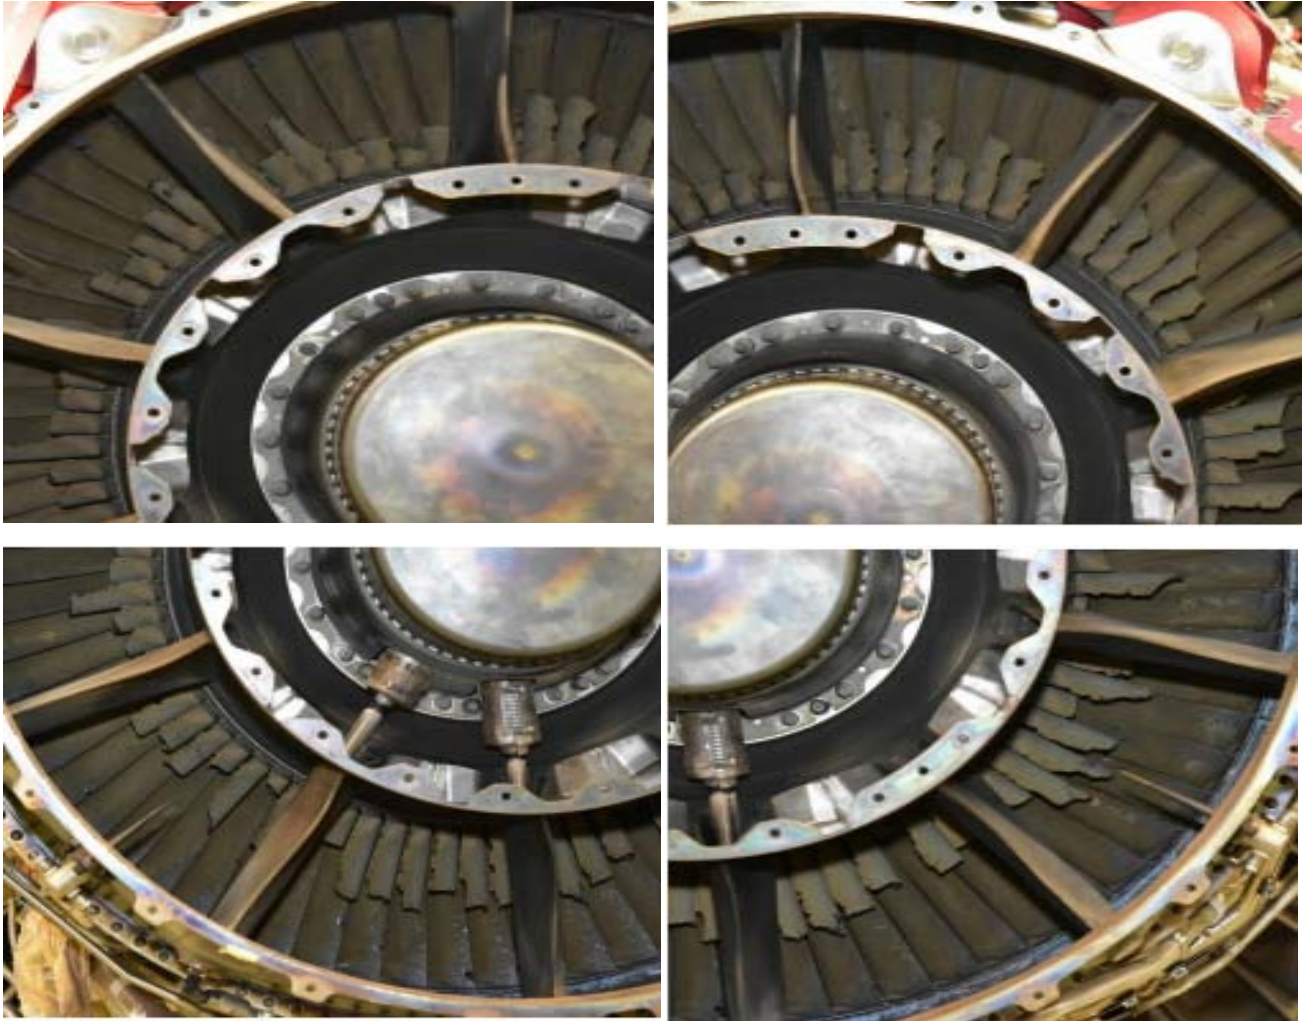
Post landing during visual inspection of the Engine # 1 exhaust area, all blades of Low-Pressure Turbine 3rd stage were found damaged.

The aircraft damages due to the incident were limited to its left engine. The LPT 3rd Stage blades of left engine were found broken during inspection. The images of damaged blades are shown in the figure below.

Figure 1: Engine LPT 3rd Stage blades were found damaged.

The incident was caused by failure of LPT 3rd stage blades in flight as the blade material lacked crack growth resistance and damage tolerance to withstand any impact from material that may have liberated upstream.

The SB required that the LPT 3rd stage disk, blades, locking plates, and shroud segments be replaced by the new set made of different material.

6. Pratt & Whitney has issued SB 72-00-0111 to Introduce of a new LPT 3rd stage blade made of a different material which is more resistant to impact damage. The airline has subsequently incorporated the said SB in all its affected aircraft.
