**FINAL INVESTIGATION REPORT OF SERIOUS INCIDENT
INVOLVING M/s INDIGO AIRLINES' A320 AIRCRAFT VT-ITB
AT HYDERABAD ON 27/08/2019**

**Jasbir Singh Larhga, Deputy Director
Aircraft Accident Investigation Bureau**

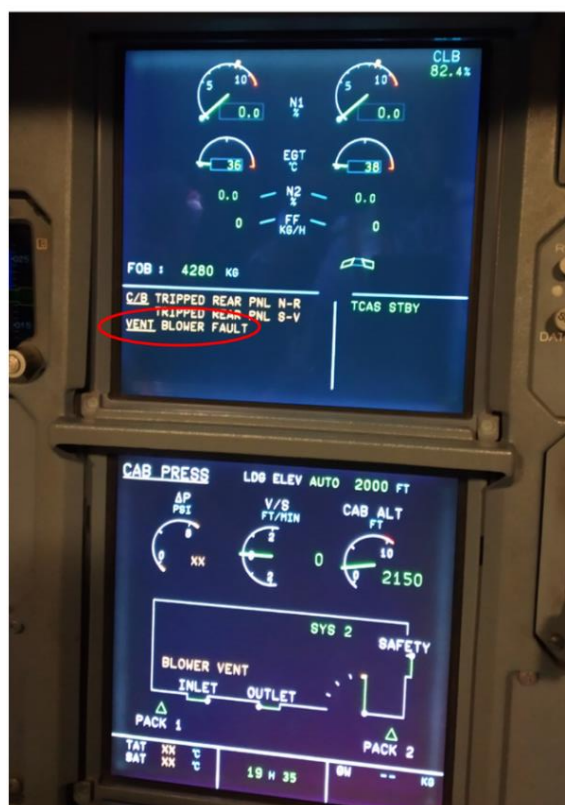
Fig. 6: Vent Blower Fault

In case of failure of any of the two avionics ventilation fans, VENT BLOWER FAULT or a VENT EXTRACT FAULT warning is generated on the ECAM. The snapshot of the warning simulated on ground is shown in the Fig. 6 below.

The warning will continue till it is cleared by the crew. In case of failure of either Blower or Extract Fan, dispatch under MEL is also allowed. In case of Blower/Extract fault alert, the ECAM procedures calls for BLOWER or the EXTRACT pushbutton switch to be set at the OVRD (override) position. This will stop the concerned fan and the system will be in closed-circuit configuration while adding air from the air conditioning system to the ventilation air.

In case of smoke, the Quick Reference Handbook (QRH) action calls for both the BLOWER and the EXTRACT pushbuttons to be set to the OVRD position. In this case, the air conditioning system supplies cooling air which is then exhausted overboard so that any smoke in the system is cleared.
