**FINAL INVESTIGATION REPORT**  
**ON**  
**SERIOUS INCIDENT INVOLVING M/S GO AIRLINES (INDIA) LTD.**  
**AIRBUS A320(NEO) AIRCRAFT VT-WGC**  
**ON 07<sup>TH</sup> January 2020.**

**GOVERNMENT OF INDIA**  
**MINISTRY OF CIVIL AVIATION**  
**AIRCRAFT ACCIDENT INVESTIGATION BUREAU**

**FINAL INVESTIGATION REPORT ON SERIOUS INCIDENT INVOLVING AIRBUS  
A320 (NEO) AIRCRAFT VT-WGC OPERATED BY M/S GO AIRLINES (INDIA) LTD  
ON 7<sup>TH</sup> JAN 2020**

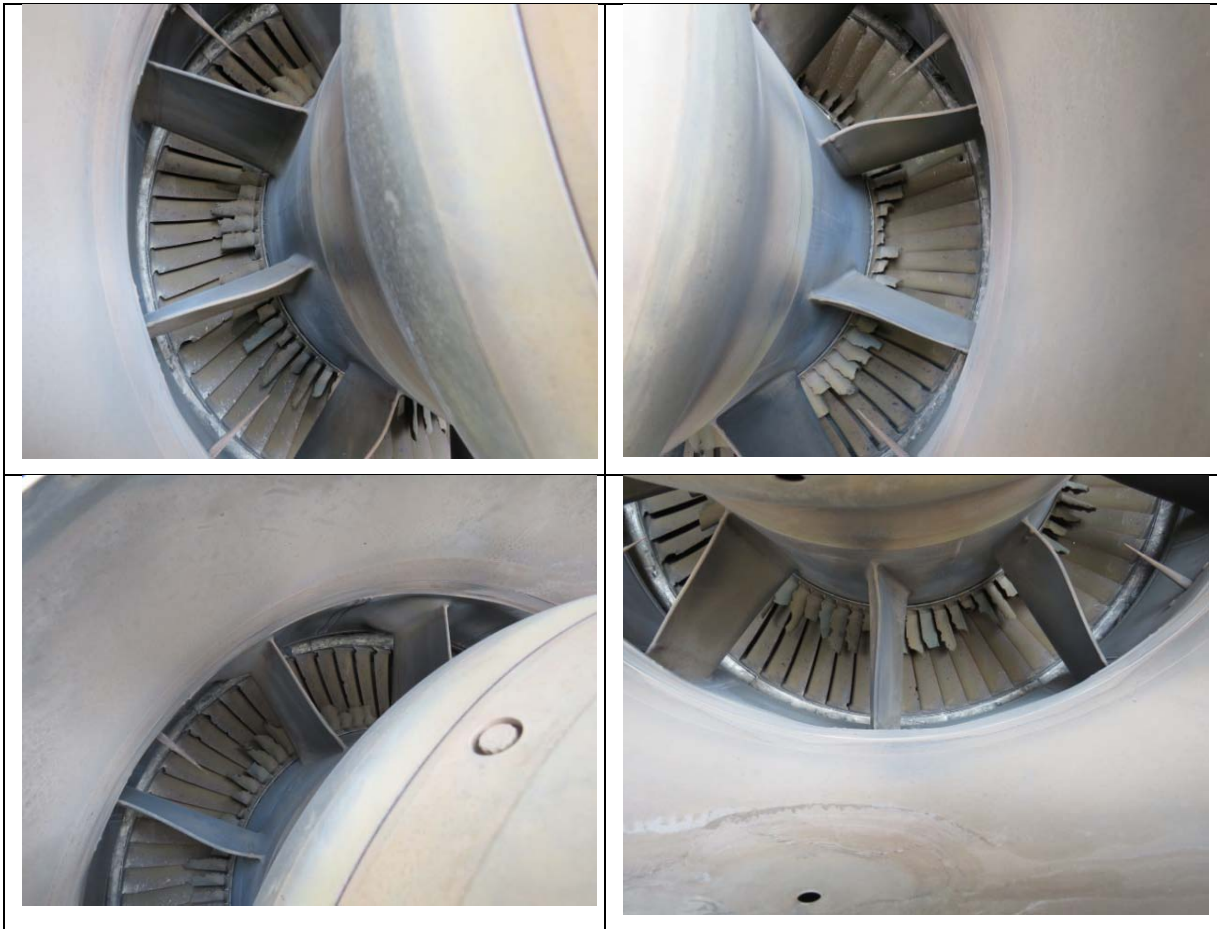
The aircraft damages due to the incident were limited to its starboard engine. The LPT 3rd Stage blades of starboard engine were found broken during inspection. The images of damaged blades taken from rear view are shown below.

Figure 1: Engine LPT 3rd Stage blades were found damaged during inspection.

- Examination revealed that all 78 LPT 3rd stage blades had fractured in the airfoil at varying heights from the blade root platform.
- Impact damages were found present predominantly along trailing edge (TE) of the available part of the airfoil.

- Fracture surfaces of the blades showed a flat appearance with vaguely delineated chevron marks emanating from the crack origins in many occasions.
- Fractography study confirmed that LPT 3rd stage blades had fractured instantaneously in a brittle manner. None of the blades showed presence of any signatures of progressive failure such as fatigue.

The incident was caused by failure of LPT 3<sup>rd</sup> stage blades in flight as the blade material lacked crack growth resistance and damage tolerance to withstand any impact from material that may have liberated upstream.

The SB required that the LPT 3rd stage disk, blades, locking plates, and shroud segments be replaced by the new set made of different material.

6. Pratt & Whitney has issued SB 72-00-0111 to Introduce of a new LPT 3<sup>rd</sup> stage blade made of a different material which is more resistant to impact damage. The airline has subsequently incorporated the said SB in all its affected aircraft.
