**FINAL REPORT ON SERIOUS INCIDENT TO M/s UZBEKISTAN  
AIRWAYS, A320 AIRCRAFT , UK32022 AND M/s INDIGO, A320  
AIRCRAFT, VT-IHQ IN DELHI AIRSPACE, ON 25/01/2020**

**KUNJ LATA  
INVESTIGATOR-IN-CHARGE**

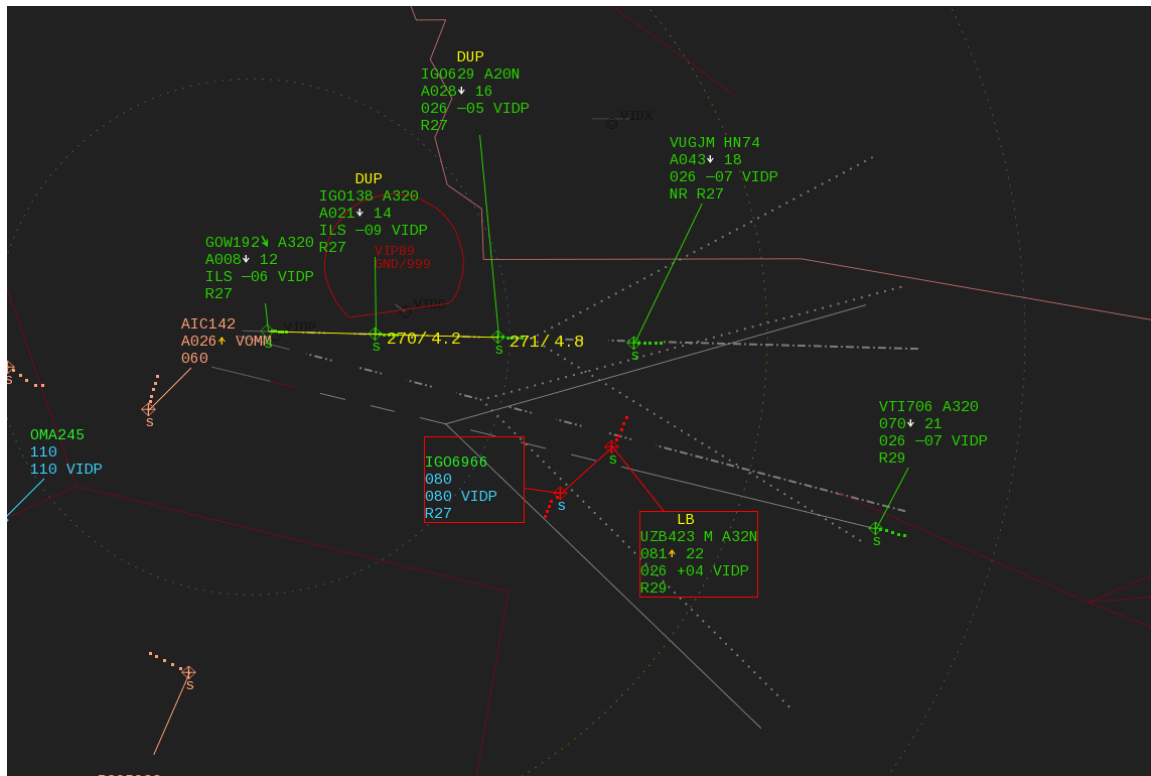
Flight crew of UZB423 stated that during descend from FL70 to 60, Crew unintentionally pushed the ENG # 2 Thrust lever to TOGA position, consequently Auto Flight System got activated “SRS” mode in vertical profile. Thus, aircraft had started climbing. Later, flight crew took the corrective action but by the time TCAS RA alert had been triggered. Crew manoeuvred the aircraft as per Resolution Advisory.

Figure: Showing TCAS-RA between IGO6966 and UZB423

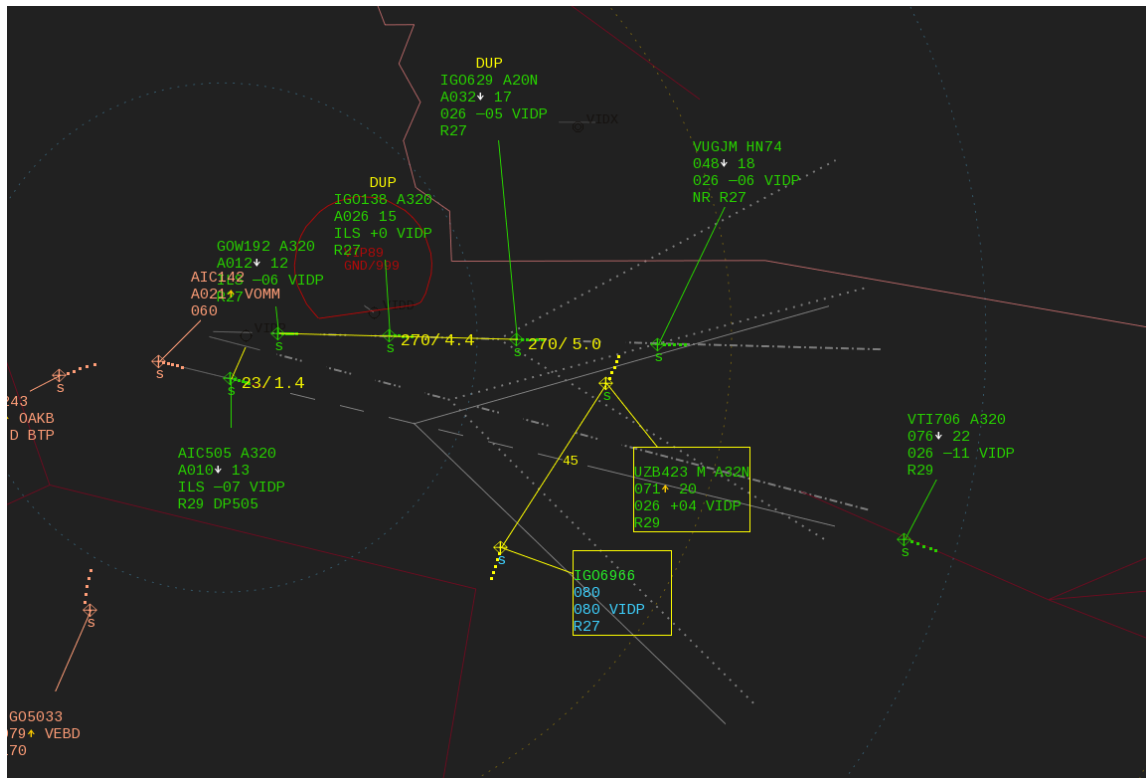
**Figure: Controller gave descent to 2600 ft but it was observed that UZB423 started climbing**

After giving descent, it was observed by the controller that UZB423 was climbing without authorisation. At 07:21:42 UTC, While unauthorised climb Automation System also showed Level Burst. This was monitored by Controller who immediately raised call to UZB423 , in turn it replied “now descend sorry”. Controller emphasized again “affirm due traffic”.

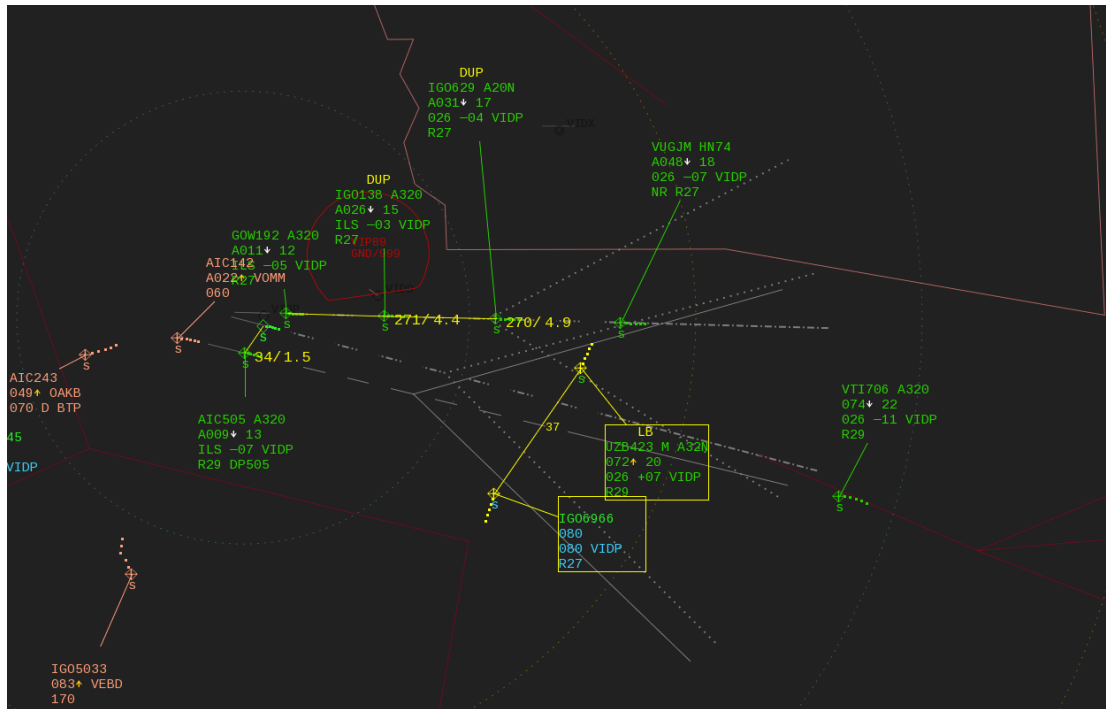
**Figure: At 07:20:42 UTC, Automation system popped (Level Burst) LB alert.**

Controller prompted for descent again and it was also read back by UZB423. However, on the contrary, the aircraft was still climbing. Consequently, the minimum required separation was breached between IGO6966 and UZB423.

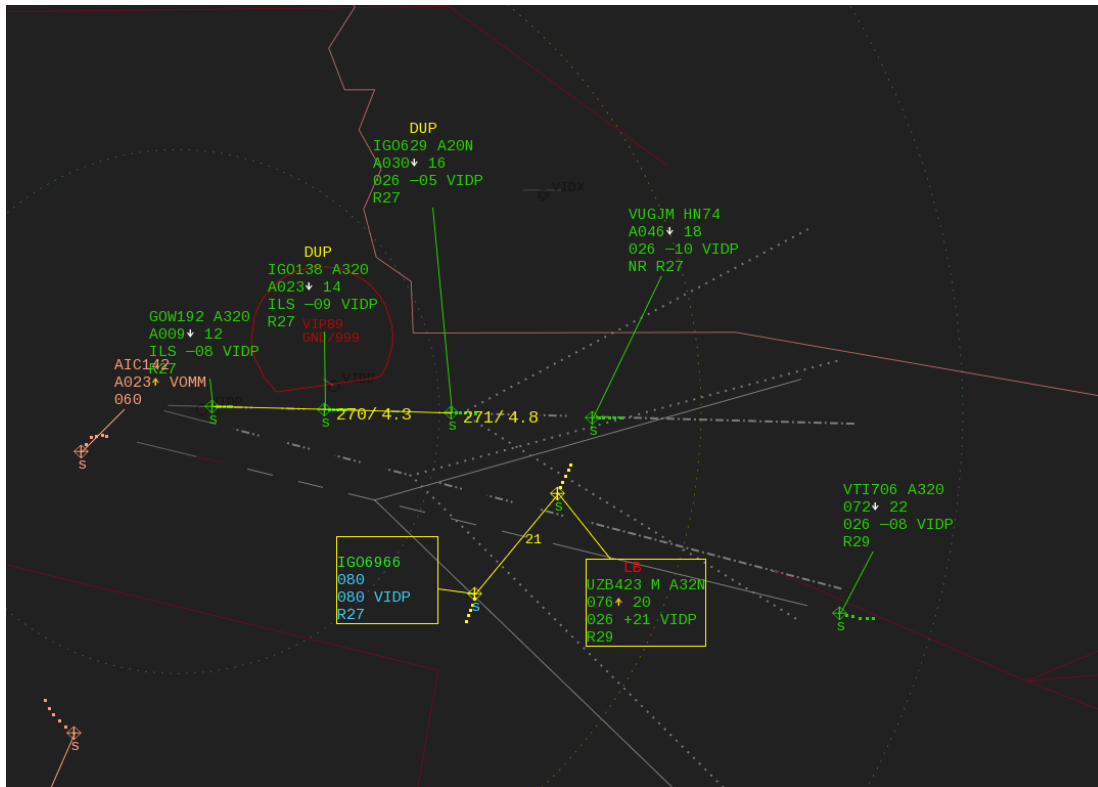
**Figure: At 07:21:00 UTC, TCAS-TA got triggered and Automation System showing STCA (Predicted)**

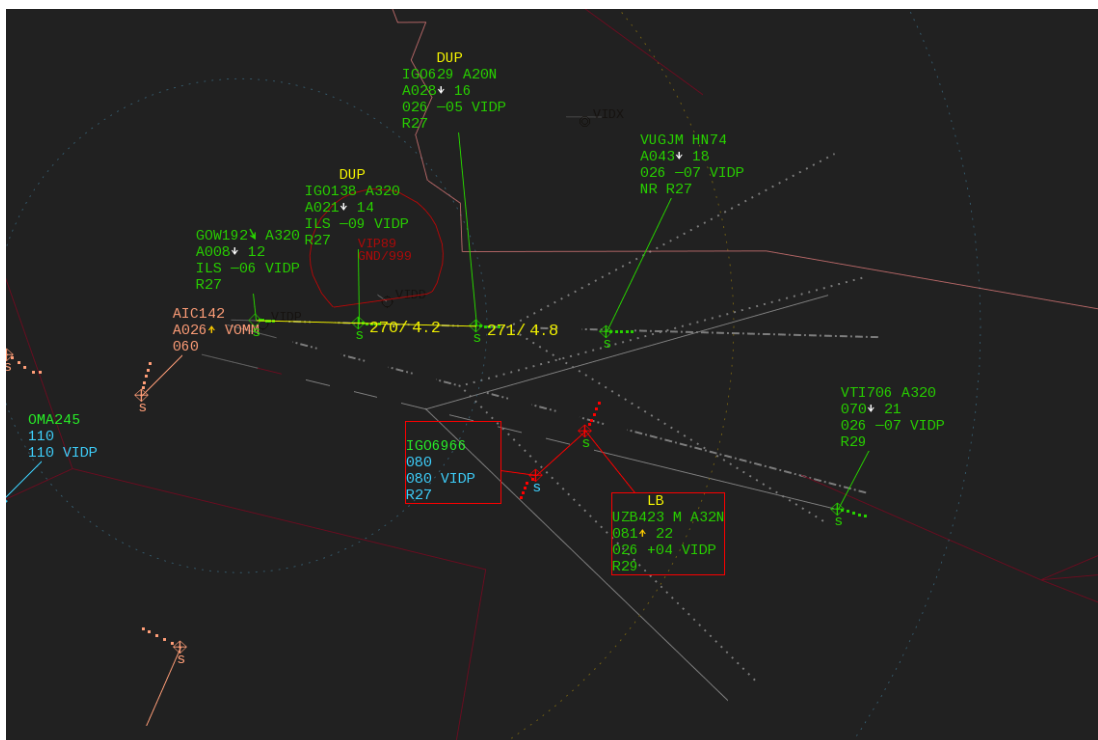
**Figure: At 07:21:31 UTC, TCAS-RA got triggered and Automation System showing STCA (Violation)**

Both aircraft did RA manoeuvres. Aircraft were clear of conflict at time 07:21:41 UTC. Standard Separation in Approach (FA) is 1000 ft vertically and 3 NM horizontally in Radar Environment which was reduced to 1.7 NM laterally when no vertical separation existed.

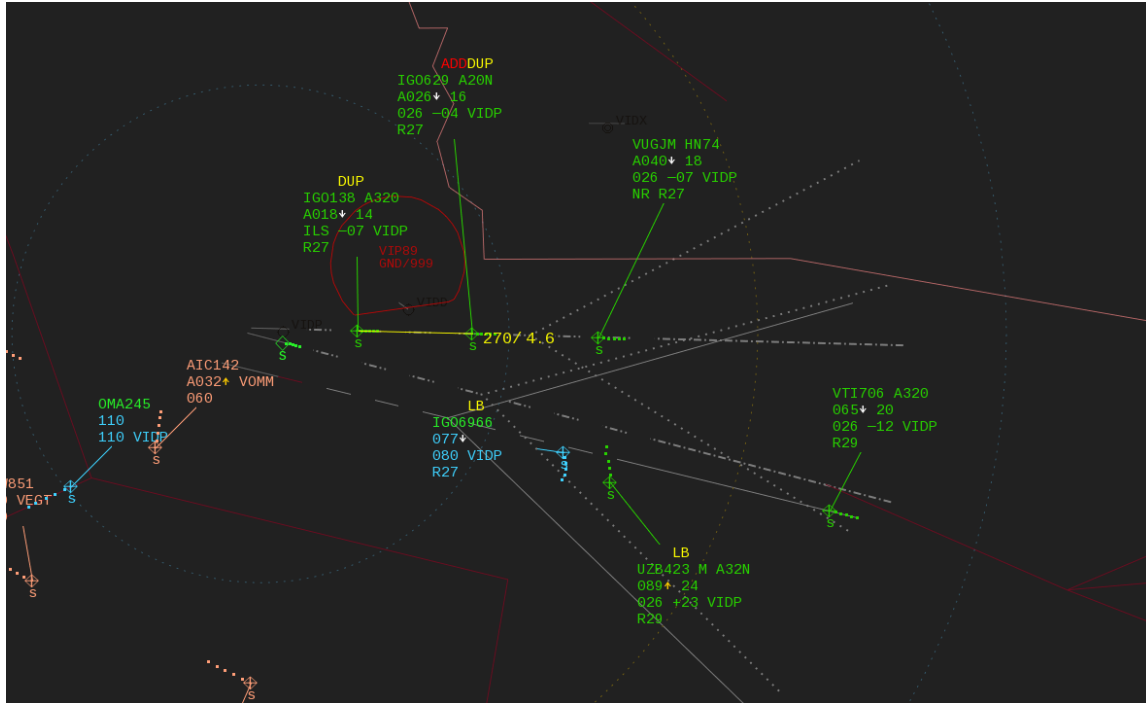
**Figure: Showing Aircrafts are Clear of Conflict, UZB423 Climbed and IGO6966 Descended.**
