FINAL INVESTIGATION REPORT
ON
ACCIDENT TO M/S JHARKHAND
FLYING INSTITUTE
L-23 SUPER BLANIK GLIDER VT-GLE
AT DUMKA (JHARKHAND)
ON 03 FEB 2020

AIRCRAFT ACCIDENT INVESTIGATION BUREAU
MINISTRY OF CIVIL AVIATION
GOVERNMENT OF INDIA

FINAL INVESTIGATION REPORT ON ACCIDENT
TO M/s JHARKHAND FLYING INSTITUTE L-23 SUPER BLANIK
GLIDER VT-GLE ATDUMKA ON 03/02/2020

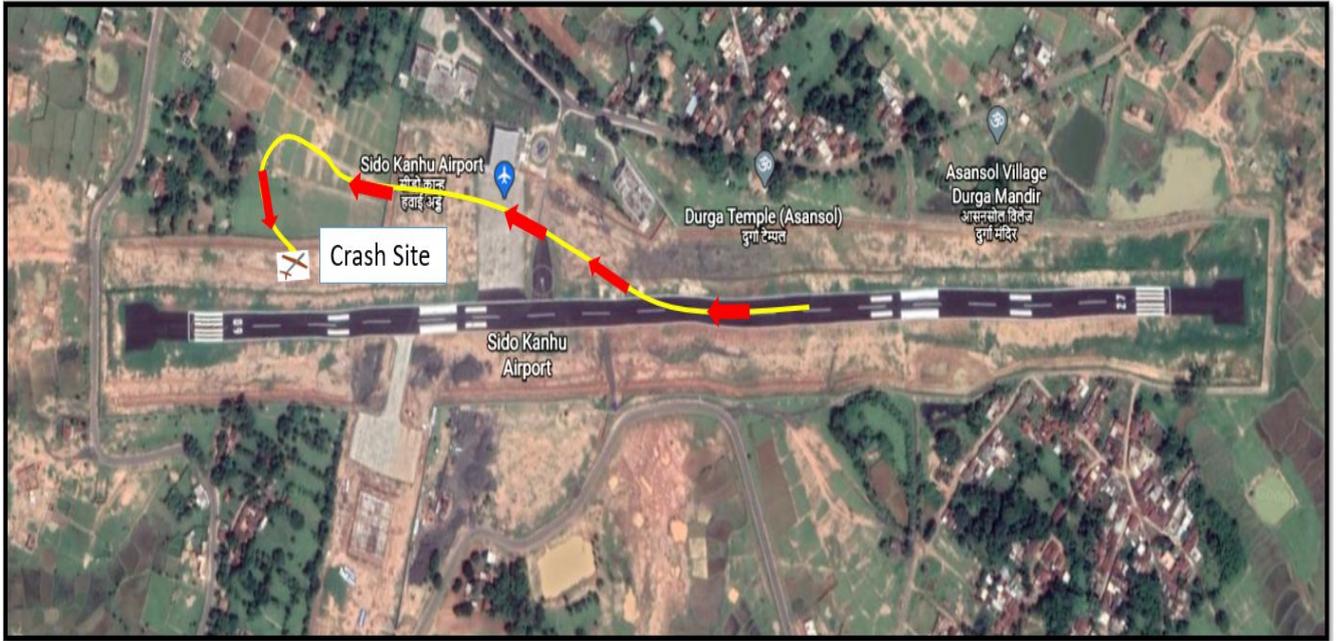
Fig 3: Tentative Projection of Flight Path Followed by Glider on Google Map

Immediately after the launch, the pilot took right turn instead of usual left hand circuit pattern. Probably, in order to correct the same, he took a steep left turn and attempted to land back. However, it could not be determined why the pilot attempted to land back.

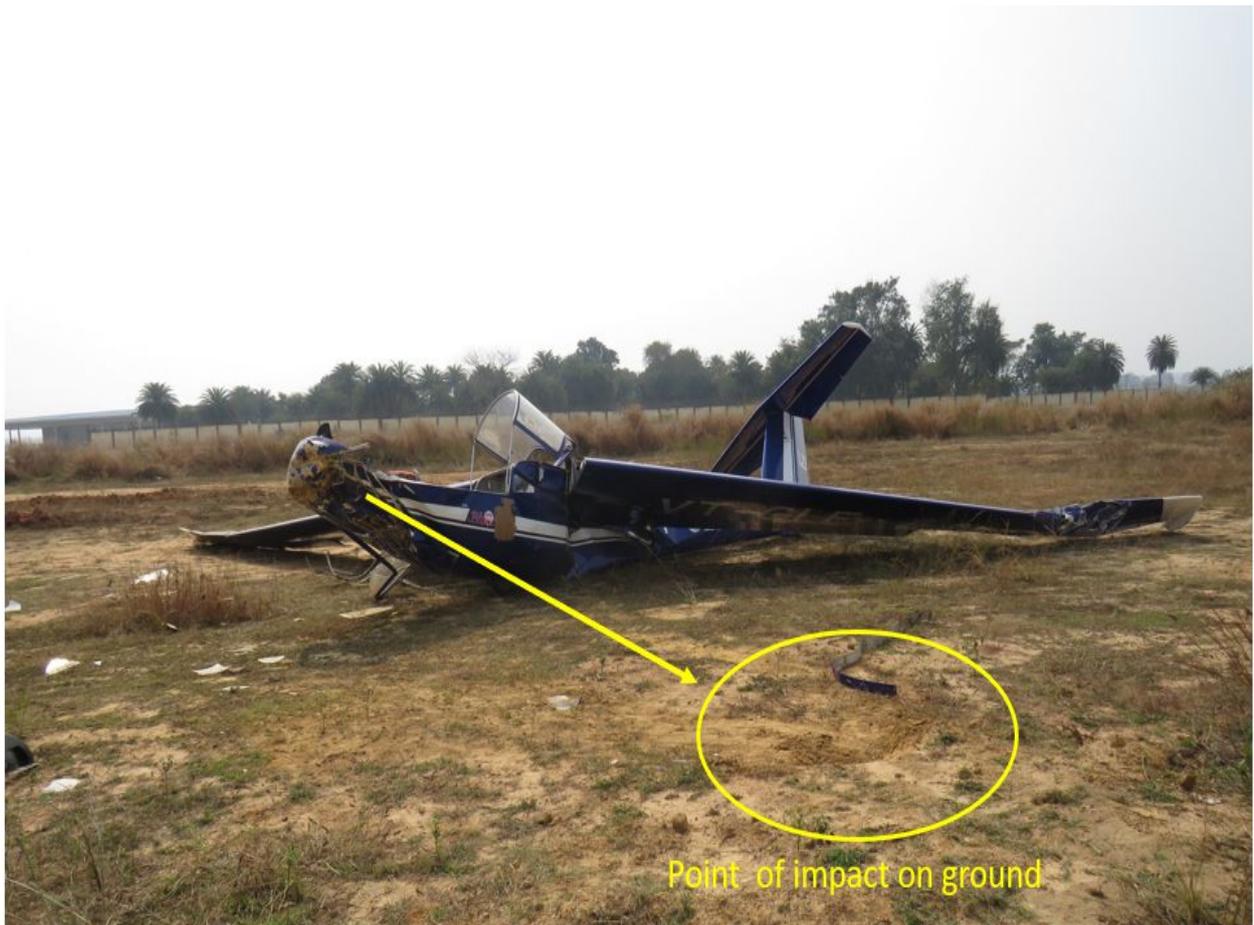
Fig 4: Final Position of Glider VT-GLE at Point of Impact

The glider came to its final rest on its belly at a distance of approximately 16 feet from the point of impact on ground, facing towards the boundary wall.

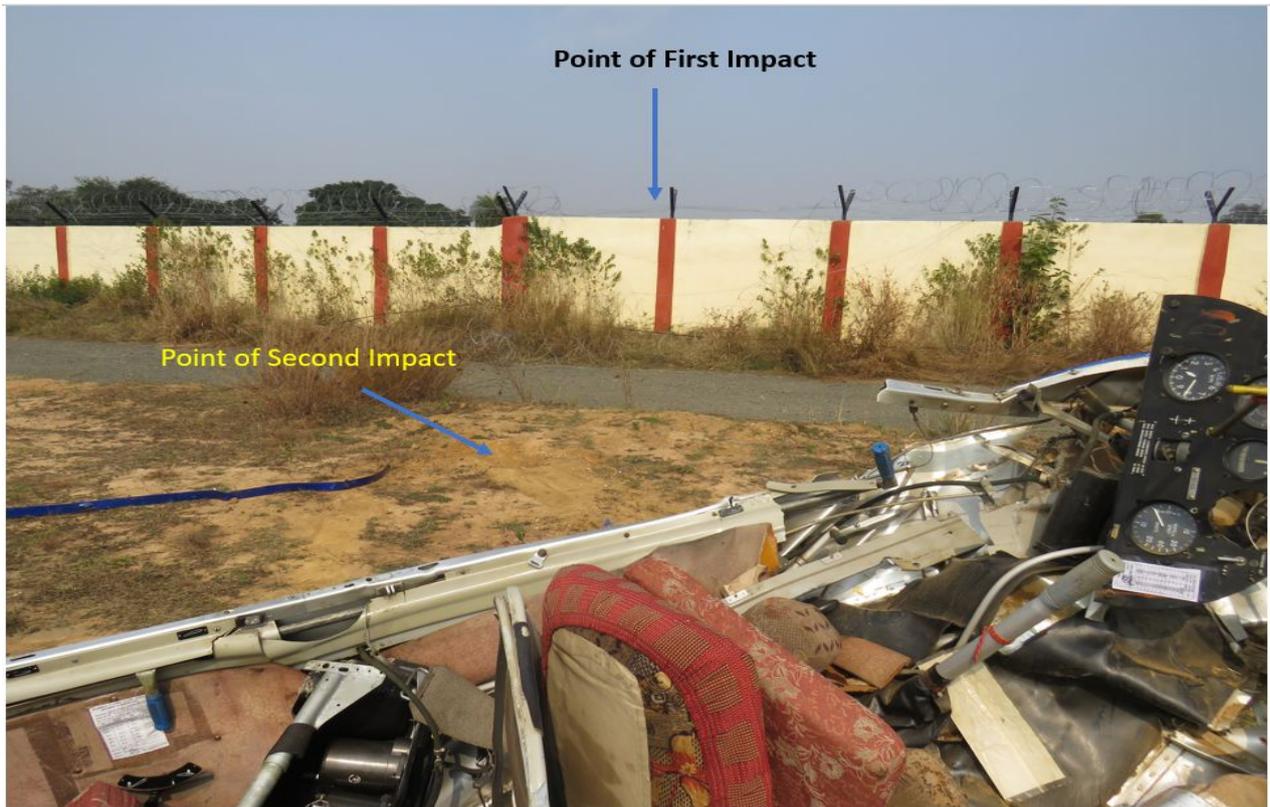
Fig 5: Points of Impacts (Viewed from Accident Site)

The left wing of the glider hit the boundary wall resulting into barbed fencing damage.

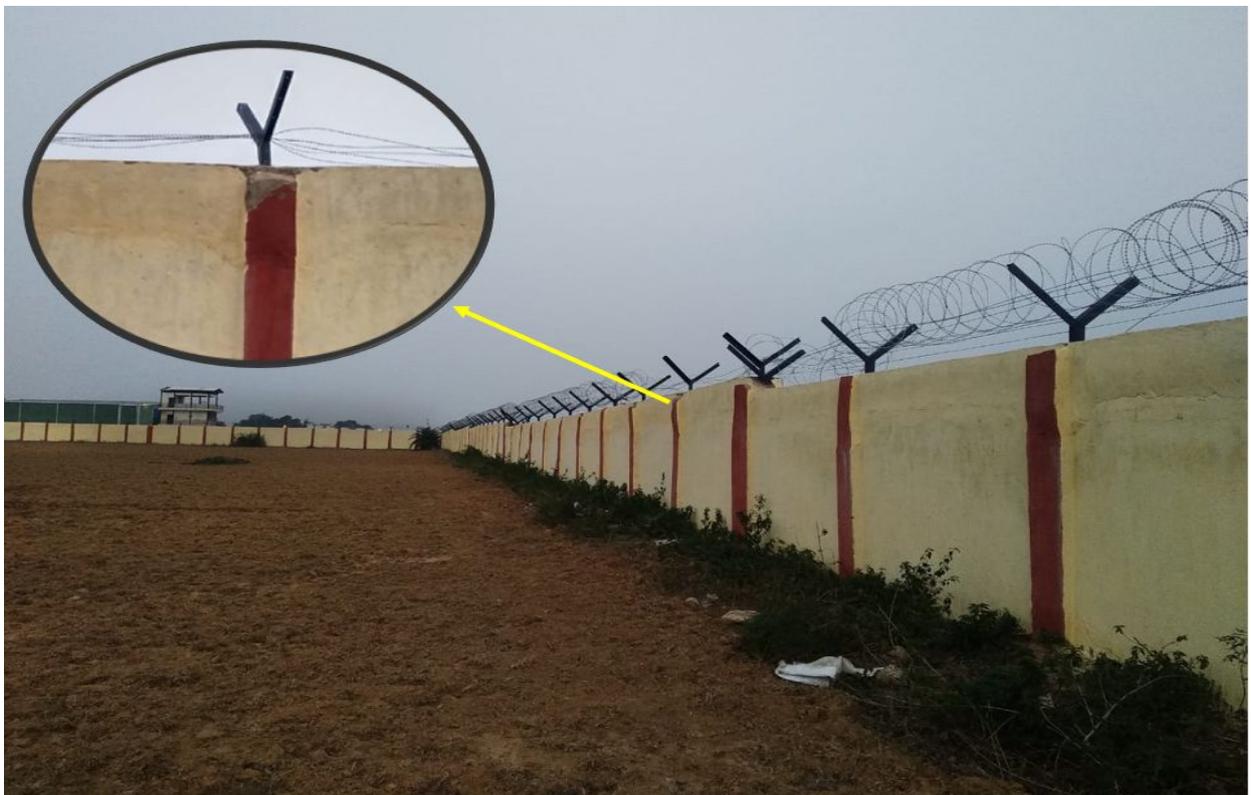
Fig 6: Point of Impact (View from Outside the Airfield)

While the glider was continuously losing height, crew attempted to land back at Dumka airfield. While doing so the left wing of the glider hit the boundary wall of the airfield which is approximately 8 feet high. During first impact, the glider was in left bank condition. At the time of first impact, left wing partially got detached from the wing root. Thereafter, glider collided on the unpaved surface of the airstrip at a distance of approximately 30 feet from the boundary wall. During second impact, glider nose and right wing hit the ground simultaneously. At the time of impact with ground, the glider was on nose down condition and hit the ground.

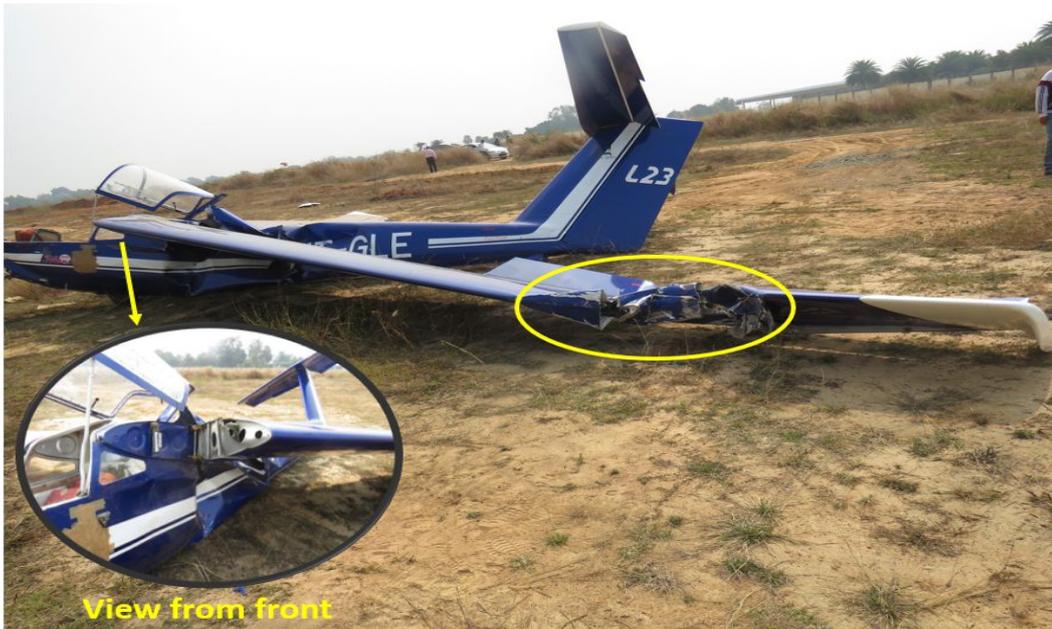
Fig 7: Damaged Left Wing

Examination of wreckage revealed that nose section of glider was completely damaged along with the front canopy. The control stick of forward cockpit was found intact; however, the control stick of rear cockpit was found damaged but intact. Due to impact of left wing with boundary wall, left wing was found intact but got deformed at the point of impact. Tow Release Handle on the front instrument panel was found disengaged from its original position.

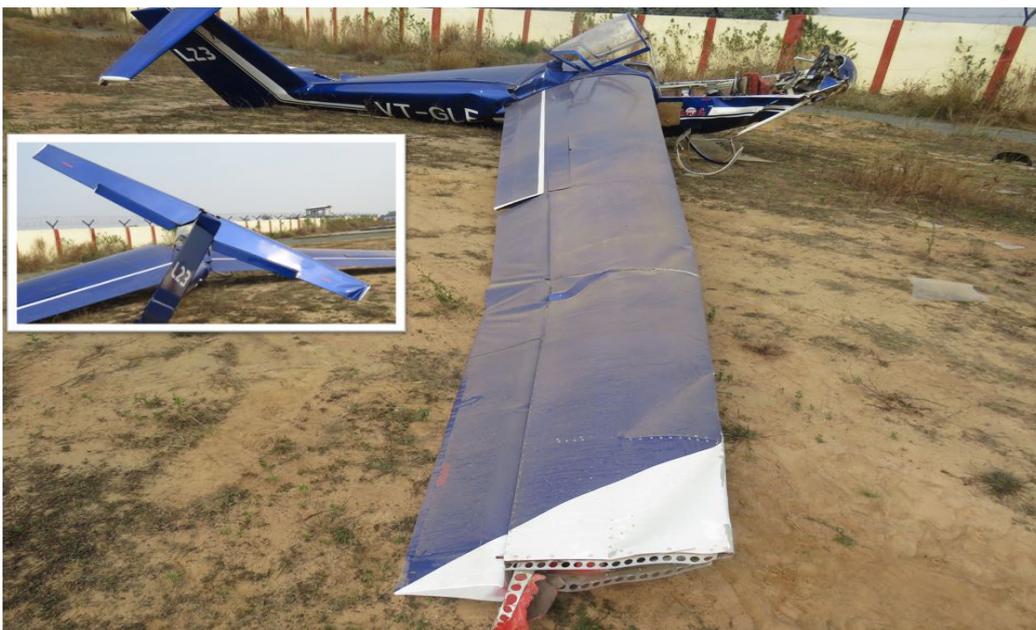
Fig 8: Damaged Right Wing and Tail Section

The Main Landing Gear along with tail skid wheel and all control surfaces (Ailerons, Elevators, Rudder, Trim Tabs and Airbrakes) were found to be intact. However, Vertical Speed Indicator of both instrument panels (front and rear) was found detached from installed locations. Both VSIs were found near the glider. The Variometer installed on the front instrument panel was found to be stuck at maximum sink position.
