FINAL INVESTIGATION REPORT
ON
ACCIDENT INVOLVING CESSNA 172 R AIRCRAFT VT-CAF
OPERATED BY M/S CHIMES AVIATION ACADEMY
AT DHANA ON 3RD JANUARY 2020.

AIRCRAFT ACCIDENT INVESTIGATION BUREAU
MINISTRY OF CIVIL AVIATION
GOVERNMENT OF INDIA

**FINAL INVESTIGATION REPORT ON ACCIDENT AT DHANA
ON 3RD JAN 2020 INVOLVING CESSNA 172 R AIRCRAFT VT-CAF OPERATED
BY CHIMES AVIATION ACADEMY**

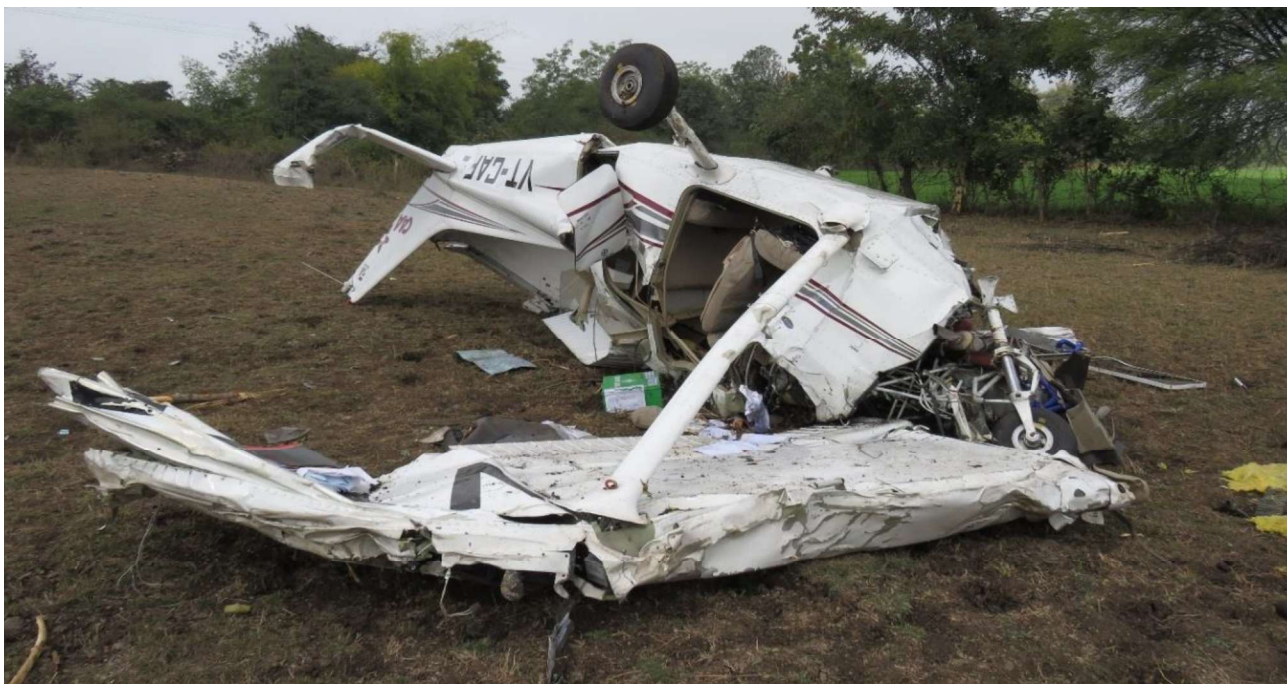
Figure 1: Aircraft wreckage

The aircraft was destroyed due to impact.

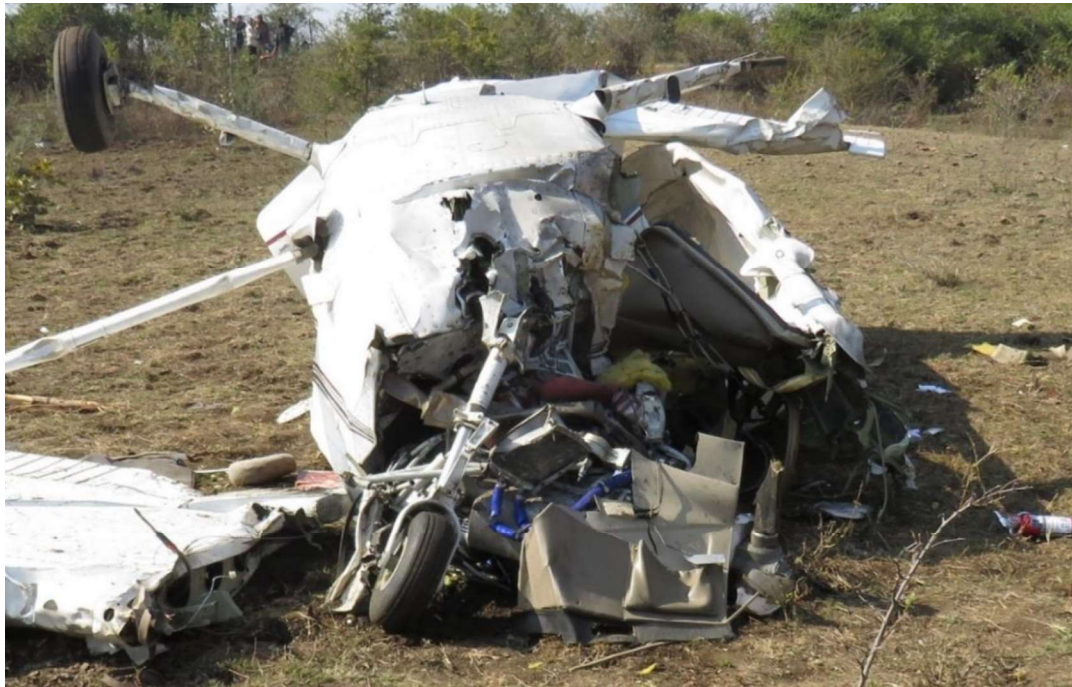
Figure 2 : Aircraft wreckage viewed from front

Nose Section of the aircraft was severely damaged. Upper and lower firewall separated at the RH side (Zone 121 and 123). Both upper and lower firewall were found crumbled and ripped at several pieces. The Nose gear was found separated from firewall. Engine cowling was found ripped off from the right side and had separated from the aircraft. Engine got separated from airframe as the tubular members of mount structure got broken at several places.

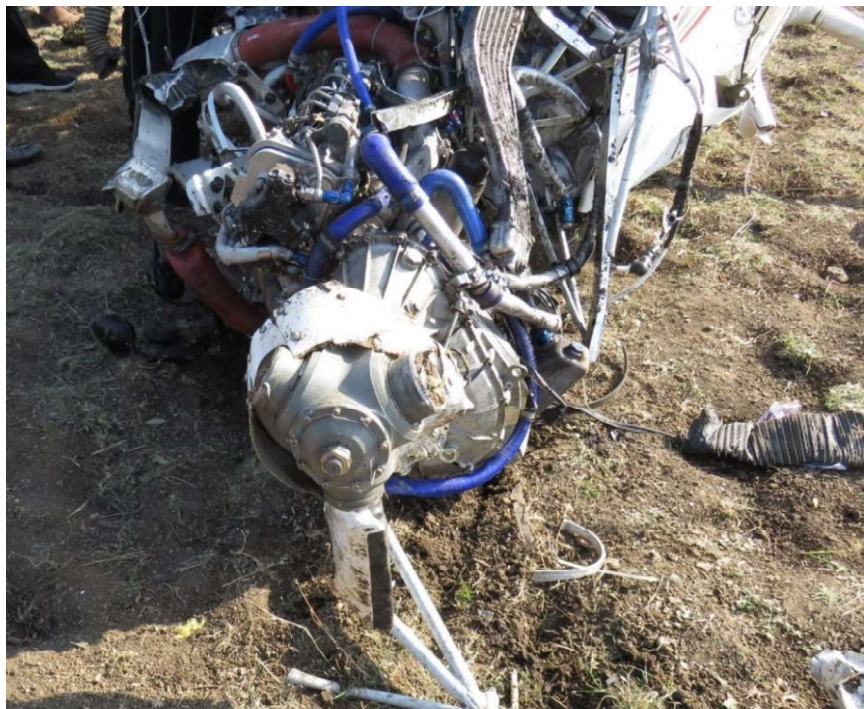
Figure 3 : Aircraft Engine

Propeller blades were found sheared off from the blade root ferrule. FRP Spinner was found ripped open and spinner forward bulkhead had got separated from hub. Spinner rear bulkhead was found deformed and attached to the hub.

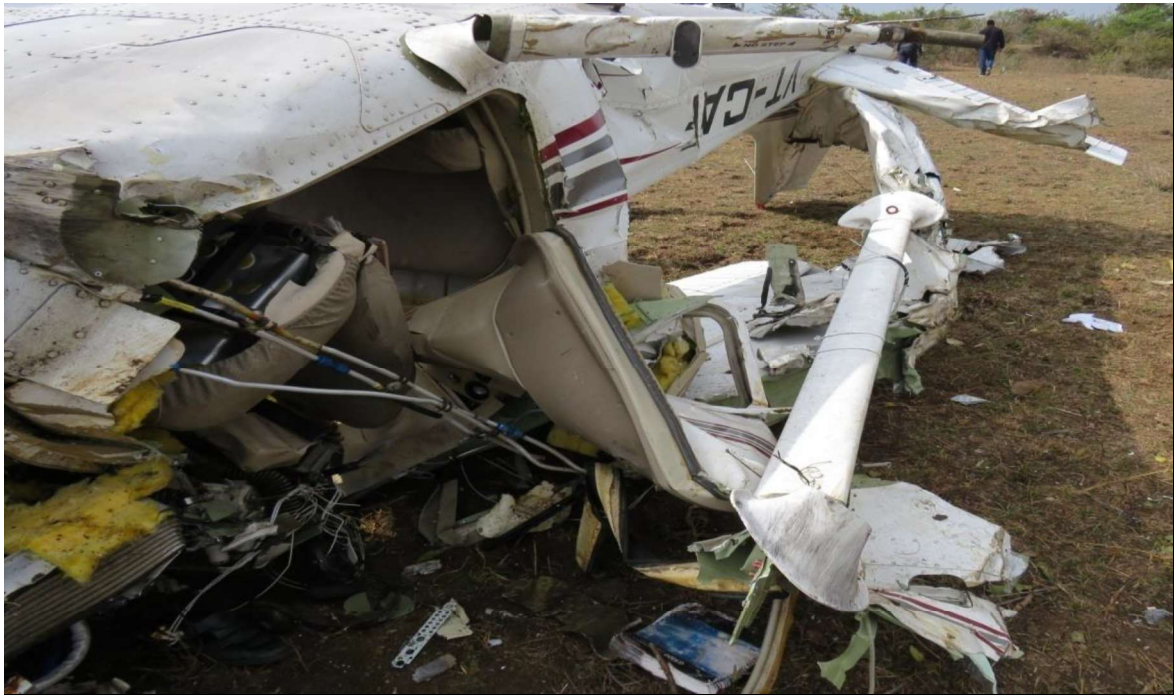
Figure 4: Fuselage RH side

Fuselage suffered major damage. The door was found stuck between RH wing and wing strut as the wing was folded backwards due to broken forward fuselage box beam. RH rear door was found sheared at middle. RH rear attachment point was found sheared from wing. RH strut Lower attach point was found ripped off from fuselage.

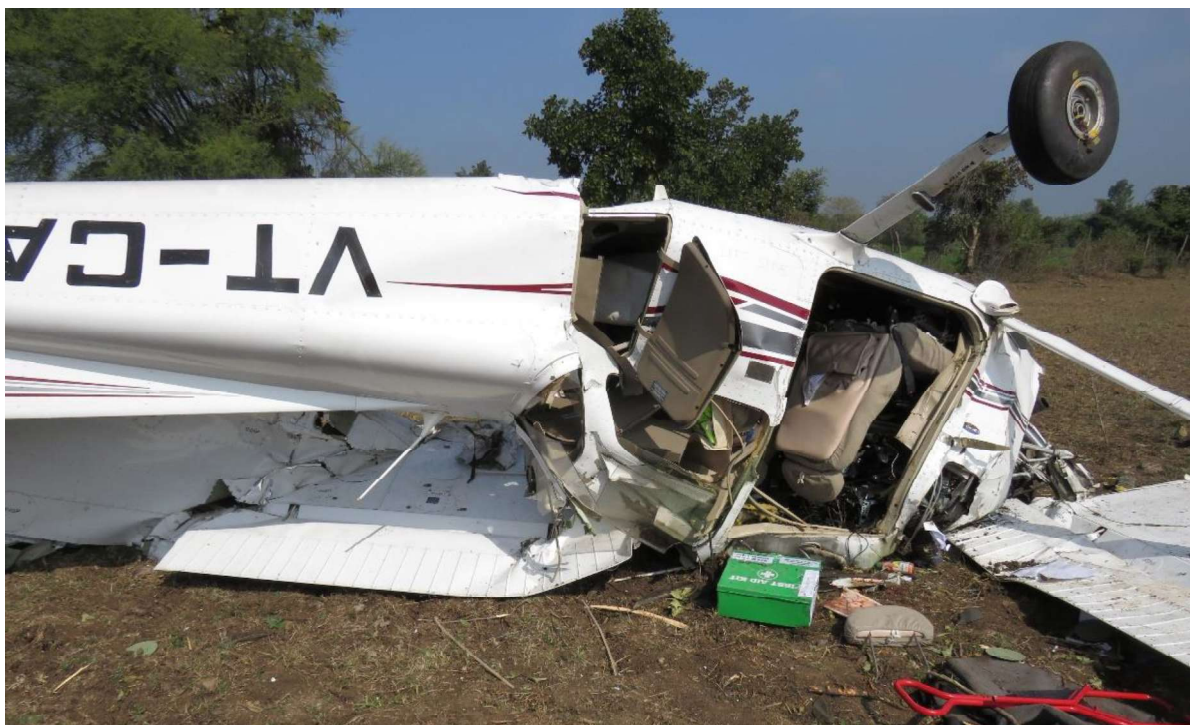
Figure 5 : Fuselage LH Side

RH and LH door windows were found detached. LH door was found fully thrown outside. Forward wind shield was found broken. LH & RH rear wind shield plexi was found totally broken due to deformation of baggage area. Rear windshield was also found totally broken into pieces.

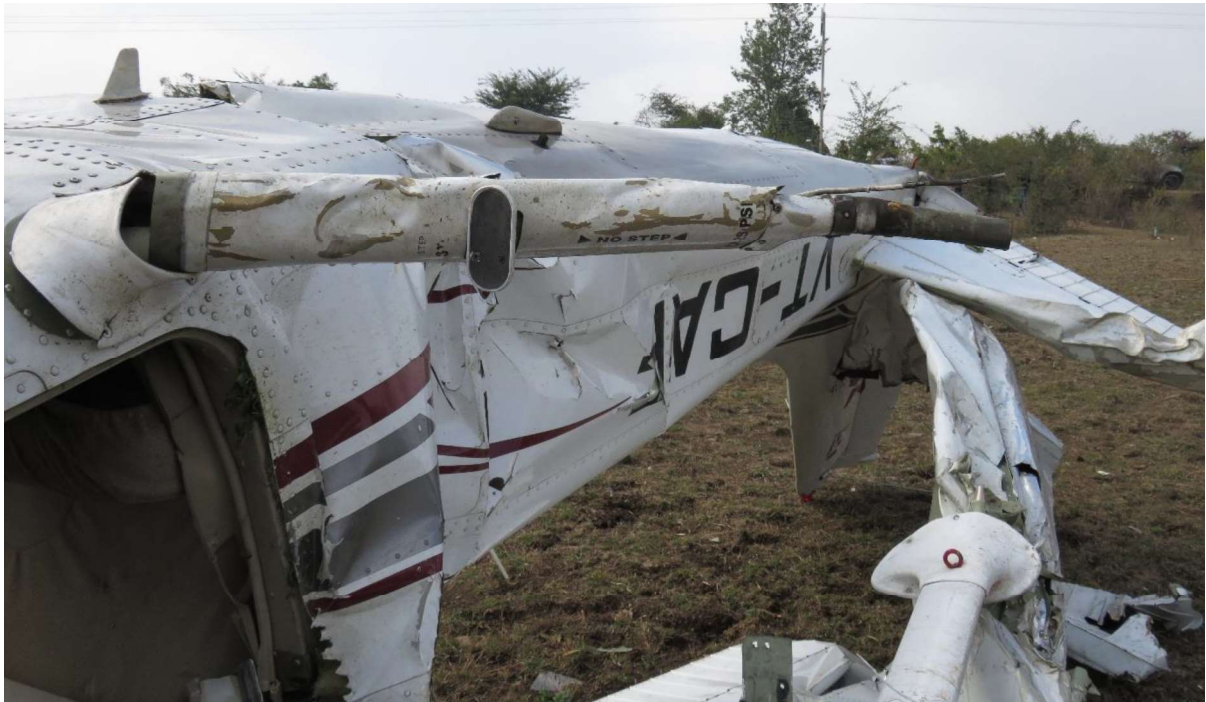
Figure 6 : Fuselage and Tailcone

Tail cone was found crushed near the attachment point to fuselage. Tail cone was also found buckled at several places. LH tail plane & elevator were found bent upwards from middle. RH tail plane leading edge got partially detached, and tip was found crushed. Fin fairing to dorsal fin was found cracked in the middle.

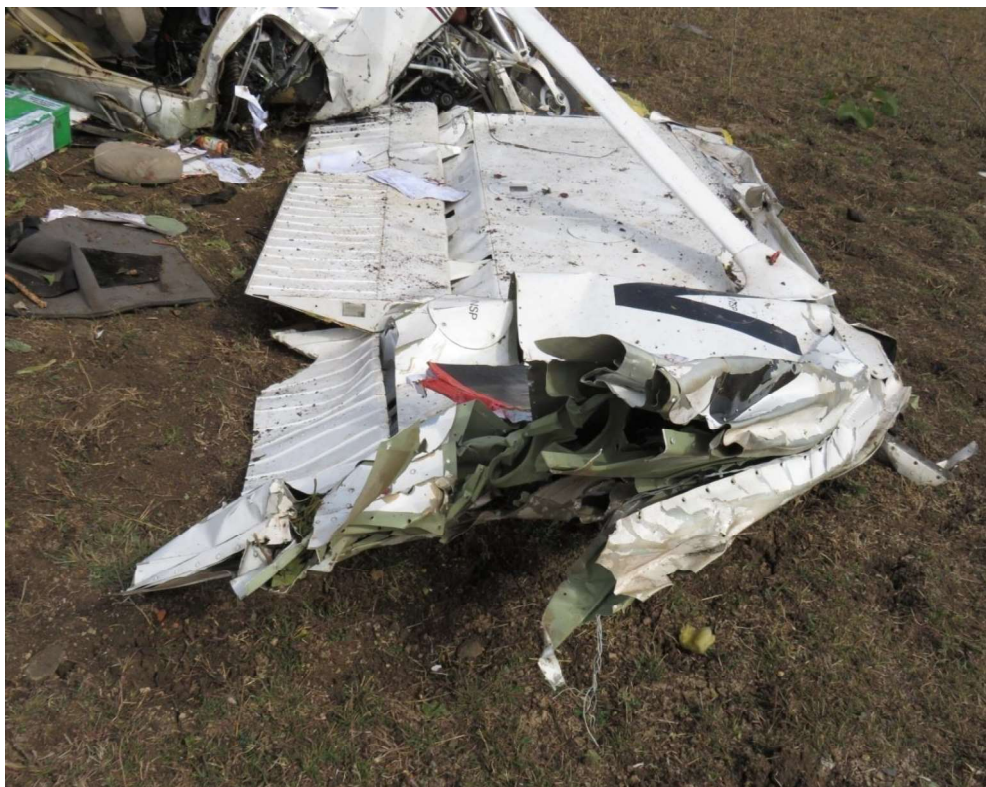
Figure 7: LH Wing

A portion of LH wing got sheared off due to impact with the tree. The leading edge was found caved inwards with maximum displacement up to 2.5 feet.

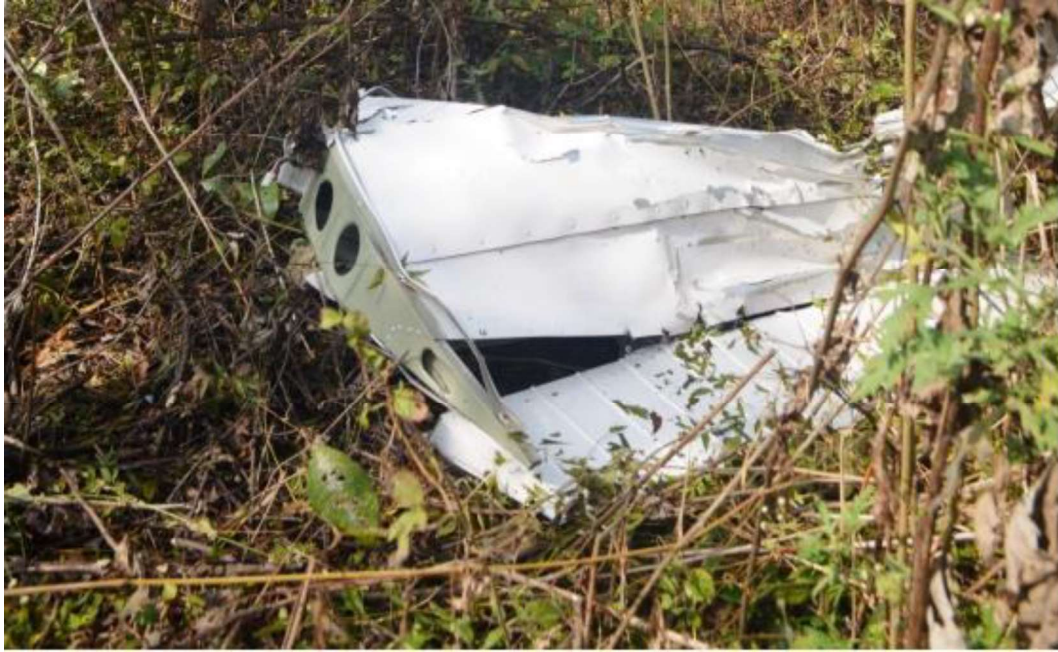
Figure 8 : LH Wing portion separated due impact with the trees

The flaps were found severely buckled. Inboard portion of LH aileron was found ripped and buckled. Outboard portion of aileron attached to the separated piece of wing was also found buckled. The separated portion of wing was retrieved from near the point of impact with the trees.

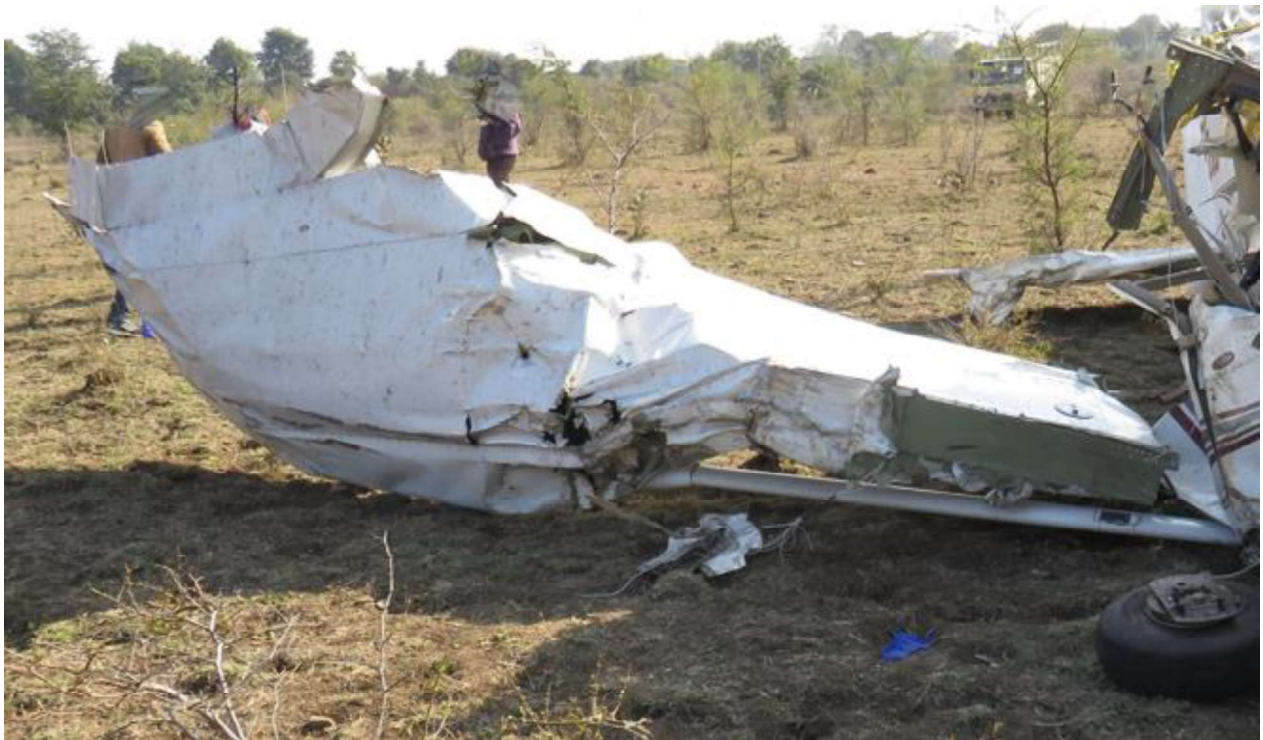
Figure 9 : RH Wing

RH wing was found folded backwards. The wing was bent and curved downwards with a vertical displacement of approximately 3 feet. RH wing tip fairing was found broken and separated from wing structure.

RH wing Leading edge skin was ripped off. The front spar was found bent towards rear and the leading edge had caved inward approximately 12 inches. The upper strut attachment point was found sheared off. RH Flap and aileron was found attached to wing with severe buckling and cracks.

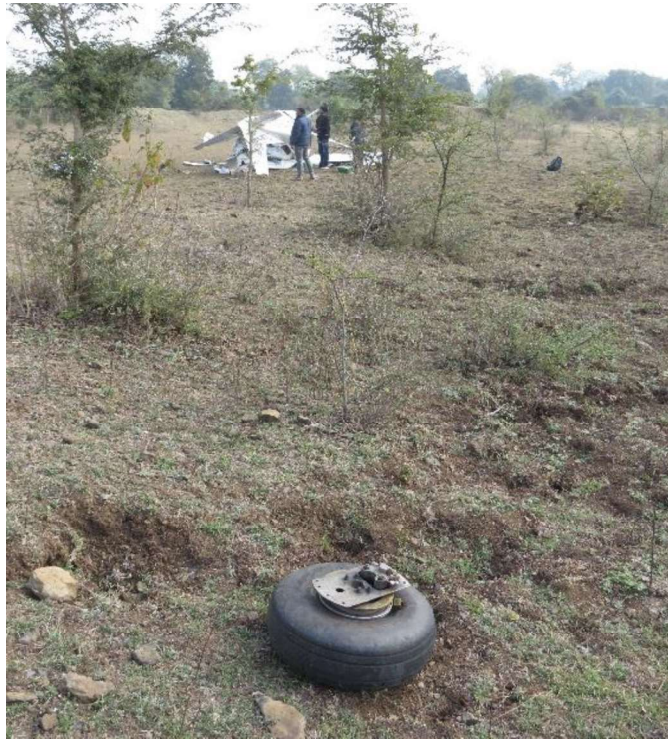
Figure 10 : Wheel Assembly

RH main gear bolt was found sheared. RH main gear wheel assembly along with axle was found separated from the gear spring and was lying about 90 feet away from the main wreckage.

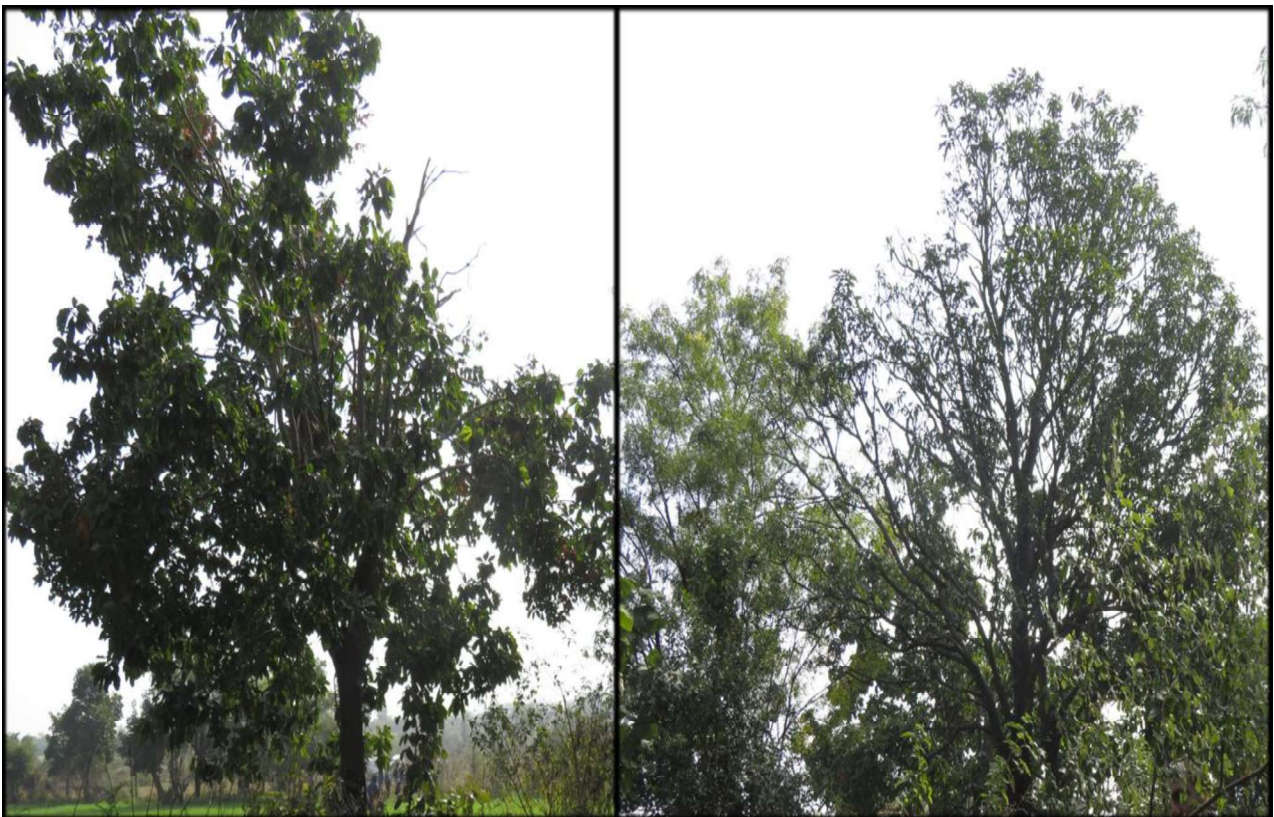
Figure 11: Closer view of trees hit by the aircraft

The aircraft impacted three trees and hit the ground before coming to rest.

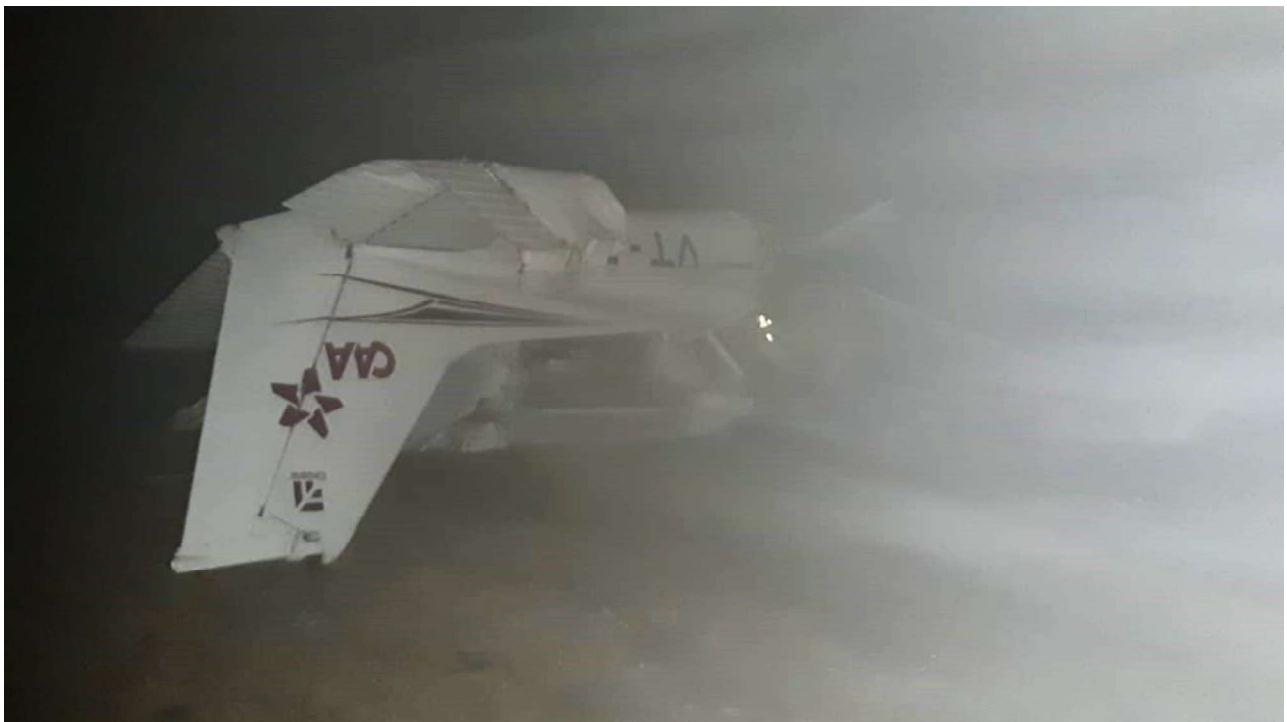
The witnesses had stated that very low visibility and dense fog was prevailing during the night around the time of accident. The presence of fog was also observed in the photographs of aircraft taken by a witness on the night of accident shown in the following figures.

Figure 13 : Photo of wreckage taken by a witness during the night after the crash

The outdoor air temperature logged by the weather stations at 1207 UTC (17:37 IST) was 12.1 C and was close to Dew point which was logged as 10.9 C. The weather conditions therefore were conducive of fog. The photographs of aircraft wreckage immediately after the crash provided by a witness also confirms presence of significantly dense fog.

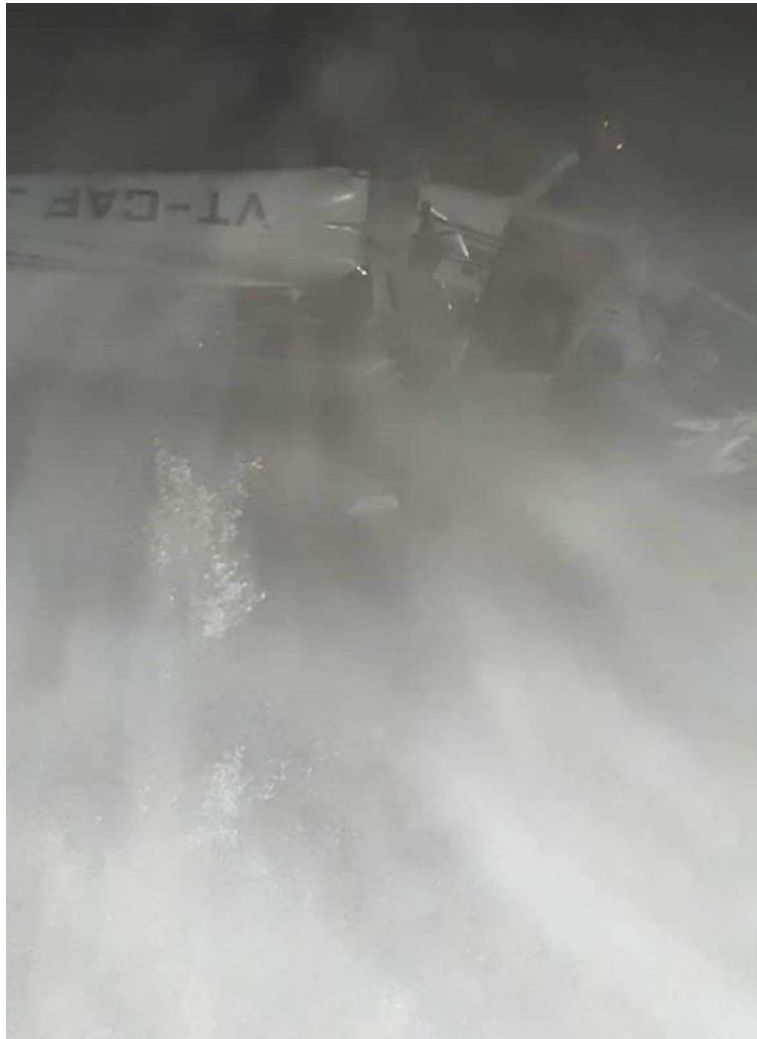
Figure 14 : Photo of wreckage taken by a witness during the night after the crash

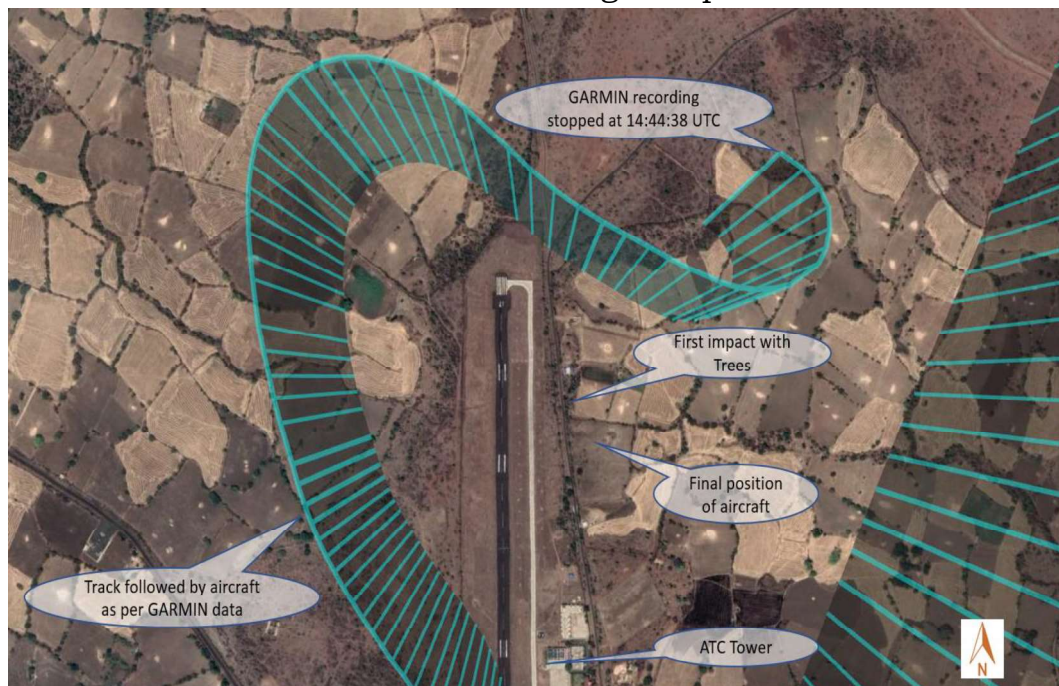
Figure 17 : Final Phase of Flight Path taken by VT-CAF

At the point when Garmin 1000 recording stopped, the aircraft speed was 84.96 kt speed and aircraft was at approximately 86.6 ft altitude in air. Vertical speed (downward) of the aircraft was 1972 ft/min with negative pitch of 10.32 degree and at that time aircraft was tilted toward left with roll value of - 33.56 degree. Negative Roll value indicates left turn and negative pitch indicates nose down.

Data recorded on Garmin 1000 system showed that vertical speed oscillated excessively in the last 10 min of flight. The data also showed excessive oscillation of indicated air speed, altitude and pitch with Air speed reaching stall speed more than

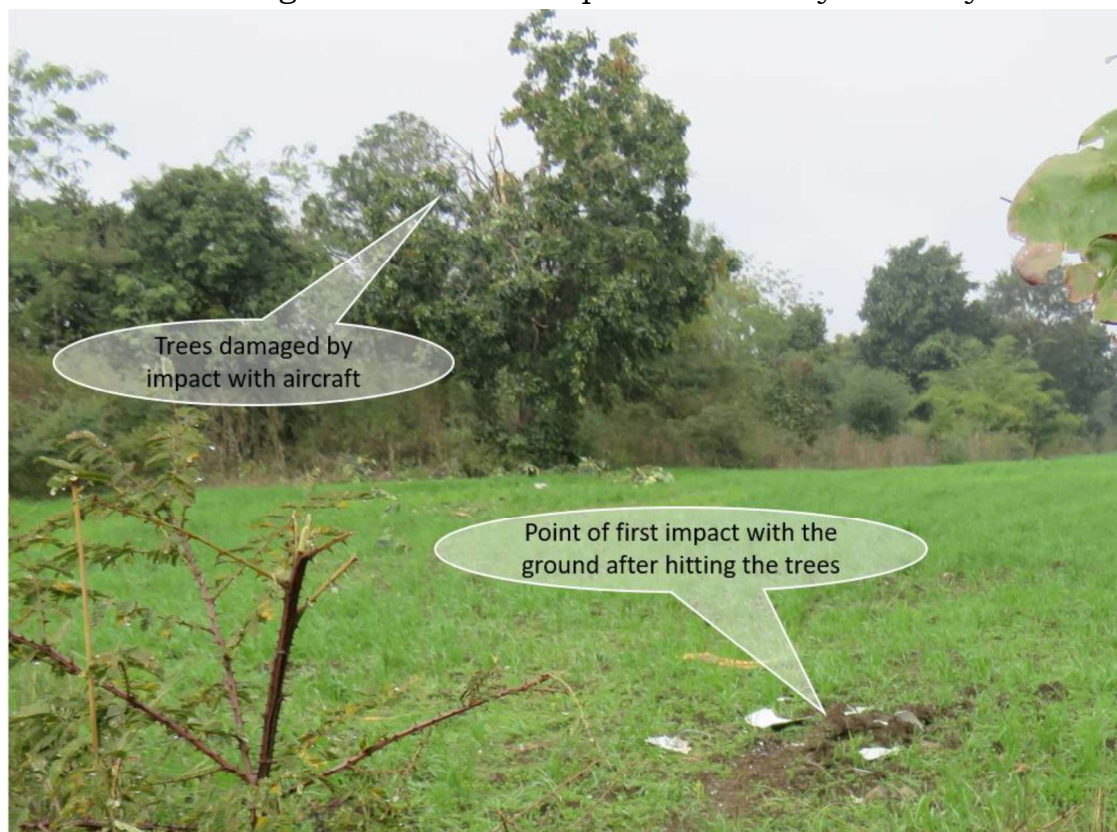
Figure 18 : Flight Path taken by VT-CAF

The aircraft impacted a group of trees at a height of about 30 feet on the east side of airfield before impacting the ground. A portion of LH wing sheared and fell near the trees indicating that the initial impact was mainly borne by the LH wing.

As the aircraft dropped, its RH wing and RH wheel made their first contact with the ground at about 100 feet ahead of the trees. The resulting impact caused the RH wheel to break away and damaged the RH wing causing it to bend.

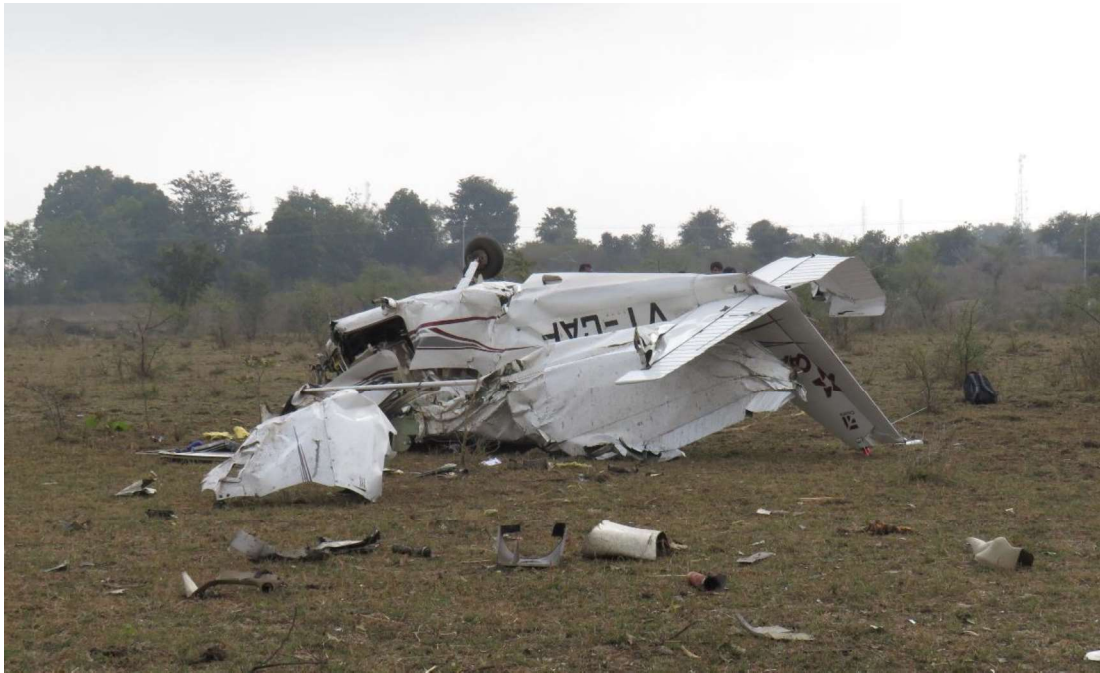
Figure 19 : Final resting position of the aircraft

The aircraft bounced further and its nose hit the ground a little further. The forward momentum caused the aircraft to topple and travel further before coming to rest at about 223 feet from the group of trees that bore the first impact.

The wreckage was primarily confined to the path, from the point of first impact with the trees to the final resting position. There were no indications of any pre-impact disintegration.
