FINAL INVESTIGATION REPORT ON SERIOUS **INCIDENT TO SPICEJET DHC-8-402 AIRCRAFT** **VT-SQC** **AT BELAGAVI AIRPORT (VOBM) ON 24.10.2021**

FINAL INVESTIGATION REPORT ON SERIOUS INCIDENT TO SPICEJET
DHC-8-402 AIRCRAFT VT-SQC
AT BELAGAVI AIRPORT (VOBM) ON 24.10.2021

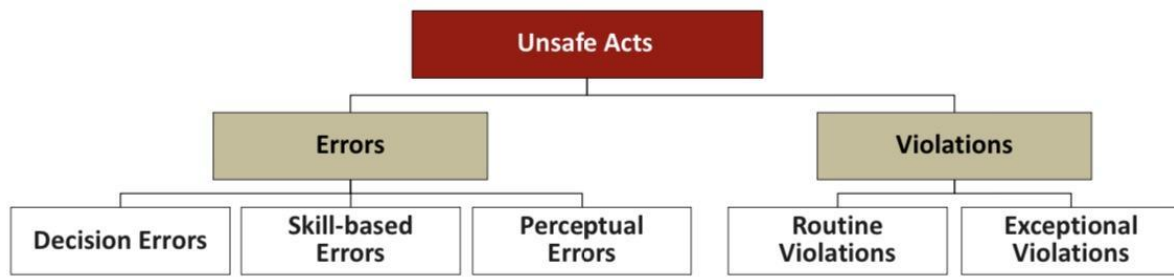
2.6.1 UNSAFE ACTS (ACTIVE FAILURES) :

ERRORS			
	PIC	CO-PILOT	ATCO
DECISION ERROR	NIL	NIL	NIL
SKILL-BASED ERROR	NIL	NIL	NIL
PERCEPTUAL ERROR	Distractions leading to not hearing that the runway had been changed	Distractions leading to not hearing that the runway had been changed	NIL

VIOLATIONS			
	PIC	CO-PILOT	ATCO
ROUTINE VIOLATIONS	NIL	NIL	NIL
EXCEPTIONAL VIOLATIONS	Landing on runway 08 instead of 26	Landing on runway 08 instead of 26	<ul style="list-style-type: none"> Non-Adherence to SOP: Change of Runway not notified to flight-crew Allowing aircraft to land on unassigned runway despite being aware.

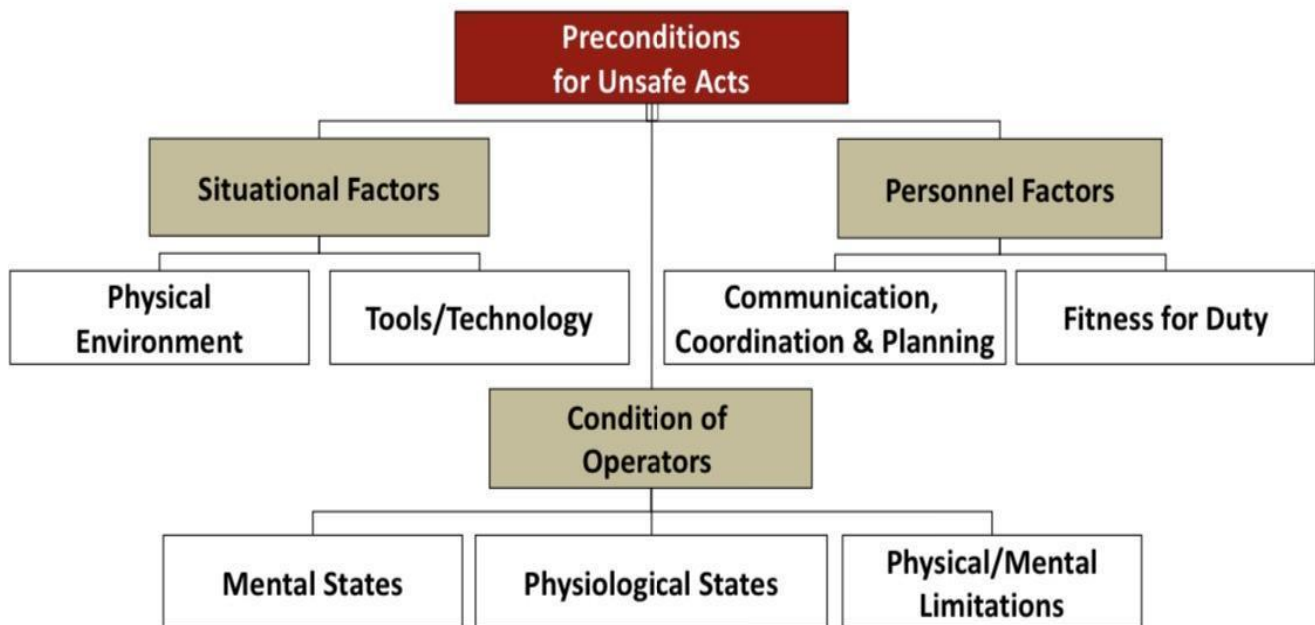
2.6.2 PRECONDITIONS FOR UNSAFE ACTS (LATENT FAILURES) :

SITUATIONAL FACTORS			
	PIC	CO-PILOT	ATCO
PHYSICAL ENVIRONMENT	NIL	NIL	NIL
TOOLS/ TECHNOLOGY	Did not use the on-board automation (FMS) to enhance their Situational Awareness	Did not use the on-board automation (FMS) to enhance their Situational Awareness	NIL

PERSONNEL FACTORS			
	PIC	CO-PILOT	ATCO
COMMUNICATION, COORDINATION AND PLANNING	Non-essential conversation during descent and initial approach phase of the flight.	<ul style="list-style-type: none"> Non-Assertive behaviour. Non-essential conversation during descent and initial approach phase of the flight. No FMS cross-check. 	<ul style="list-style-type: none"> ATCO1 did not inform the flight crew regarding change of runway. ATCO 2 did not notify aircraft to go around.
FITNESS FOR DUTY	Fit for Duty	Fit for Duty	Fit for Duty

CONDITION OF THE OPERATOR			
	PIC	CO-PILOT	ATCO
MENTAL STATES	Distracted due to organisation issues related to restructuring of working conditions due to COVID-19.	Distracted due to organisation issues related to restructuring of working conditions due to COVID-19.	NIL
PHYSIOLOGICAL STATES	Nil	Nil	Nil
PHYSICAL / MENTAL LIMITATIONS	Nil	Nil	Nil

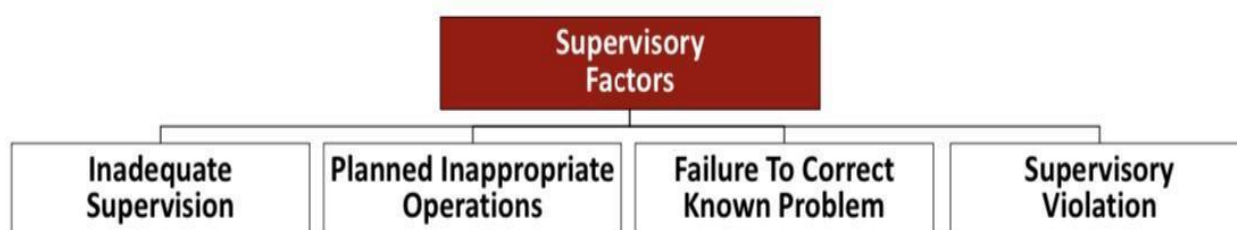
2.6.3 SUPERVISORY FACTORS (LATENT FAILURES):

INADEQUATE SUPERVISION	Inadequate awareness raised by the training dept of Spicejet wrt to the previous case of "Wrong runway landing".
PLANNED INAPPROPRIATE OPERATIONS	NIL
FAILURE TO CORRECT KNOWN PROBLEM	SOP of Spicejet not requiring runway to be positively identified before landing as per Air Safety Circular of DGCA.
SUPERVISORY VIOLATION	Inadequate deliberation by Spicejet to address the causal factors of wrong runway landings.

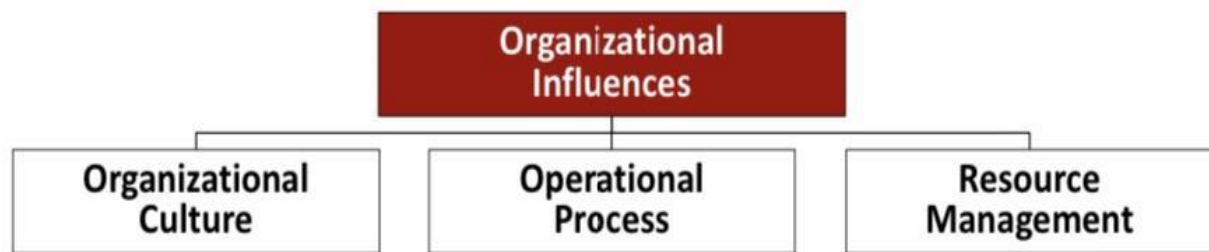
2.6.4 ORGANIZATIONAL INFLUENCES:

Spicejet	Airports Authority of India	REGULATOR
ORGANIZATION AL CULTURE	Weak Safety Culture	Reporting Culture	NIL
OPERATIONAL PROCESS	Not process driven	Hierarchy driven processes	NIL
RESOURCE MANAGEMENT	Limited in the current scenario	No limitations	No Limitations
