# Final Investigation Report on Serious Incident to M/s SpiceJet Ltd. Aircraft VT-SYZ (Boeing 737-800) in PATNA Airspace on 17 November 2021

**Gp Capt Rajendra Pratap Singh VSM (Retd.)**  
**Investigator-in-Charge**

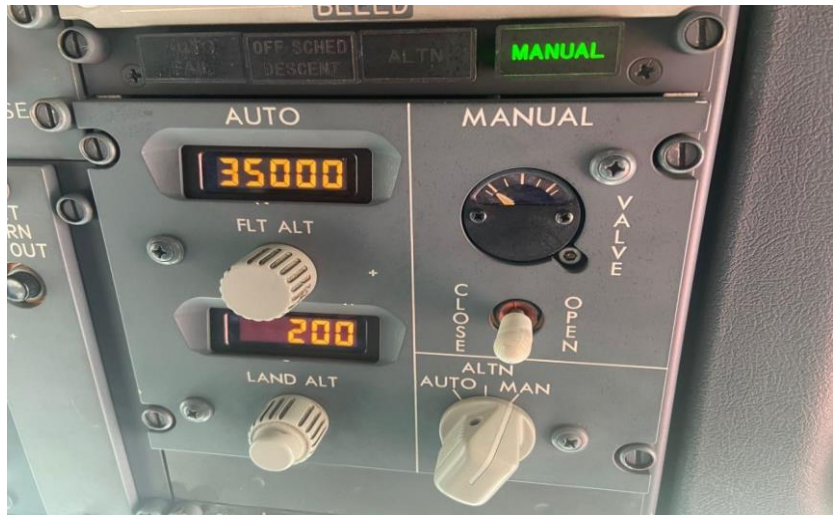
**Fig 2: Selection of manual mode**

Post landing it was found that the outflow valve selector switch was in manual position and the out flow valve was in fully open position.

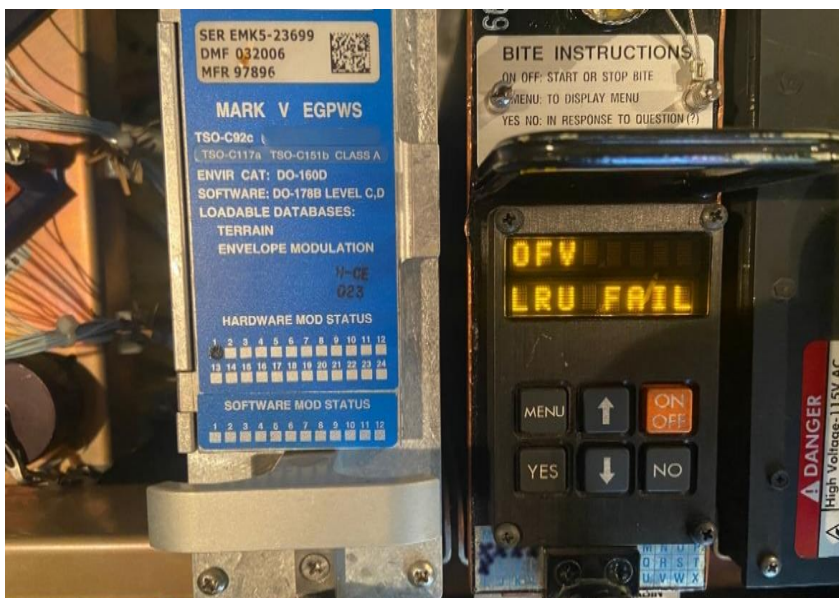
**Fig 3: LRU Fail Message before replacement of OFV**

As OFV LRU FAIL MSG was stored in CPC, respective FIM task 21-31, task-801 was referred and as per the FIM, the possible cause for the fault code was Cabin Pressure Outflow Valve V48. Hence, the outflow valve was replaced and post installation checks, the system was found working satisfactory.

As per tear down report of the component (**Refer Appendix 01**) received from Nord-Micro Frankfurt, Germany, “the performed potentiometer tests indicate that the removed outflow valve P/N 21230-03AC S/N 07101936 failed in Poti synchronism test (open 4,40V / 115°) on 09 Mar 2022. As per the report, the outflow valve had to undergo major repairs and the defects are as follows: -

- a. The Gear box functional incoming test failed, so gear box defective bearings were replaced.
- b. Anti-skating foils were damaged/ missing which were replaced
- c. Teflon seals were bent and hence replaced
- d. Rod ends were found sluggish/ stuck and hence replaced
- e. Aumot 1 brake function was defective which was renewed
- f. Worn-out bonding cables were replaced
- g. Potentiometer was replaced as it was out of tolerance

As per OEM of the OFV the described damages are normal wear and tear for OFV with +15 year of service. Mechanical wear out of OFV is considered as likely cause of malfunction in auto mode; however, manual operation of the OFV was possible.

B1 & B2 AME were detailed by SpiceJet for snag rectification of pressurization system. Replacement of OFV of pressurization system was under taken based on the fault message shown during CPC BITE check. The complete BITE check as per FIM 21-31 task 801 was not undertaken by AME before replacement of OFV.

After change of OFV the CPC BITE test was carried out and the ground test passed. Further, pressurization system manual mode test & cabin pressure control system ground aircraft was carried-out and the same were found satisfactory.

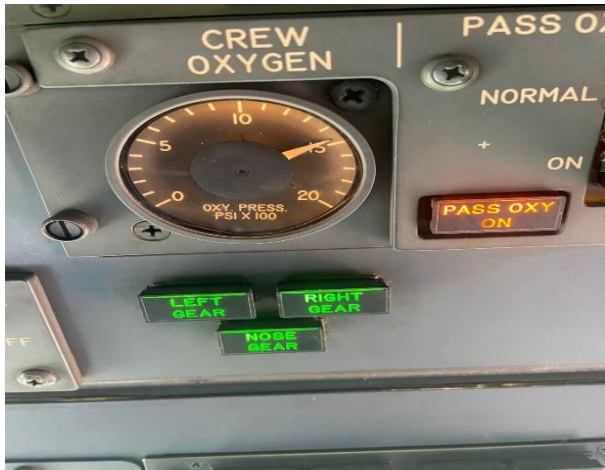
**Fig 5: Crew oxygen pressure level after occurrence**

The crew oxygen bottle pressure was checked and found that the cockpit crew oxygen pressure was sufficient (approx. 1500 PSI).

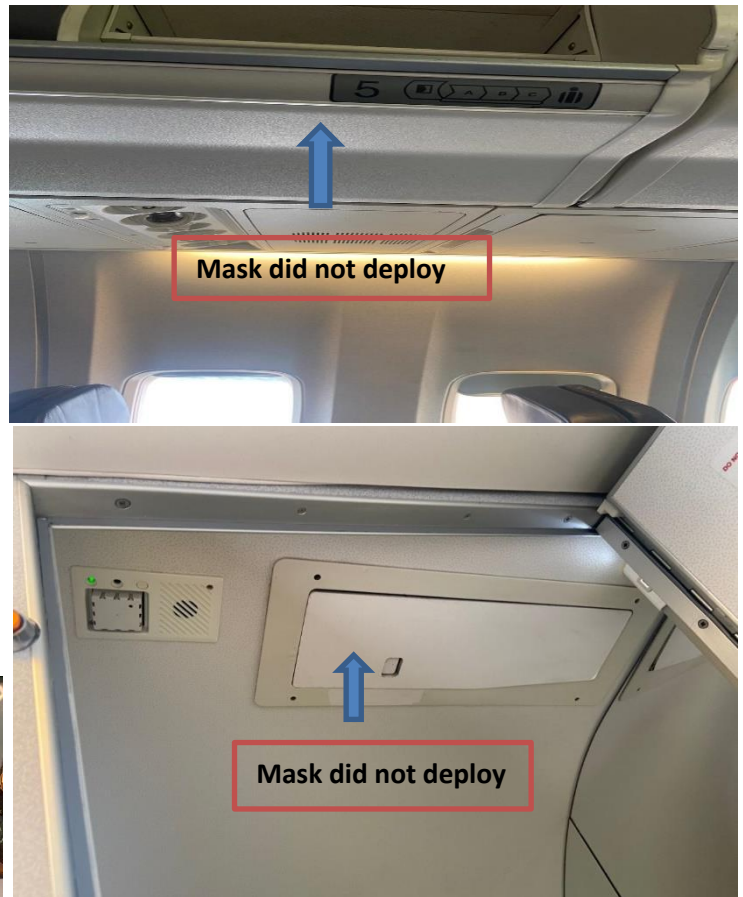
**Fig 4: Seat no. 5 mask did not deploy (above); LAV A mask did not deploy (below)**

Cabin galley and LAVS were checked and found that all PSU panels were in dropped condition. However, during LAV A inspection it was observed that latch door was getting stuck during deployment.

Chemical oxygen generators were checked and found that all chemical oxygen generators fired except for seat 5A, 5B & 5C.

Seat 5A, 5B & 5C oxygen mask did not deploy as the door latching spring was found faulty.

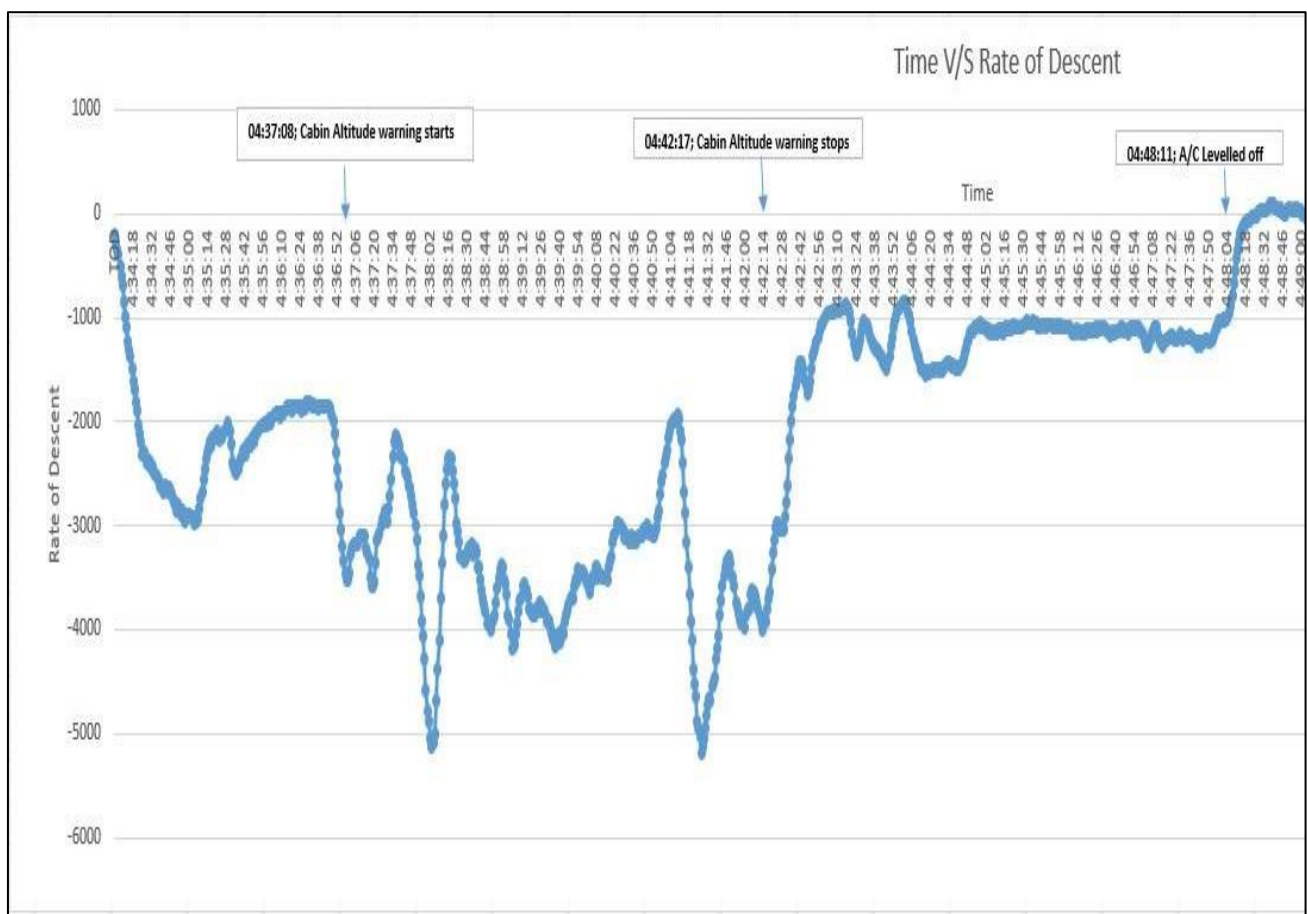
Fig 6: Graph Time v/s Rate of Descent

The aircraft rate of descent from top of the climb (35004 ft at 04:34:01UTC) to the point of annunciation of Master Caution and Auto Fail light on (34292 ft at 04:34:32UTC) was approx. 1378 Ft/min.

1. **High rate of descent initiated by the PIC beyond the controlling capability of the system –**  
The aircraft rate of descent from top of the climb (35004 ft at 04:34:01UTC) to the point of annunciation of master caution and auto fail light on (34292 ft at 04:34:32UTC) was approx. 1378 ft/min. This data alone is inadequate to conclude that initiation of warning was due to high rate of descent (Refer Fig 6: Time v/s Rate of descent graph)

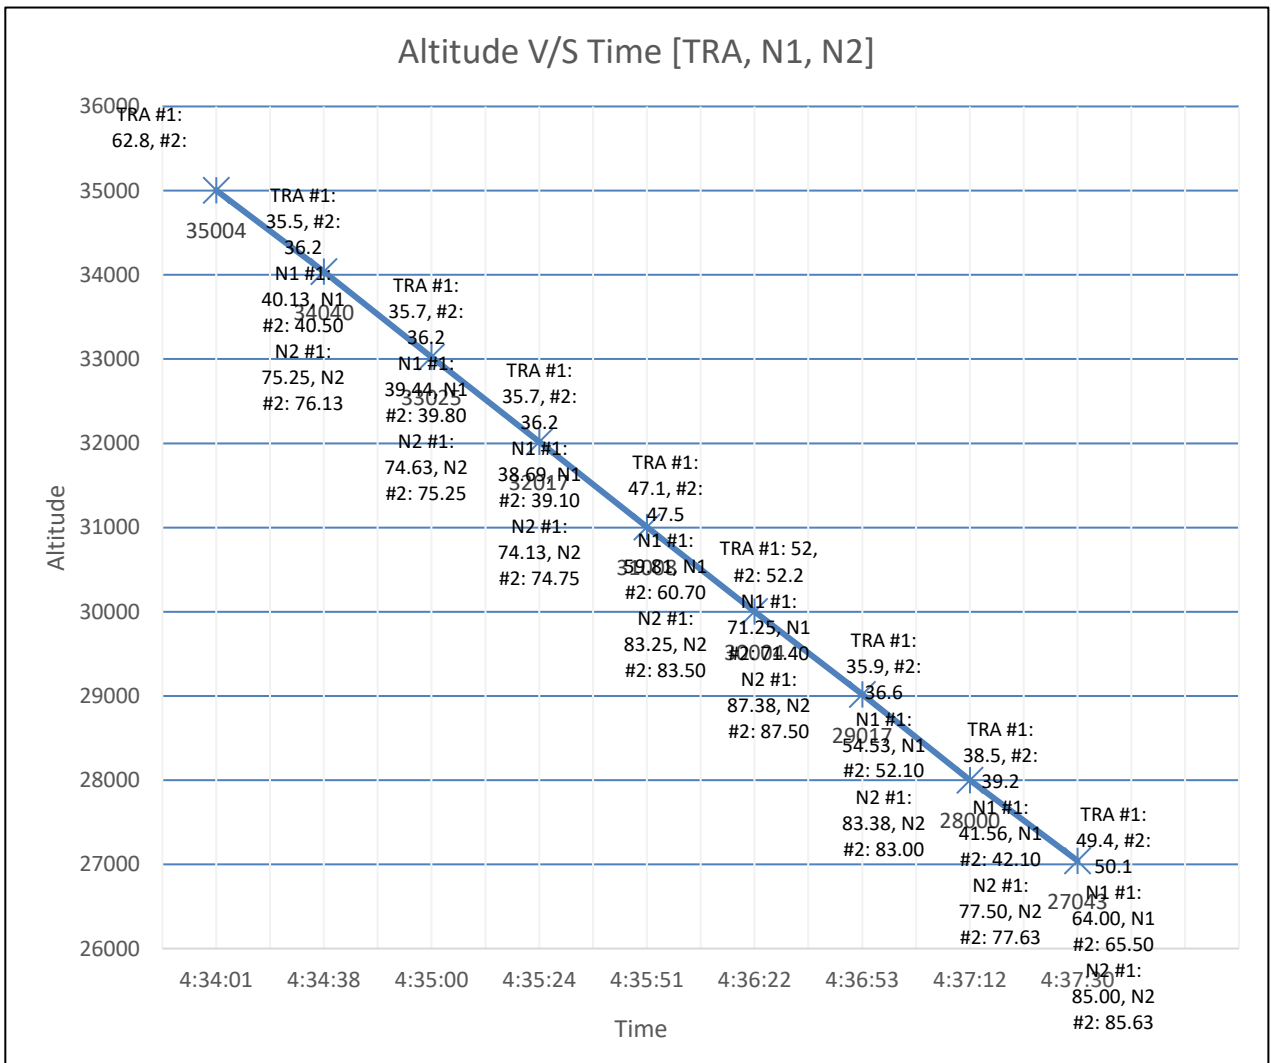
**Fig 6: Aircraft parameter Altitude V/S Time [TRA, N1, N2]**

The throttle position and engine RPM indicate that the air was being delivered to the pressurization system.

2. **Power Loss –** The DFDR read out does not indicate power loss as the reason for failure of auto control system of pressurization. (Refer Fig 8)
3. **Cabin altitude rate of change is too high –** The cabin rate of change could be a reason for failure of auto system if air outflows (through the fuselage, systems, doors/seals, and outflow valve) exceeds cabin air pressurization system requirements resulting in high rate of change of cabin altitude. There was no evidence that cabin altitude rate of climb was too high or evidence of any significant air outflows through the fuselage, systems, doors/seals, etc.
