**FINAL INVESTIGATION REPORT
ON
SERIOUS INCIDENT INVOLVING
M/s SPICE JET'S B737-800 AIRCRAFT VT-SZN
AT SEYCHELLES ON 14 SEPTEMBER 2021**

**GOVERNMENT OF INDIA
MINISTRY OF CIVIL AVIATION
AIRCRAFT ACCIDENT INVESTIGATION BUREAU**

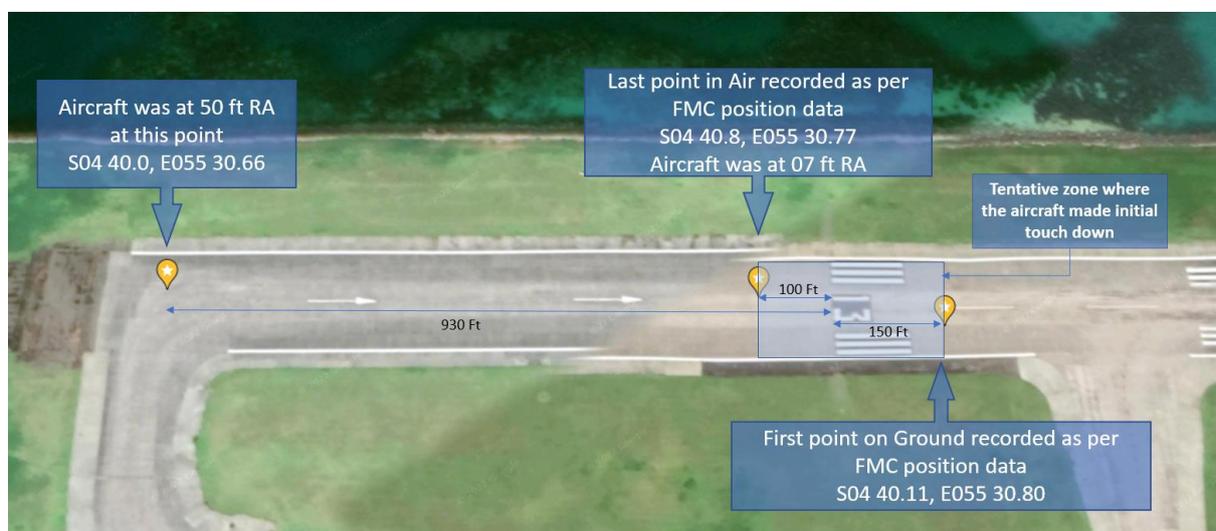
Figure 1: Tentative area of initial touchdown based on FMC Position Data

The last "In-Air" position recorded as Flight Management Computer (FMC) position data was "S04 40.8, E055 30.77". The first "On-Ground" position recorded as per FMC position data

was “S04 40.11, E055 30.80” at about 09:01:59 UTC. The last “In-Air” point “S04 40.08, E055 30.77” is about 100 feet before threshold, but initial touchdown position was erroneously estimated to be 180 feet before the threshold by the Airlines and reported to DGCA and AAIB.

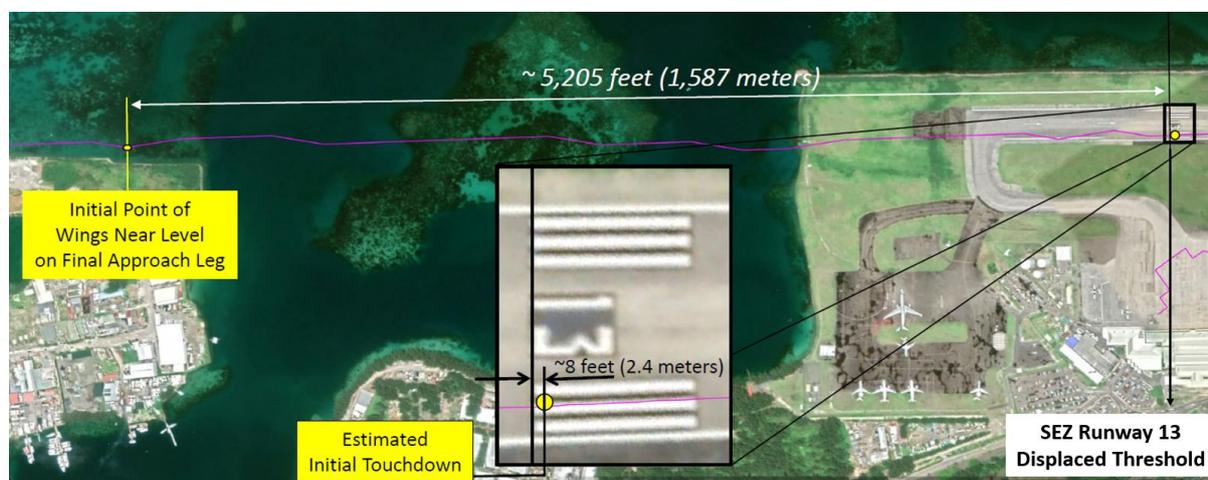
Figure 3: Initial Touchdown estimated by OEM to be 08 ft beyond Threshold

The initial touchdown point was estimated to be approximately 8 feet (2.4 meters) beyond the Runway 13 displaced threshold by the OEM based on the recorded FMC latitude and longitude parameters.

The touchdown point was estimated by OEM through interpolation and the figure is influenced by the following factors:

1. Position accuracy
2. Uncertainty in Airplane distance travelled between recorded position and touchdown determination

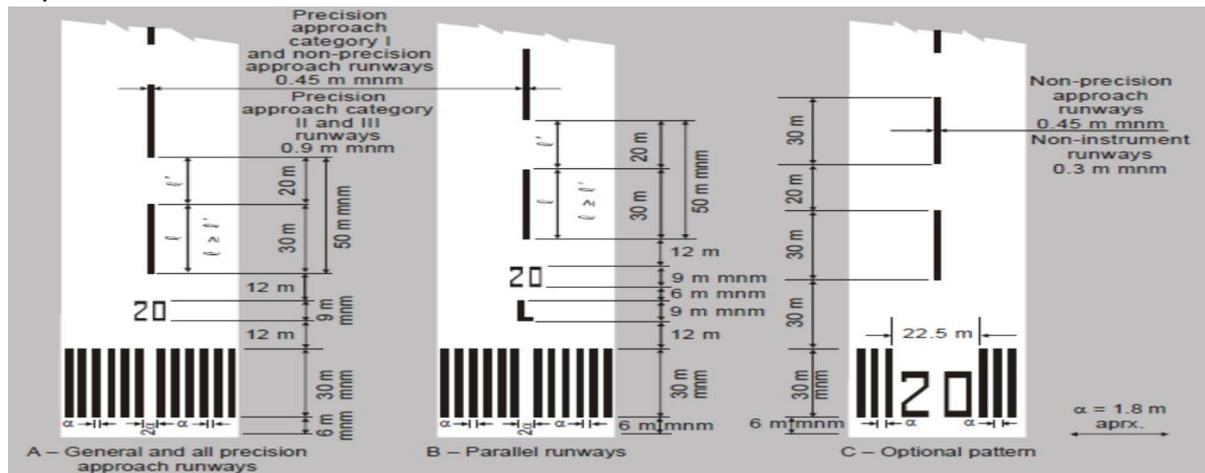
Figure 4: Threshold markings as per standard defined in Chapter 5 of ICAO Annex 14

Seychelles airport follows pattern C shown in the above image whereas most of the airport in India where Spice Jet operates follow pattern A and B shown in the above image.

The threshold markings at Seychelles were as per the Optional Pattern defined in Chapter 5 of ICAO Annex 14 which is not common at Indian Airports where Spice Jet regularly operates. The markings also did not have transverse stripe recommended in Annex 14. In challenging visual conditions, this marking can be mistaken to be aiming point by the crew not familiar with the marking.

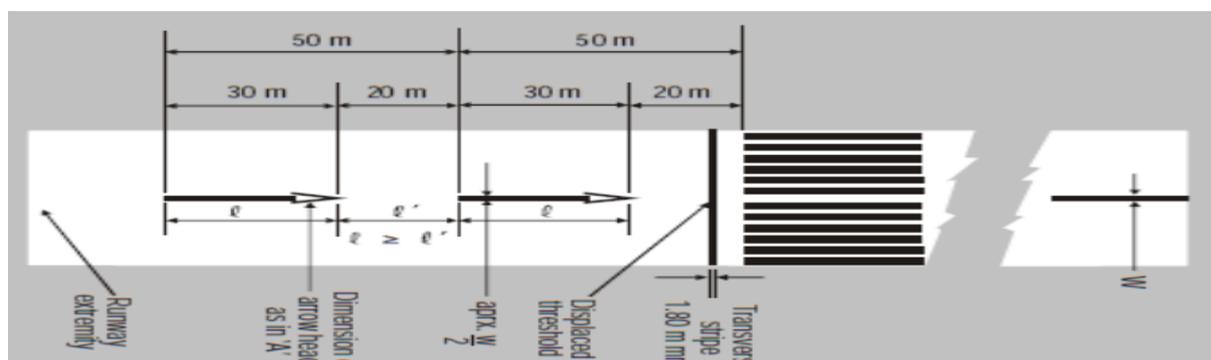
Figure 5: Transverse Stripe

Further, as per recommendations contained at Para 5.2.4.7 of ICAO Annex 14, where a threshold is displaced from the extremity of a runway or where the extremity of a runway is not square with the runway centre line, a transverse stripe as shown in the Figure 5 should be added to the threshold marking.

The threshold markings at Seychelles did not have the recommended Transverse Stripe marking, but was otherwise compliant with standards of ICAO Annex 14.

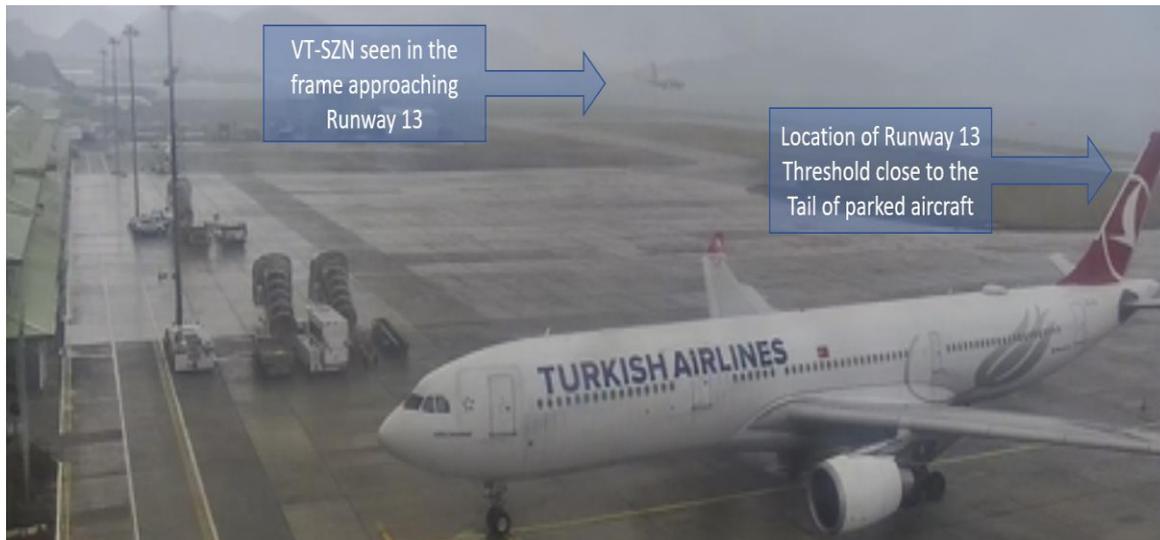
Figure 7: Frame from CCTV footage showing VT-SZN approaching runway 13

CCTV camera footage of landing was made available by the Seychelles Authorities. The screenshots from the CCTV footage are shown in the figures below. The threshold is close to the tail of aircraft parked in the apron.

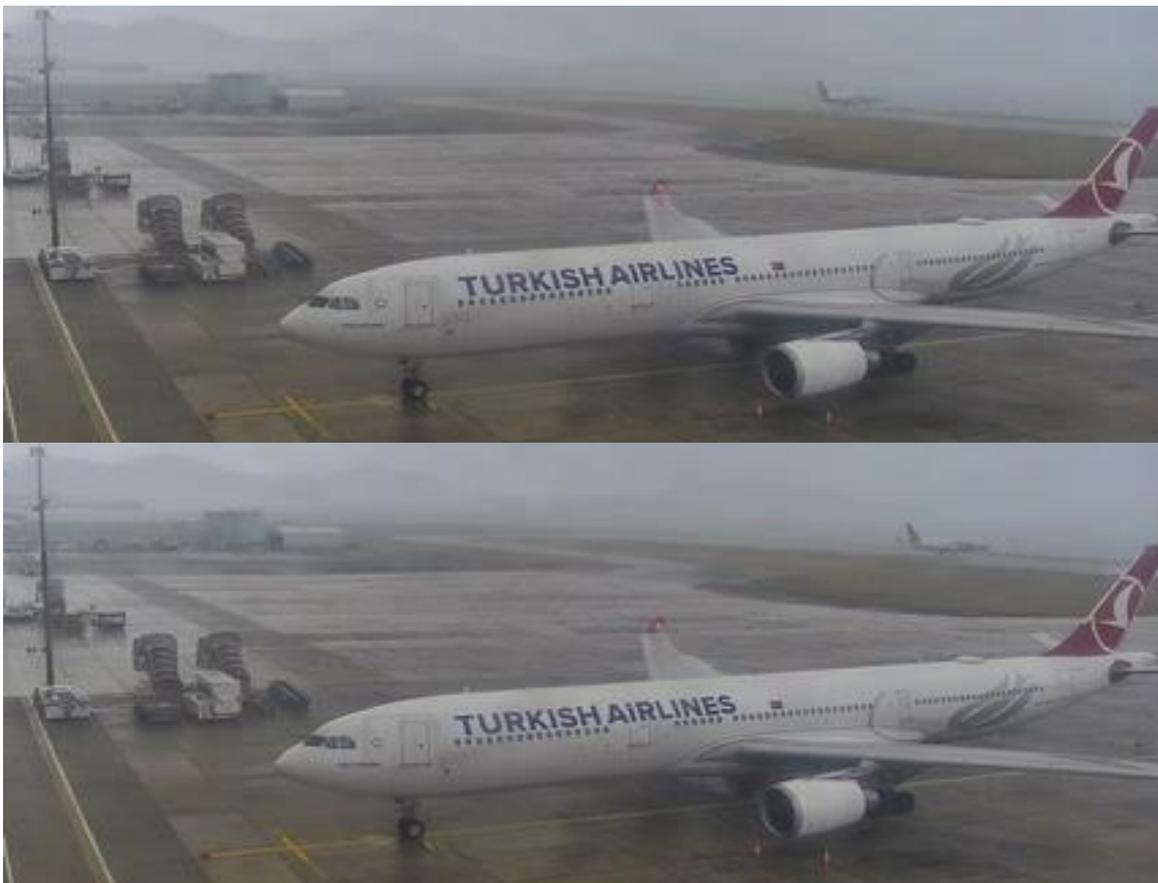
Figure 8: Frames from CCTV footage showing aircraft flare close to runway surface

The Figure 8 below shows the frames from CCTV footage while the aircraft flared very close to the runway surface.

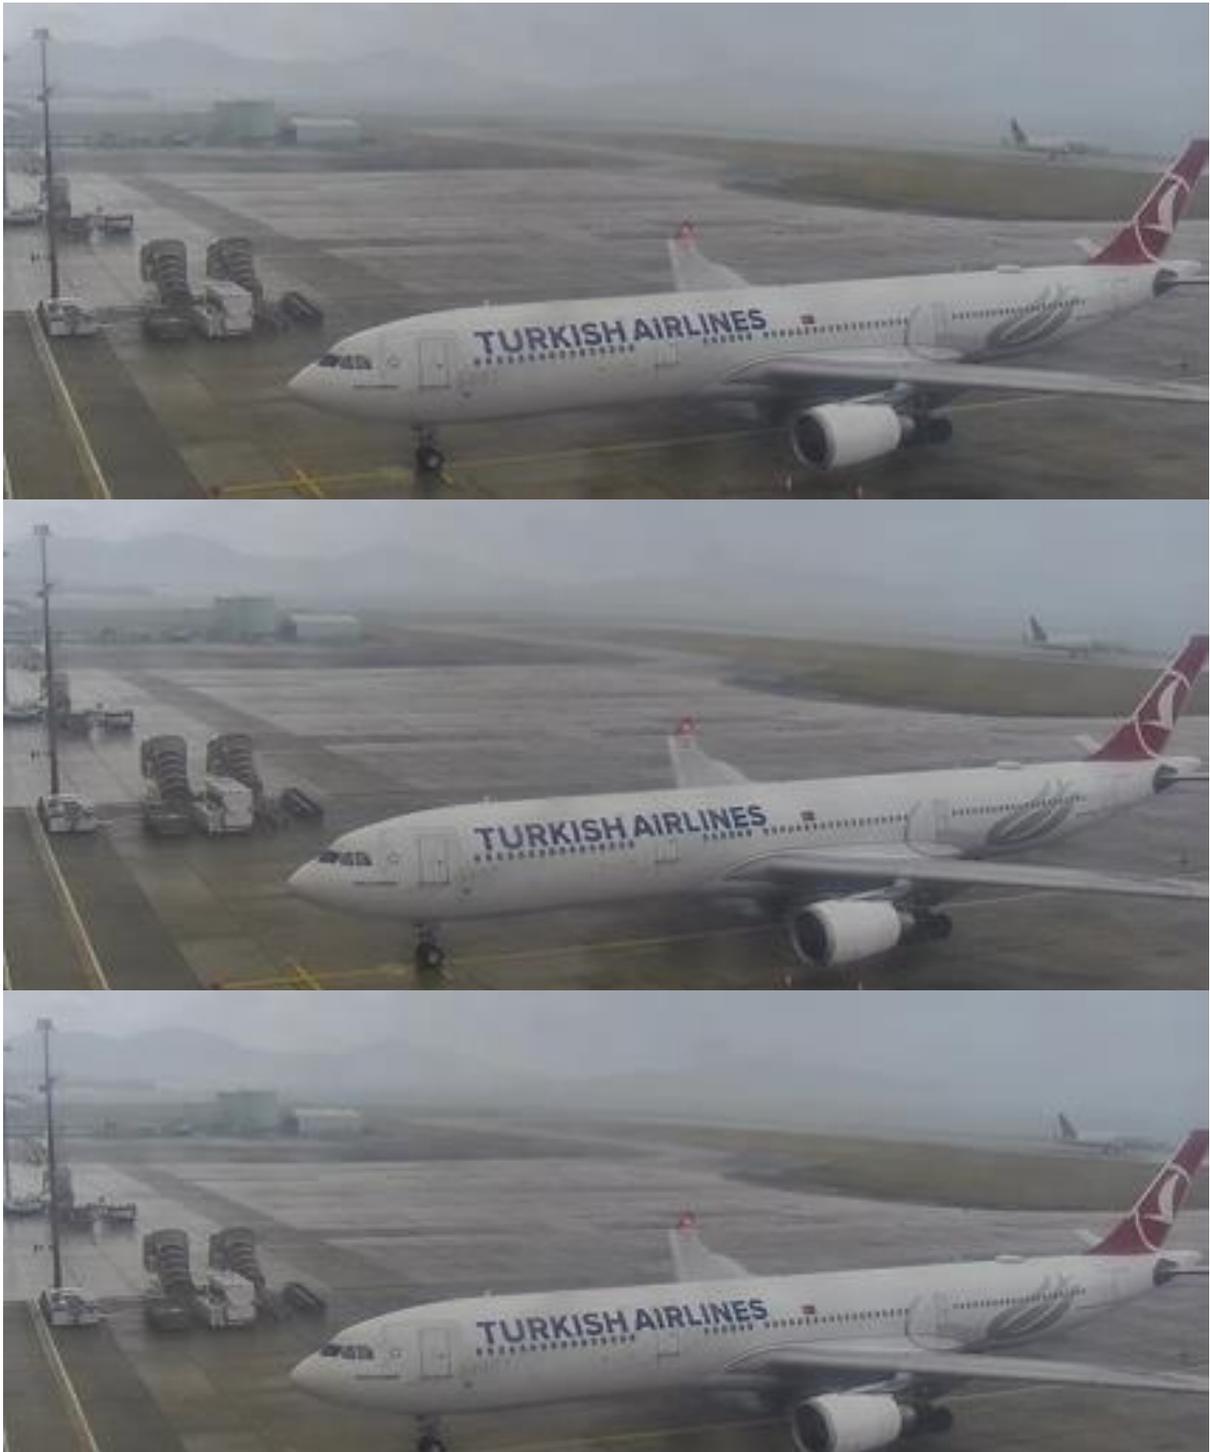
Figure 9: Frames from CCTV footage showing aircraft having touched down.

The images in Figure 9 shows aircraft having touched down. The images are not very clear but it is apparent that the aircraft wheels have touched down very close to the threshold, short of threshold. Due to the time lag between wheels touching the runway surface and generation of weight on wheels signal, the first on-ground position was recorded in DFDR when the aircraft was about 150 feet ahead of threshold.

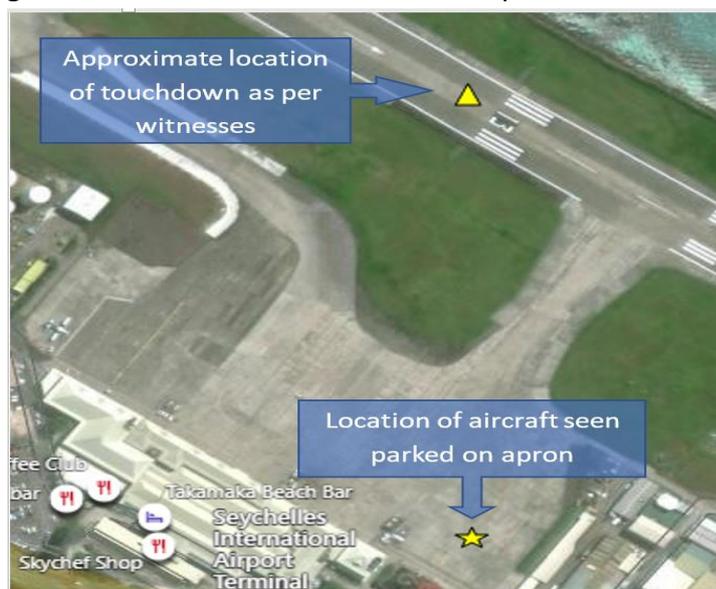
Figure 10: Likely touchdown point as informed by Airport personnel

As per the Airside Control & Management Center personnel at Seychelles Airport, the aircraft touched down at location marked by a yellow triangle in the figure below. The yellow star in the image shows the location of aircraft seen parked in the CCTV footage.

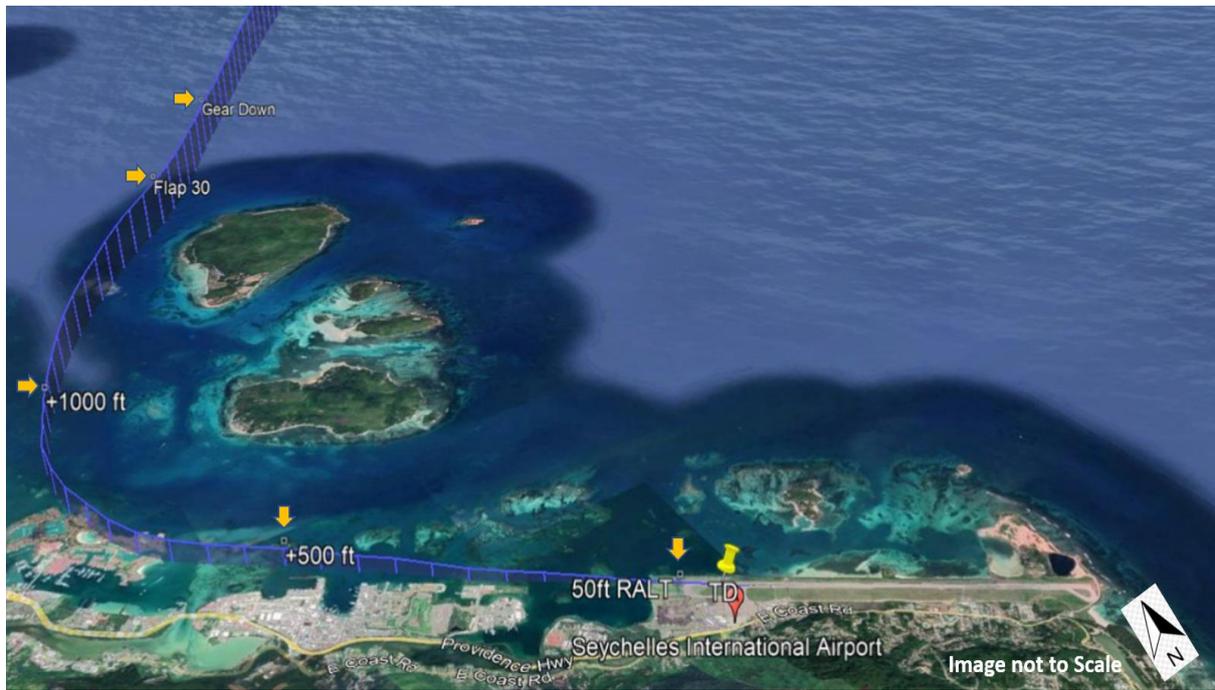
Figure 11: Flight track showing approach to Seychelles

DFDR analysis reveals that Auto-throttle was disengaged at about 580 ft and Autopilot channel A was disengaged at about 565 ft. Rate of Descent was arrested between 500 ft and 432 ft AGL and reached 160 fpm. Rate of Descent increased thereafter and reached a peak of 912 fpm at 150 ft AGL before being corrected again. The aircraft was flown low on final segment of visual approach with average rate of descent maintained higher than required till 150 ft AGL. The incident flight data was also analysed for any exceedance in flight parameters by Spice Jet in accordance with their Flight Data Monitoring program. As per the airline, the observed parameters were found to be within limits prescribed in DGCA approved Flight Safety Manual.

The Flight Crew carried out a Visual Approach as required by their SOP and while doing so directly joined the Base Leg of the Visual Pattern. The Flight Crew established the Landing Configuration while on Base Leg and eventually turned Finals after carrying out all related Checklists. The Flight Crew turned Finals at approximately 509 ft (RA 556 ft) while aircraft was about 2.36 nm approximately from the runway threshold. Aircraft was observed to be lower than the ideal altitude at wings level on final leg of the visual approach. The aircraft was at RA 50 ft at position “S04 40.0, E055 30.66” as per FMC position data. This position corresponds to the start of the paved area of runway. From DFDR analysis it is evident that the aiming point which was mandatorily required to be established was judged incorrectly.
