Aircraft and Accident details of Cessna 152 Aircraft VT-ALI on 25 July 2022			
1	Aircraft	Type	Cessna 152
		Nationality	Indian
		Registration	VT – ALI
2	Owner		M/s Academy of Carver Aviation Pvt. Ltd
3	Operator		M/s Academy of Carver Aviation Pvt. Ltd
4	Pilot – in –Command		SPL holder
	Extent of injuries		Minor Injury
6	Passengers on Board		Nil
7	Place of Accident		Kabdanwadi(Indapur)Village, Pune
8	Date & Time of Accident		25 July 2022 &0543 UTC (approx)
9	Last point of Departure		Baramati Airfield
10	Point of intended landing		Baramati Airfield
11	Latitude/Longitude of accident site		Lat 18° 08'05.694"N, long 74°50'57.163"E
12	Type of operation		Solo Cross Country Training Flight
13	Phase of Operation		Cruise
14	Type of Accident		Fuel (Fuel Exhaustion)

On 25 July 2022, Cessna152 aircraft with registration VT-ALI of M/s Academy of Carver Aviation Private Limited (ACAPL), while carrying out a solo cross country training sortie, on the route Baramati-Akkalkot-Baramati, made a forced landing on an agriculture field near Kadbanwadi (Indapur) village at 0543 UTC.

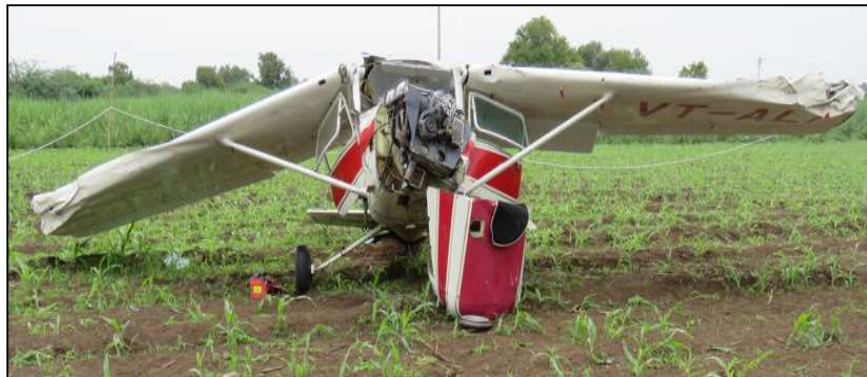
**Figure 6: Final Resting position**

Trainee Pilot searched for appropriate landing location. While executing the force landing, aircraft descended in LH circuit, aircraft LH wing and landing gear brushed the top branches of approx 30ft Neem tree in the landing path. Thereafter, aircraft's propeller hit the ground first with a steep angle. Due to impact propeller assembly got separated from the propeller hub and remained stuck in the ground. Then aircraft bounced on its RH wing and turned approx 90°. Before coming to rest aircraft's tail cone section dragged for approx 10 ft. Finally, aircraft came to rest on its two main landing gears with the support of empennage.

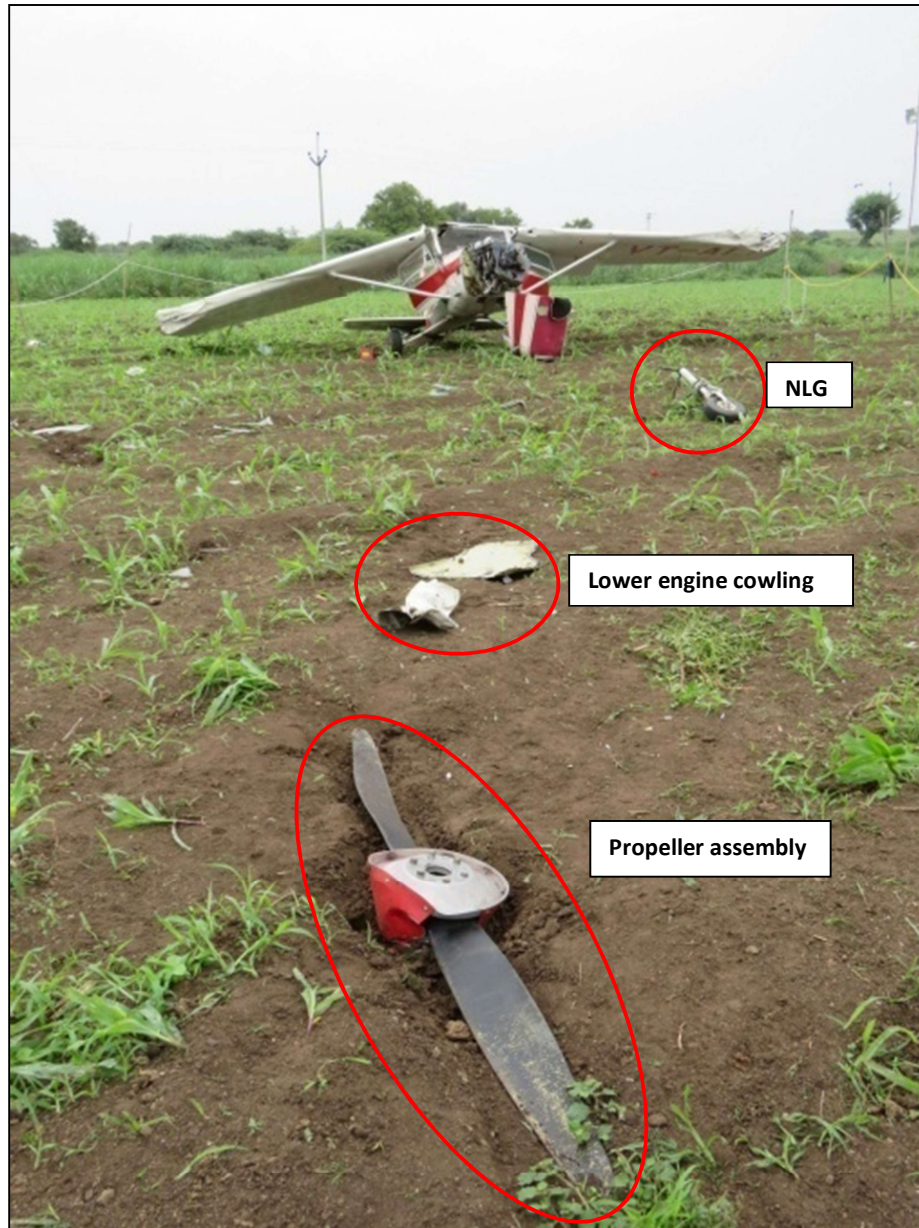
**Figure 8: Aircraft wreckage**

Most of the aircraft parts were found intact with main wreckage. NLG, propeller and few small parts were found scattered nearby in the landing path within a radius of 50ft approx. NLG and propeller were found approx 20ft and approx 40ft respectively away from the wreckage. Same is depicted in the below figure: 8.

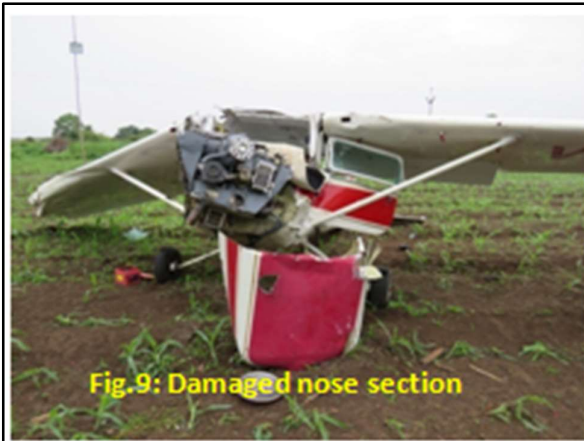
**Fuselage:** Fuselage skin between STA 00 to STA18.50 was found sheared off, buckled, cracked and bent rearward along with the firewall. Skin between STA 18.50 to STA 133.31 was found

wrinkled. Both front & rear windshields were found broken. Both LH& RH Cabin door were found damaged. Firewall was found sheared off, cracked & bent rearward.

Fig.9: Damaged nose section

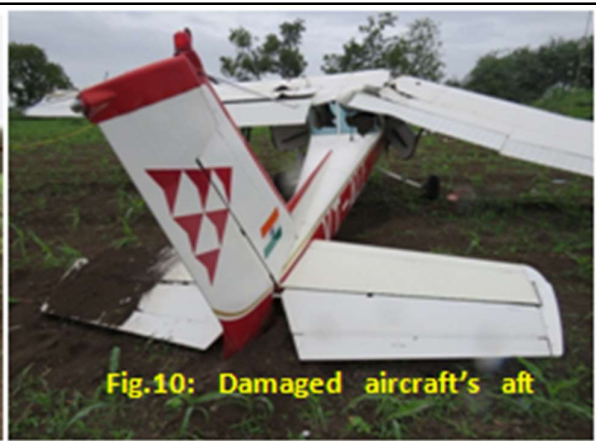
**Horizontal Stabilizer:** LH side tip was found broken.

**Vertical Stabilizer (Fin):** Tip was found broken.

**Rudder Control System:** Rudder's upper fairing was found broken.

Fig.10: Damaged aircraft's aft

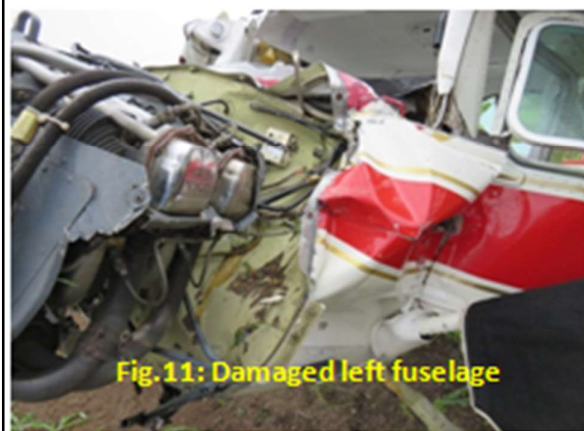
**LH Wing:** LH wing inboard leading-edge skin was found buckled between station no.WS 22.12 & WS56.87 and also between WS 102.00 & 192.00.Wingtip was found completely damaged.

Fig.11: Damaged left fuselage

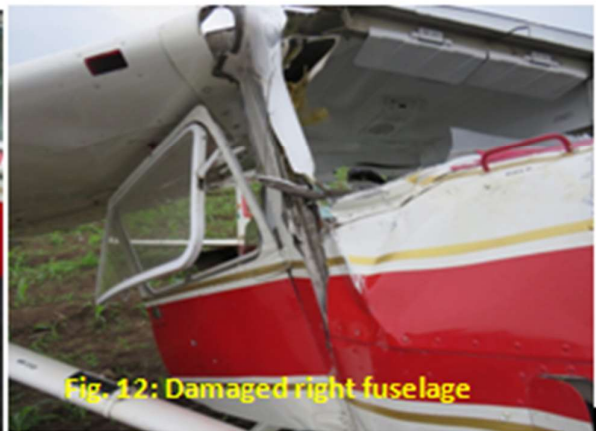
Fig.12: Damaged right fuselage

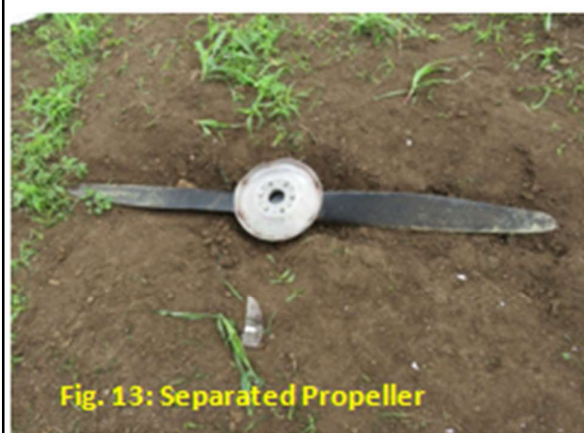
**Propeller:** Propeller with spinner, bulkhead along with its bolts got detached from the engine flange due to severe ground impact and Spinner got damaged and one blade was found bent.

Fig.13: Separated Propeller

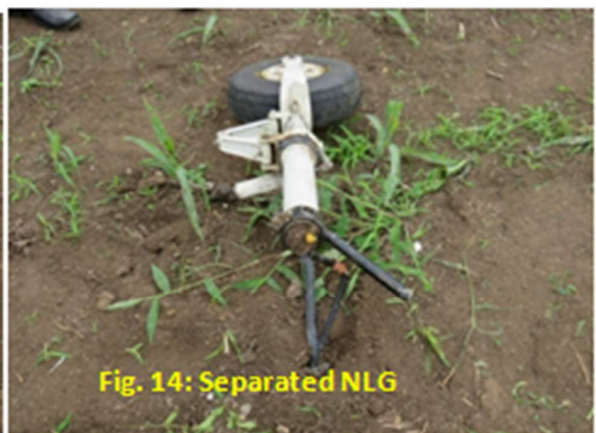
**Landing Gear & Brakes:** Both MLGs were found intact with dents and scratches. However, Nose landing gear assembly got detached from its mounting and was found at approx 21ft away from the forward of the wreckage.

Fig.14: Separated NLG

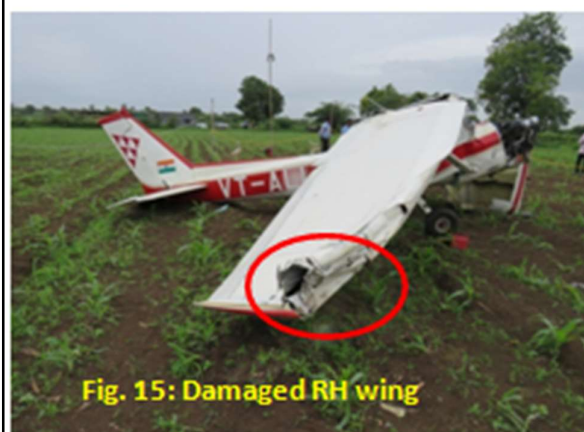
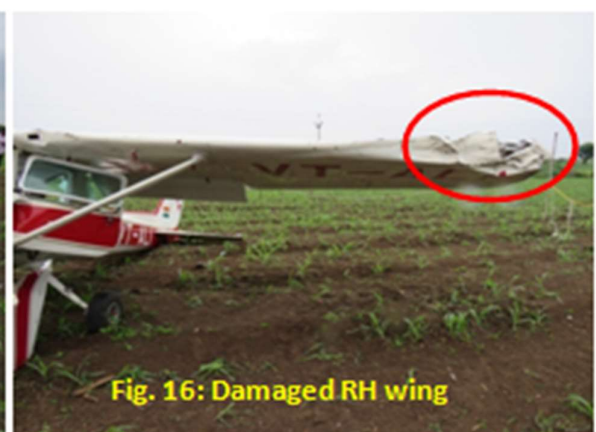
**RH Wing:** RH wing inboard leading-edge skin was found wrinkled and broken from station no. WS 22.12 to WS 84.00 and also from station no.WS 84.00 to WS 192.00.RH Wingtip was found completely damaged.

Fig.15: Damaged RH wing

Fig.16: Damaged RH wing

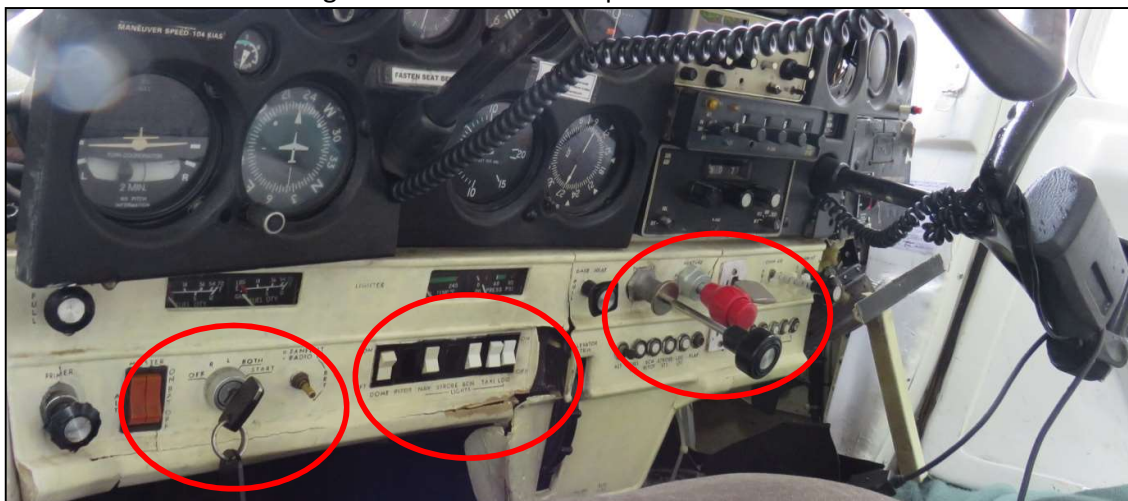
**Fig.17: Cockpit view**

- Flap lever was found at 0° position.
- Throttle control knob was found in open position.
- The mixture knob was found in rich position.
- The ignition key position was found at 'BOTH'.
- Fuel Shutoff Valve knob was found in open position.
- NAV and Beacon lights were found in ON position.
