Final Investigation Report
on
Accident to M/S Government Aviation Training Institute,
Cessna 152 Aircraft, VT-EUW
on 06 June 2022

Amit Kumar
Investigator-in-charge
Aircraft Accident Investigation Bureau

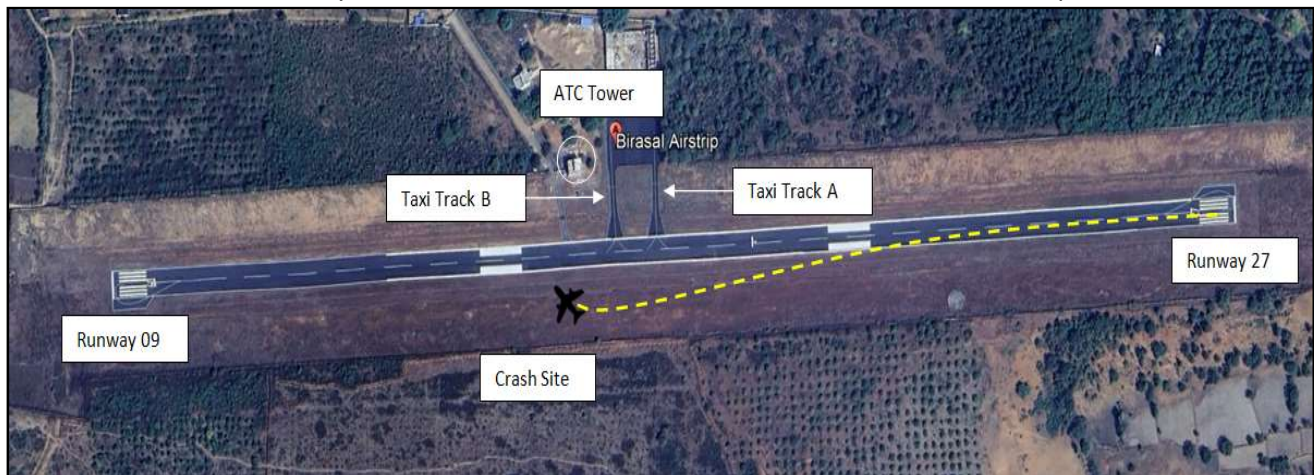
Fig. 4: Final Track

a) Immediately, after the trainee pilot opened the full engine power, aircraft started deflecting towards left and right. Trainee pilot was not able to maintain the aircraft on centerline. Thereafter, aircraft veered towards left, trainee pilot applied brakes and move the throttle to IDLE. Subsequently, aircraft exited the runway and kept on rolling under momentum. Aircraft's nose section hit a concrete drain cover of water drainage line running parallel to the runway. Subsequently, both landing gears hit the other concrete covers of water drainage line one by one. Due to sudden impact aircraft jumped and crossed the concrete cover of water drainage line. Due to the impact with the concrete drain cover of water drainage line, NLG assembly, propeller got detached from its base, RH MLG wheel assembly got damaged and tyre also got deflated. However, no major damage occurred to LH MLG wheel assembly. After jumping over the water drainage line aircraft momentum decreases and finally aircraft came to rest. The final track of the aircraft is depicted below:

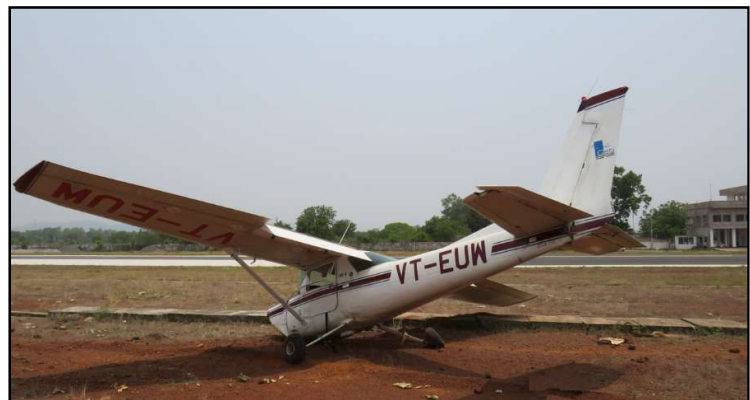
Fig. 5: Aircraft Final Rest Position

b) Most of the wreckage was confined to one place except few aircraft parts, which sheared off due to impact and scattered, for example as NLG was found at 19 ft, shimmy dampener was found at 63.5ft, steering rod was found at 28.7ft, propeller was found at 17 ft, propeller mounting bulkhead was

found at 12 ft, part of RH MLG wheel hub was found at 100.7ft, and a small part of RH MLG wheel brake was found of at 61.6ft from the main wreckage.

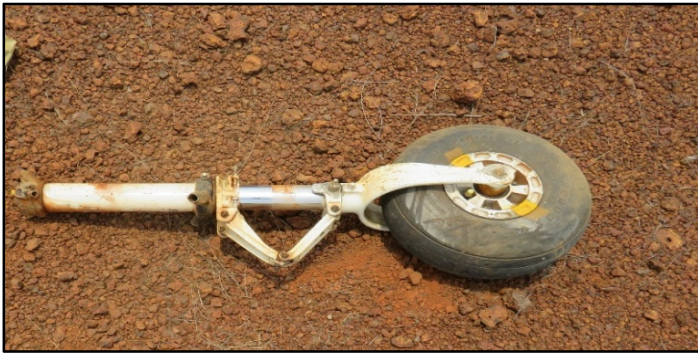
Fig. 6: Nose Landing Gear

1. Nose Landing gear was found detached from the engine mount (Refer **Figure 6**). Shimmy dampener and Nose wheel steering rod were also found detached from landing gear assembly.

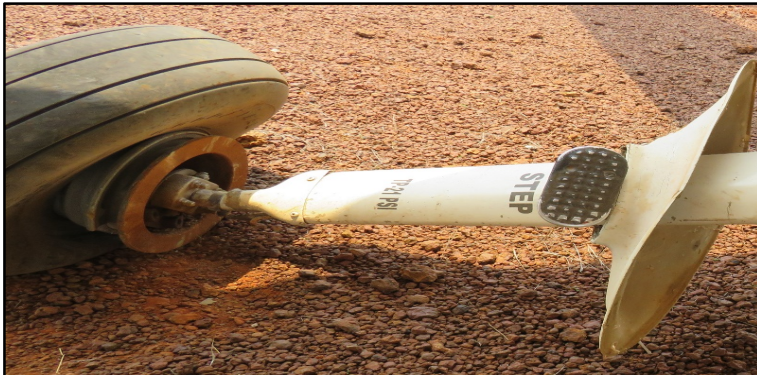
Fig. 8: Damaged RH MLG

2. The RH landing gear strut was found bent and was also found loose (Refer fig.8). Skin near wing attachment was found sheared off from rivet joint. Tyre was found deflated and lower portion of wheel hub was found broken. Brake assembly was also found damaged.

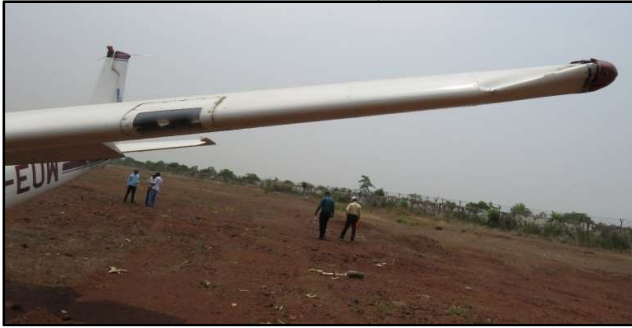
Fig. 10: Damaged LH wing

3. The LH wing was found damaged near tip (Refer fig. 10). Wind shield was also found cracked vertically on LH side at one place (Refer fig. 12). Nose lower engine cowling was found completely damaged.

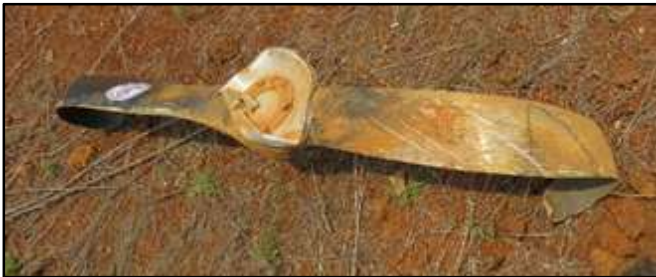
Fig. 14: Damaged Propeller

5. Propeller was found sheared off from the propeller mounting bulkhead (Refer Figure 14). Propeller spinner and bulkhead was also found completely damaged.
