**FINAL REPORT ON ACCIDENT INVOLVING CESSNA A185F
AIRCRAFT VT-ETU OF M/S AGNI AERO SPORTS ADVENTURE
ACADEMY PRIVATE LIMITED ON 17.04.2022 AT JAKKUR
AIRFIELD, KARNATAKA.**

**Dinesh Kumar
(Investigator-In-Charge)**

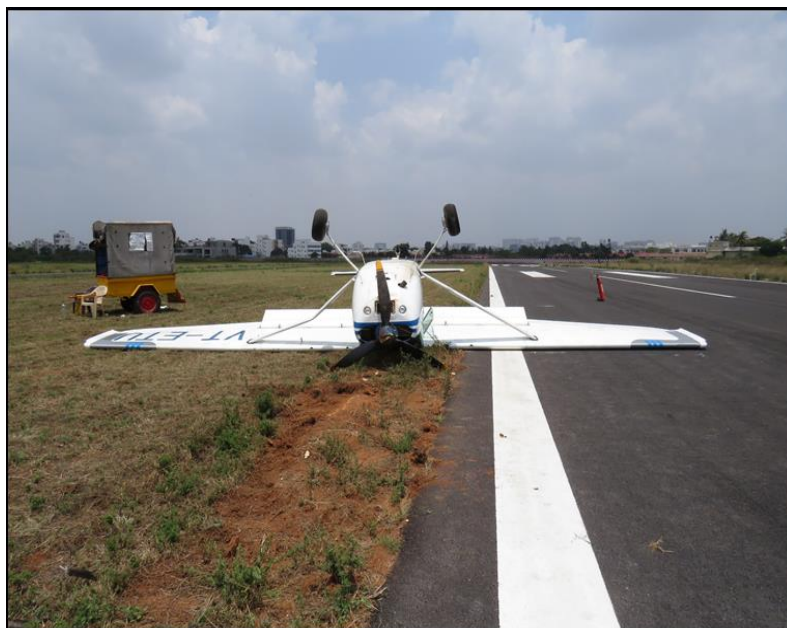
Fig 1: Aircraft lying toppled at accident site

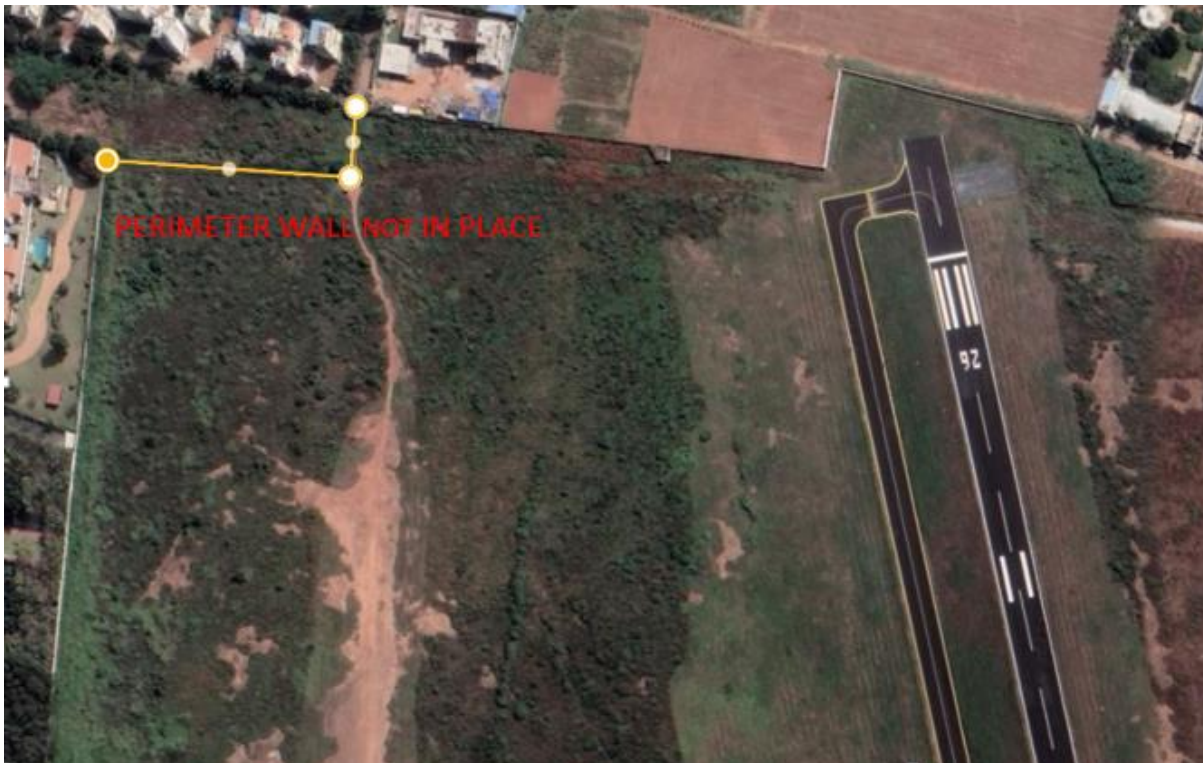
It is clearly mentioned in GFTS TPM that compound wall is not available for a small portion on the North East of the aerodrome and proper watch and ward arrangements have already been made by GFTS to prevent runway incursion during aircraft operations. Later, on further investigation about the perimeter wall, GFTS informed that a litigation is pending regarding that area due to which boundary wall cannot be constructed on that area. Furthermore, GFTS has submitted that approximately 144 meters gap is manned by a security guard permanently.

Fig 4: Open Area

- 4.1. DGCA shall instruct the aerodrome operator to take all necessary actions to ensure that
 - i. Broken Perimeter wall area is secured
 - ii. No bird activity inside the aerodrome in operational area
- 4.2. DGCA shall instruct the aircraft operator and other operators conducting Aerial Work operations to update their Operations Manual in line with the prevailing requirements of CAR before they are allowed to undertake Aerial Work Operations.
- 4.3 DGCA shall conduct an audit of the aerodrome to address the issues raised in this report and any other discrepancy for conduct of safe operations at Jakkur aerodrome.

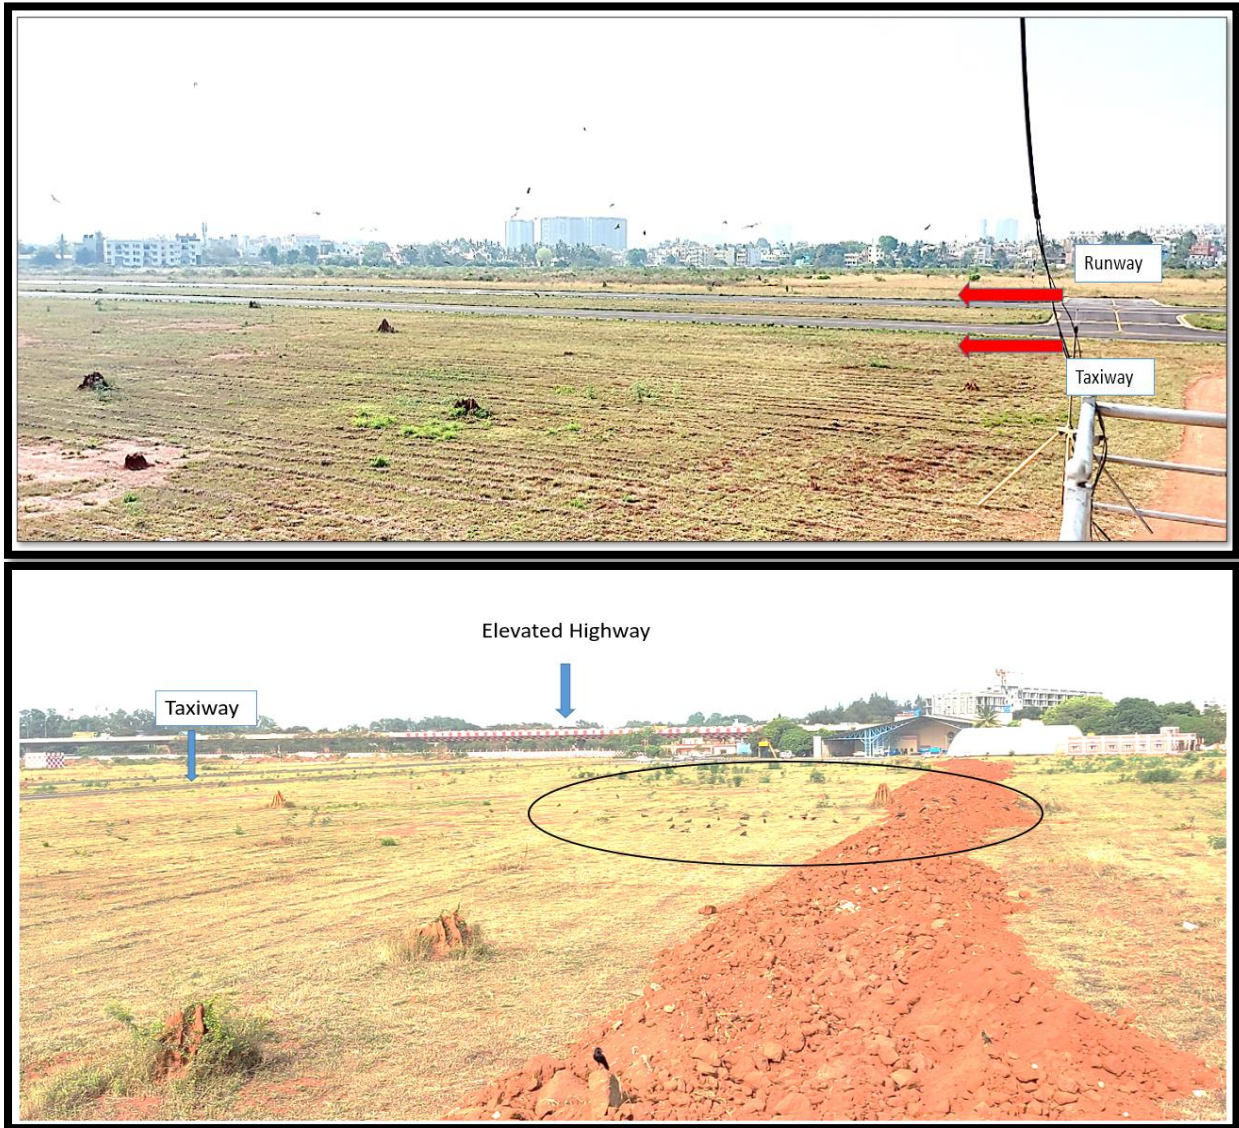
During visit to Jakkur, the investigation team had also observed bird activities inside the controlled area of aerodrome during morning and evening hours. No dedicated CFTs are presently available with the airport operator. In order to tackle any exigency, they are dependent on external support from local administration.

Fig 5: Bird activities observed inside the aerodrome

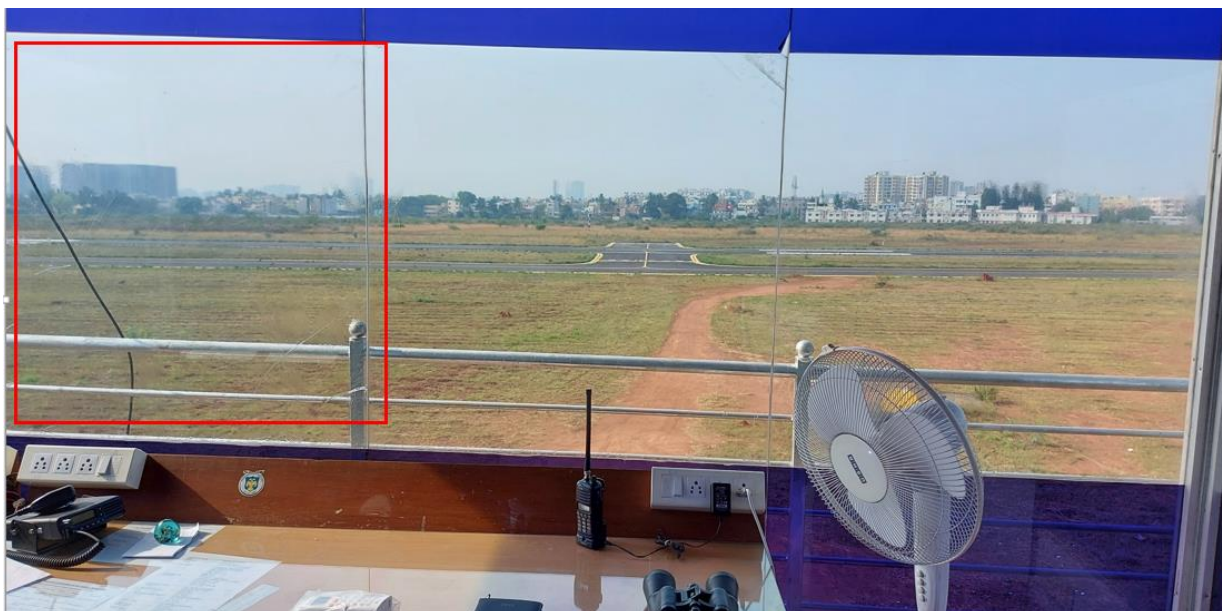
The seat from the ATC tower provides a satisfactory view of the Runway and the area around the aerodrome including approaches above the elevated highway. However, no recording camera has been installed to capture the aircraft movements on the runway at the airport. During visit by investigation team, it was noticed that the glass panels of ATC tower were slightly grimy, therefore creating hindrance in clear view of the runway.

Fig 6: Outside view from ATC tower's front glass panel

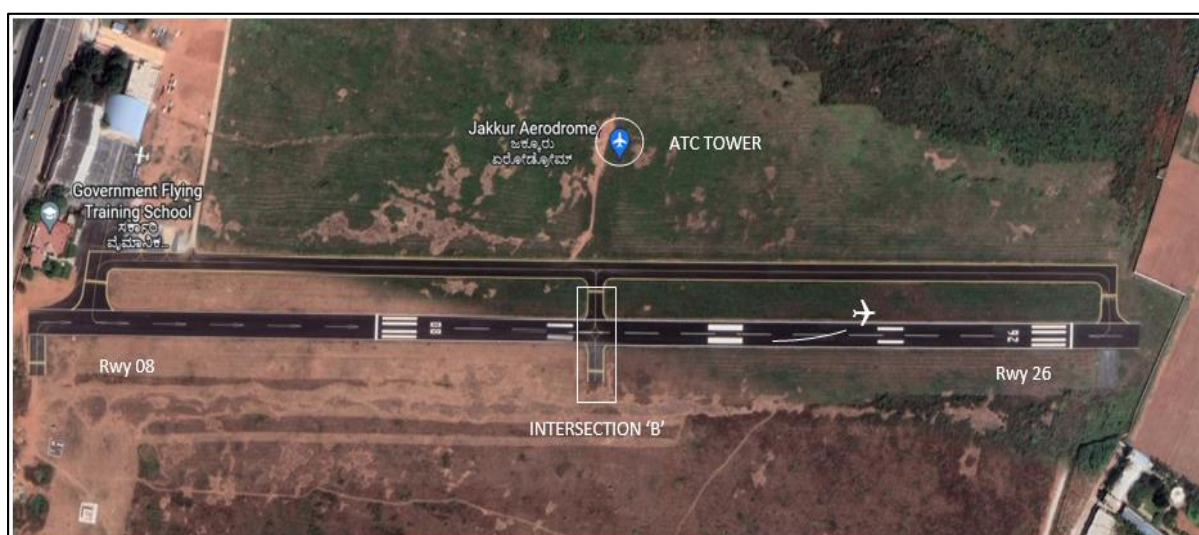
The total runway length is 854 m (2801 feet) and aircraft made a touchdown near runway intersection B. The first evidence of main landing gear tyre marks on runway was observed from 117 feet ahead of second aiming point. However, wheel marks were slightly on right of runway centerline. Thereafter, aircraft travelled for approximately 300 feet parallel to runway centerline on the right side.

Fig 7: Track followed by the aircraft

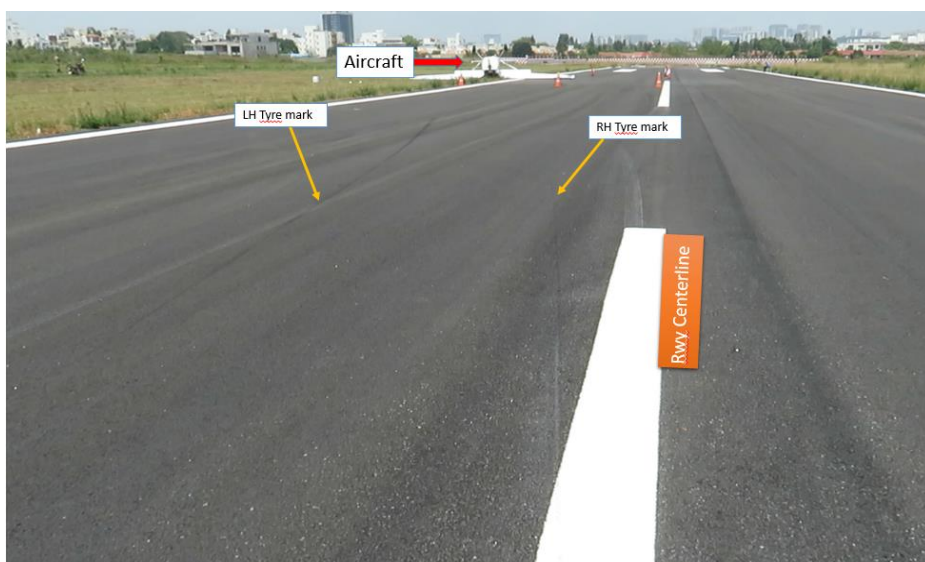
Ground marks of aircraft's tailwheel, continuously drifting towards left, up to 111 feet, crossing the runway centerline was observed on the runway. Thereafter, aircraft started rolling on left of the runway centerline. At this location, all three tyre marks were noticed on the paved surface of the runway and a gap of 7.2 feet was observed between extreme ground marks (main wheels marks). Thereafter, aircraft continuously drifted towards left and ground marks were

Fig 8: Tyre marks on the runway

observed for another 200 feet approx. However, no ground marks were observed ahead till the aircraft exited the paved surface.

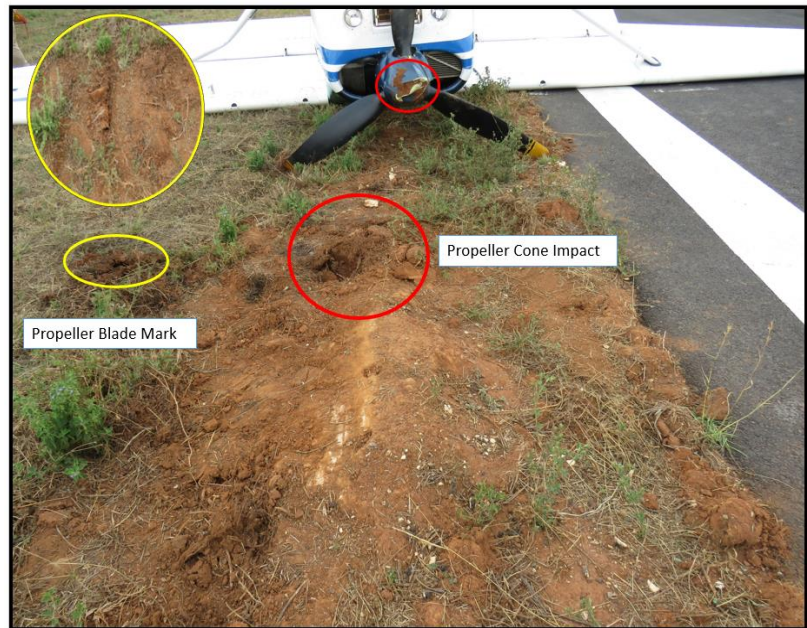
Later, aircraft travelled on soft ground for approximately 11 feet before it toppled parallel on runway edge. Ahead of toppled aircraft, two ground marks were also observed. And out of these two, one was created due to nose cone impact and the other one was of propeller blade hitting the soft ground (Fig 9).

Fig 9: Ground marks

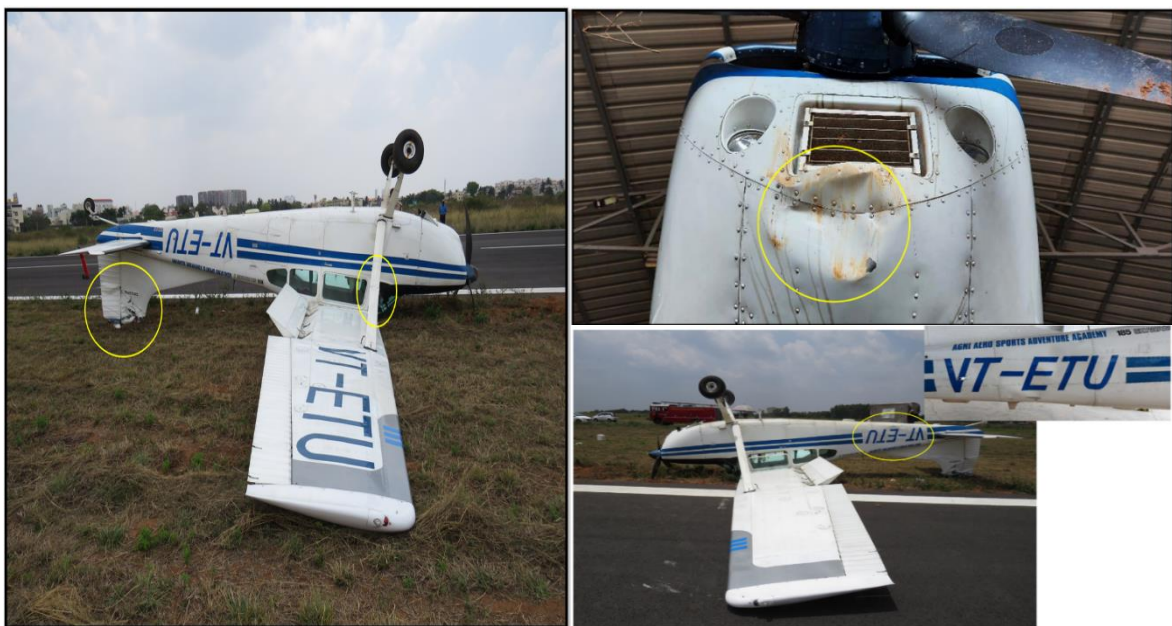
- 1) Dent noticed on lower cowling at nose section of the aircraft and the measurement of dent was Length- 11.5 cm, Height- 7.5 cm & Depth- 1.5 cm (approx.).

Figure 10: Clockwise - Nose Section; Dents observed on the Fuselage; Vertical Stabilizer and Rudder damaged

- 2) RH side aft of cabin section was found bulged and multiple dents were also noted. The paint was found flaked approximately 1.5 inch in length.
- 3) Due to impact on Vertical Stabilizer and Rudder, both found crushed approximately 18 inches from the top.
- 4) Left Side Wing Strut was found bent at 51 inches away from Wing-Strut joint.

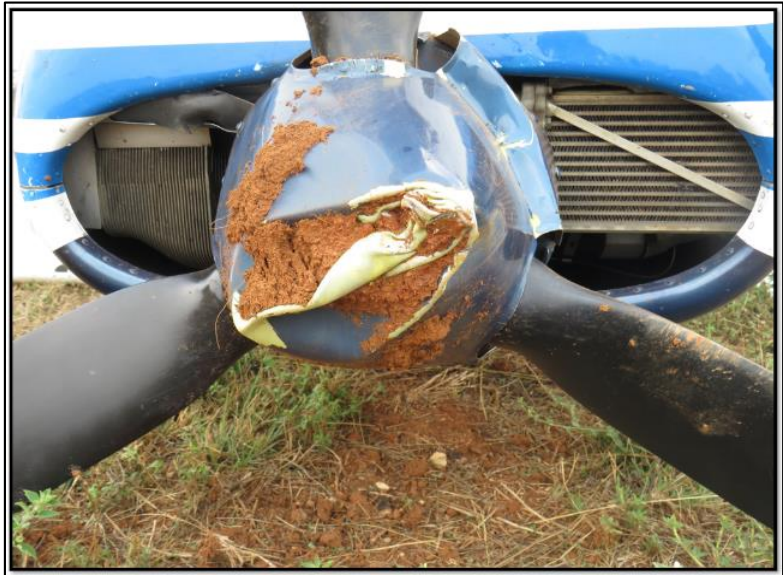
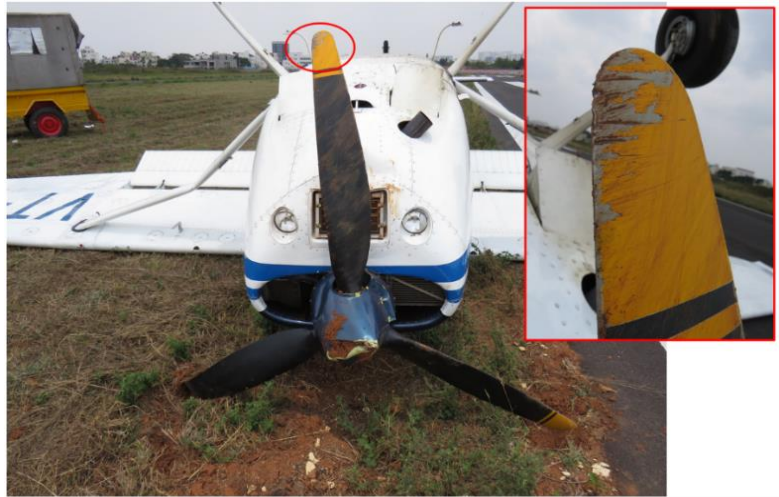
- 1) Propeller cone crushed due to impact with ground.
- 2) Rub marks observed on two propeller blades. One propeller blade found bent rearwards about 1/4th from root hub. And the other one was found curved along the length of the blade.
- 3) Nick noticed on tip of one propeller blade. Score mark noticed on blade.

Fig 11: Propeller cone damaged (above), Nick and score marks on propeller blade (below)

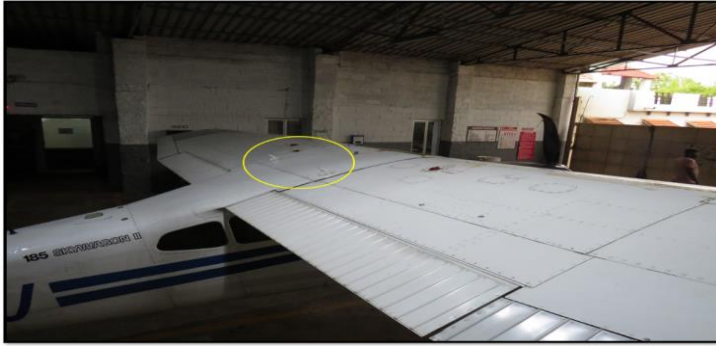
Fig 12: Broken Antenna

5) Further, Communication Antenna No.1 and No.2 were also found broken.
