**Final Report on Serious Incident Involving Airprox between
M/s Air India, B787 aircraft VT-ANM and
M/s Virgin Atlantic Airways, B787 aircraft G-VBZZ in Mumbai Oceanic region on
14 Sep 2022**

**Aircraft Accident Investigation Bureau
Government of India
Ministry of Civil Aviation**

Final Report on Serious Incident involving Airprox between Air India's B787 aircraft VT-ANM and Virgin Atlantic's B787 aircraft G-VBZZ in Mumbai Oceanic region on 14 September 2022

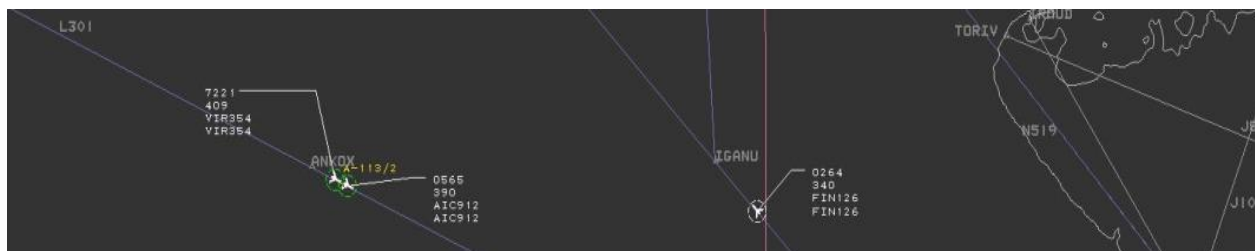
By then, both VT-ANM and G-VBZZ had crossed waypoint ANKOX on Route 301. The U-5 controller had not taken G-VBZZ in its jurisdiction yet, but observed descent by G-VBZZ on the CCWS at 02:39:27 UTC.

Fig 1: G-VBZZ observed descending at 02:39:27 UTC

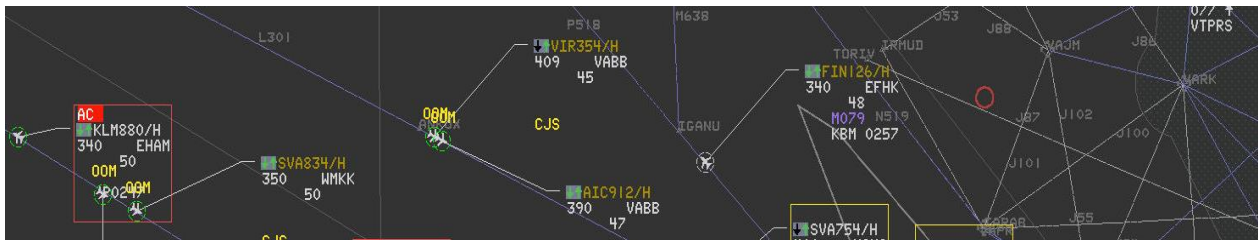
Fig 2: Separation reducing observed at 02:39:29 UTC

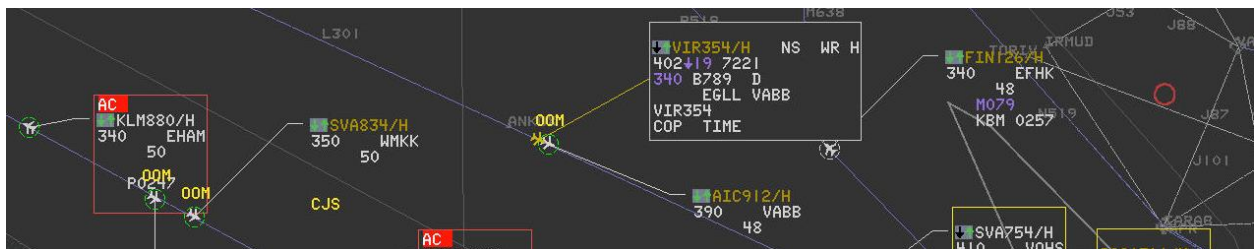
U-5 controller observed that the Pilot Selected Altitude on CCWS was shown as FL340. U-5 gave repeated calls to G-VBZZ between 02:40:02 UTC and 02:40:29 UTC, but none was answered. The flight crew in their statement stated that they did not receive these calls from the U-5 controller.

Fig 3: Selected altitude on G-VBZZ observed to be FL 340 at 02:39:56 UTC

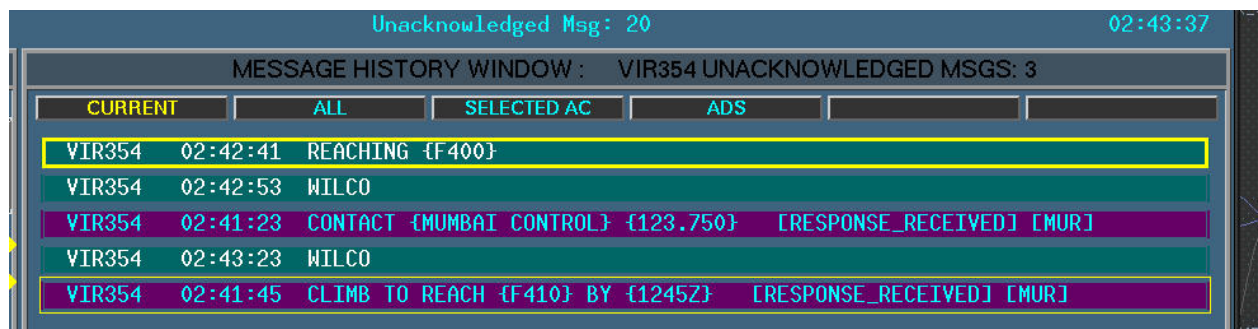
As U-5 controller could not establish contact with G-VBZZ, she advised OCC (N) controller to give Frequency 135.75 Mhz to G-VBZZ on CPDLC. OCC-N mistyped frequency as 123.75 Mhz and sent CPDLC message at 02:41:23 UTC. The crew of G-VBZZ checked in as requested and was told to contact Mumbai on 135.75 Mhz.

Figure 4: CPDLC Message Window

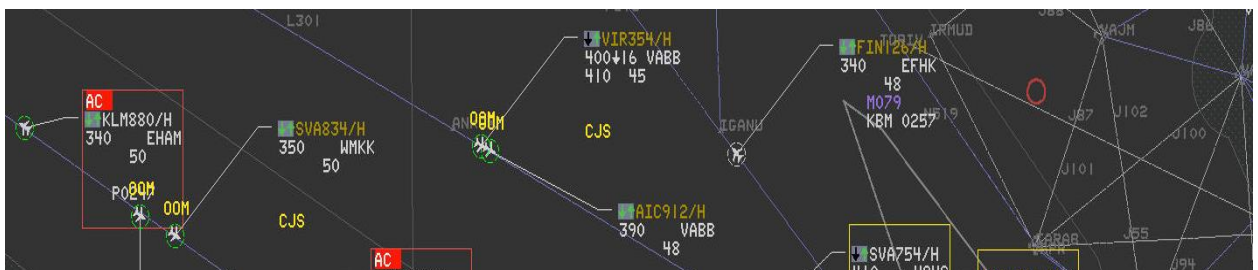
Fig 5: Selected altitude by G-VBZZ observed changed to 410 02:40:03 UTC

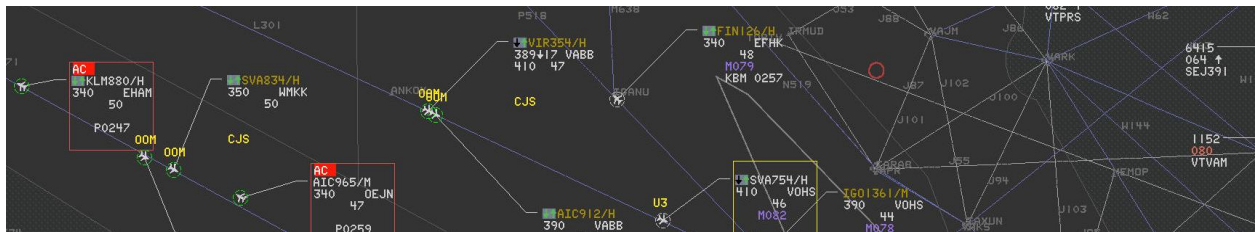
Fig6: G-VBZZ descended to lowest level of FL389 at 02:40:42 UTC

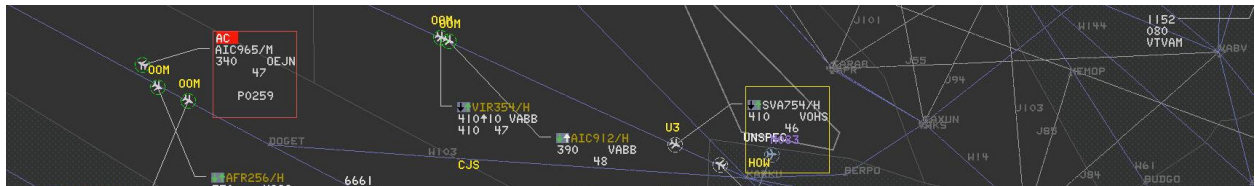
Fig 8: G-VBZZ observed reaching FL410 at 02:43:37 UTC
