Preliminary Report: Serious Incident to M/s Kestrel Aviation Pvt.ltd Augusta A119 Helicopter VT-CLR at Kedarnath Helipad on 24.05.2024.

6. Brief description of Serious Incident

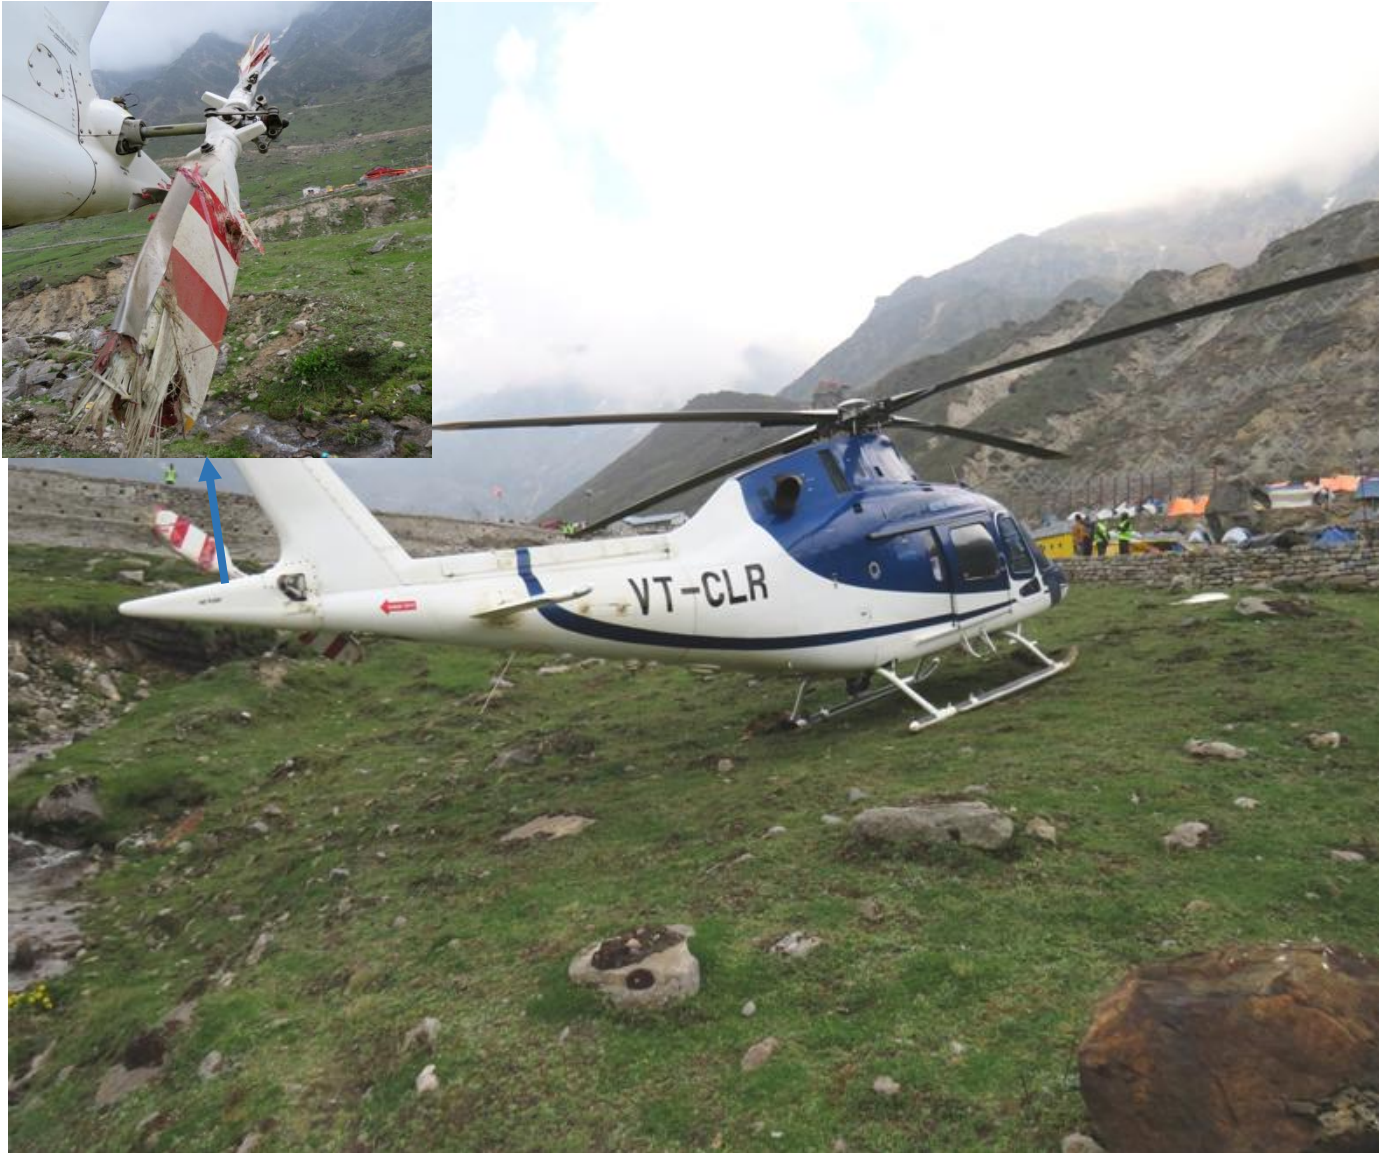
Figure1. Aircraft parked at last position

After the aircraft settled down, the main rotor was still rotating and the engine was shut down by the Pilot. The tail rotor impacted the terrain and stopped rotation immediately due to which rear tail rotor drive shaft got sheared. Further both the tail rotor blades sustained shredding of honeycomb bonding and severe surface bruises due to ploughing of blades in terrain

- The ventral fin got sheared off the tail due to terrain contact while spinning and just before getting settled down. The left stabilizer bottom skin surface sustained puncture.

- When the tail rotor transmission shaft got sheared, the shaft came in contact with the tail rotor drive shaft service door and sustained tear in the door.
- When the helicopter made initial ground contact while simultaneously spinning to right, the right skid forward section sustained damage and the cap got dislodged.
- Both the hydraulic system reservoir fluid levels were found empty and fluid was lost.
- The forward upper deck and rear upper deck surface was found with hydraulic fluid flow signs and there was puddle of fluid in rear upper deck. The upholstery mat of the cargo compartment was soaked with hydraulic fluid.
- The hydraulic fluid was dripping through the drain mast and signs of fluid were found in the rear belly of helicopter.
