**Preliminary Report: Accident involving M/s Samvardhane technologies' Cessna 152 Aircraft VT-BBB near Guna Airport on 11.08.2024**

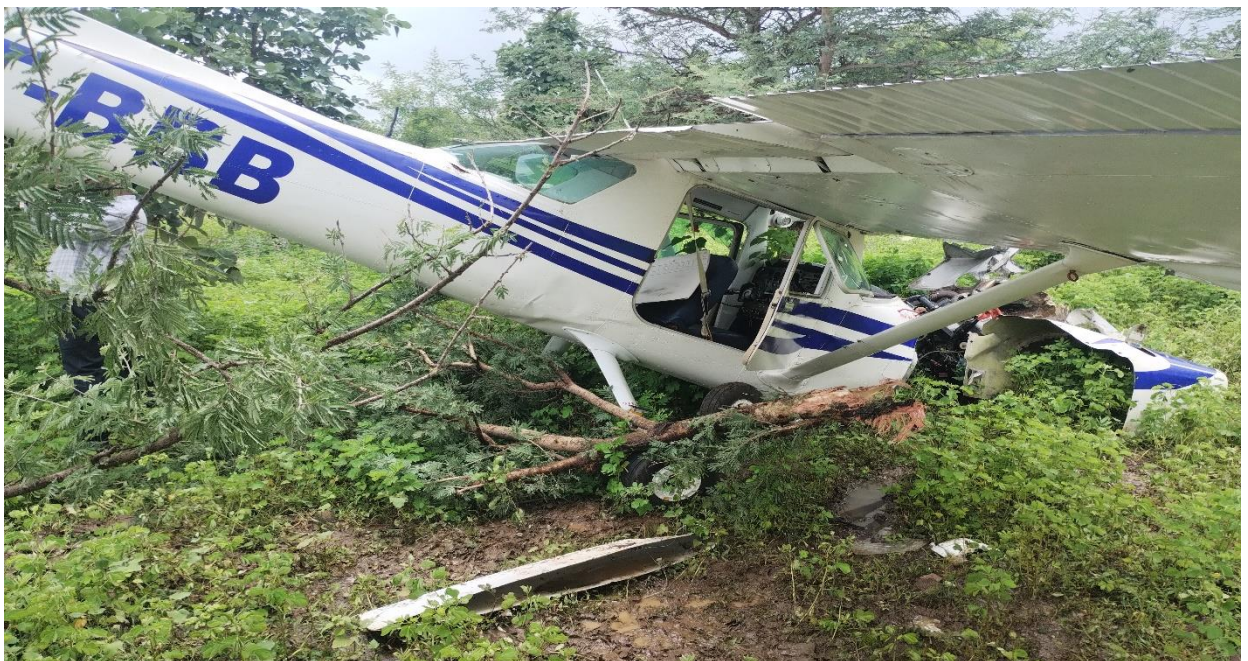
The aircraft crash-landed in a bushy area at approximately 200 meters from the left edge of Runway 32. Before impacting the ground, it collided with trees along its flight path and came to final resting position. The force of the impact caused the nose landing gear to collapse, and the engine was dislodged completely from its mounting structure. The left horizontal stabilizer, right wingtip, and right-wing leading edge, and the left wingtip, sustained damages.

The test flight was the first flight following maintenance. During an onsite investigation following the accident, corrosion was observed on the control cables and the firewall. Samples of these components were sent to the DGCA laboratory for further analysis. The laboratory report on the samples confirms the broken cable strand, rubbing signatures on the left-hand (LH) rudder control cable, as well as corrosion signatures on both the firewall and the control cables.

*Figure 1: Aircraft's Main Wreckage*

In view of the corrosion and rubbing signatures observed in the control cables, it is recommended that a one-time inspection be conducted by DGCA to ensure that the maintenance activities carried out on other two aircraft of the operator are compliance with relevant standards. The report on the same may be shared to AAIB.
