**Final Investigation Report**  
**on**  
**Accident to M/S Jharkhand Flying Institute,**  
**Sinus 912 Motor Glider aircraft, VT-GDI at Dhanbad airport on 23 March 2023**

**Government of India**  
**Ministry of Civil Aviation**  
**Aircraft Accident Investigation Bureau**

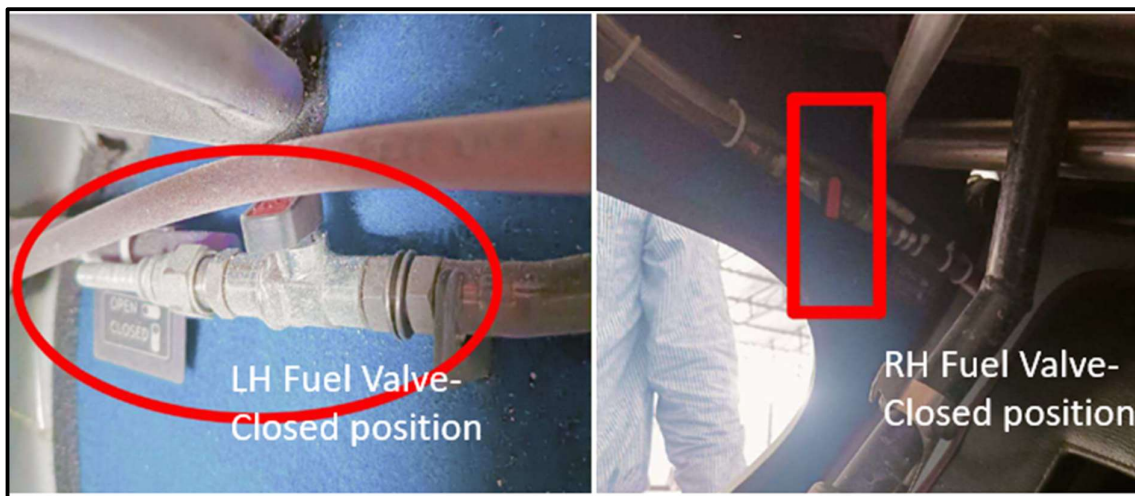
**Figure 7: Actual position of Fuel valves.**

During the onsite inspection, both fuel valves were found in closed position (Refer below pictures). It was also confirmed by the company personnel, who reached the accident site first that nobody has entered cockpit after the accident.

During the on-site visit by the preliminary investigation team, both fuel valves were found in a closed position. During investigation, M/s JFI's staff, who reached the accident site first had submitted to the preliminary investigation team that none of them accessed any of the aircraft controls, switches, valves etc. However, only one person of M/s JFI, had accessed the aircraft wreckage post-accident, to take out the keys.

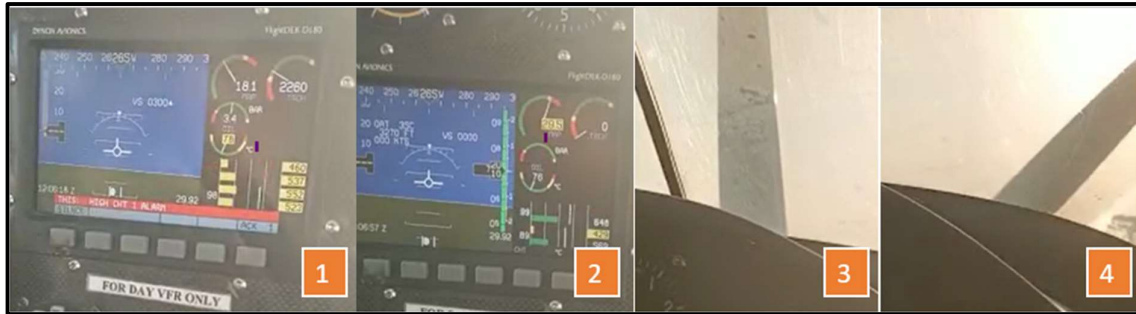
**Figure 10: Screen shot of Aircraft Display Unit**

- a) Engine started at  $t = 0$  second.
- b) Display unit turned ON after  $t = 10$  second
- c) Low Fuel Pressure Alarm triggered at  $t = 17$  second. (Refer below figure 1)
- d) Engine stopped at  $t = 45$  second. (Refer below figure 2 and 3). Propeller blade position after the engine stopped due to fuel starvation.
- d) Engine restart was carried out. The propeller turned but engine did not reignite. (Refer below figure 4). The propeller blade after few rotations stopped at a new position.

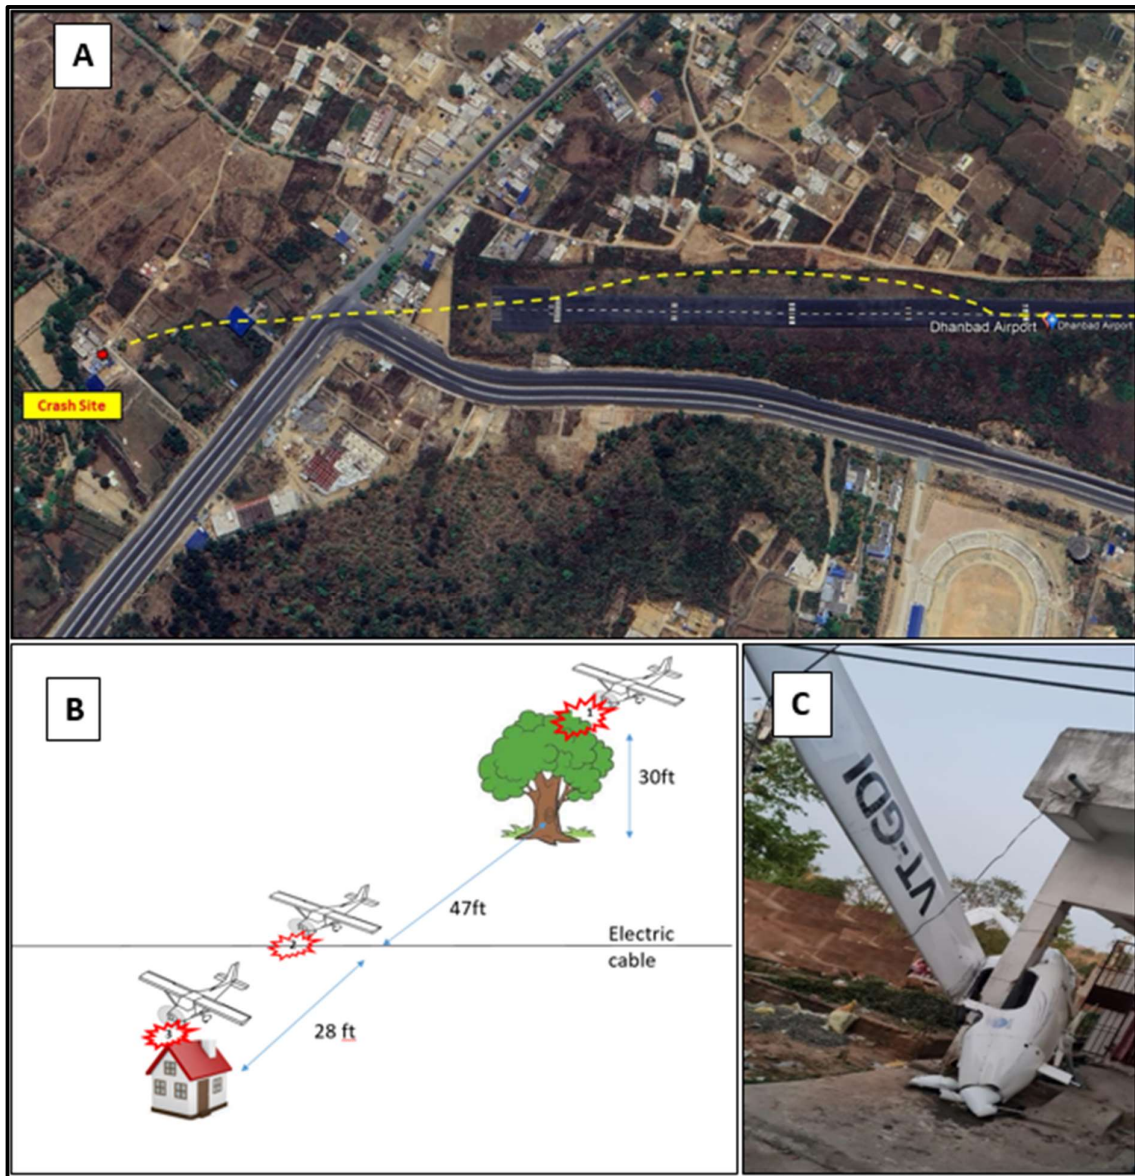
**Figure 11: Aircraft's Track and Final resting position**

When the aircraft's engine stopped in air, initially, the aircraft headed slightly towards the right side and then drifted towards left. Thereafter, the aircraft continued to descend rapidly with left heading. When the aircraft descended to a very low altitude, its right wing hit 30 ft high tree on its way. Consequently, a portion of RH wing was disintegrated from the aircraft and was hanging on the tree branches. Aircraft's second impact was with the electric cable. The electric cable was clipped due to aircraft's impact. Subsequently, aircraft made the third impact with a roof of the house. After impact with roof aircraft fell at the entrance area of that house, where a concrete pillar sliced in the aircraft's cockpit from LH side. Finally, the aircraft came to rest in inverted position. Above figure 'A' depicts the aircraft's course, figure 'B' depicts the aircraft's Final trail and figure 'C' depicts the aircraft's final resting position.

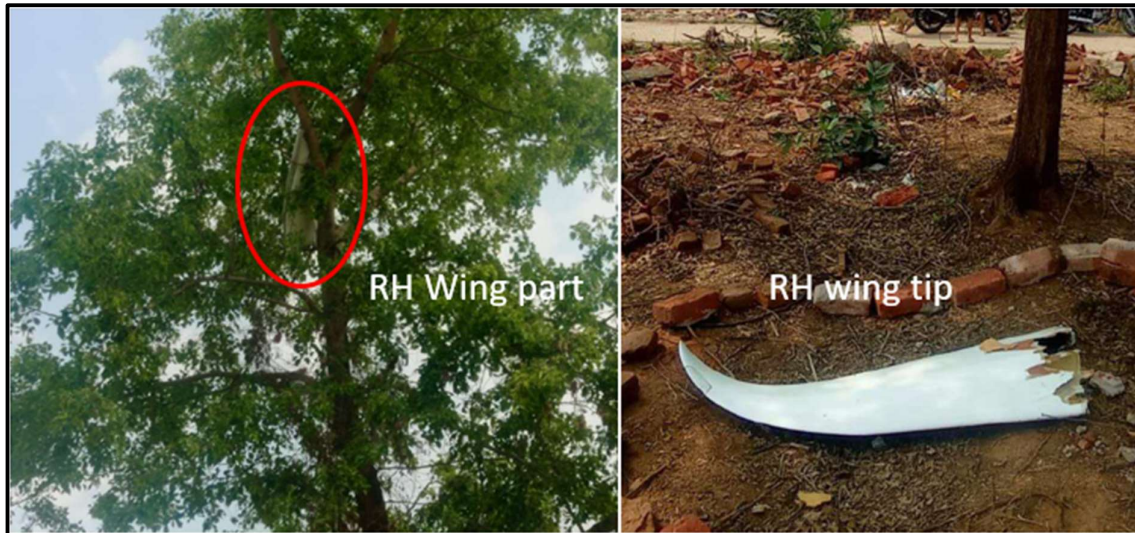
**Figure 12: Separated parts of Aircraft's RH wing**

Most of the wreckage was confined to one place i.e., at the aircraft's final resting position, except few aircraft parts which were sheared off due to impact such as right-wing tip portion was found at the bottom of the tree, nearly 70 ft. away from the final resting position and some portion of right wing was found hanging on the top of the tree.

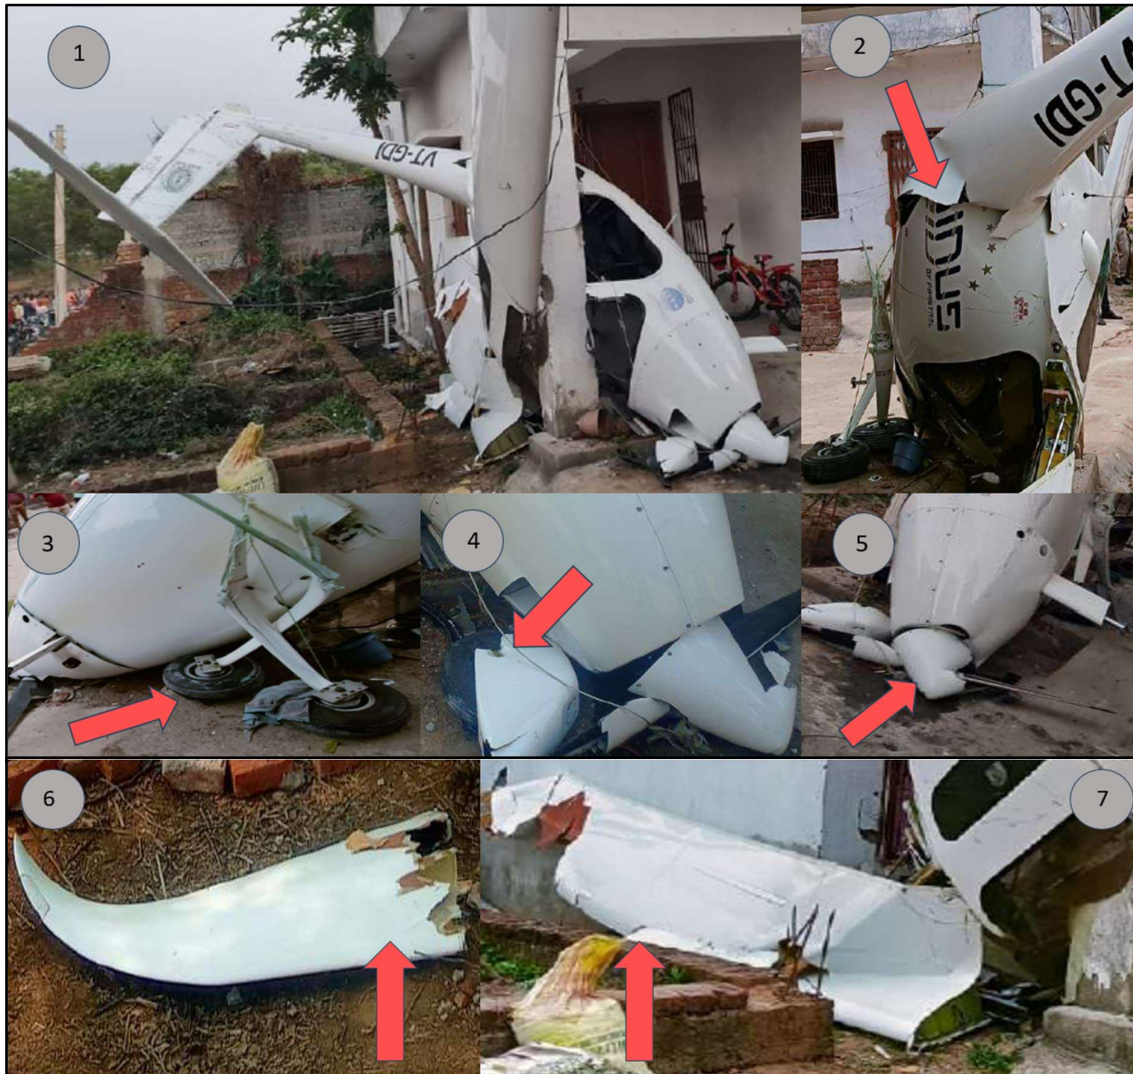
**Figure 13: Damages to the Aircraft**

1. One Propeller blade was found broken in two pieces & other one suffered minor damage, refer figure 13(5).
2. The nose wheel fork was found broken from the attachment point, refer figure 13(4).
3. Both main wheel struts were found broken from the attachment point. However, wheels were found intact on axel, refer figure 13(3).
4. The right wing was found broken from the root section and was found in multiple pieces, refer figure 13(6) & 13(7).
5. The Left-wing root section point was found intact with minor damage.
6. The cabin section was found completely damaged, refer figure 13(1).
7. The front windshield and both windows were found shattered.
8. Fuselage was found broken from middle portion, refer figure 13(2).
9. The horizontal stabilizer and elevator were found intact with minor damages.
10. The vertical stabilizer and rudder were also found intact with minor damage.

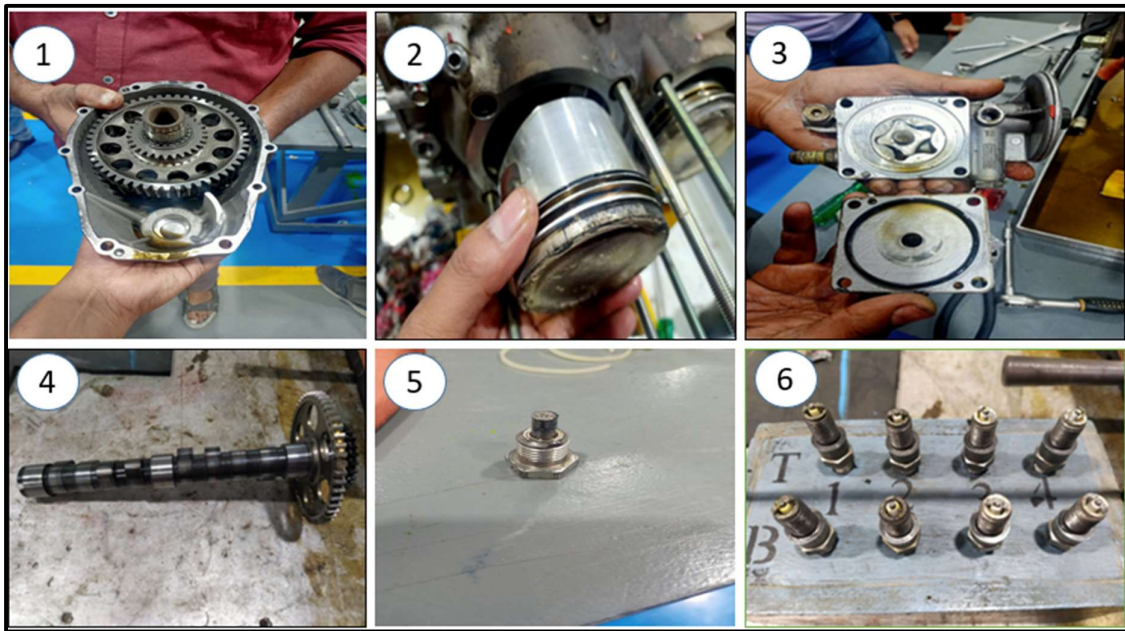
**Figure 16: Images of engine components**

- a) A visual inspection was carried out. During the visual inspection the engine's external condition was found satisfactory except few impact damages observed on some parts.
- b) All accessories were found intact at their respective mounting locations.
- c) Crankshaft's rotation was found normal.
- d) Camshaft was also found in good condition. Refer above figure 16 (4).
- e) All 4 pistons were checked and were found to be in good condition. Cylinder heads were also checked and were found to be in good condition. Refer above figure 16(2).

- f) All spark plugs were subjected to bench check and were found working satisfactorily (Refer above figure 16(6). The electrical harness was also subjected to bench check and was found working normal.

- g) Both Air filters were found intact at their respective locations on the engine and condition of the same was found good.
- h) Fuel pump condition was checked and except fuel pump mounting rest were found satisfactory. The Fuel pump mounting was found damaged due to impact.

- i) The exhaust pipe was found damaged due to impact.
- j) No metal particles were found except traces of carbon deposits on Magnetic plug. Refer above figure 16 (5).

- k) The gearbox and the bearing were also found in good condition. Refer above figure 16 (1).
- l) Oil pump was also found in good condition. Refer above figure 16(3).

- m) No traces of residual fuel were found in both Carburetors.
- n) No damage was observed on the Ignition system.

Rotax 912 engine, fitted on Sinus 912 Motor Glider VT-GDI was Strip examined and was found in good condition along with its all accessories. No abnormality was found during inspection. Crankshaft, camshaft, pistons and all other moving parts were found intact and free for movement. No sign of engine stoppage due to malfunctioning of its component was found. The inference drawn after the strip examination was “There may be no fuel supply to the fuel system of the engine”
