Subject: Accident to M/s PHLH Bell 407 Helicopter VT-PHH at Katra on 30.12.2012

Final Investigation Report on Accident to
Pawan Hans Helicopters Limited (PHHL)
Bell 407 Helicopter VT-PHH on 30-12-2012
at Katra Valley, Jammu & Kashmir

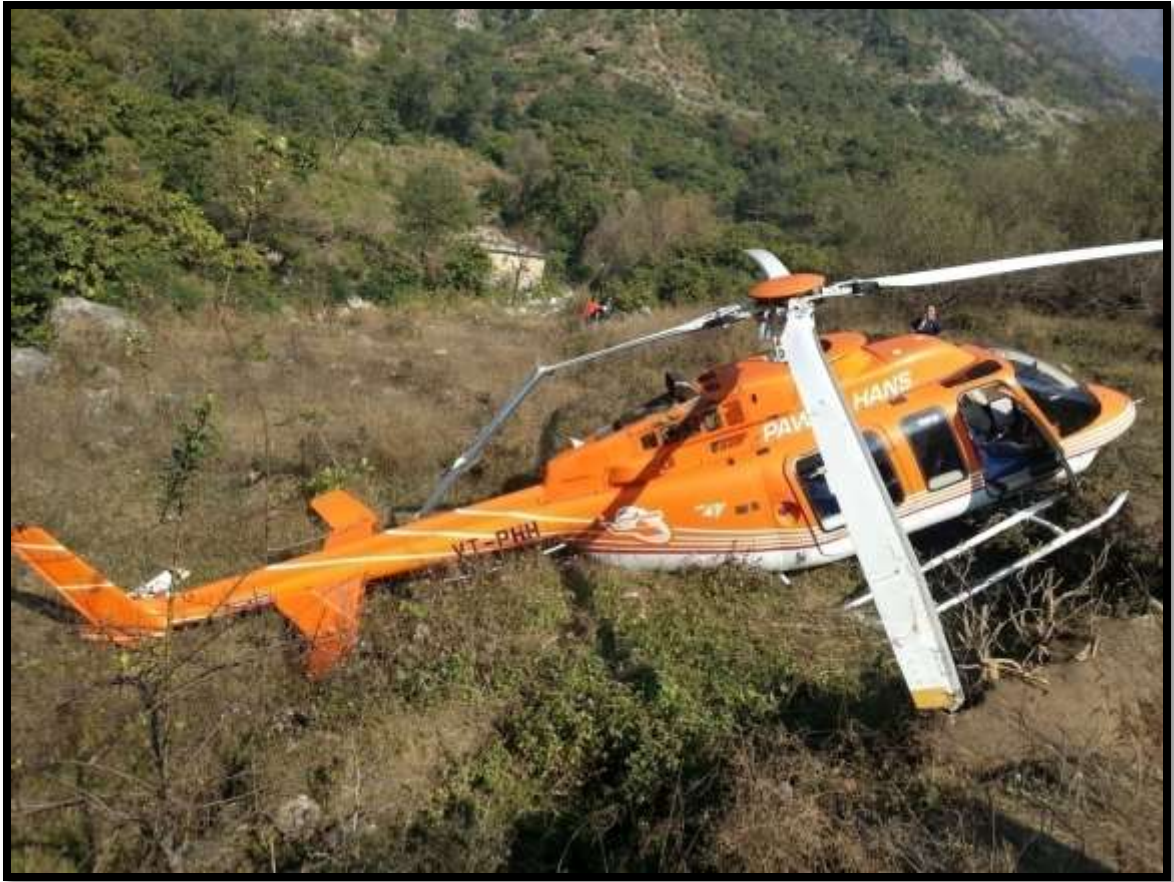
Landing of helicopter on sloping surface

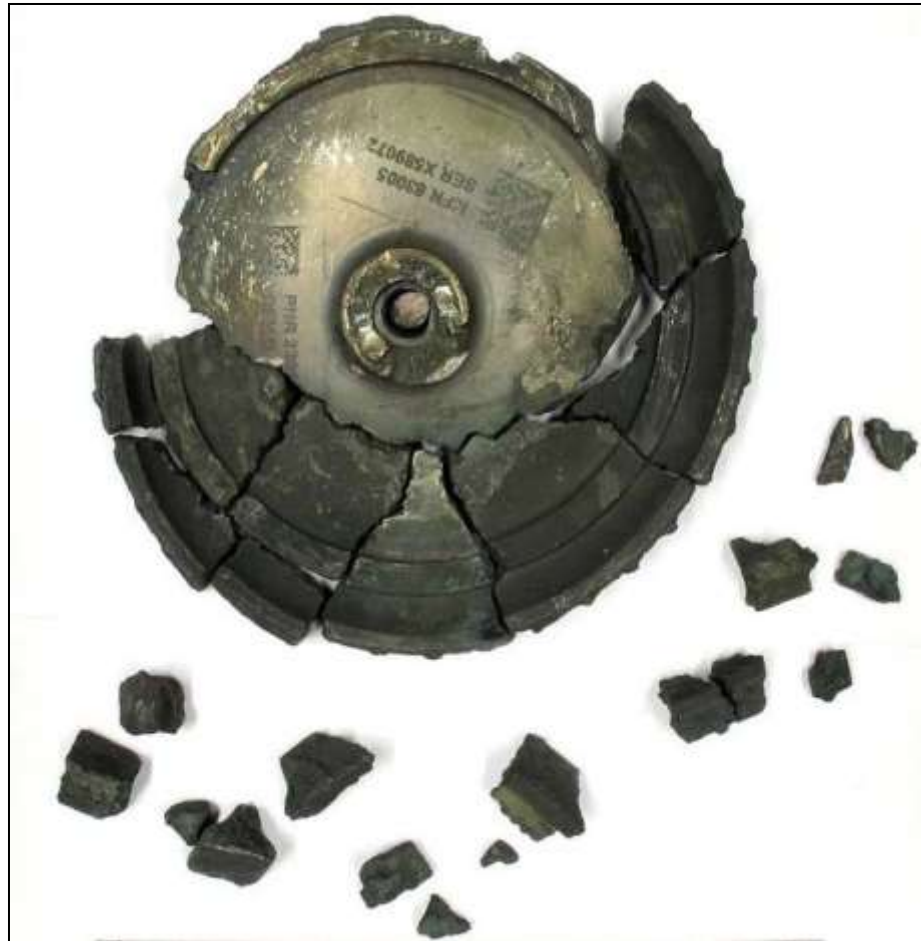
The 1st Stage Turbine wheel was fragmented into multiple pieces from an apparent overspeed burst, which is consistent with a decoupling of the gas generator turbine from the compressor. The 1st stage turbine Energy Absorption Ring was bulged from contact by the 1st stage turbine wheel. The gas-producer turbine support was bulged and fractured axially at the 12 o'clock position.

First Stage Turbine Wheel

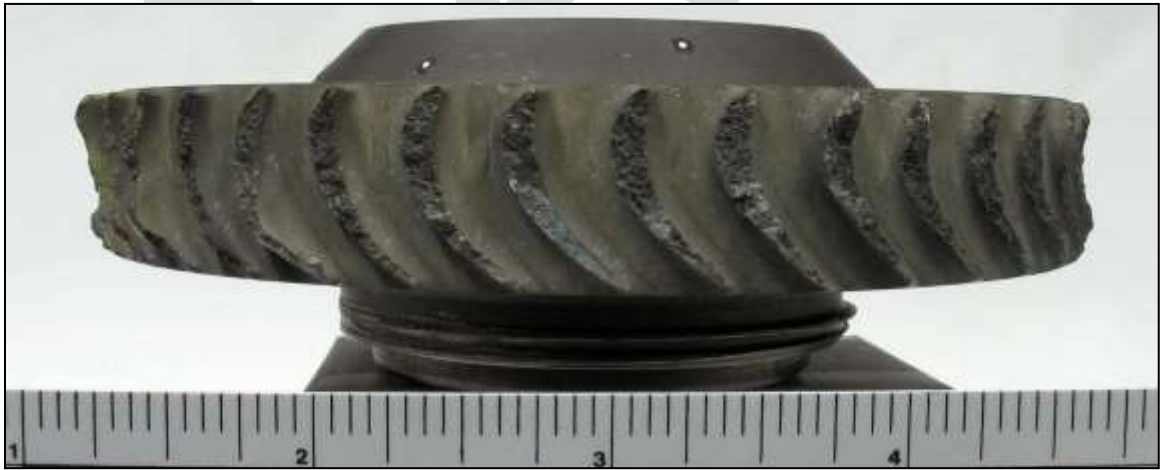
The 3rd stage turbine wheel had liberated all of its blades at the root. Detailed examination of the 3rd stage turbine blade fractures revealed a single blade had failed in high cycle fatigue (HCF). All other blades had fractured in overload. The high cycle fatigue fracture of the single 3rd stage turbine blade was determined to be the initiating event of the engine failure.

3rd Stage Turbine Wheel

During investigation it was found that that 3rd stage turbine wheel blade fractured in high cycle fatigue at the trailing edge hub location due to operation of one or more natural frequencies of the wheel. Failure of first blade led to a rapid failure of turbine wheel as remaining blades fractured in overload.

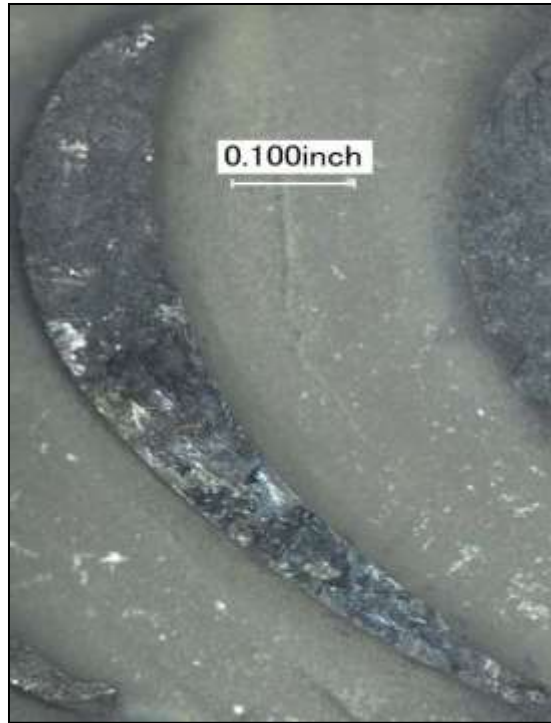
Metallurgical examination of the fatigue-fractured blade revealed the fatigue crack progressed approximately 0.48 inch from the trailing edge before final fracture and separation of the blade in overload. The total cross sectional area of the blade measured approximately 0.0593 square inches, and the cross sectional area of the overloaded portion of the fracture measured approximately 0.0308 square inches

Scanning Electron Microscope (SEM) examination of the fatigue fracture revealed rub damage on the suction side and a Stage I fatigue facet on the pressure side of trailing edge. No surface anomalies were noted on the walls of the blade near the facet. These fracture features are consistent with high cycle fatigue initiation and propagation of the crack.

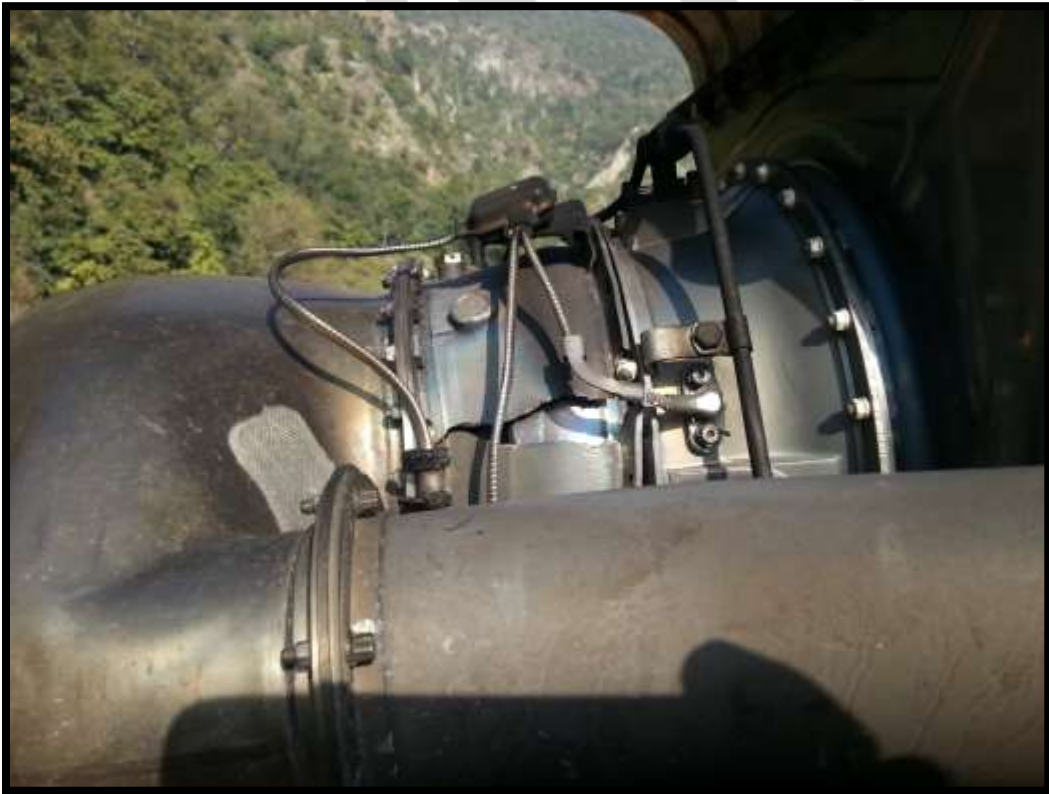
Inspection of the engine exterior didn't revealed any obvious signs of damage from ground impact but exhibit evidence of uncontained turbine burst. Fractured pieces of power turbine wheel and turbine outer shroud were observed.

Damage to Engine
