FINAL REPORT ON ACCIDENT TO FAST HELICHARTERS INDIA PVT. LTD.
HELICOPTER BELL 206 B III VT-TBA AT GODHRA (GUJARAT) ON
29/08/2012

SUMMARY

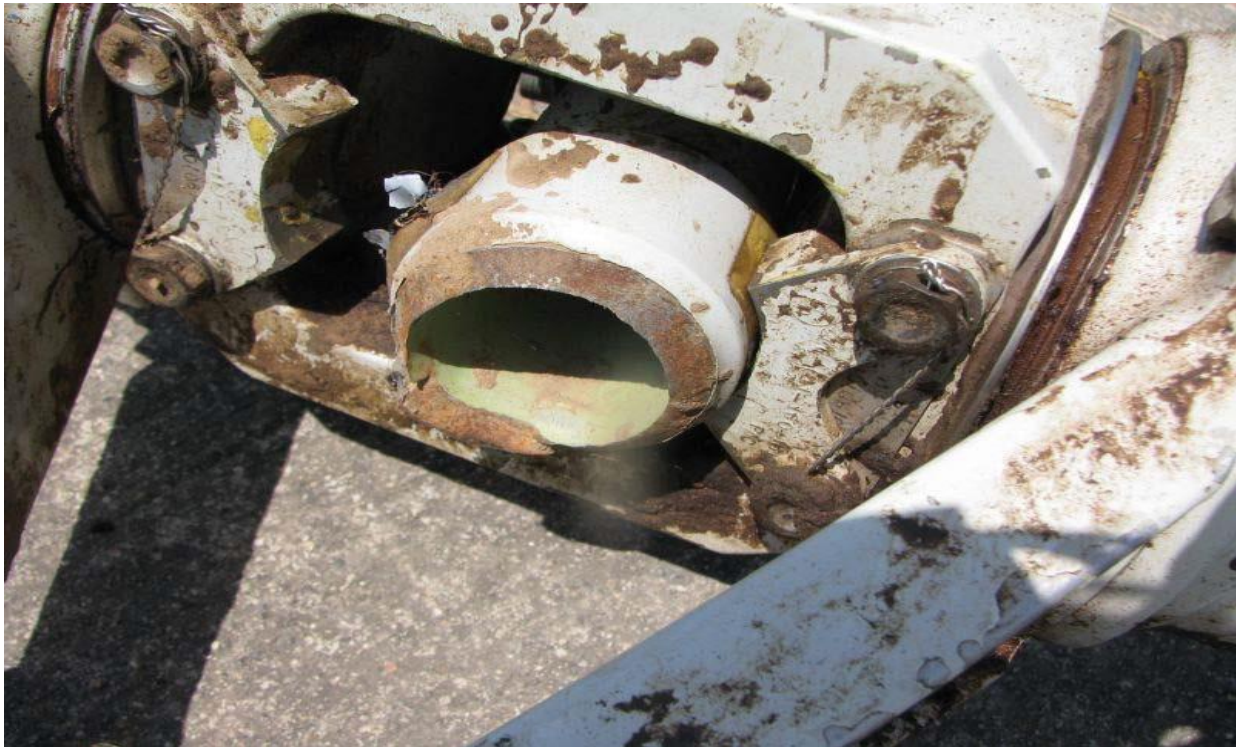
shaft was rotated by hand, corresponding rotation was observed forward through the main driveshaft to the mast, demonstrating drive continuity within the main transmission. The freewheeling unit operated freely, being driven when the #4 power turbine wheel was turned by hand and rotating freely when the main or tail rotor driveshafts were rotated by hand. The three chip detectors on the main transmission revealed no debris or chips. The mast fractured below the static stop contact pad consistent with bending overload from hub to mast contact at impact (Picture 1).

Picture 1 Mast fractured below static stops

Rotation marks on the mast were consistent with the mast rotating in the dirt after impact.

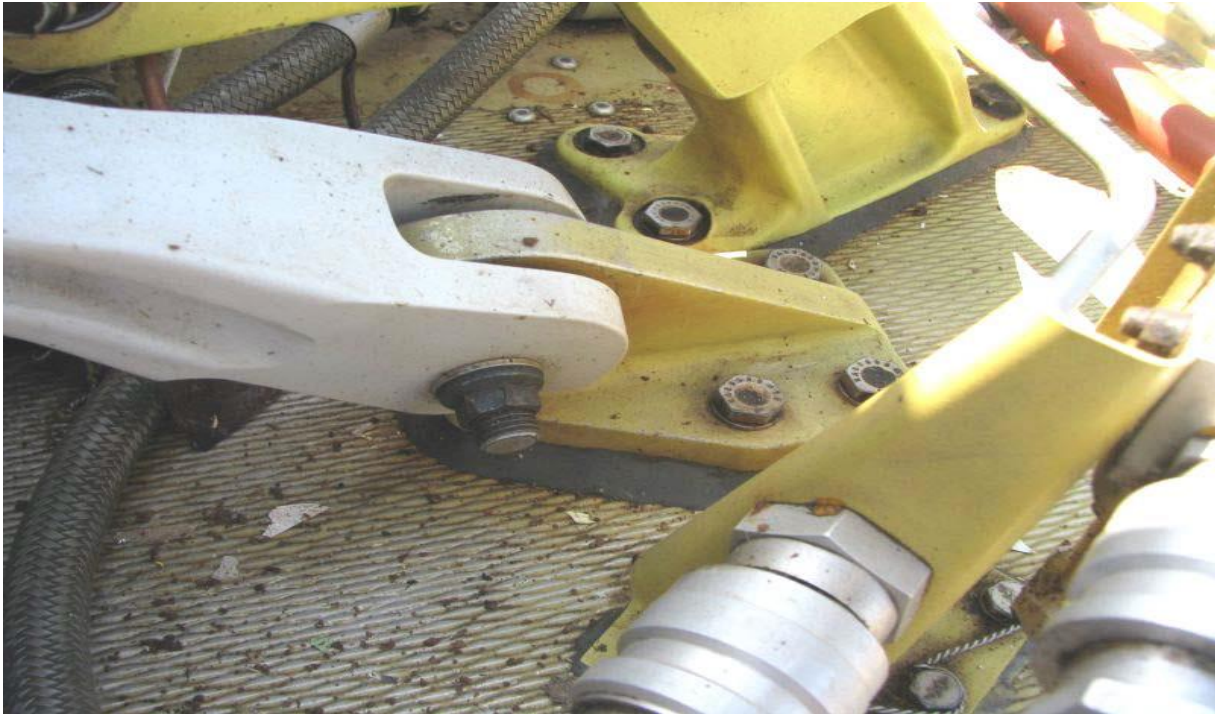
The spindle mounts that connect the transmission case to the A-frame mounts on the left and right sides were intact. The four A-frame mount legs were all securely attached to roof structure (Picture 2).

Picture 2 Right forward transmission A-frame mount solidly connected to roof structure

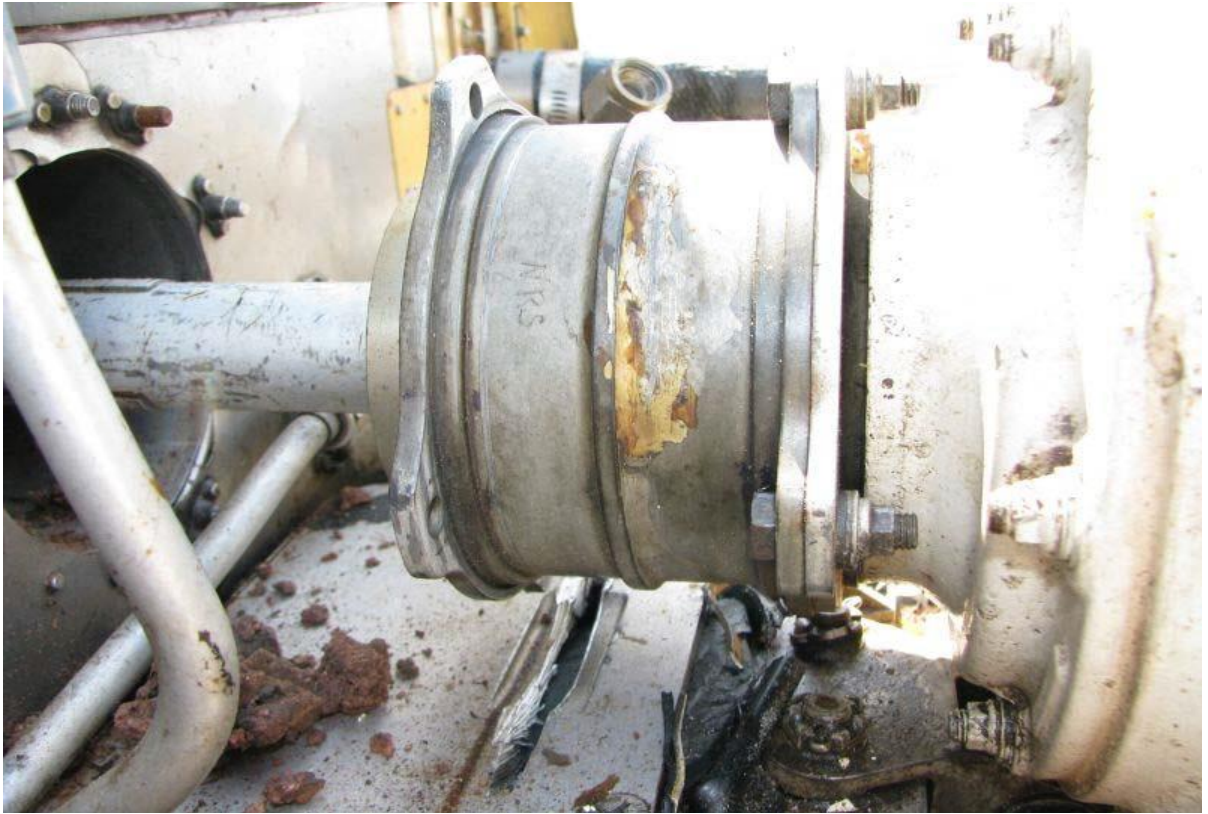
The main driveshaft was intact. However, overheat indicating temperature dots on forward and aft outer couplings were missing. The aft (engine side) outer coupling was missing two temp dot arrays, a red and yellow array. The remaining red and yellow temp dots were all white in color, indicating that an overheat condition had not occurred on the aft coupling. The forward (transmission side) outer coupling was missing all four temp dot arrays (Picture 3).

Picture 3 Forward outer main driveshaft coupling with no temp dot arrays installed

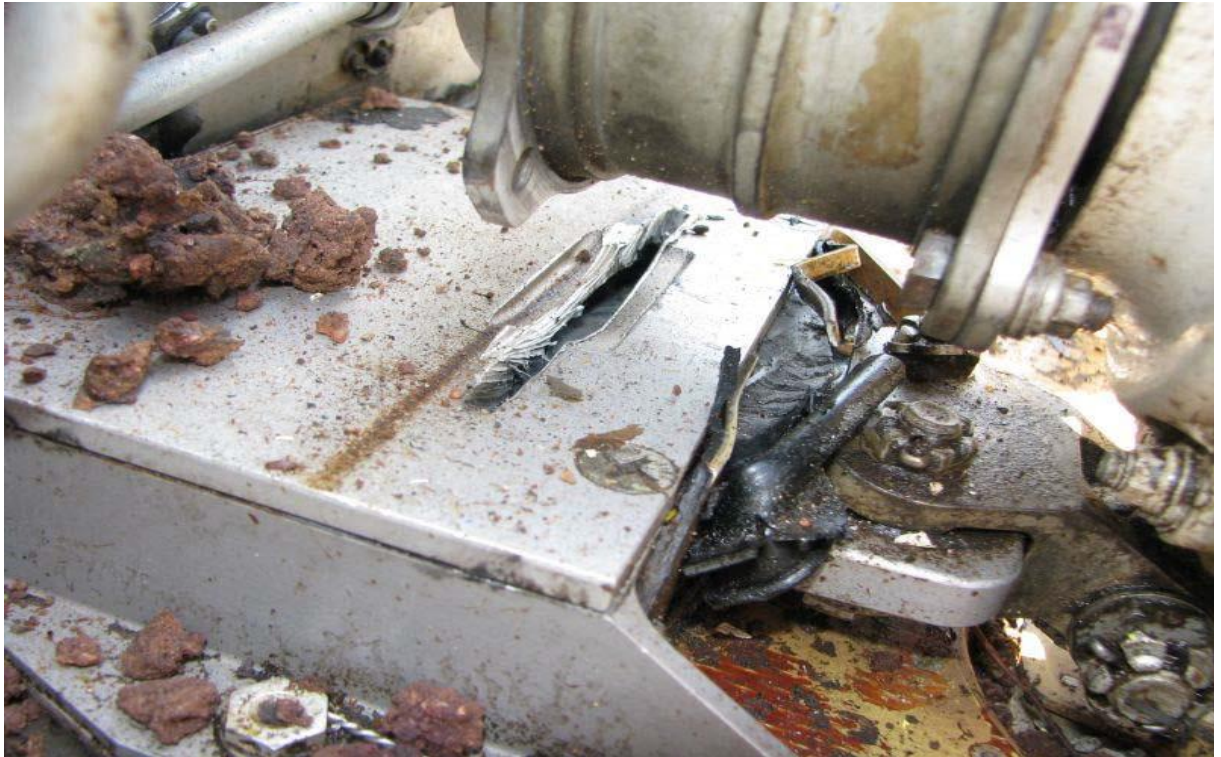
The aft flange on the forward outer coupling made rotating contact with the isolation mount below it and aluminium material from the mount was abraded away, consistent with occurring during impact (Picture 4).

Picture 4 Isolation mount with abraded away material from rotating contact with outer coupling

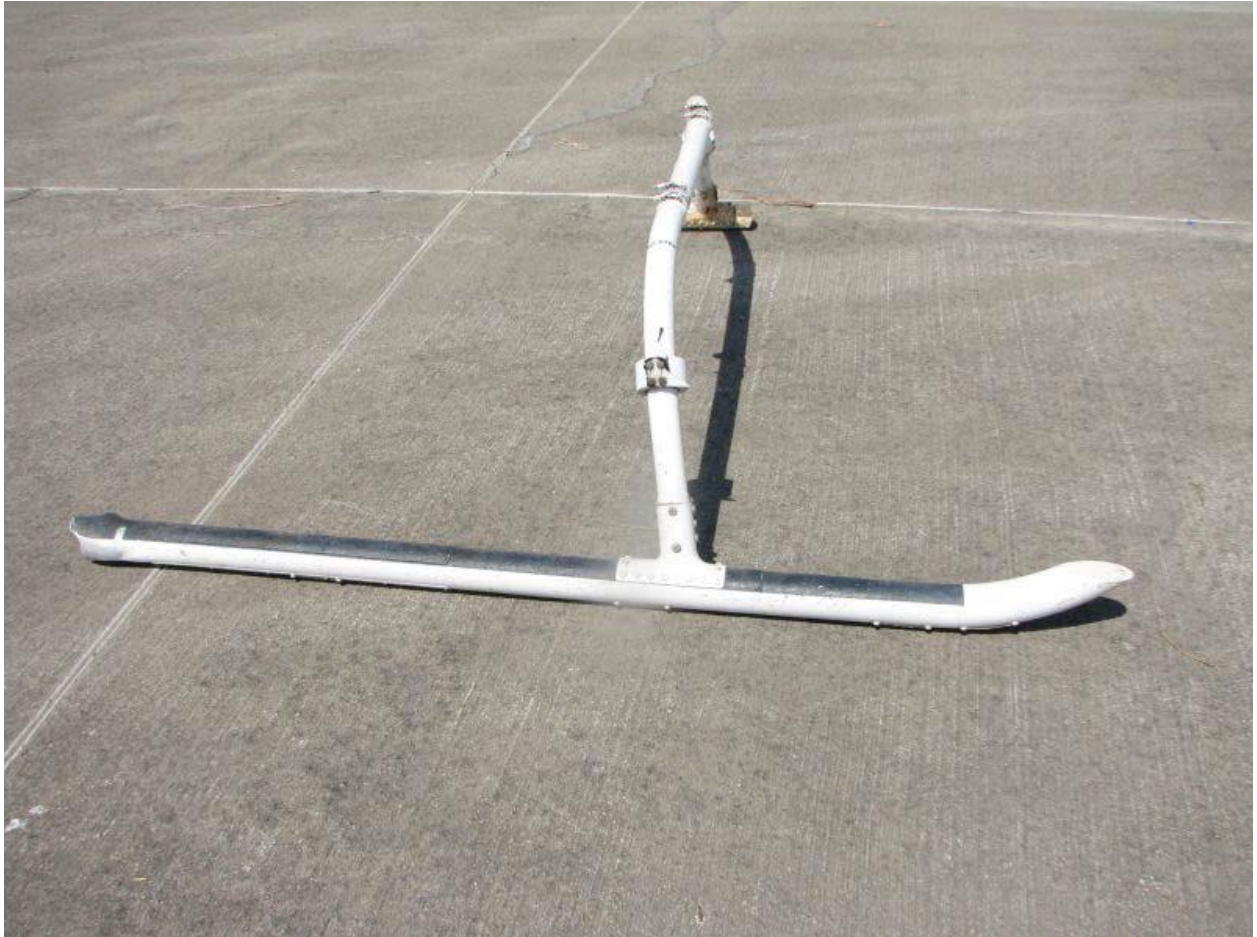
Much of the landing gear was also missing after recovery of the wreckage (Picture 5).

Picture 5 Remnants of landing gear

On the remaining landing gear available for examination, the left skid toe was observed to have fractured consistent with the nose low impact forces. All seat belts and shoulders harnesses were intact for the five seat locations and all shoulders harness inertial reels were found to operate properly by locking when pulled by hand and then releasing when pressure was relaxed.

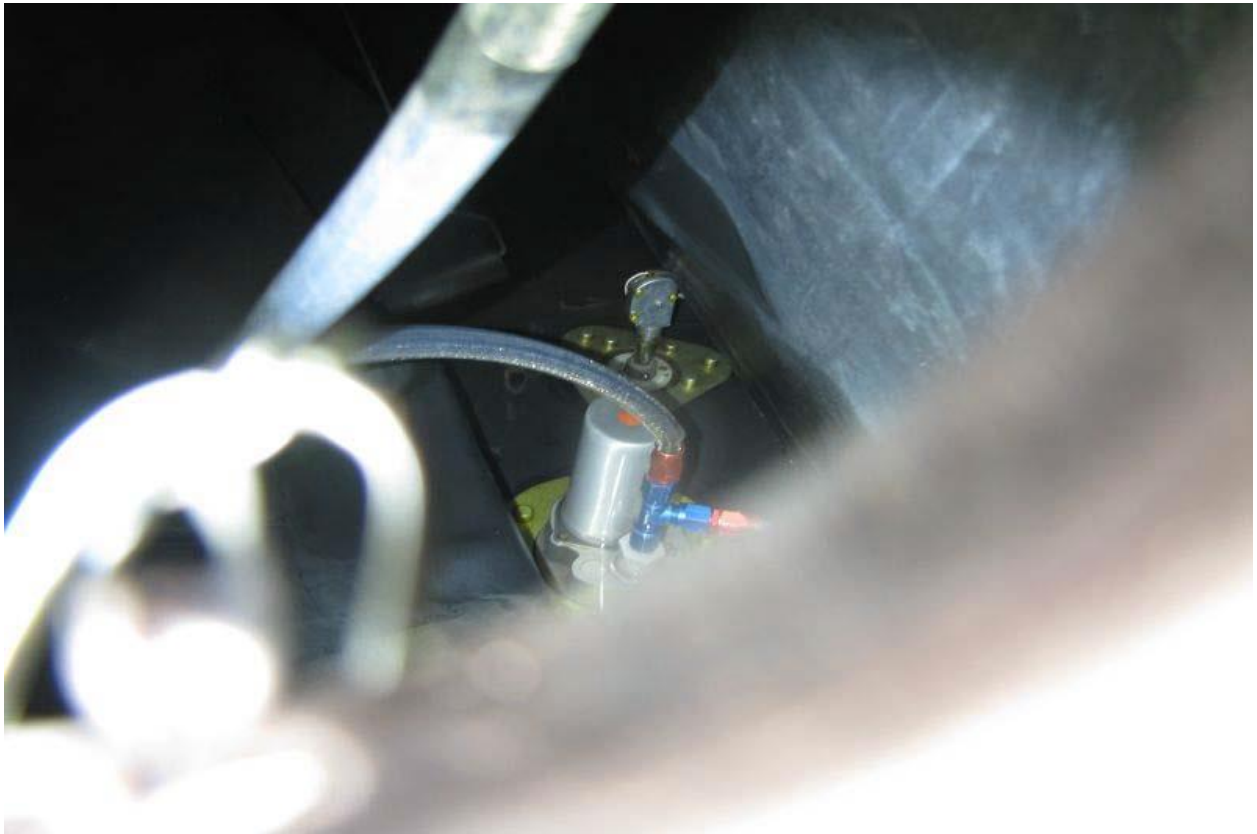
A small amount of clear liquid was observed in the bottom of the fuel tank through the fuel filler and vapors smelled like fuel. The aft boost pump was observed intact with the bottom end of the fuel feed line attached (Picture 6).

***Picture 6 View through fuel filler of aft boost pump and intact fuel feed line attachment
The top end of the fuel tank feed line was firmly attached to the fitting at the top of
the tank.***

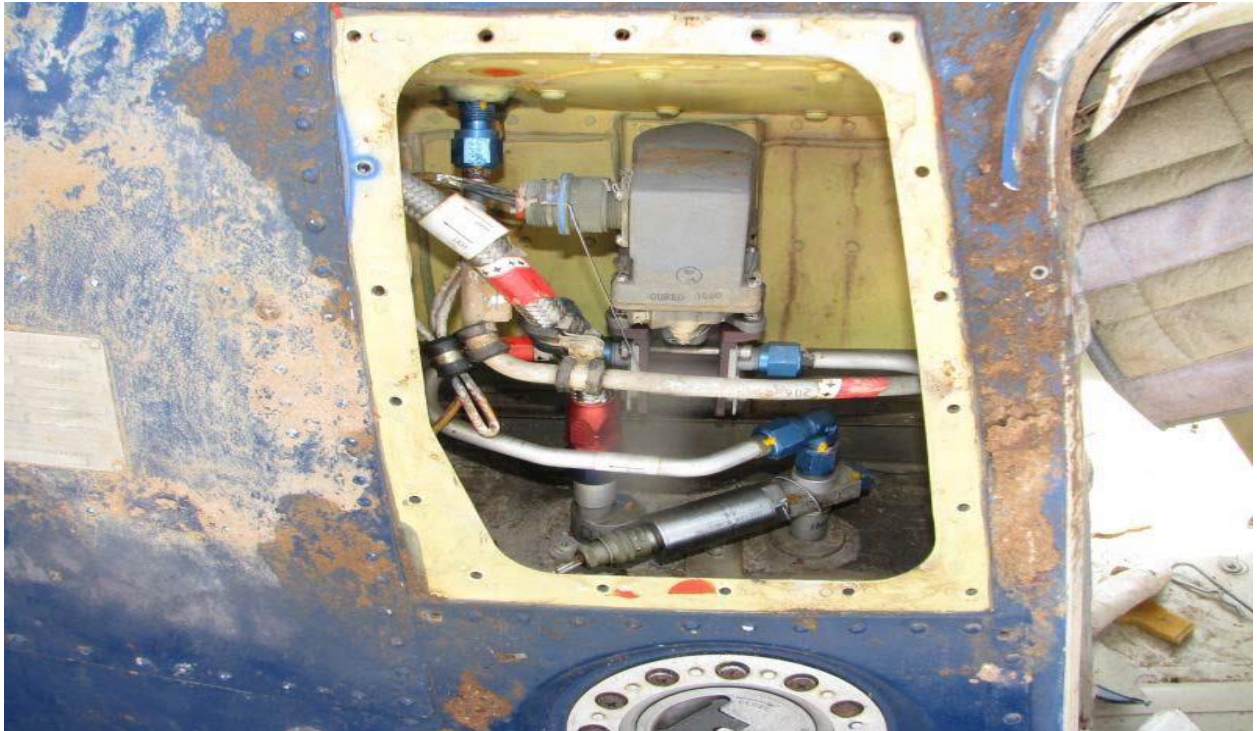
Fuel lines to the fuel shut-off valve and fuel pressure transducer all appeared intact with no leakage noted (Picture 7).

Picture 7 Fuel lines to shut-off valve and fuel pressure transducer were intact

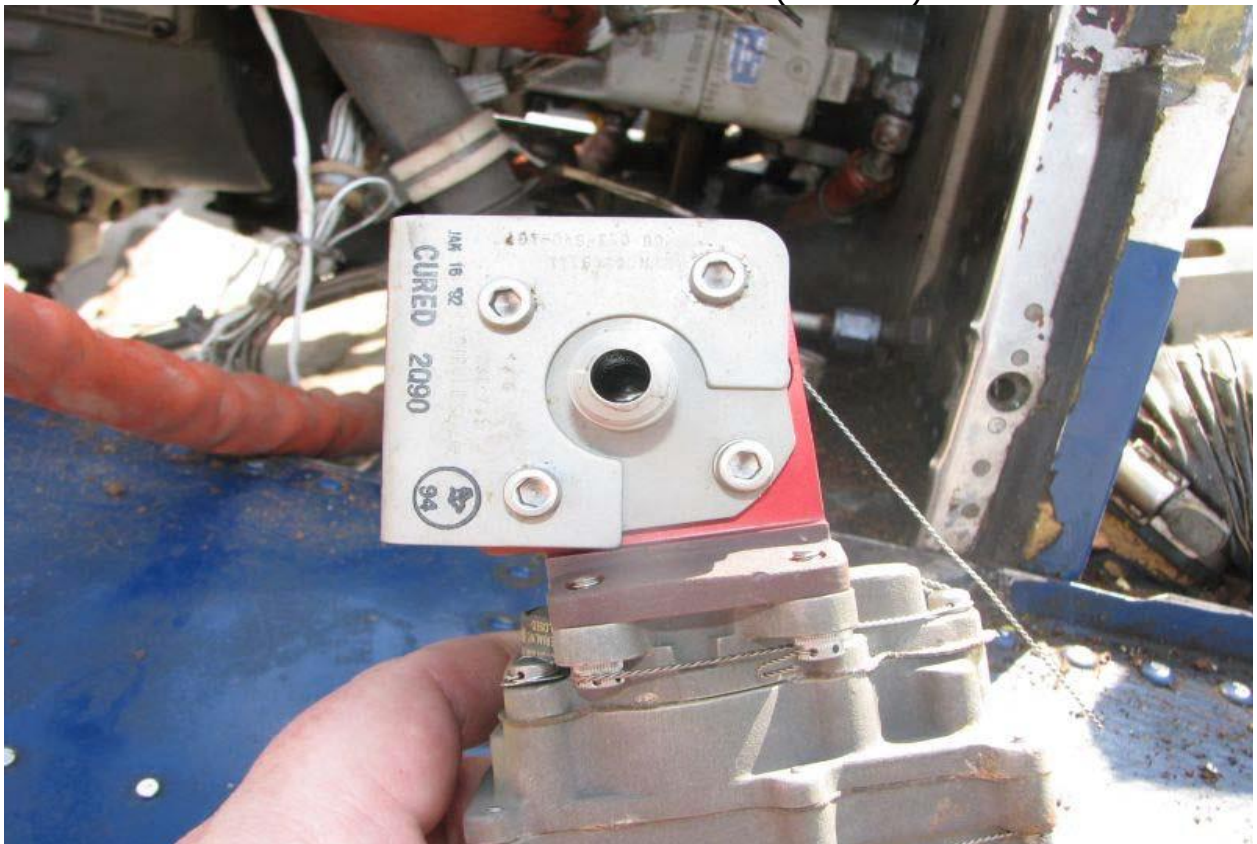
The fuel valve was removed and observed to be close (Picture 8)

Picture 8 Fuel valve removed from mounting and observed to be in Closed position which corresponded to the Off position observed on the fuel valve switch in the cockpit (Picture 9).

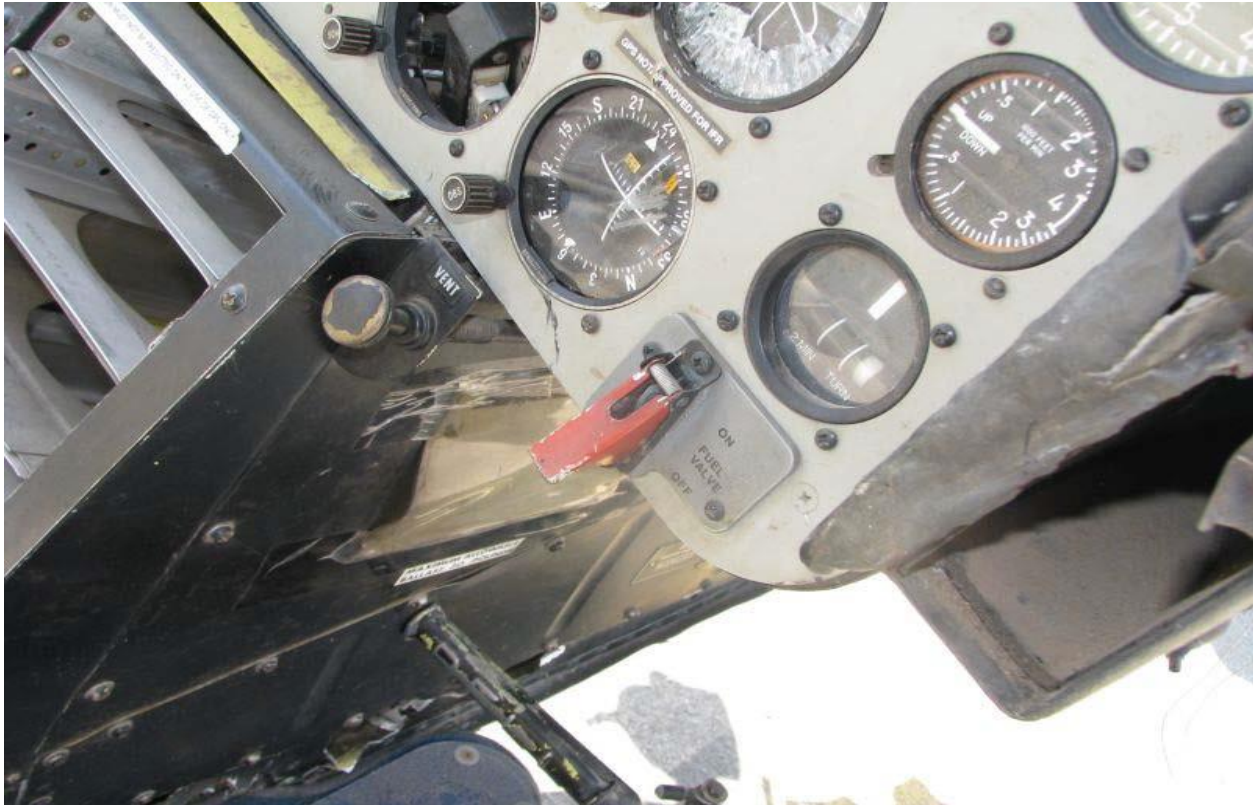
Picture 9 Fuel valve switch in Off position

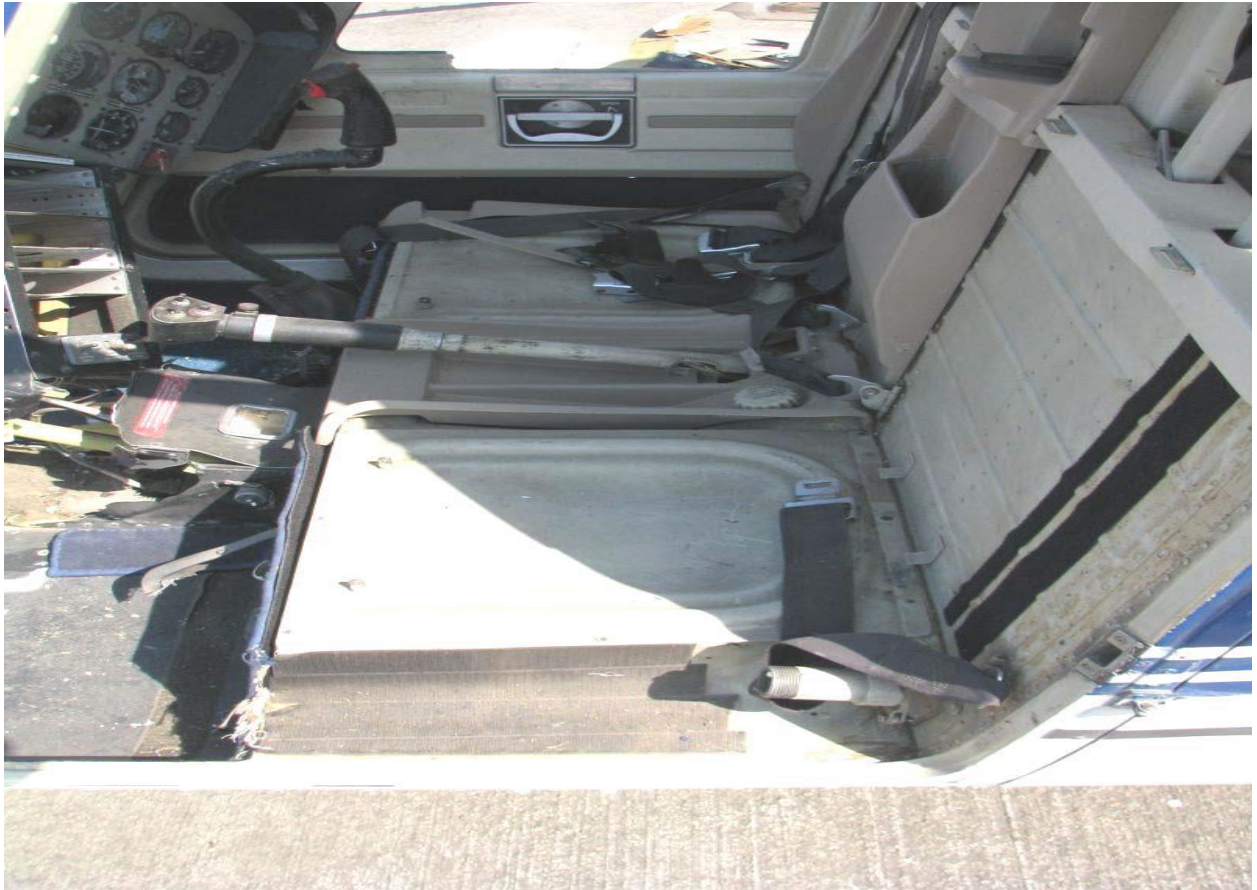
Picture 10 Helicopter equipped with single controls at pilot station

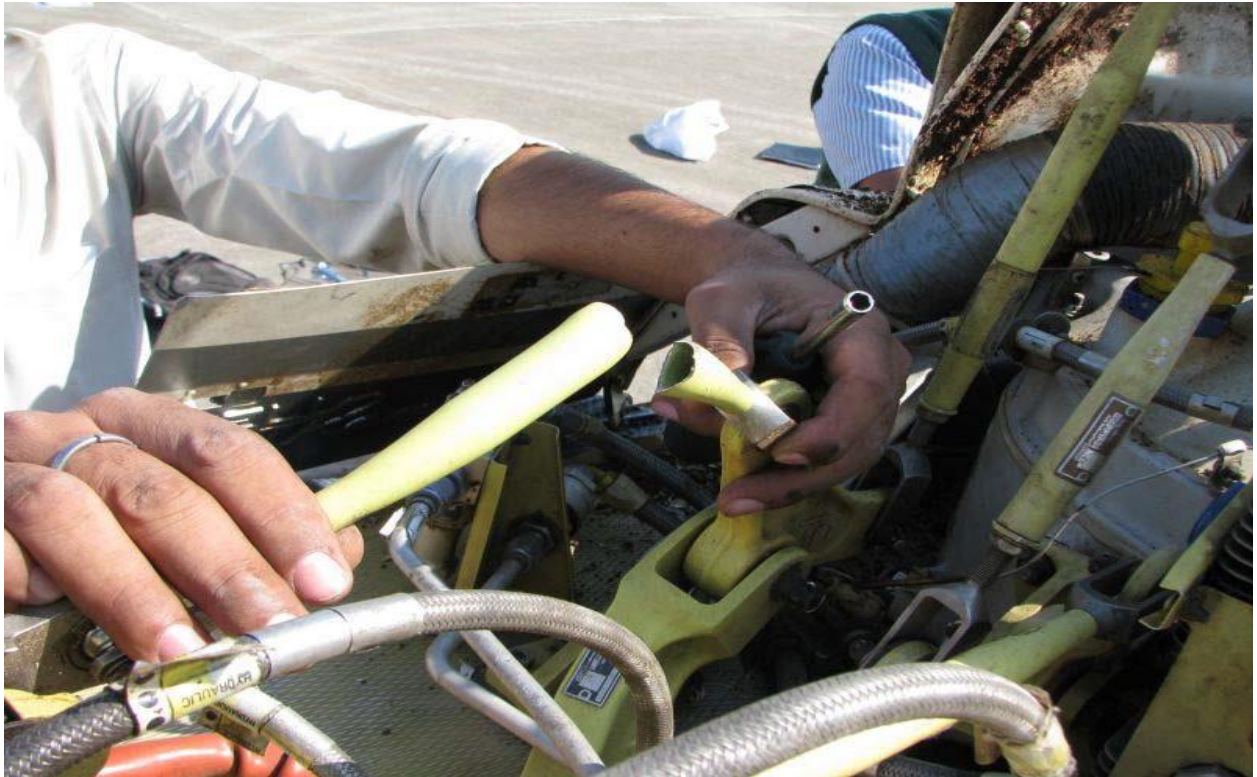
The right side servo extension tube aft of the right servo was fractured consistent with overload bending forces (Picture 11).

Picture11. Right servo extension tube fractured consistent with bending overload at impact.

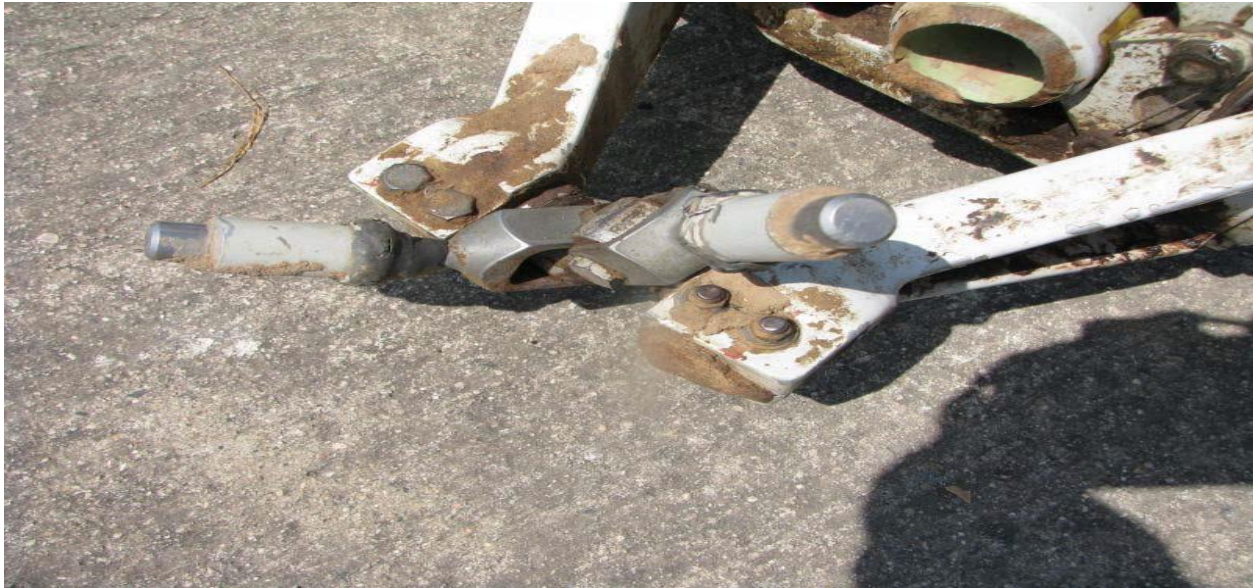
The pitch change links between the swash plate and main rotor hub exhibited overload fractures consistent with departure of the main rotor at impact. The top end of both pitch change links were fractured at the clevis insert (Picture 12).

Picture 12. Top end of both pitch change links fractured at clevis inserts consistent with overload

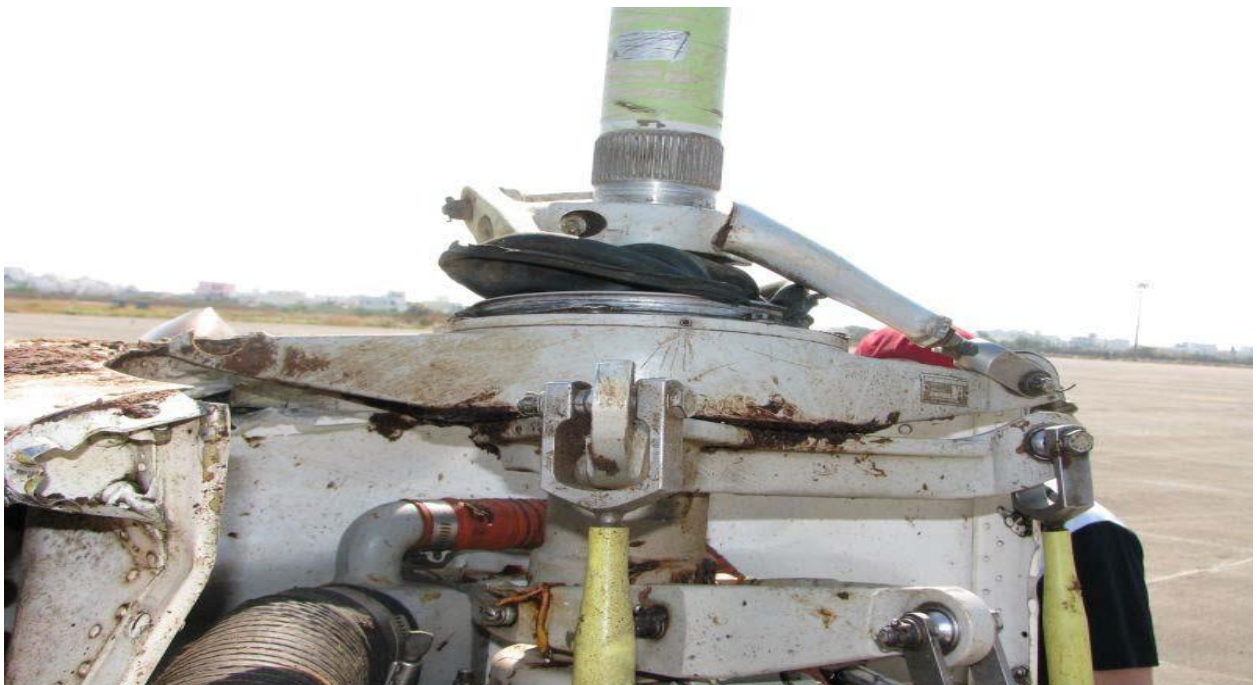
The clevises remained attached to their respective pitch change horns. On the bottom end, one pitch change link was fractured consistent with bending overload forces approximately 6 inches from the bottom of the link (See Picture13). On the other pitch change link, the swash plate attachment ear that supports a monoball bearing was fractured (Picture 13).

Picture13 Pitch change link (red) and swash plate attachment ear (blue) overload fractures

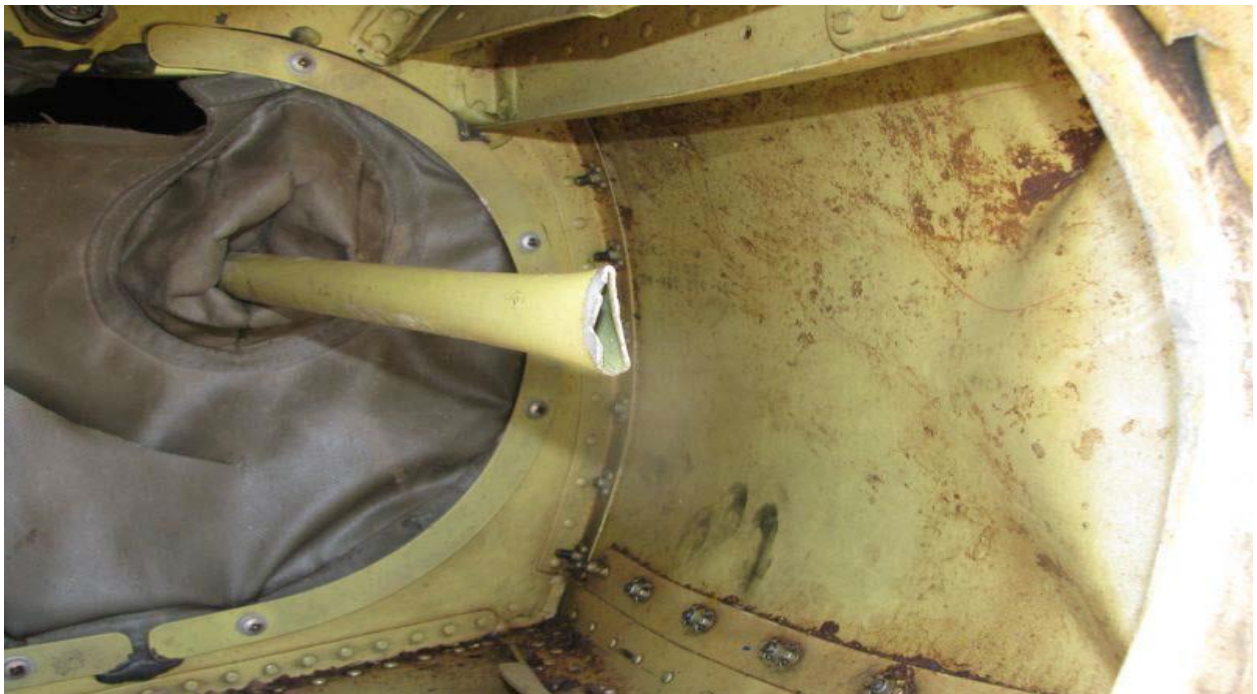
Since the tailboom and attached tail rotor control system were missing and not available for examination, it was not possible to fully examine the tail rotor control system. An overload fracture of the forward end of the long tail rotor control tube that transits the tailboom was observed at the aft fuselage tailboom attachment fitting (Picture 14).

Picture14 Overload fracture of long tail rotor control tube near aft fuselage tailboom attach point

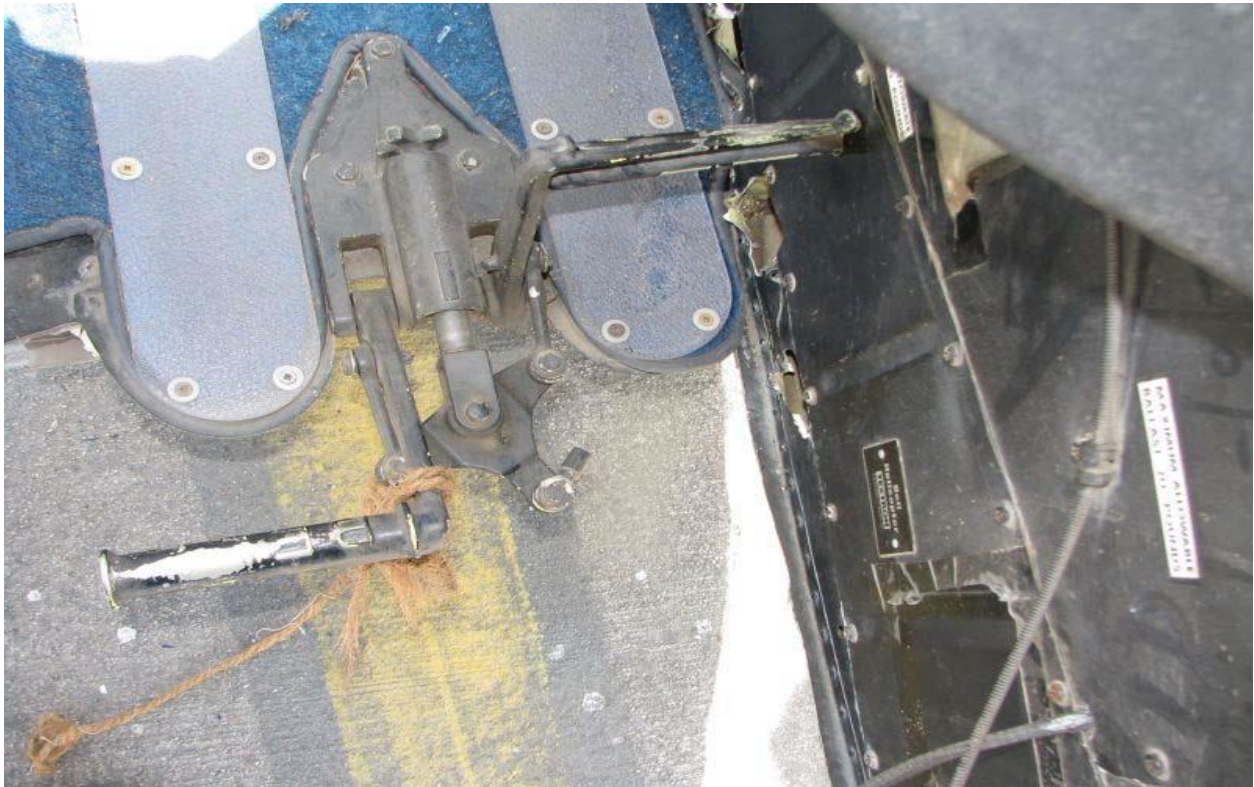
Picture15 Pilot anti-torque pedals intact

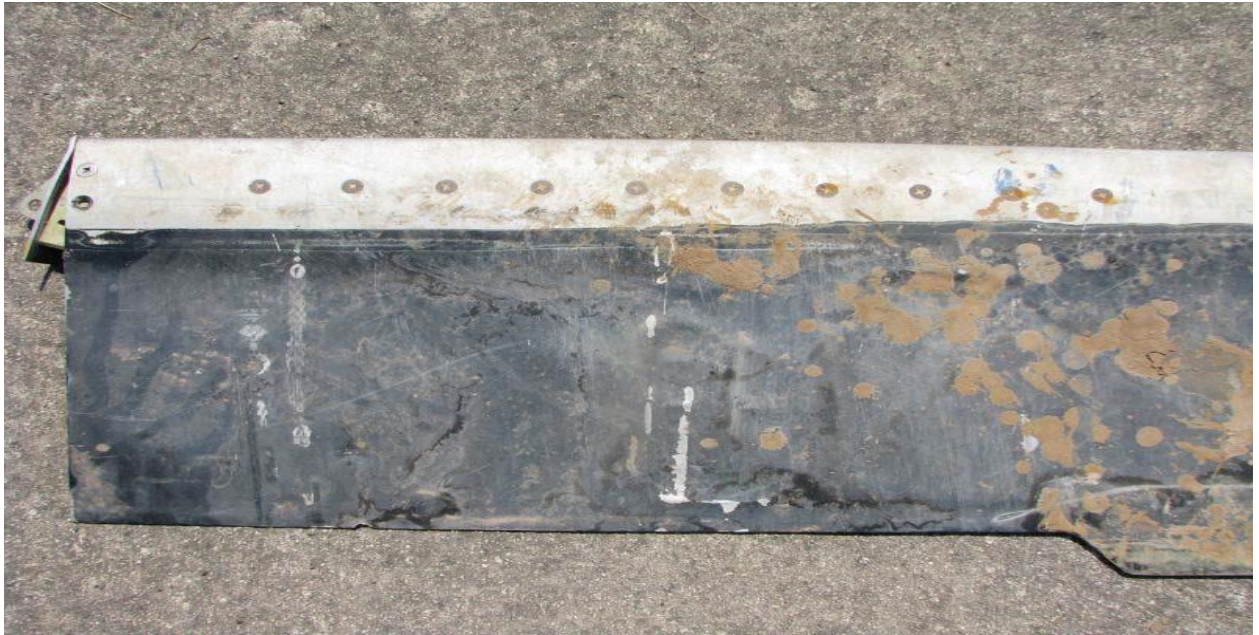
Both main rotor blades had intact spars. Each plate exhibited chordwise markings at outboard surfaces consistent with striking the tail booms (Picture 16).

Picture16 Main rotor blade tip section with chordwise markings on bottom of blade

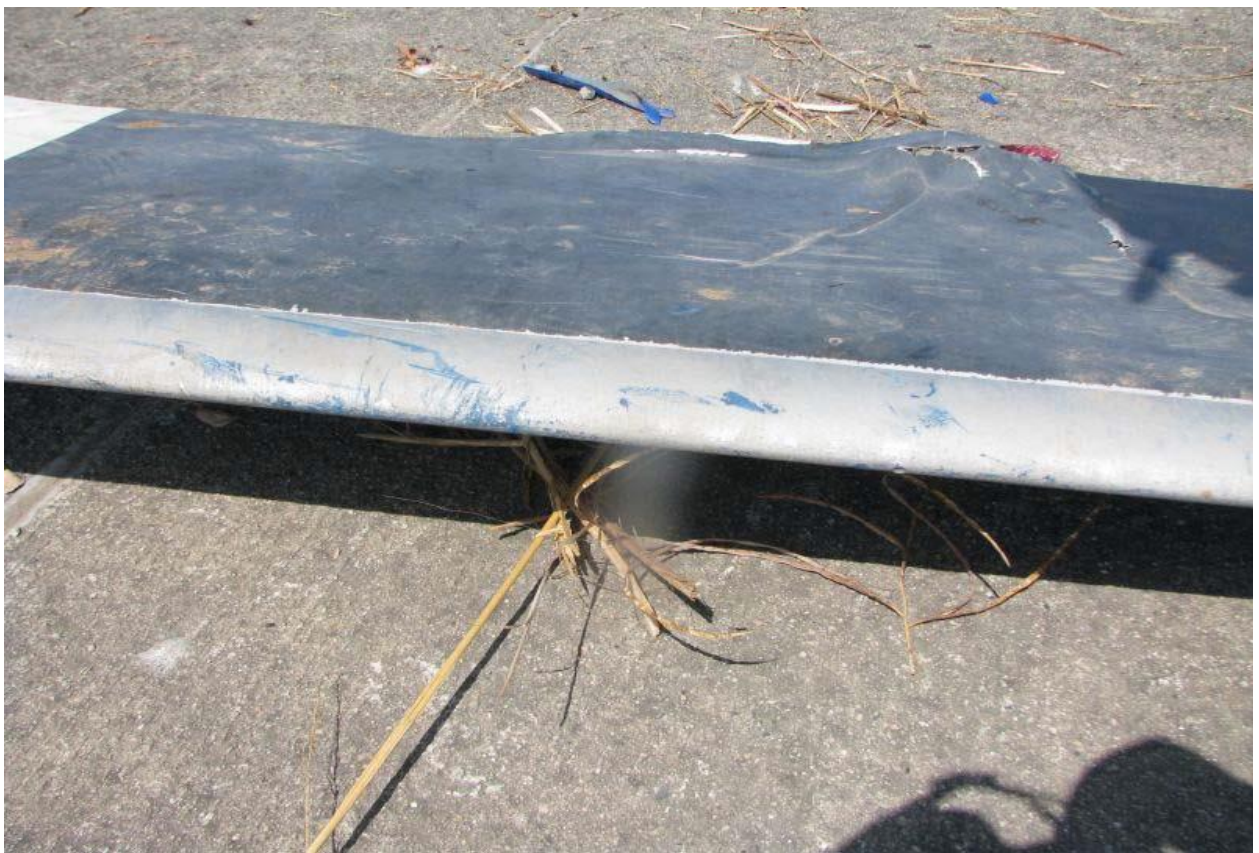
Blue paint transfers on leading edge surfaces were consistent the reported colors of the tailboom (Picture 17).

Picture 17 Blue paint transfers consistent with tailboom color on main rotor blade leading edge

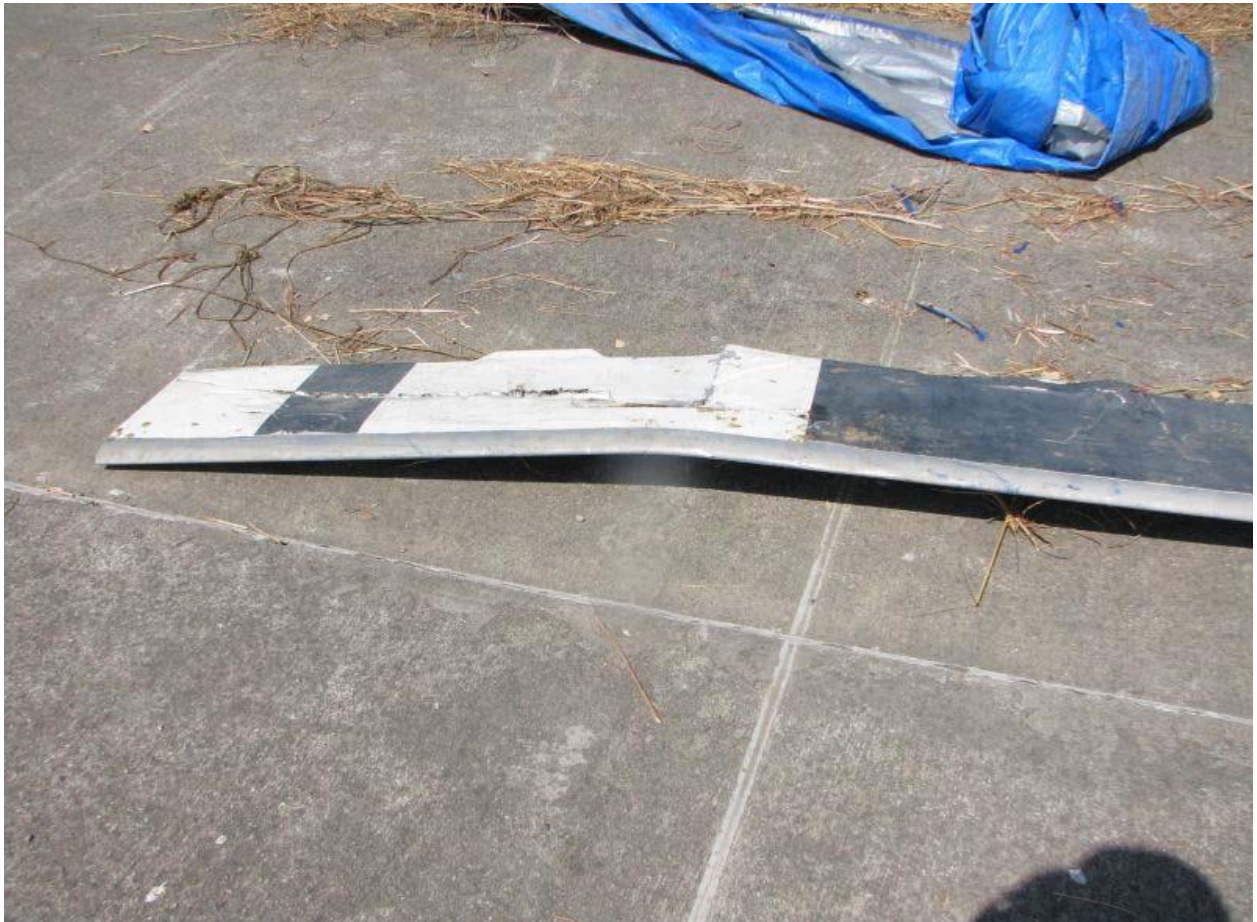
One main rotor blade exhibited a downward bend approximately three feet from the tip consistent with compression forces applied at ground contact when the helicopter nose over (Picture 18).

Picture 18 Main rotor blade bent down approx. 3 feet from tip consistent with ground contact

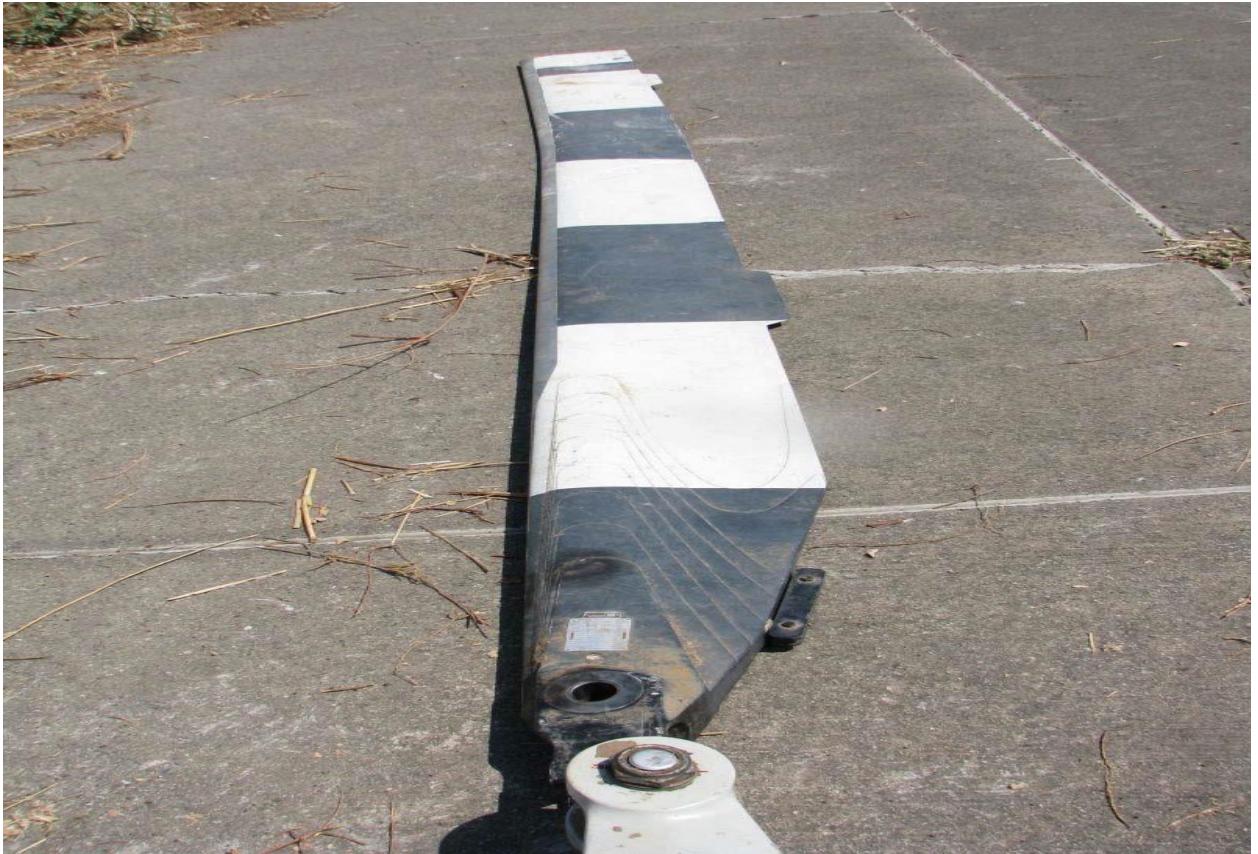
The other main rotor blade was removed from the hub at the accident site to facilitate ground transport. The blade spar had bent forward at the approximate 2/3 span location consistent with inertial forces when the first blade made ground contact (Picture 19).

Picture19 Main rotor blade bent forward consistent with inertial forces when other blade struck round.

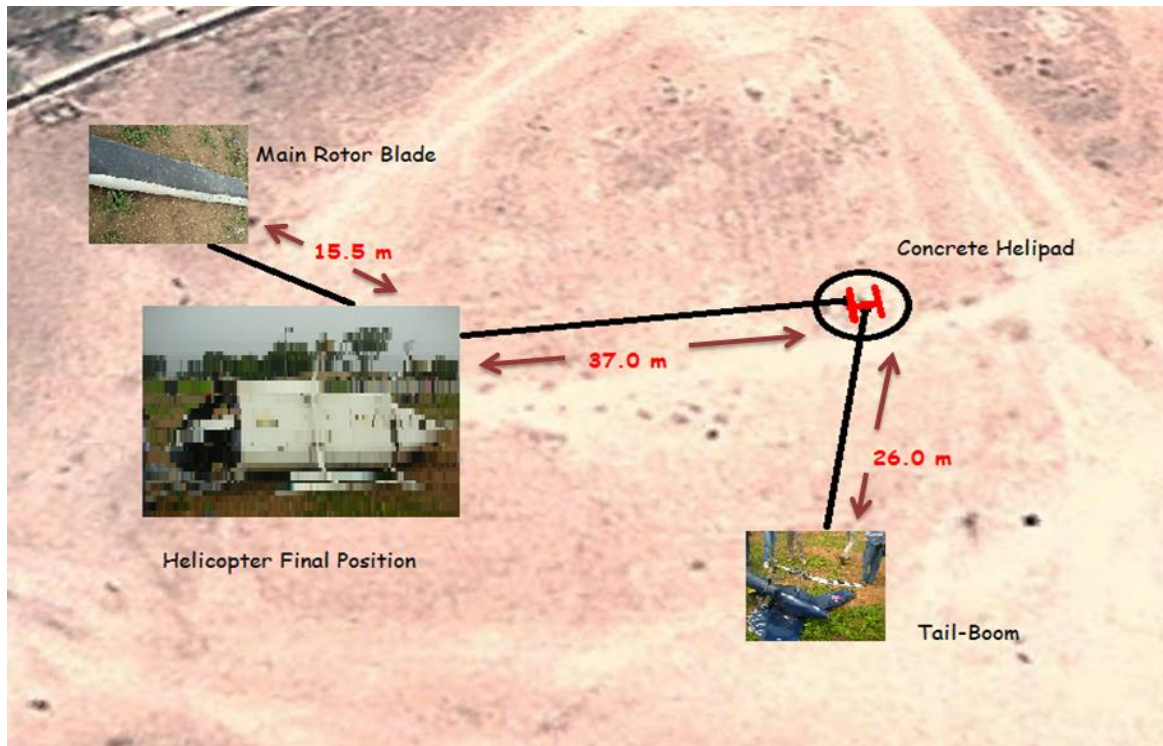
The Helicopter completely destroyed as it had sustained substantial and irreparable damage.

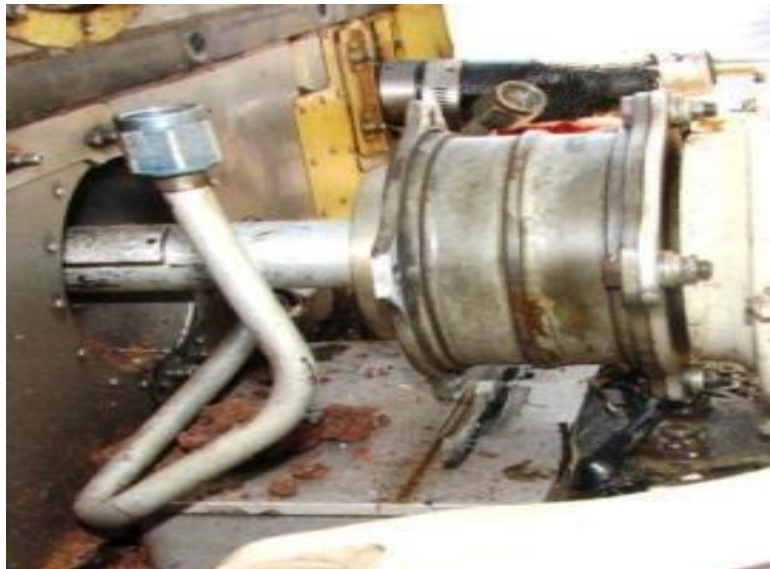
Fuel-Filter 'Pop-Up' Bypass Indicator

7. The airframe mounted fuel filter was equipped with a filter bypass and associated "pop-up" bypass indicator. The bypass had not been activated.

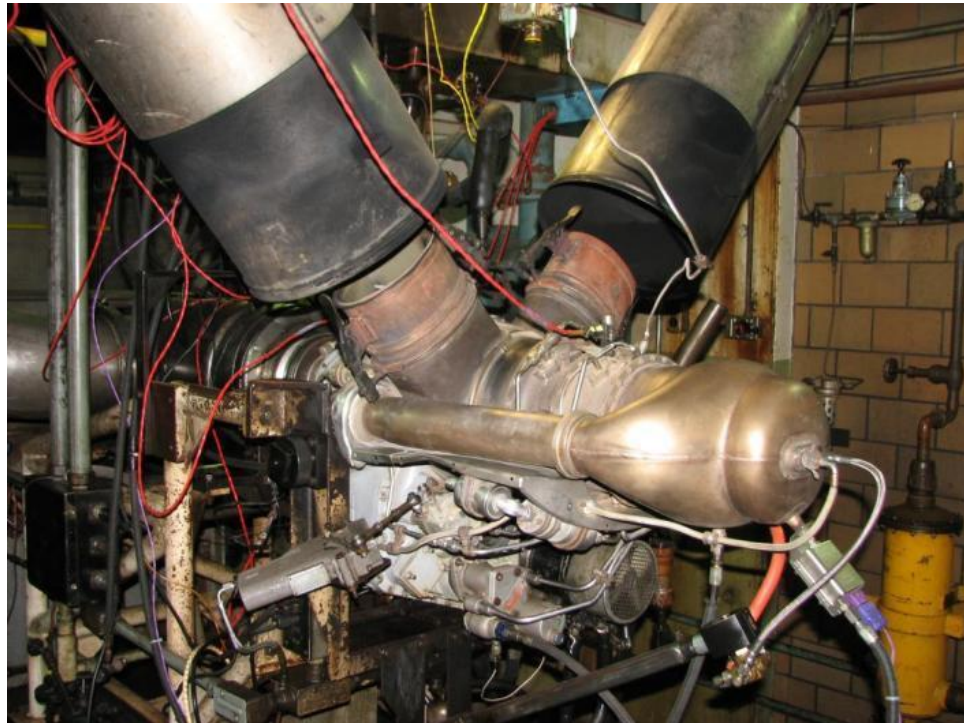
Engine Test Run carried out on the Test Bed

The engine was installed on test cell #145 and a 6-point performance test was conducted to new engine production standards, in accordance with EDR 19034D. The engine successfully started, ran and shut down. The engine successfully completed ground-idle, flight-idle, max-continuous-power and take-off power runs, in addition to "wave-off" max-power increases. When corrected for standard atmospheric conditions, the engine yielded performance 11.3% below new-production standards at „low cruise“ (300 horsepower), -9.5% below new-production standards at normal cruise (370 horsepower), and +0.5% above new-production standards at maximum (Take-Off) power (420 horsepower). The engine then completed "wave-off" max-power transients,

simulating the accident sequence, where the power was reduced to flight idle and then rapidly increased to take-off power. The engine responded normally and responded with maximum power without surging or hesitation.
