FINAL REPORT ON ACCIDENT TO FAST HELICHARTERS INDIA PVT. LTD.
HELICOPTER BELL 206 B III VT-TBA AT GODHRA (GUJARAT) ON
29/08/2012

SUMMARY

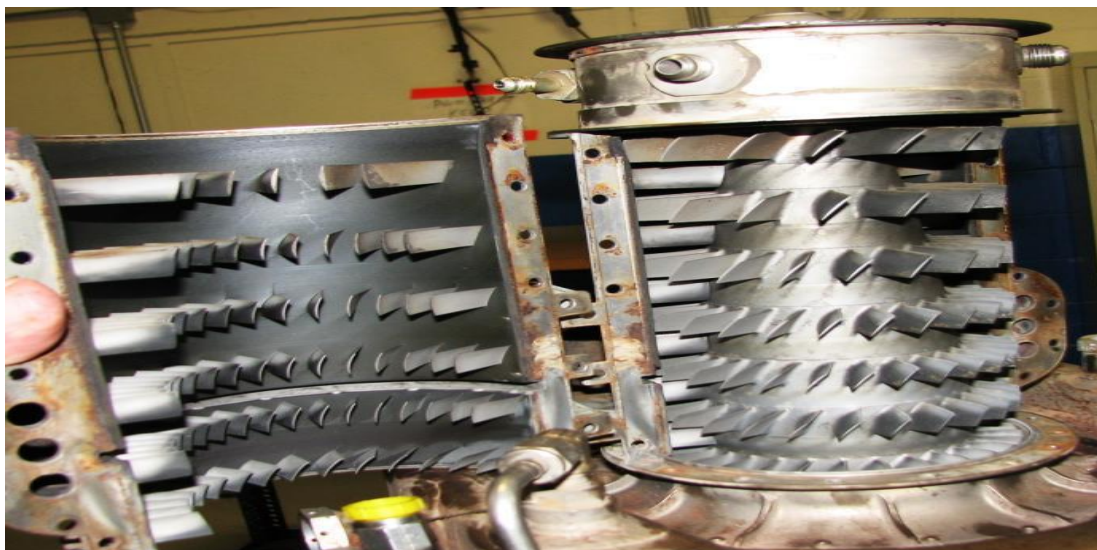
Condition of Engine's Compressor Blades

Following the successful test cell run, the compressor case halves were opened and examined. No abnormal wear, erosion or foreign object damage was noted on any internal compressor components. Evidence of corrosion was present on all compressor blades.

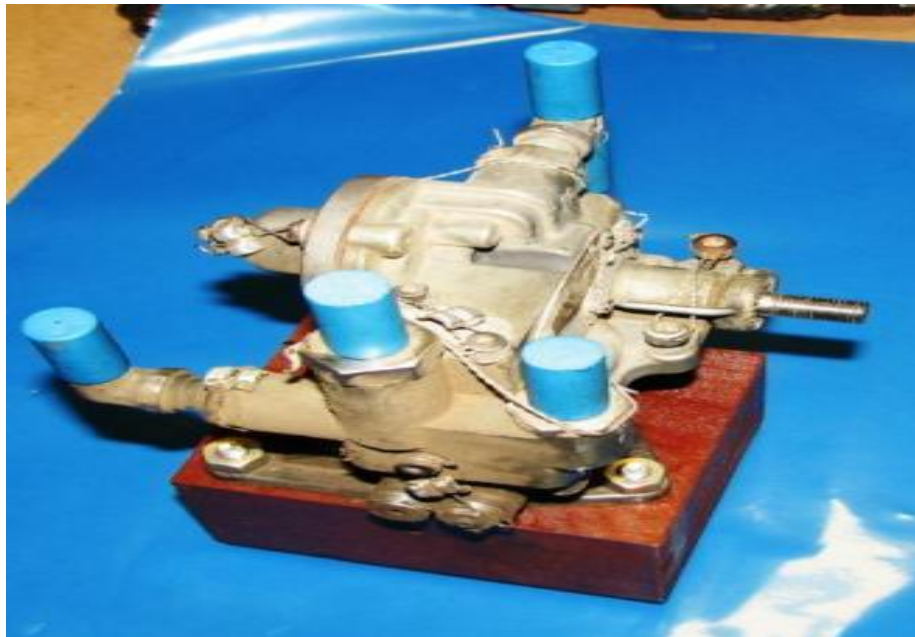
Functional testing of the unit did not disclose any condition that would cause a sudden change in output to the fuel control. The Power Turbine Governor functioned normally.

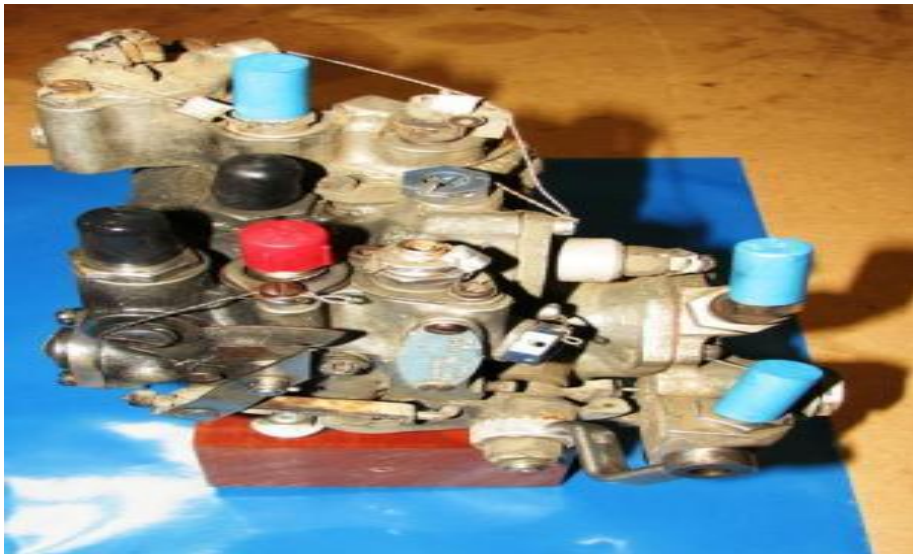
Fuel Control Unit

Functional testing of the unit did not disclose any condition that would cause a sudden change in fuel flow.

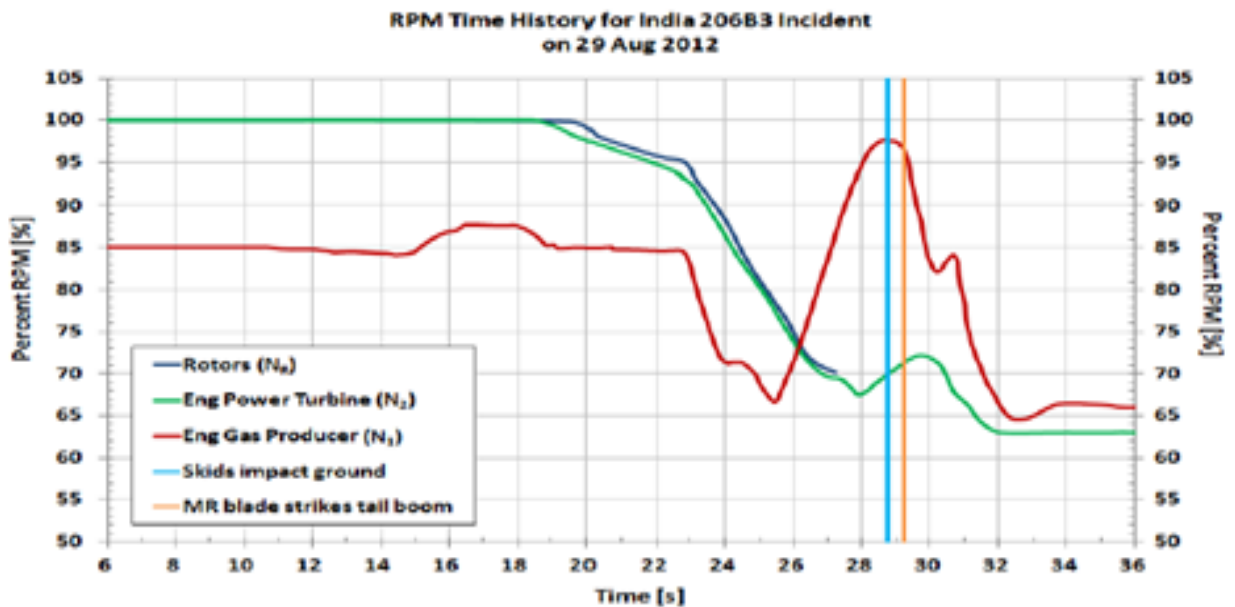
Test Result

The plot further indicates that approximately 4 seconds before impact, when NR has dropped to around 80%, N1 is seen to increase sharply, reaching nearly 100% rpm at the time of ground impact. This steep rise in N1 is consistent with the PIC's increasing the throttle prior to impact. After impact N1 quickly falls to around 66%, which closely corresponds to the compressor nominal ground idle speed of 65%. The increase in N1 is followed by a brief increase in N2, which then also falls after the crash to around 63%. The pilot also indicates that the engine continued to run for approximately 65 seconds following the impact, after which the engine shuts down. During this time following the crash, N1 stays between approximately 65 – 68%, which corresponds to a power output of between 20 – 30 shp. A similar trend is seen from N2 which stays at approximately 61 – 63% during this time. At around 94 seconds both N2 and N1 begin to drop. The engine can be heard in the audio to spin down at this time.

It was concluded that during the final 10 seconds of flight, the rotor and engine power turbine speeds dropped quickly from 100% to approximately 68% at the time of ground impact. The Bell 206B3 low-rotor-rpm alert is reported to have been heard by the PIC during descent. A sharp rise in N₁ 3-4 seconds before skid impact is consistent with a
