FINAL REPORT OF ACCIDENT TO KING AIR C90A AIRCRAFT VT-KPC AT PUNE AIRPORT ON 07th SEP. 2012

Type	:	King Air
Model	:	C90A
Nationality	:	INDIAN
Registration	:	VT-KPC
Owner and Operator	:	M/s Finolex Industries Limited
2. Date of Accident	:	07.09.2012
3. Time	:	20 :08 hrs.
4. Last point of Departure	:	Pune
5. Point of intended landing	:	Pune
6. Geographical location of Accident (Lat. Long)	:	18°34'57''N 073°55'13''E
7. Type of operation	:	Practice Flight (Circuit & landings).
8. Phase of operation	:	Landing
9. Type of Accident	:	Undershoot, Non-fatal
10. Commander's License	:	ATPL
11. Damage to aircraft	:	Substantial

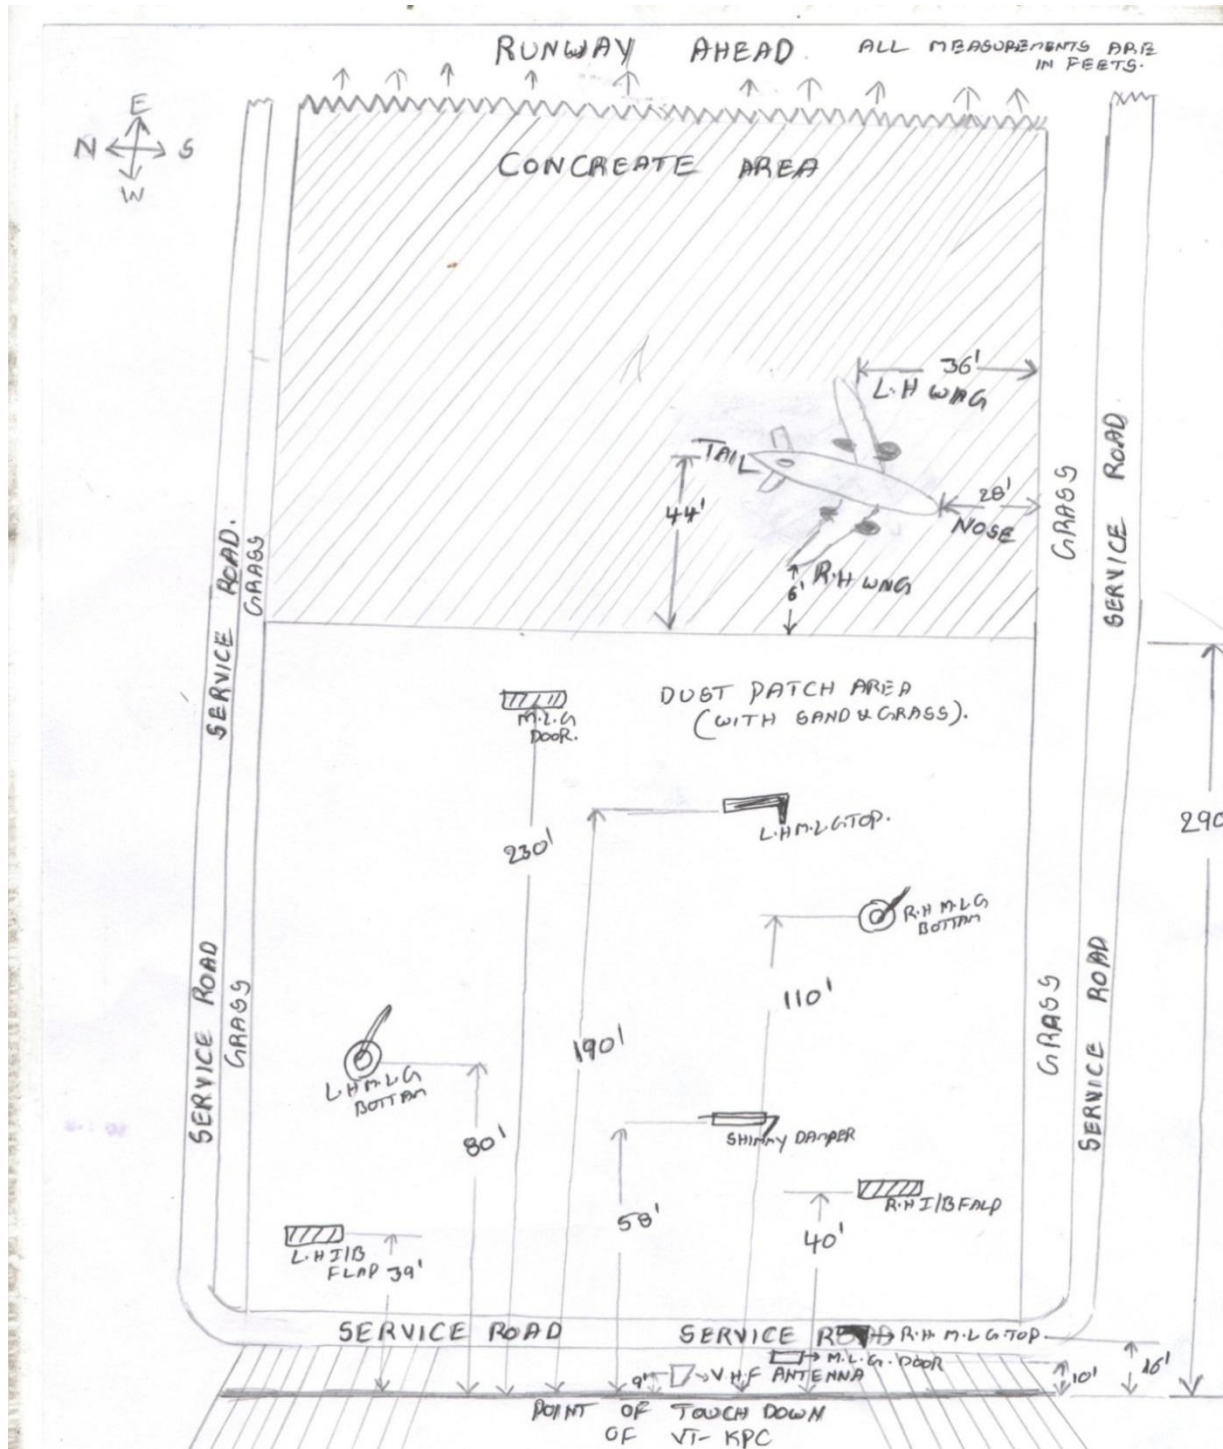
Wreckage Diagram of Accident Site

The first point of impact was the edge of the ramp of Runway 28. The ramp edge has a fall of approximately 23-25 metres. The PAPI lights are located ahead of the edge of the ramp of the runway. The perimeter road has iron L- section angles on the edge of the ramp. Further there exists the safety area, followed by the arrester nets and from thereon is the beginning of Runway 28. The airplane nose wheel made first physical contact with the ground on the edge of the ramp of Runway 28. This is indicated by an impression of the nose & the main wheels gears on the edge & the slope portion of the ramp respectively.

The next in line of impact was the balusters on the perimeter road that pierced both the outboard wings just outboard of the nacelles between the front & rear spars, at which time the Main wheels hit the slope of the ramp and probably the airplane bounced a bit over the perimeter road as, there were no impressions of contact across the width of the perimeter road. The outboard flap also has impact & pierced damage towards the inboard trailing edge.

After the Main Landing gear got detached the bottom of the fuselage skin made contact with the overrun section of the runway, wherein all the antennae affixed to the belly of the fuselage were torn off & flung rearwards.

An impression of the nose & the main wheels on the edge & slope portion of the ramp indicates that the airplane nose wheel made first physical contact with the ground on the edge of the ramp of runway 28. The impact can be described as skid cum impact. This impact component has forced the Nose Landing gear shock strut rearwards and folding the drag legs into the nose wheel well. The nose wheel was skewed a little to the left and the landing gear wheel well doors were forced into the wheel well. The airplane then made contact with the undershoot portion of the runway, where both main landing gears got detached from the airplane, followed by the loss of both inboard flaps which were selected to the ‘Down’ position as observed by the physical position of the flap lever in the cockpit. The damage to the outboard flap suggests the same balusters (iron angles) damaged the inboard trailing edge corner of the outboard flap. No material or component failures occurred prior to the impact. All material failures & damage to aircraft structures & components were caused by impact.
