**FINAL REPORT ON SERIOUS INCIDENT TO M/s EMIRATES  
BOEING 777-300ER AIRCRAFT A6-EBO  
WHILE OPERATING FLIGHT EK 373 (BANGKOK-DUBAI)  
ON 07.11.2012**

**AIRCRAFT ACCIDENT INVESTIGATION BUREAU  
MINISTRY OF CIVIL AVIATION  
NEW DELHI INDIA**

**FINAL REPORT ON SERIOUS INCIDENT TO BOEING 777-300ER AIRCRAFT  
A6-EBO WHILE OPERATING FLIGHT BANGKOK-DUBAI  
ON 07/11/2012**

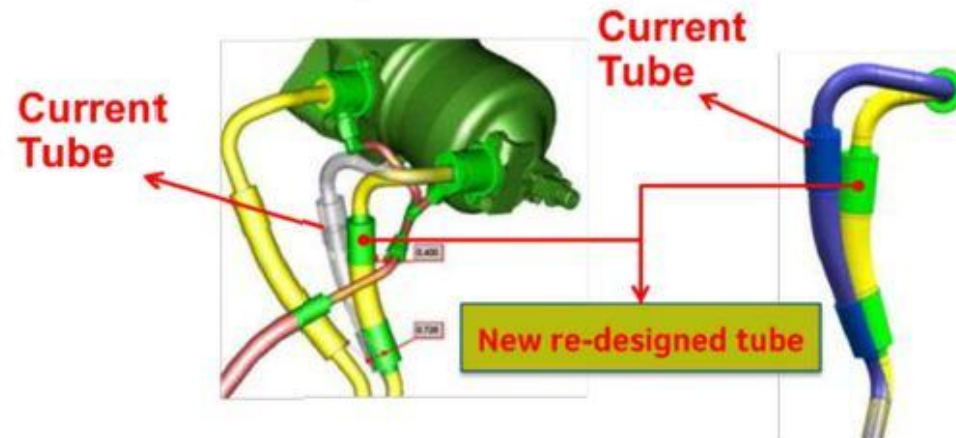
*Root Cause and Corrective Action Summary*

- The root cause of observed cracks is a tube mode shape excitation within the engine cruise frequency range exacerbated by
  - High stress sensitivity of the welding at the tube end
  - High core vibration
  - Pre-existing condition on the inner surface of the tube end
- The tube was redesigned to move the mode-shape out of the cruise frequency range
  - The shortened hose results in stiffer tube end (higher frequency mode)
- New tube P/N 2483M12P01 was introduced by SB 73-0069 (Cat. 3) issued May 3, 2012
  - Next shop visit of the engine
