**FINAL REPORT ON ACCIDENT TO DIAMOND DA – 40
AIRCRAFT VT-FGE OF IGRUA NEAR VILLAGE
SITADONGRI, CHINDWARA DISTRICT,
MADHYA PRADESH ON 24.12.2013**

| 10. Type of Accident | : | Controlled Flight into Terrain |

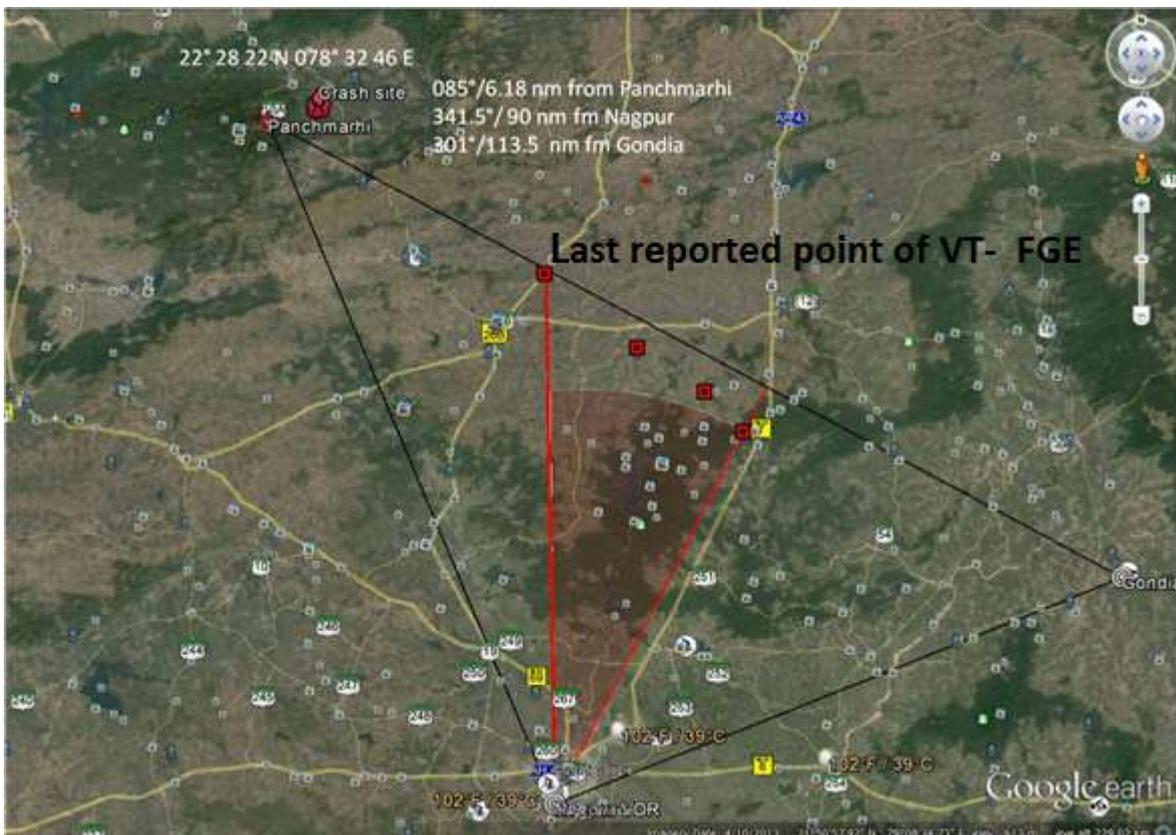
Crash site location with respect to Nagpur VOR and Gondia VOR

The aircraft had deviated 6.18 NM (11.45 KM) away from the ATC cleared flight path for Panhmarhi and crashed into the dense jungles near Village Sitadongri in Chhindwara district. The aircraft was completely destroyed and the wreckage was scattered in half km area from uphill to downhill in dense forest area. The trainee cadet pilot could not survive the accident. There was no evidence of fire.

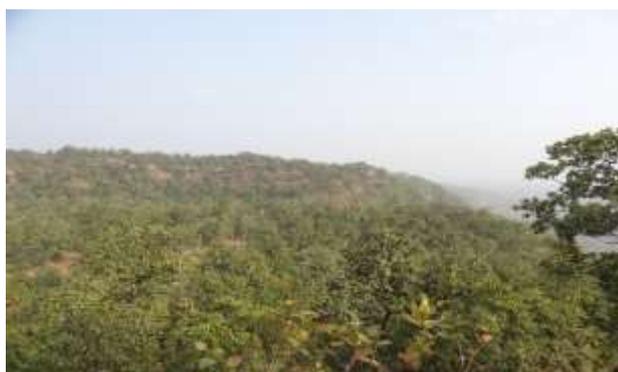
Accident site (Hilly area with tall trees)

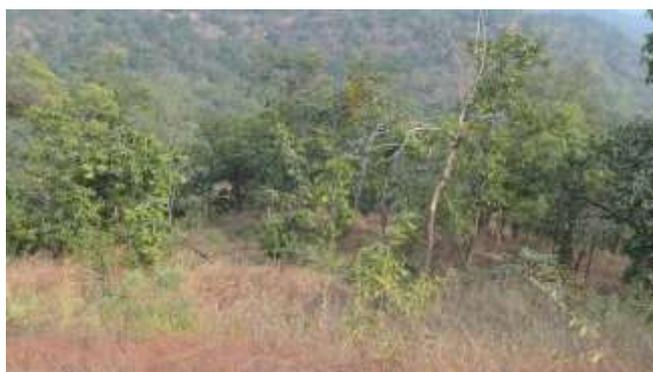
Downslope of the hills

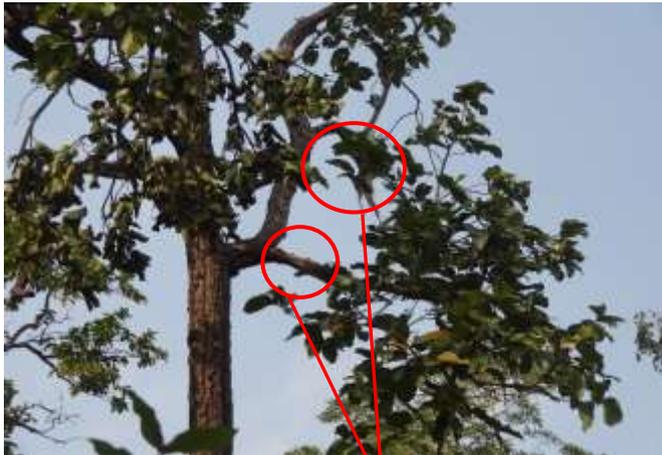
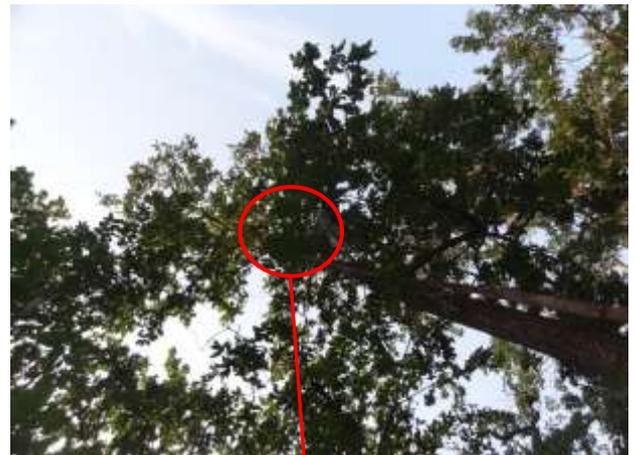
***Aircraft first impact with tree on the hill top
after impact***

Aircraft part stuck on the tree

The aircraft impact marks were observed on one of the tree about 150 ft high above the hill top and around 220 ft. down the slope. This appears to be the first aircraft impact followed by the second impact with another tree around 20 ft. ahead of the first impact tree. Parts of left wing and the tail section as well as some parts of the canopy were found at the first point of impact. From the impact marks and the parts of the aircraft it can be ascertained that the left wing and the tail surface must have hit the trees and thereafter the aircraft went out of control.

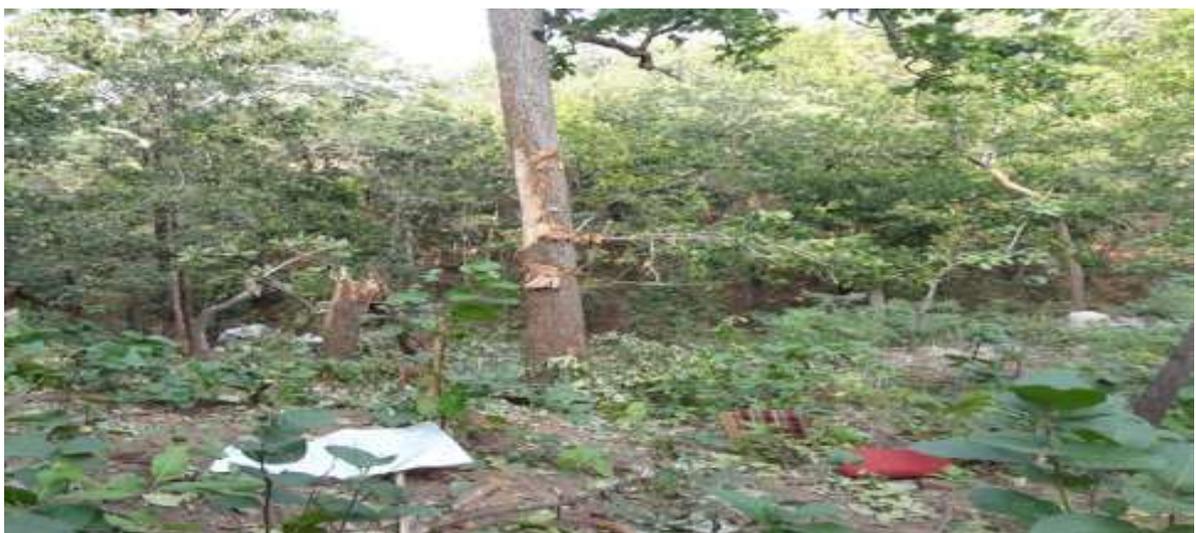
***After initial impact aircraft disoriented and hit other trees moving
downslope***

Due to repeated impacts with the trees, the rudder, horizontal stabilizer, large portions of the tail section and some parts of the left wing sheared off from the aircraft and were scattered around, Thereafter the aircraft became totally uncontrollable and presumably moved ahead at a very high speed. Subsequent to the first impact it appears that the aircraft became uncontrollable and had another major impact breaking a big tree having bark of more than half a meter diameter which was around 350 ft. from the first impact causing the fuselage to break from the central area and liberate. Thereafter the remaining portion of the fuselage along with damaged right wing and the engine dragged ahead around 50 ft and settled down in a Nulla located 400 ft from the first impact.

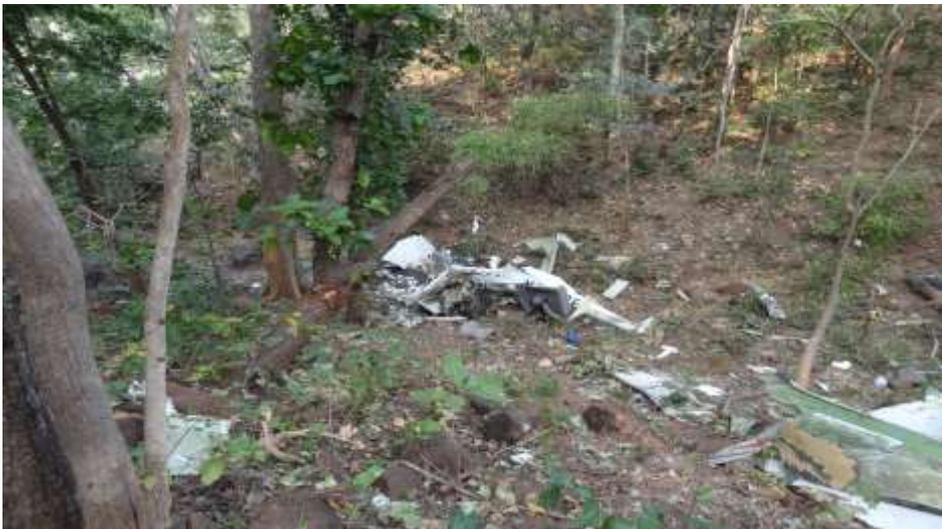
Final position of the wreckage on downslope of the hill

Examining the main wreckage it was observed that the engine controls were found in fully forward position and the flaps were in retracted position. The forward acceleration of the aircraft was very high and that could be corroborated by the indication in the ASI which was found stuck at 185 kts (VNE 178 kts). The cockpit area got disintegrated as the instrumentation in the cockpit, the panels, aircraft documents etc were found spread around in a radius of 50 ft.

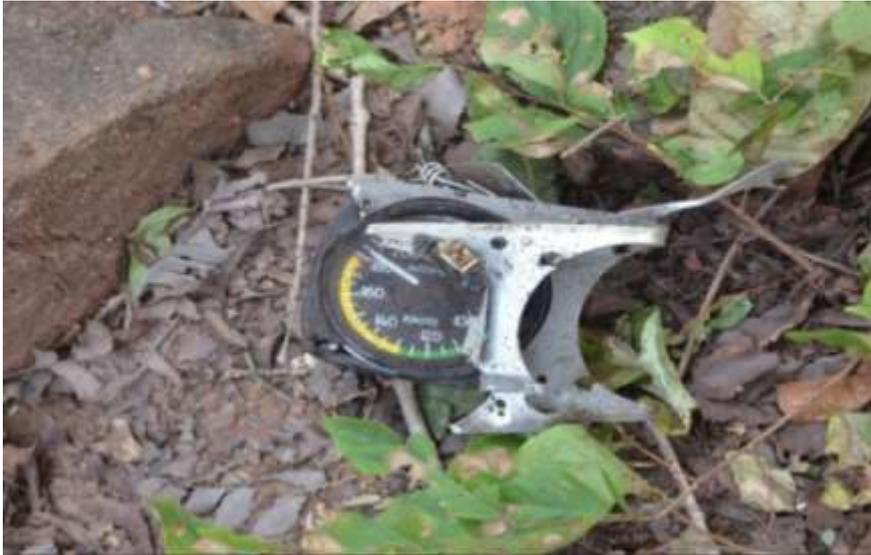
Aircraft speed indicator stuck at 185 knts

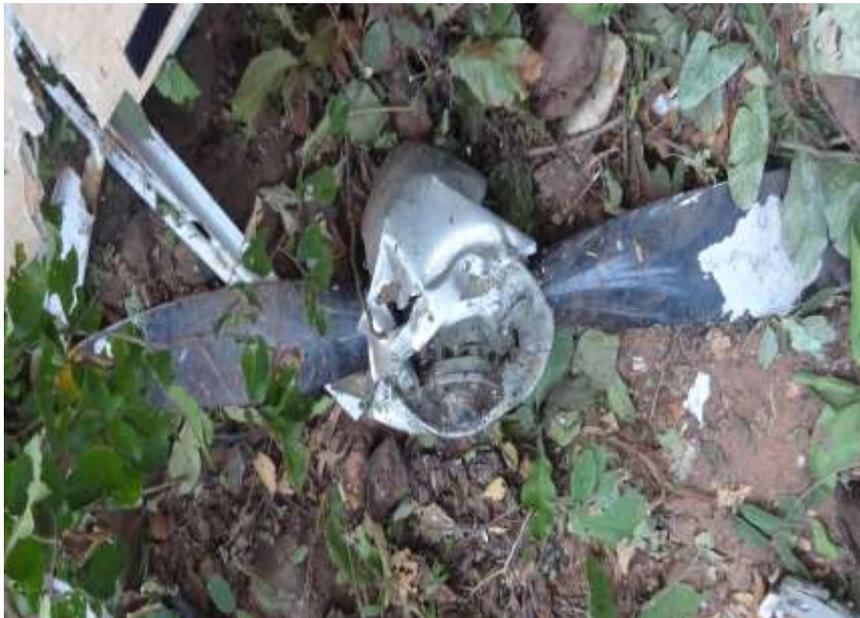
One of the main landing gear strut and the nose gear strut with wheel assembly was found at the impact point and the main wheel assemblies were found 100 to 150 ft away from the main wreckage. The ELT antenna got detached from the fuselage structure and was lying on the ground. The engine and propeller had signs of impact causing the propeller and the after gear ring from the front portion of the engine to shear off.

Sudden impact of propeller shows breaking of shaft under power

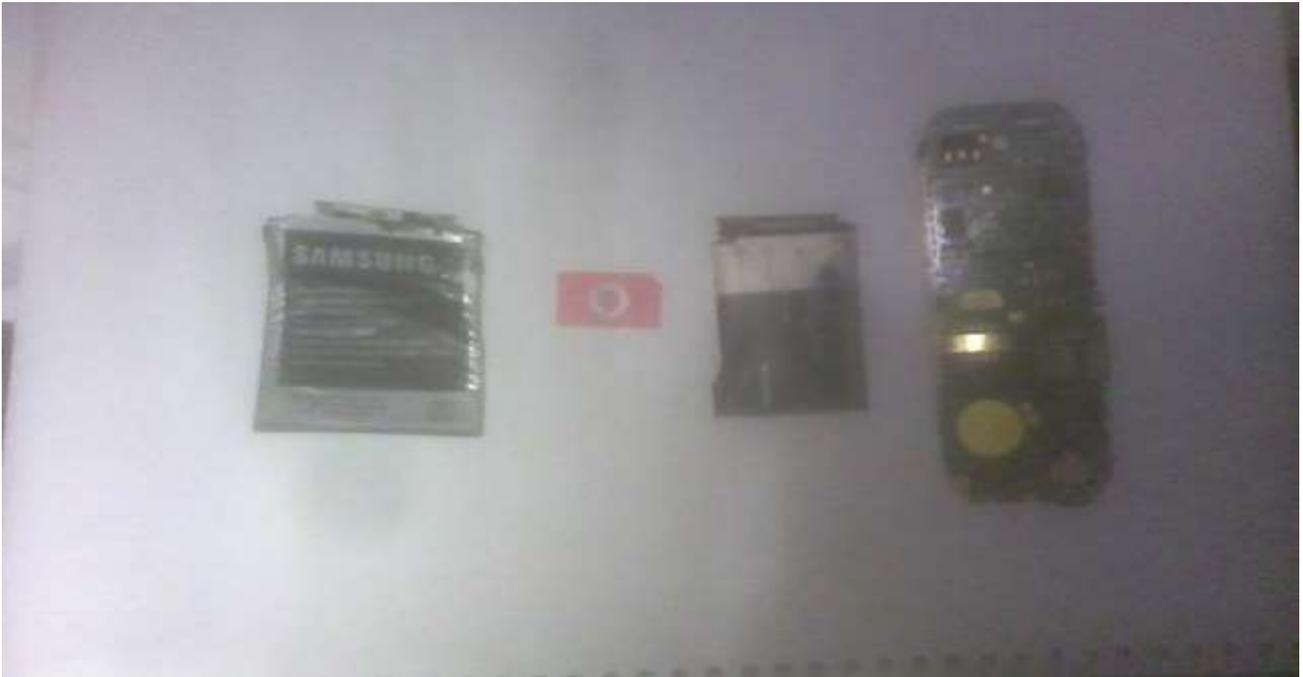
found in the fuel tanks as the tanks were badly ruptured under impact. Pieces of two different mobile phones were recovered from the aircraft wreckage however they were severely damaged/partially burned and were not in a condition to recover any data.

Battery of two different mobile phones, Circuit board of one Phone & One sim card recovered from crash site.

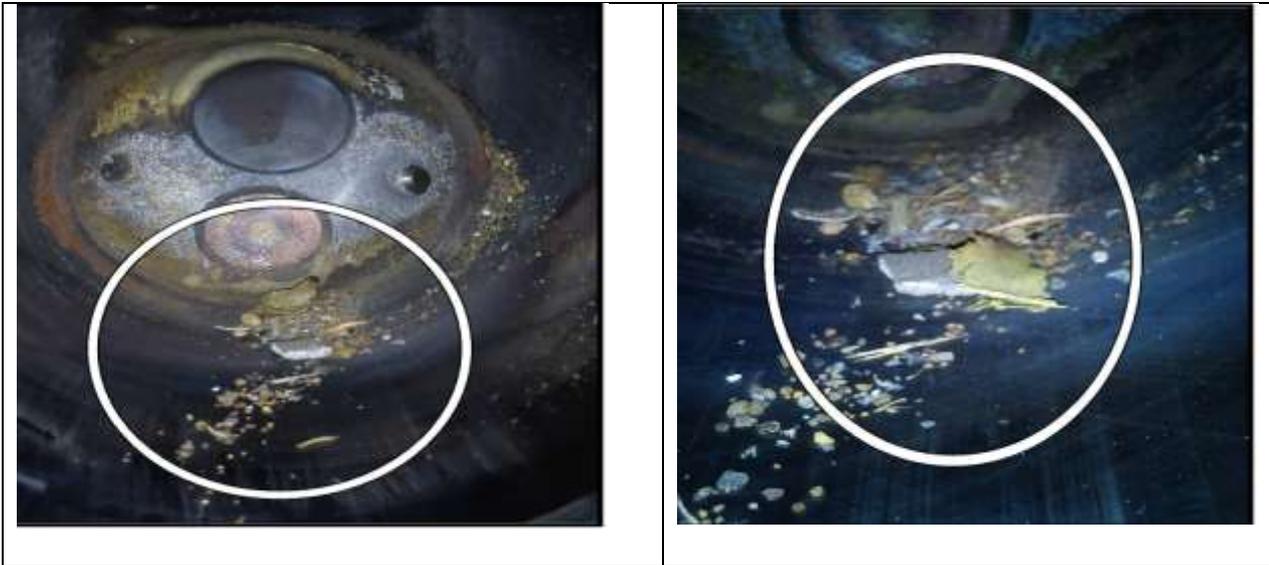
1) Cylinder No. 1

Few pebbles, a broken piece of oil sump, a piece of dry leaf of tree and dust were found inside the combustion chamber of the cylinder. No other abnormalities noticed.

Pebbles, broken piece of oil sump, a piece of dry leaf of tree and dust were found inside the combustion chamber indicates that the engine was running at the time of impact.

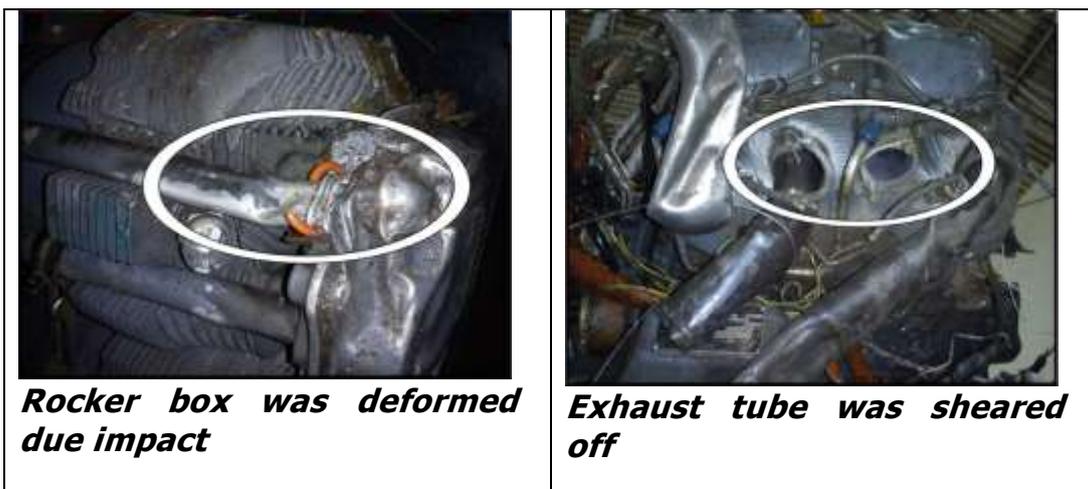
Fins were damaged, rocker box found deformed, induction tube was not found with the engine & induction flange on the cylinder was broken into half, exhaust tube was sheared off. Push rod found bent.

Rocker box was deformed due impact

Exhaust tube was sheared off

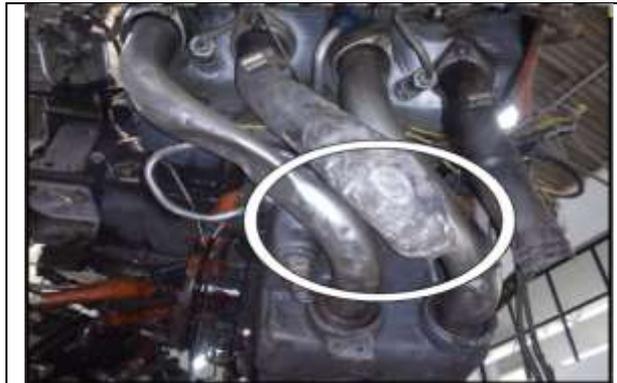
Cylinder No.2:

Induction tube sheared off from sump, exhaust tube was sheared off, Oil drain tube was broken.

Induction tube and exhaust tube was sheared off

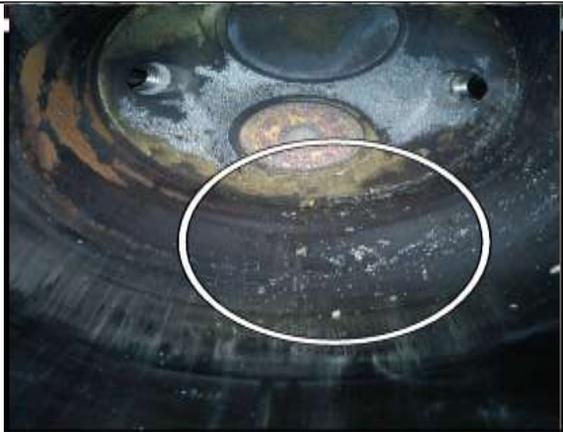
2) Cylinder No. 3

Dust like material was observed inside the combustion chamber. No other abnormalities noticed.

Dust like material observed inside Combustion chamber

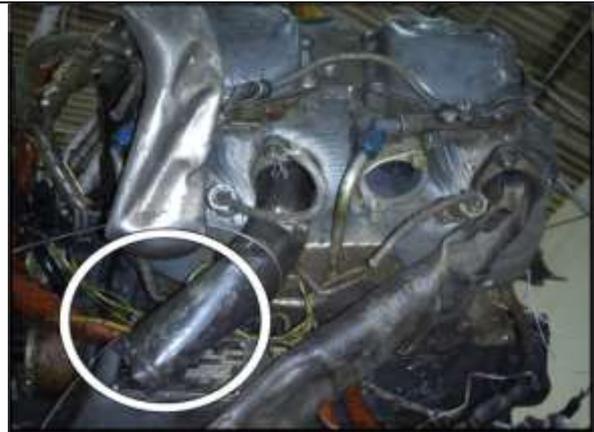
Exhaust tube was found sheared

Exhaust tube was found sheared, induction was intact and its seal was satisfactory.

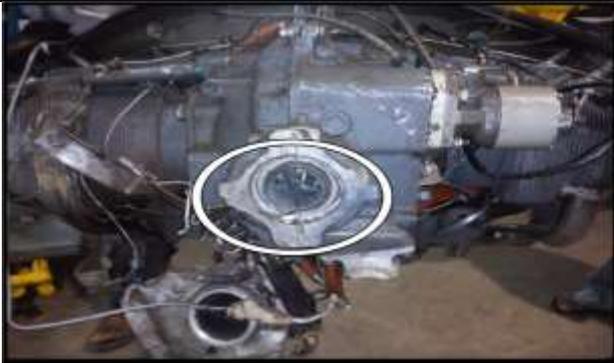
Crankshaft flange was sheared off near the propeller attachment flange.

- i) The propeller shaft had sheared off near the propeller attachment flange. The type of failure on the propeller shaft indicates that the engine was running and delivering power at the time of accident. Also the debris observed inside the No. 1 Cylinder indicates these were sucked into the induction port at the time of accident.
- ii) With the observation made during disassembly it appears that engine was running and delivering power at the time of accident. The above damages observed were due the result of the aircraft accident.

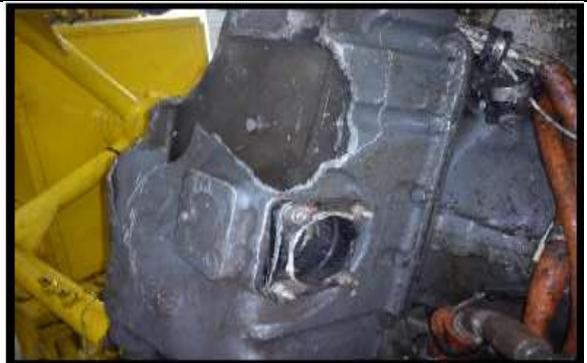
Sump was broken from the induction area due impact.

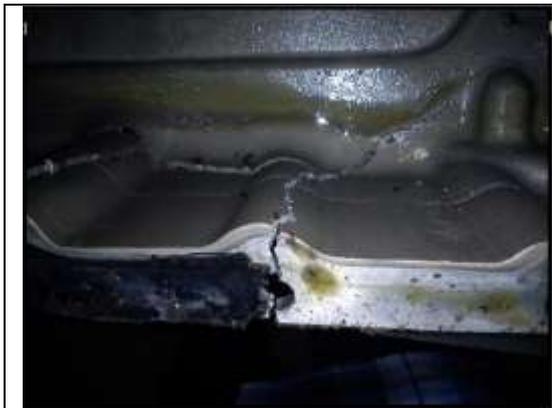
Top reservoir was cracked which might have caused oil to drain out

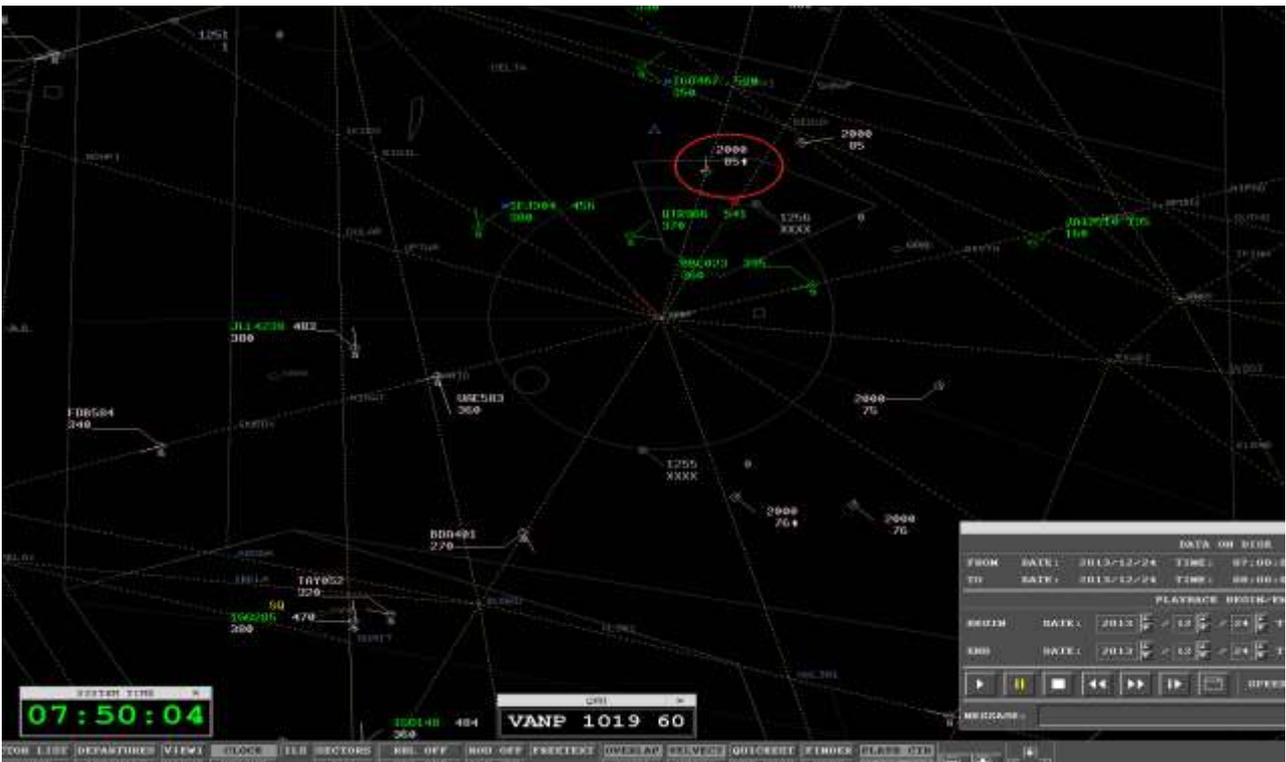
After the accident the radar situational data display was replayed and it was observed that the aircraft VT-FGE was maintaining flight level 85 and bearing 359/66.66 Nm (Approx. 6 Nm front of Chindwara city) squaking 2000 at time 0757 UTC and 80 Nm from Gondia VOR. Thereafter the signal dropped from the radar. The aircraft wreckage was found around 45 Nm from the position the signal had dropped from the radar. If the aircraft was cruising at an average speed of around 110 to 120 knots then it would have taken at least 25 to 30 minutes for the aircraft to reach the accident site. Also after the aircraft dropped from the radar the ATC controller also failed to monitor/check the position of VT-FGE and did not make any call to check the position of the aircraft. If the aircraft had developed any technical snag then as per procedure it would have called the ATC or relayed its position from the overflying aircraft in the area. However there was no call made by VT-FGE. Secondly if any transmission/transponder failure would have occurred then also as per procedure he would have not continued the flight and diverted to Nagpur station for assistance.

VT-FGE painted on Nagpur radar

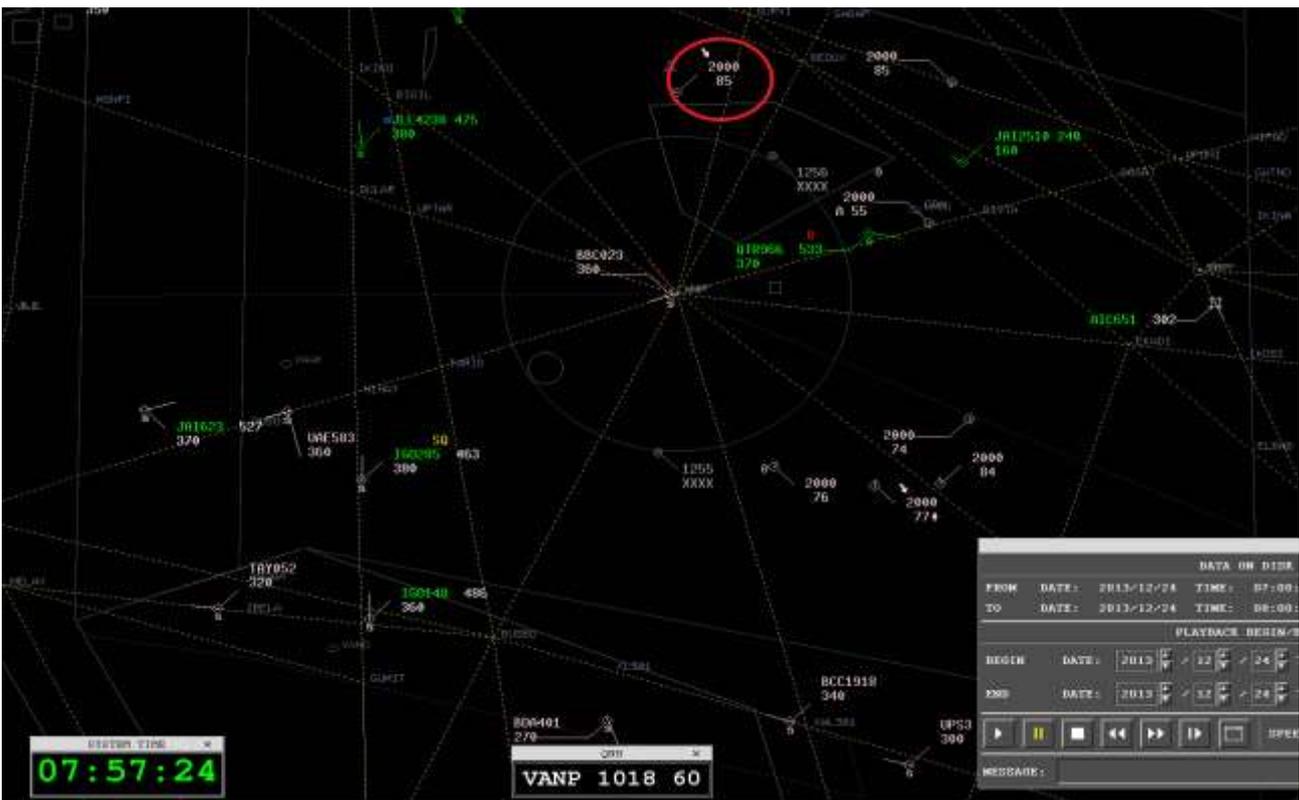
VT-FGE last painted on Nagpur radar

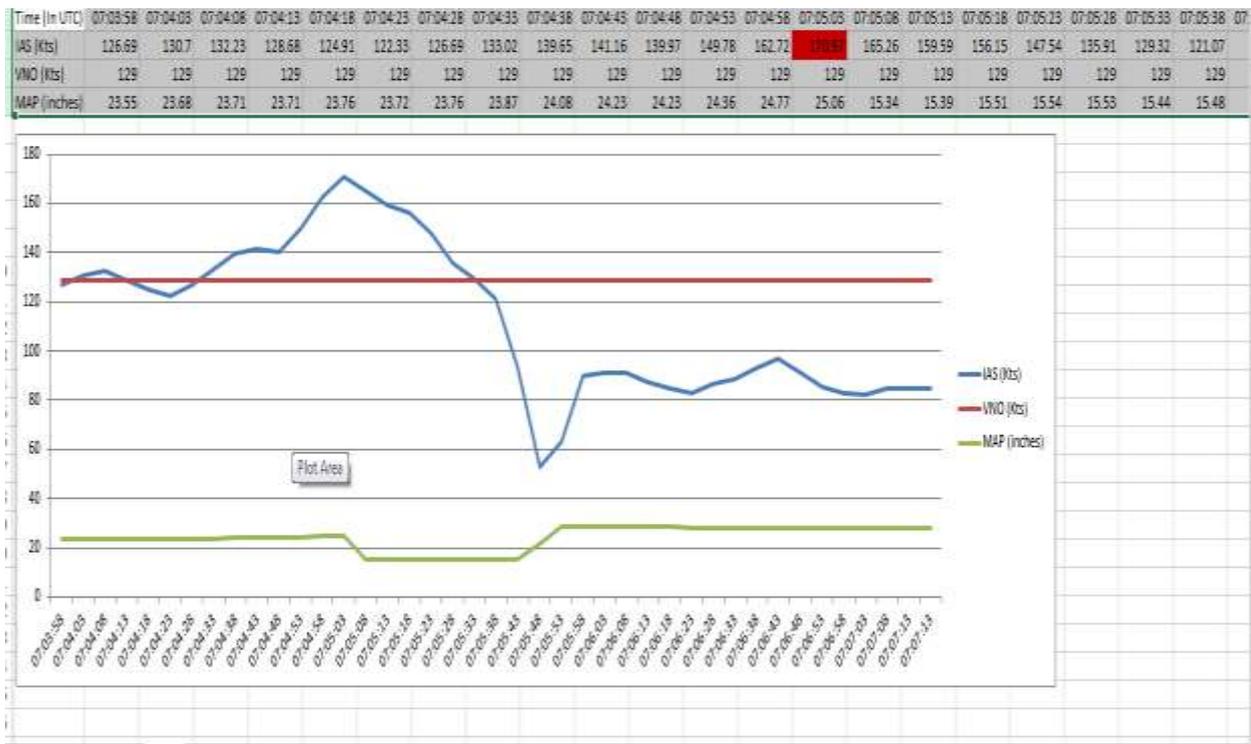
1. On 03/10/2013- Cadet was cleared to operate in sector D (Radial 165-195 FSG) between 8 to 15 NM and between 2500-3500 feet. Cadet pilot engaged into low flying and as per the data available it flew around 50 feet above the small lake in the sector. The data also revealed that the aircraft had engaged into dive with engine power max to attain speeds of around 170 knots during dive with pitch angle of minus 15 degrees (-15°). This was serious indiscipline flying by the cadet pilot as the student pilots are not permitted to fly beyond 120 knots and also with such high negative pitch angles.

Graphical representation of DFDR data for low flying on 3/10/2013

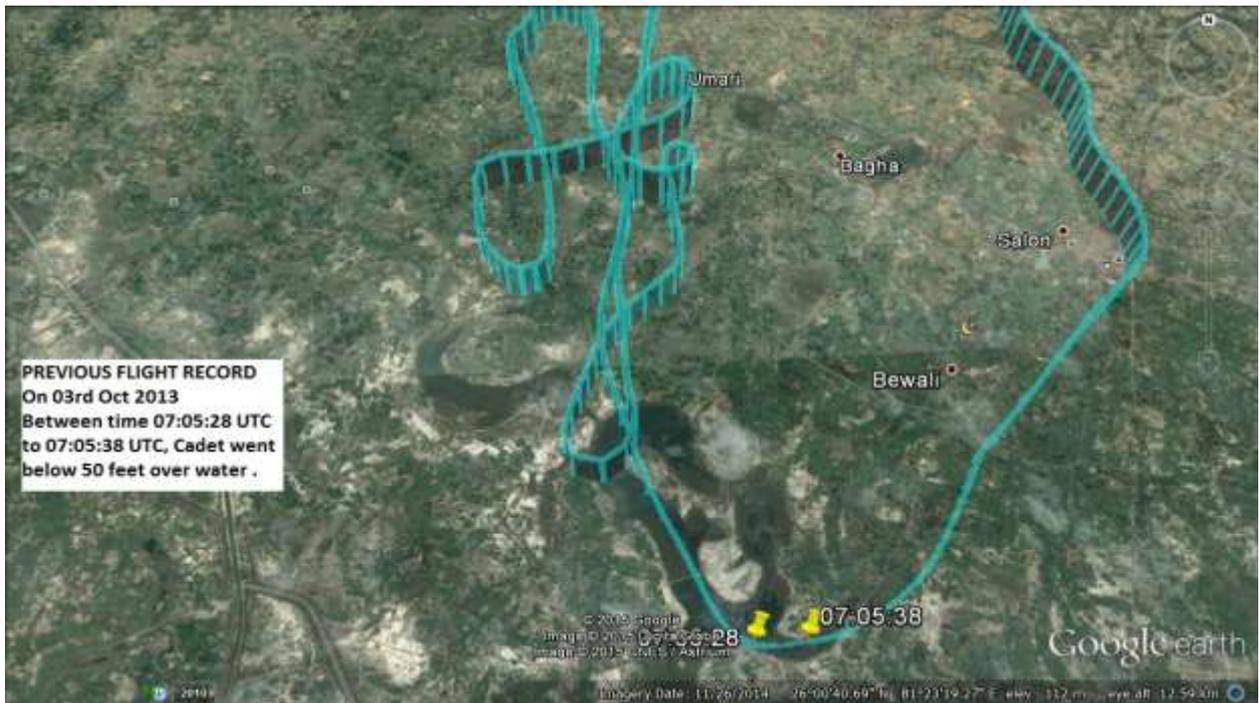
Path followed by aircraft during low flying

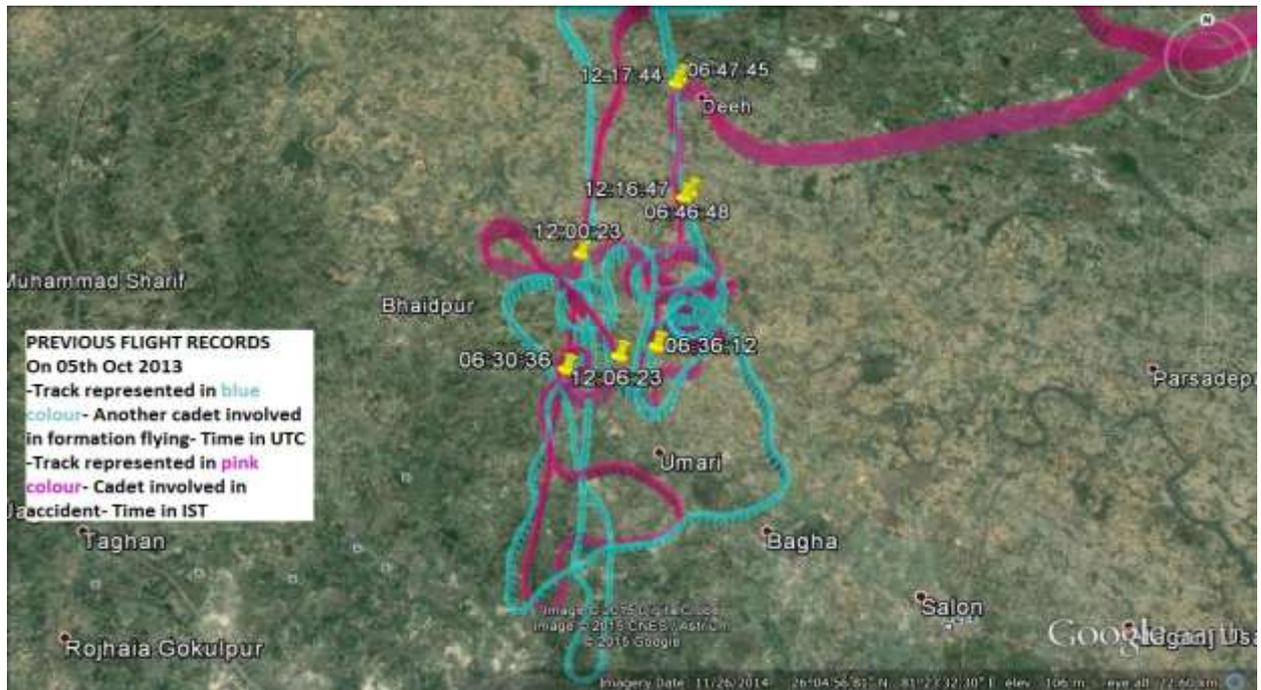
2. On 05/10/2013- Cadet was cleared to operate in sector C (Radial 105-135 FSG, other same as above). However Cadet proceeded to Sector D instead, whereas per time in data, another cadet was flying. As per the data both of cadets were flying at the same time in same sector as if carrying out formation flying.

Formation flying carried out by Cadet Pilot on 05th Oct 2013
