**FINAL INVESTIGATION REPORT ON ACCIDENT
TO M/s UNITED HELICHARTERS
BELL 212 HELICOPTER VT-HGB
AT (TUKAWADE) THANE
ON 29/09/2013**

**GOVERNMENT OF INDIA
MINISTRY OF CIVIL AVIATION
AIRCRAFT ACCIDENT INVESTIGATION BUREAU
NEW DELHI INDIA**

AAIB (India) Report No. : 2014-ACC-

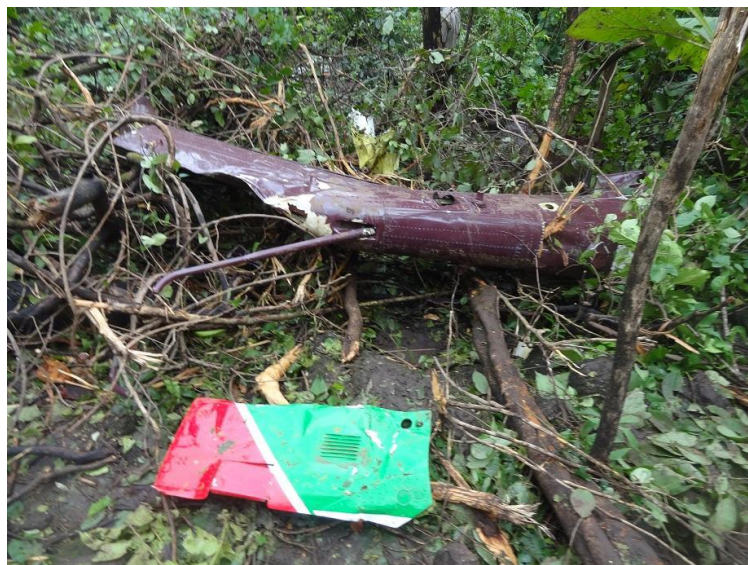
- The tail boom was broken with 90 degree gearbox intact.

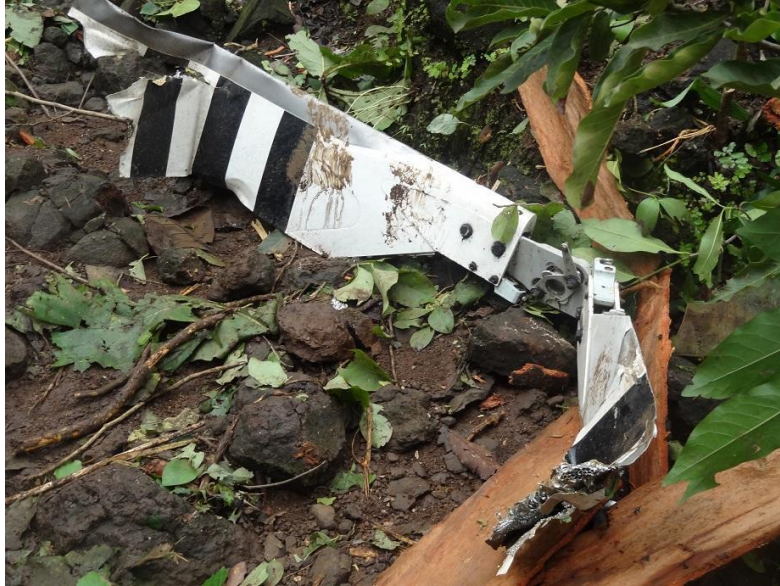
- The tail rotor hub and blade assembly were lying together at some distance from the tail boom.

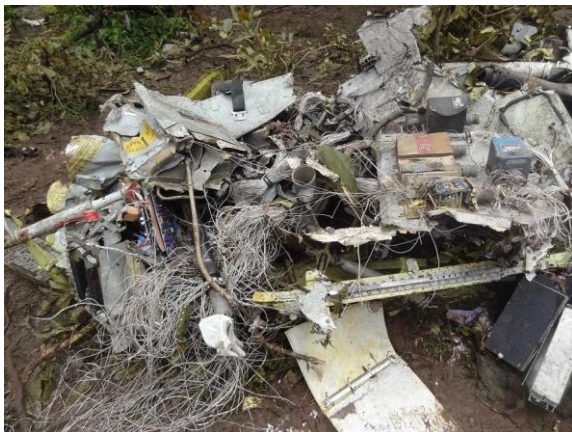
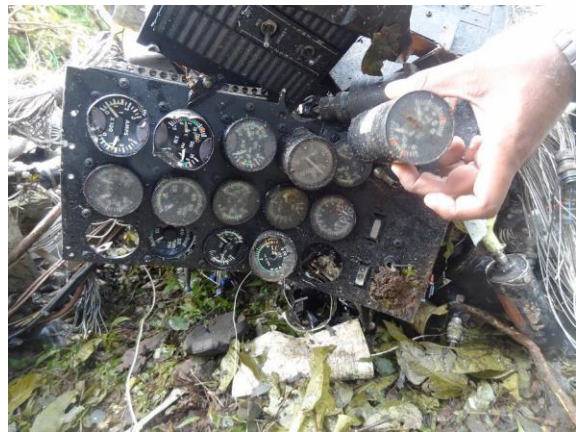
- Both the elevators were in completely distorted condition.
- The skid tubes and aft cross tube were found broken in 2-3 pieces. The forward cross tube was intact lying singly.
- The co-pilot door was in one piece lying on the ground with broken window.
- Both the passenger doors were completely broken into many pieces.
- All the flight control tubes, bell crank were found to be either bent, broken or distorted.
- The cockpit had completely collapsed along with all the instruments, equipments and collective, cyclic controls.

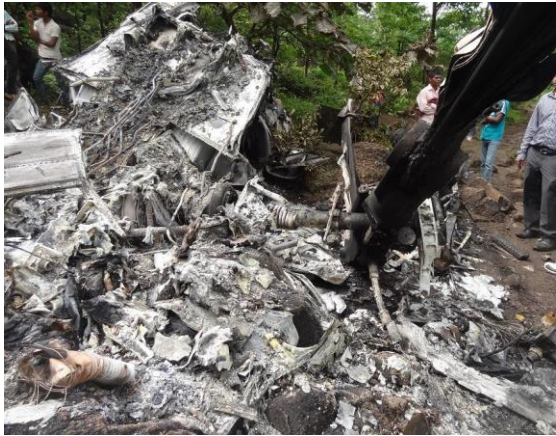
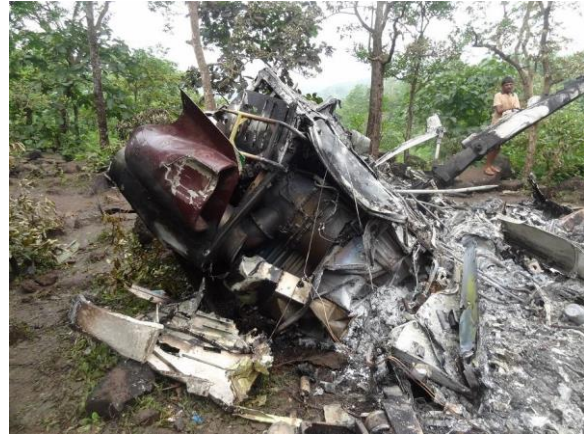
- The floor panel of the cabin was completely uprooted with all the passenger seats flung on the ground either in burnt or completely broken condition.

- The power plant (2 engine and 1 C. box) was found toppled as a combined unit along with the enclosed cowlings. The fire extinguishers were in discharged state.

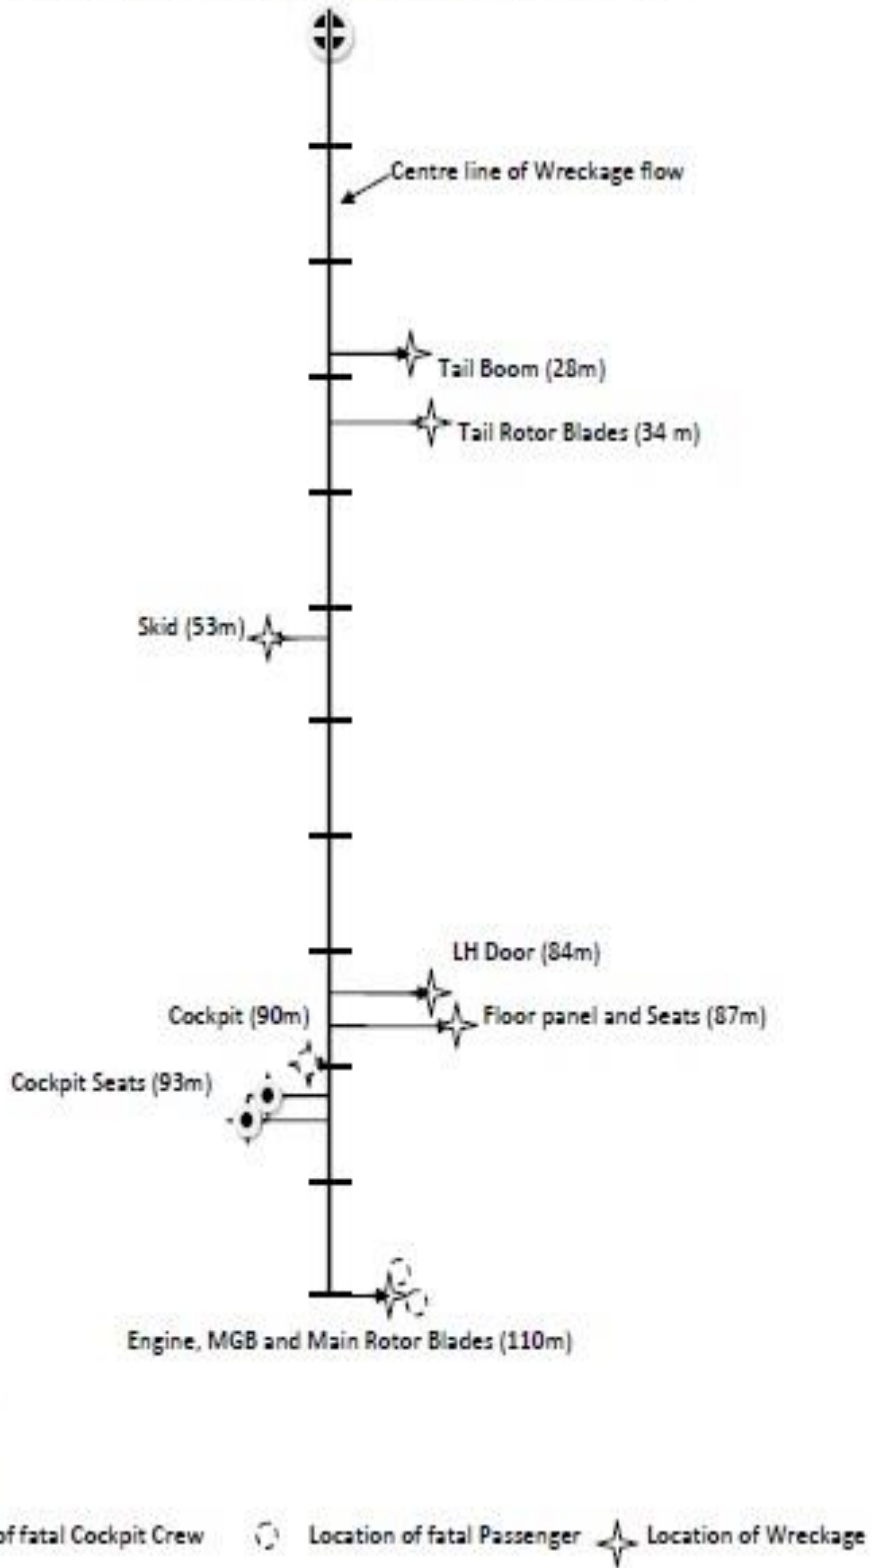
WRECKAGE PLOT

Wreckage was spread in an area measuring around 120m in a straight line in East – West direction from the first point of impact. The width of the wreckage spread was 15m. The Engine, MGB and Main Rotor Blade wreckage was completely damaged and burnt, whereas other components were severely damaged and scattered in pieces. The helicopter has not struck the hill head-on nor made any contact with High Power Electricity Cables.

Point at which Helicopter strikes first on tree 10m above ground
