**GOVERNMENT OF INDIA
MINISTRY OF CIVIL AVIATION
AIRCRAFT ACCIDENT INVESTIGATION BUREAU**

**FINAL INVESTIGATION REPORT OF
ACCIDENT TO M/S PINNACLE AIR R-44
HELICOPTER VT-HPC
AT AHMEDABAD ON 14/08/2013**

**FINAL INVESTIGATION REPORT ON ACCIDENT TO M/s PINNACLE AIR R44
ROBINSON HELICOPTER VT-HPC AT AHMEDABAD, ON 14/08/2013**

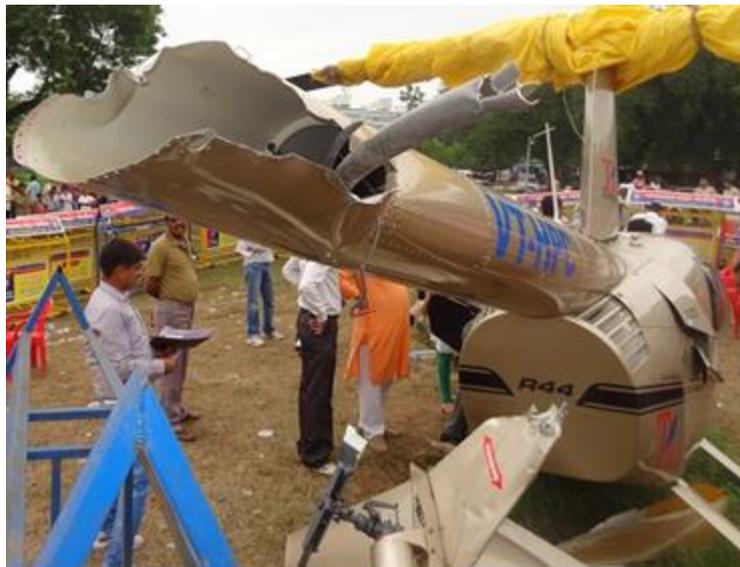
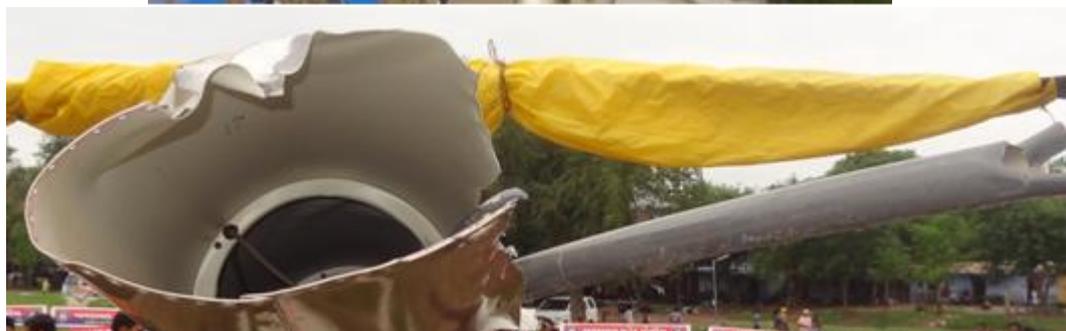
Photographs showing separation of tail rotor boom from the rivets

1. Tail boom broken from last segment along with horizontal, vertical stabilizer, tail gear box and tail rotor blades.
2. One Tail rotor blade totally damaged sheared out from root.

The tail boom was broken from the last segment along with the vertical fin and was lying next to the helicopter with the tail gear box. Both the tail rotor blades were damaged on impacting ground.

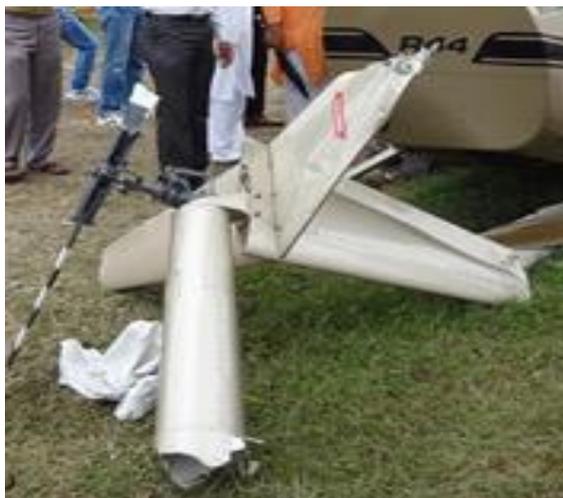
Damaged tail boom

- 15) Simultaneous with the impact of helicopter on ground, the main rotor blade has hit the tail boom and detached the rear portion along with TGB and tail rotor blades from the main airframe.
- 16) In its final position, the helicopter main body had tilted towards the forward and left direction.
- 17) All the occupants came out of the helicopter of their own and without any injuries.

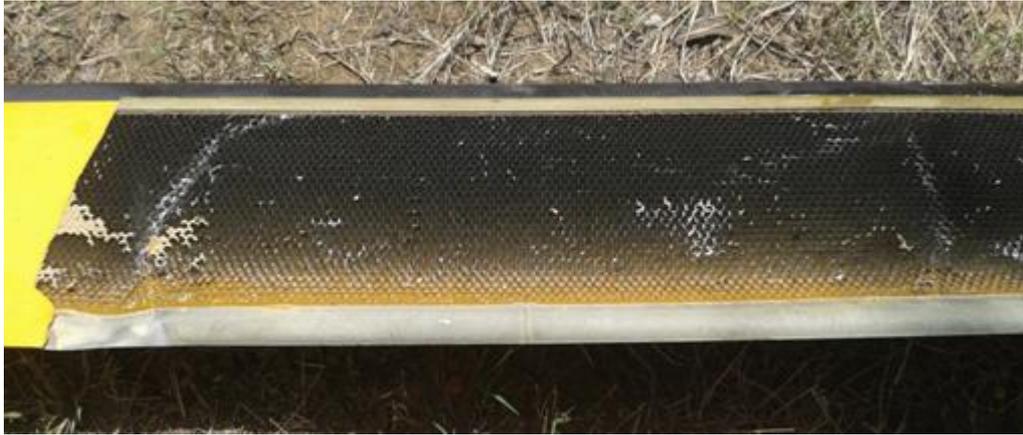
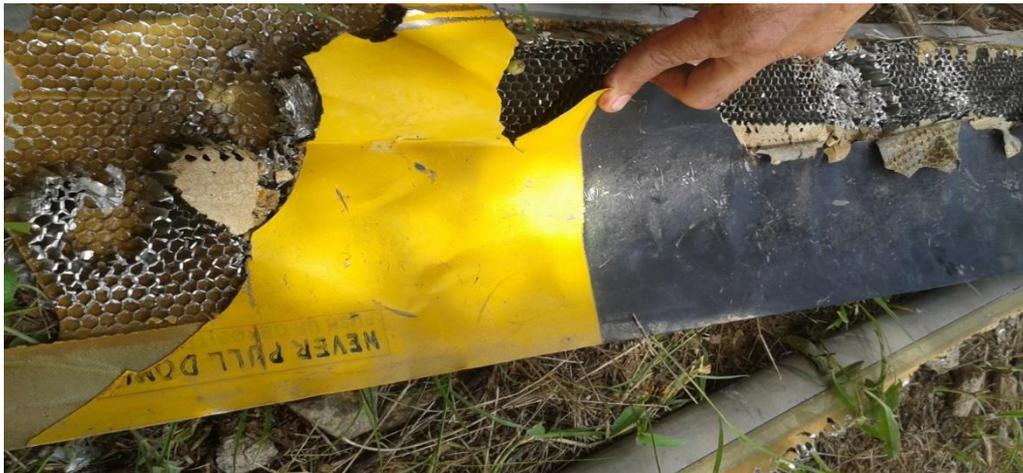
3. Main Rotor Blade: One of the main rotor blade skin separated about 3 feet from tip. Next three feet (approx) only upper skin came out. Lower skin along with honey comb is intact. Spar is intact all along the length.
4. Tail Rotor Drive Shaft sheared out from last segment of tail boom.
5. Tail Rotor Pitch change control sheared out.
6. Tail Rotor Guard broken into two pieces.
7. Main Rotor Shaft Core/Fin damaged.
8. Structure just ahead of Main Rotor shaft core damaged.
9. Auxiliary Tank (LH Side) structure/Fuselage damaged.
10. Forward Portion of LH skid broken.
11. RH and LH both side windshield broken.
12. LH side door window glass broken from upper end.
13. Magnetic compass came out along with base/stand.
14. ELT antenna broken.
15. Fan Belts: Out of 4 belts 2 belts damaged and rest two broken.

Photographs showing peeling of the blade skin with consequential damage to honey comb structure

The wreckage examination particularly the main rotor blades indicate the one of the main rotor blades skin had got de-bonded in-flight with consequential damage to the honeycomb structure.

The type of de-bonding failure observed on one of the main rotor blades which had occurred in-flight (from tip end) caused static and dynamic imbalance of the main rotor system which in turn resulted in severe vibrations in lateral and vertical planes, making the helicopter uncontrollable. During the whole process, no feedback was felt on the cyclic and the whole helicopter was shaking.

The accident was caused by in-flight de-bonding of main rotor blade skin resulting in static and dynamic imbalance of main rotor system. The pilot had to make a forced landing due severe vibrations, which resulted into the substantial damages of the helicopter.

Stringent checks of main rotor blades of R44 helicopters particularly at outstations before issuing CRS should be carried out prior to every flight.

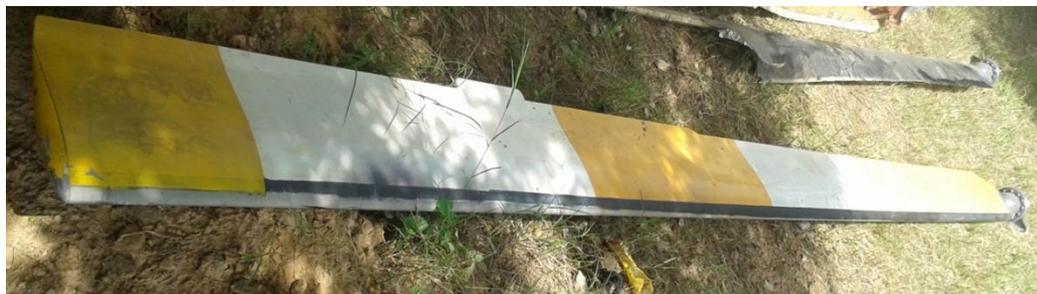
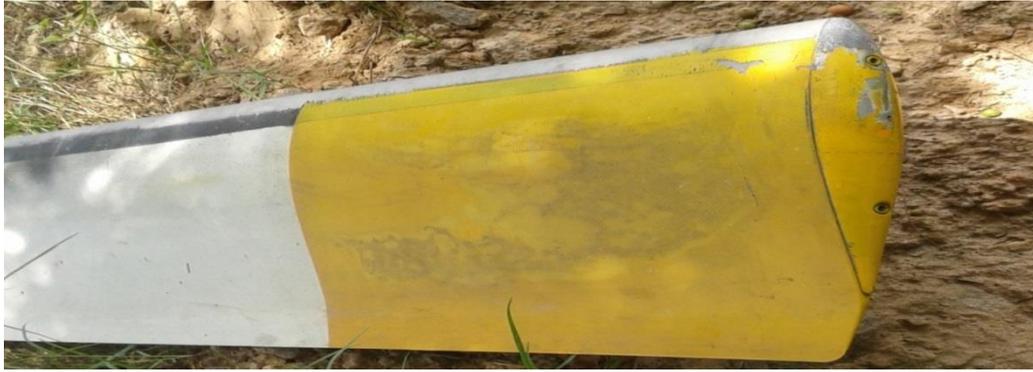
The photograph of undamaged blade (below) indicates that there was very high probability of de-bonding initiation taking place.

Photographs showing exposed bond line on the blade (without debonding)

Examination of the second main rotor blade revealed signs wherein there was a very high probability of the similar skin debonding as occurred on the damaged blade. Prior to the accident flight the helicopter has flown for almost 95 minutes comprising of 3 sectors. It is not possible for a pilot to check the condition of the blades (top view) by a pilot while carrying out pre flight inspection. Secondly once there is initiation of debonding of the skin, resultant failure is immediate.

- 13) Second blade was though undamaged but had indications of debonding setting in.
- 14) The pilot could manage an almost straight & level landing.
