**FINAL INVESTIGATION REPORT OF
ACCIDENT TO GOVERNMENT OF
JHARKHAND IS-28M2/GR MOTOR GLIDER
VT-GJH AT DEOGHAR AIRSTRIP,
JHARKHAND ON 07/08/2013**

(A. X. Joseph)
Assistant Director-AAIB
Chairman, Committee of Inquiry VT-GJH

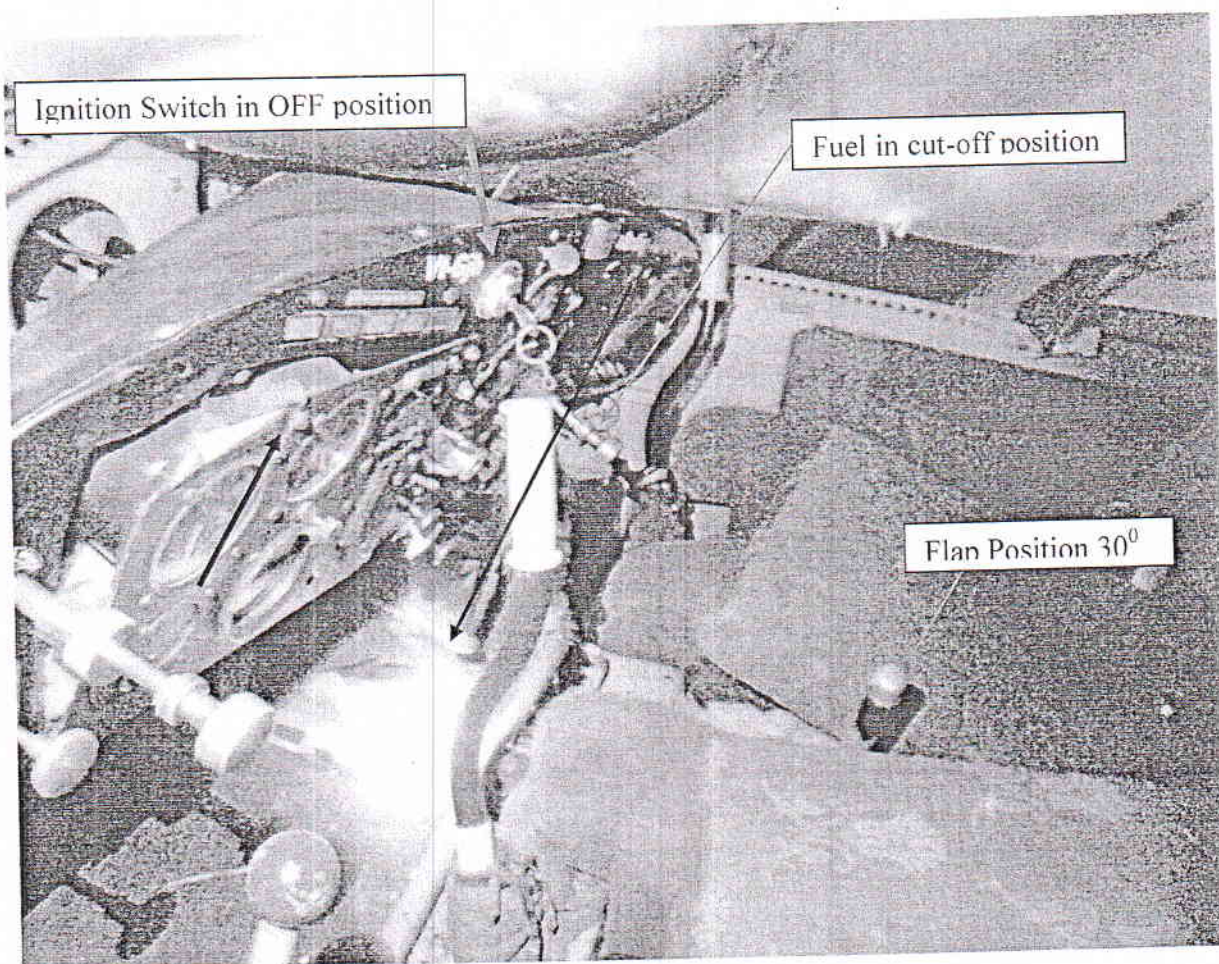
In the cockpit the fuel levers were found in OFF position, flaps in 30° positions and the ignition was OFF. Since the motor glider had impacted the ground the windshield plexi had broken. The tail wheel has also sheared and dislocated from its position.

Position of switches in cockpit

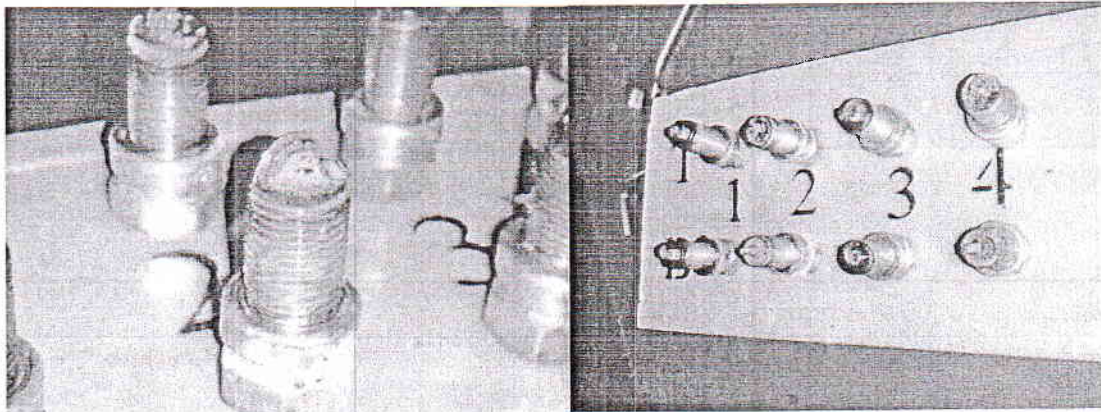
1. During disassembly it was observed cylinder 2 spark plug was having traces of coolant.

Heavy deposits were observed on the spark plugs

Among the 8 spark plugs, 3 spark plugs (Cylinder No.2 bottom spark plug, Cylinder No. 4 bottom and top spark plug) found not functioning.

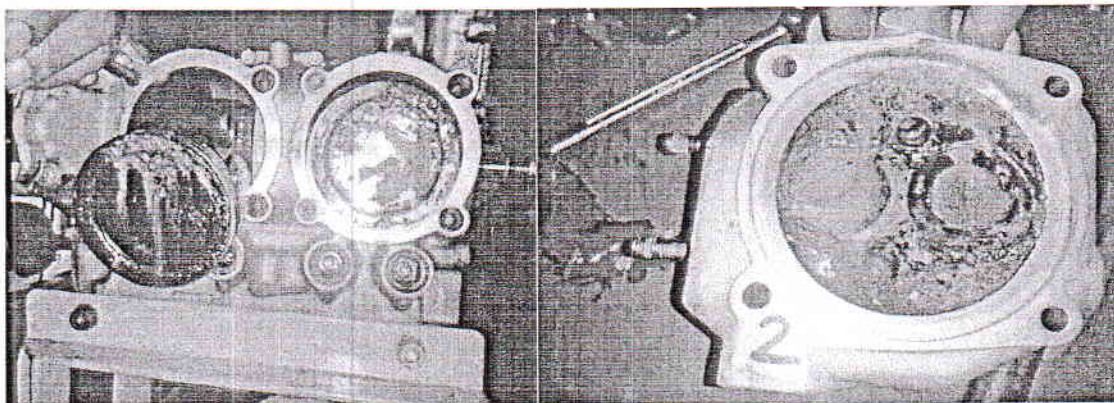
2. Cylinder No. 1,2,3 had traces of oil in the combustion chamber and Cylinder no. 4 was dry.

Heavy carbon deposits observed on all pistons and valves

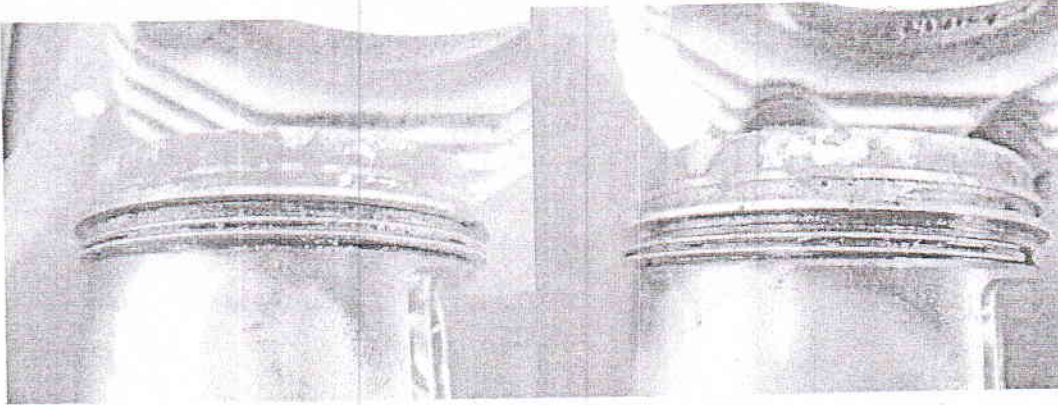
3. Piston in cylinder no. 2 & 4 found seized.

Condition of piston rings

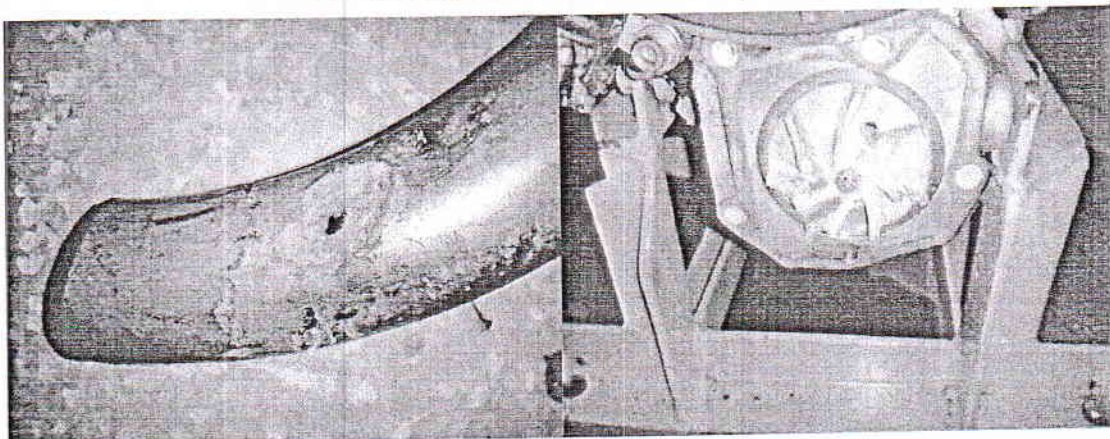
Coolant holes punctured

No sign of coolant in the impeller

1. Connection tube identified at No. 9 above from suspension tank to radiator was found punctured due to abrasion which had caused the coolant to be drained from the coolant system during flight. Hence engine was running dry of coolant resulting over heating of cylinder heads. This was also evident from the complaint impeller which was totally dry during disassembly of the engine.
2. Cylinders No. 2 & 4 piston ring was seized due to heavy deposits caused by burning of lubricating oil inside the combustion chamber due to overheating, which might have caused engine seizure / stoppage.
3. The engine failure was due to non-supply of coolant to the cylinder head because of the punctured coolant pipe resulting into overheating and subsequently seizure/stoppage of pistons of No. 2 & No. 4 cylinders and failure of engine.

11. During strip examination of Engine it was inferred that the engine failed due non supply of coolant to the cylinder head because of punctured coolant pipe resulting into overheating, seizure/stoppage of the pistons of No. 2 & 4.
