**Final Investigation Report on**  
**Accident to M/s Prabhatam Aviation Pvt.**  
**Ltd., AS 350 B3 Helicopter VT- PED on**  
**21-06-2013 at Rambara, Near Kedarnath**  
**Shrine, Uttarakhand**

**COMMITTEE OF INQUIRY VT-PED**

<b>Final Investigation Report on Accident to M/s Prabhatam Aviation Pvt. Ltd. (PAPL) AS 350 B3 Helicopter VT- PED on 21-06-2013 at Rambara, Near Kedarnath Shrine, Uttarakhand.</b>

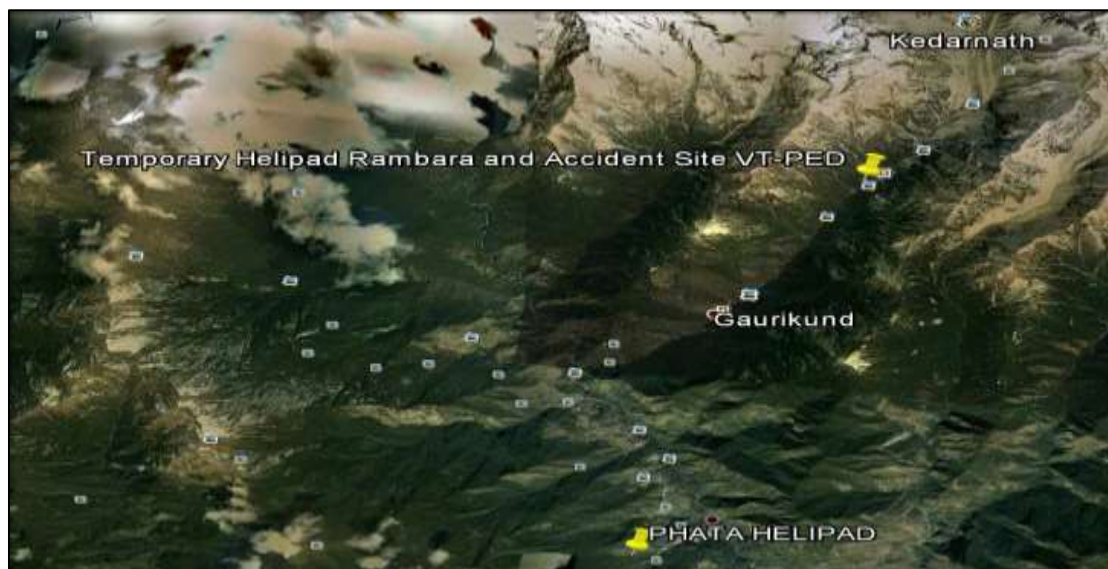
The helipad at Rambara (Jungle Chatti) is temporary helipad situated at approx 8500 feet made at end of Road curve for rescue/evacuation of stranded pilgrims. The helipad surface contains loose soil and tiles with slope. There was no H marking at

Helipad surface and lots of obstructions were around the helipad. The approach to helipad was around 210°- 220° along the cliff side.

The helipad at Rambara (Jungle Chatti) was a temporary helipad made at end of Road curve for rescue/evacuation of stranded pilgrims situated at approx 8500 feet. The helipad surface contains loose soil and tiles with slope. There was no H marking at Helipad surface and lots of obstructions were around the helipad. The approach to helipad was around 210°- 220° along the cliff side.

Improper construction and location of temporary helipad was contributory factor to the accident.
