**FINAL INVESTIGATION REPORT ON ACCIDENT  
TO M/s TRANSBHARAT AVIATION PVT. LTD.  
BELL 407 HELICOPTER VT-TBE  
AT SHRI KEDARNATH JI  
ON 24/07/2013**

AAIB (India) Report No. : 2013-ACC-0

**FINAL REPORT ON ACCIDENT TO M/S. TRANSBHARAT BELL 407**

**AT GARUD CHETTI, NEAR KEDARNATH HELIPAD**

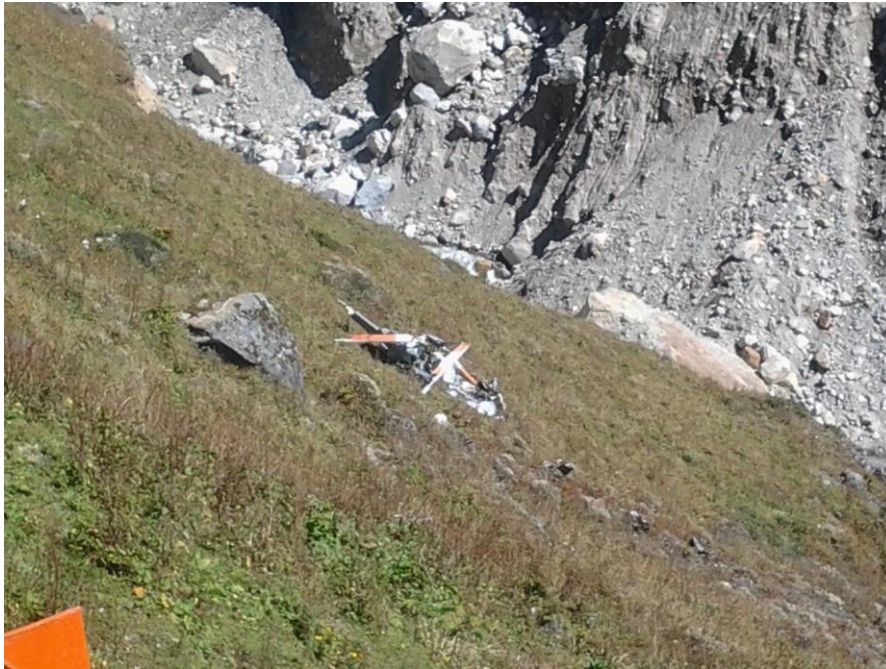
**FINAL POSITION OF THE HELICOPTER  
(SELF CONTAINED WRECKAGE)**

- The major salvage of the helicopter was found lying in the valley below the track path to Kedarnath.
- The abandoned dead cable in the area, above the track path in the valley, on the sloping hill, was found damaged/broken and was lying on the ground between the two poles along with pieces of cabin shell door and torn flight manual.

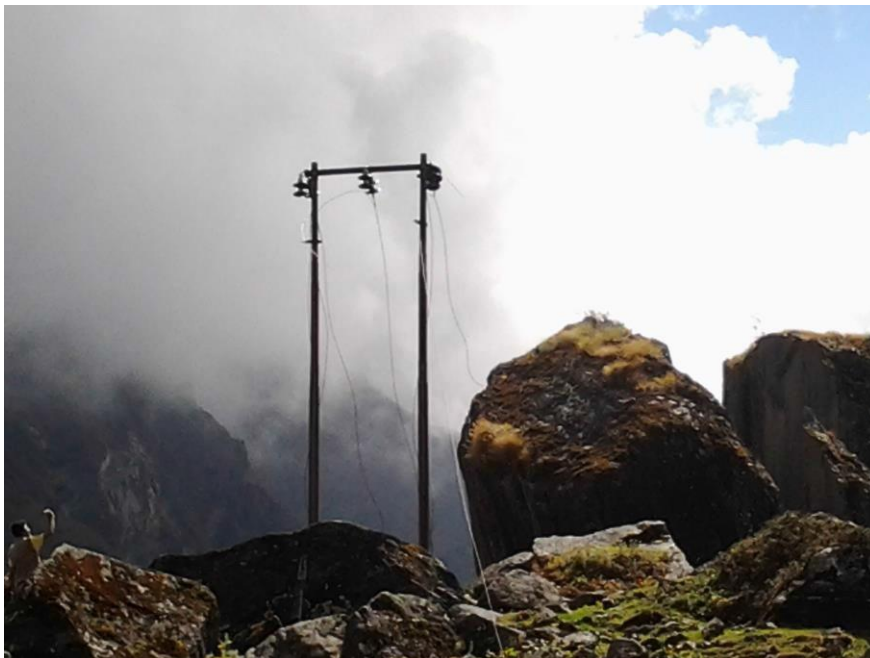
**CABLE (WHICH WAS HIT BY HELICOPTER)  
RUNNING ACROSS THE ABANDONED POLE**

pieces were lying adjacent to the broken dead cable in between two poles. The Main Rotor Blade of the helicopter first impacted with the cable running in the area and then with the ground. It had skidded thereafter into the valley and stopped due to an obstruction on the slope before the bank of the river. The helicopter was destroyed.

The helicopter after taking off in marginal weather, encountered sudden severe bad weather and while turning back hit the dead cables across the hills resulting into impact with the sloping hill sustaining substantial damages.

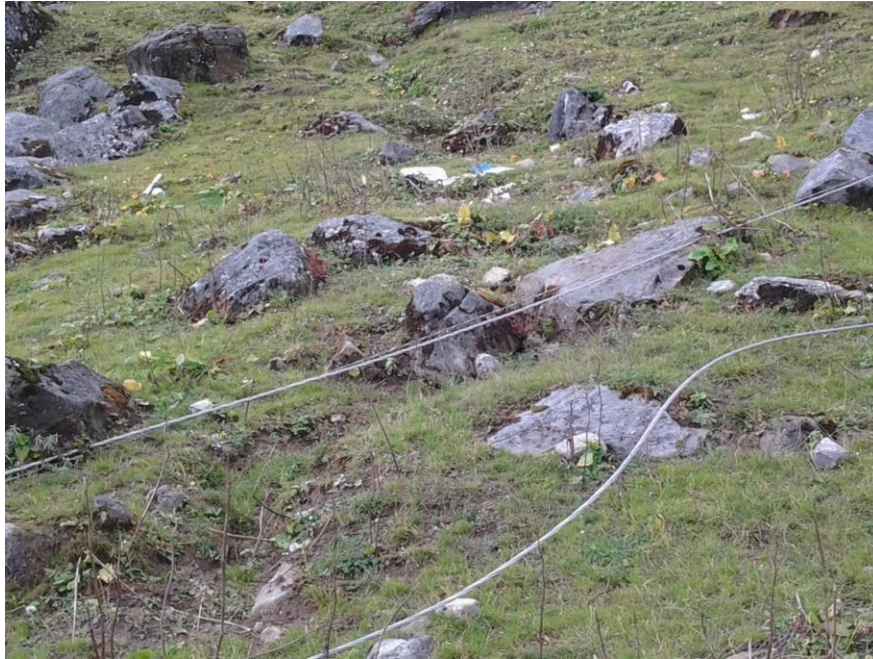
**CABLES ALONGWITH VERY SMALL BITS OF HELICOPTER TERTIARY STRUCTURE & MANUAL**

Some pieces of the fuselage and torn documents were found on the uphill at a distance of approximately 150 feet upslope from the main wreckage. These

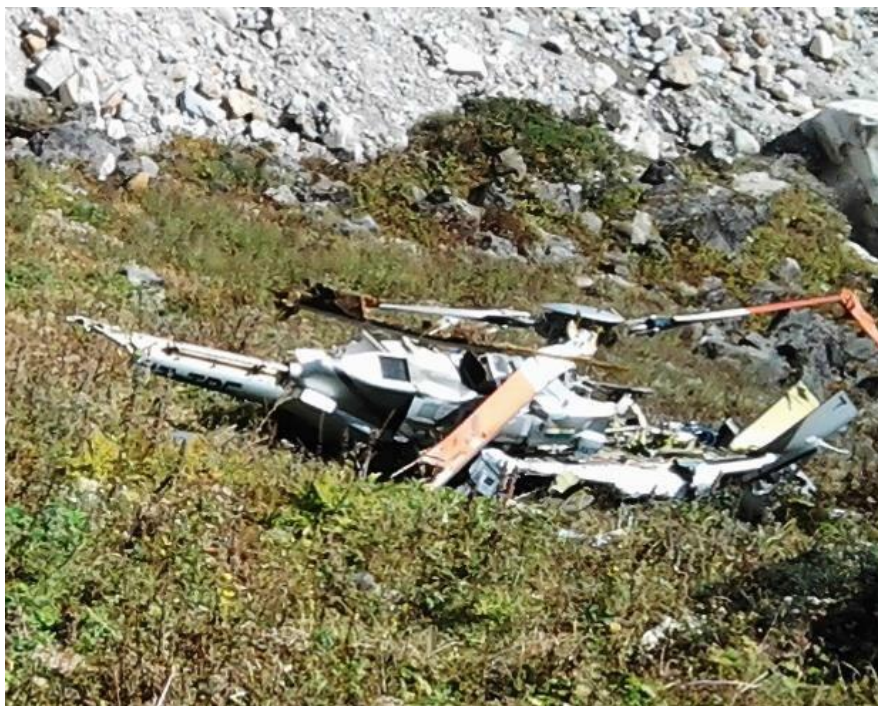
**CLOSE UP OF THE WRECKAGE**
