AIRCRAFT ACCIDENT INVESTIGATION BUREAU

**FINAL INVESTIGATION REPORT ON SERIOUS INCIDENT
TO
AIRBUS A-320 AIRCRAFT VT-IEW
AT
MUMBAI AIRPORT
ON
9th MARCH 2013**

**REPORT OF SERIOUS INCIDENT TO AIRBUS A-320 AIRCRAFT
VT-IEW ON 09TH MARCH 2013 AT MUMBAI.**

AAIB (India) Report No. : 2013-INC-

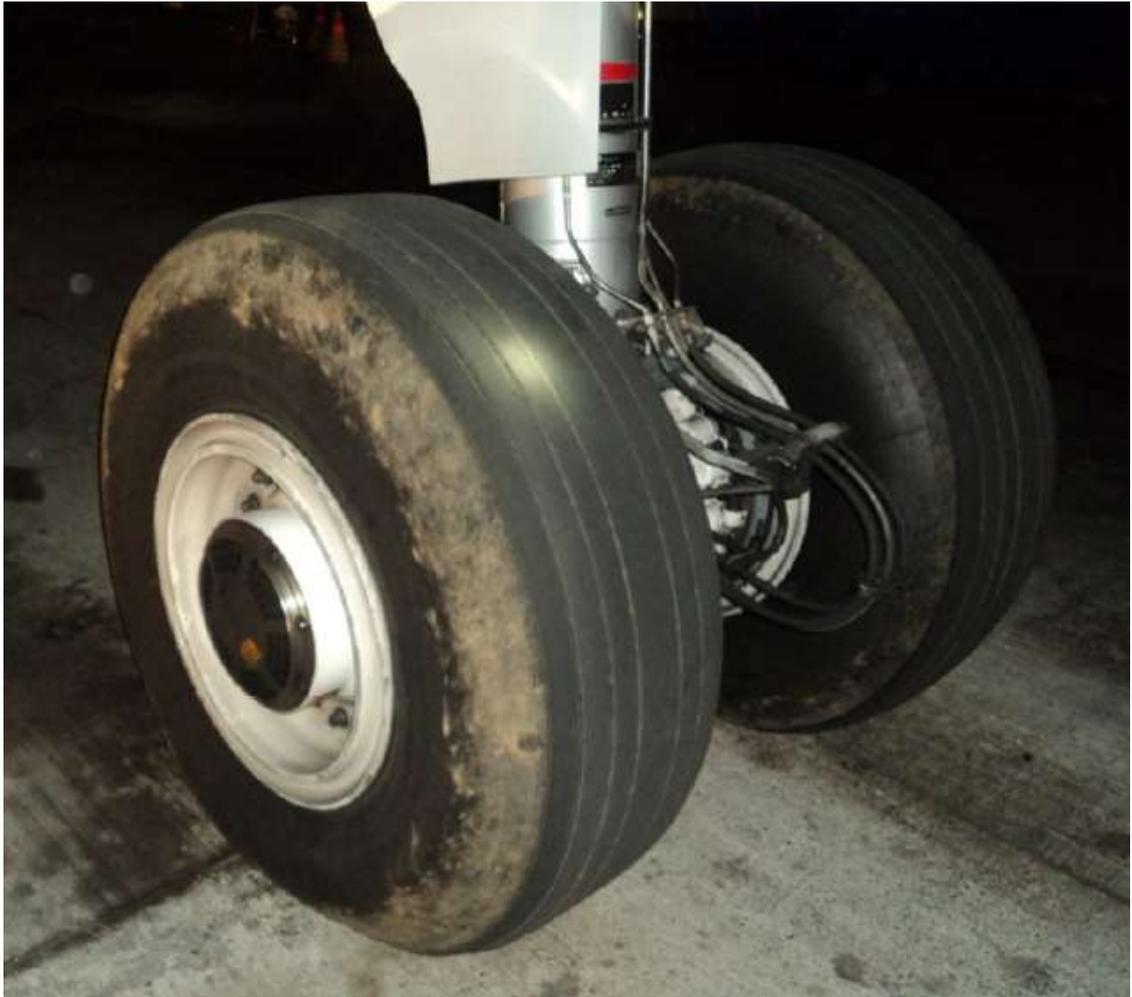
No. 1 Main Wheel was found deflated and had cut marks. Glass pieces were found on the main wheel and deep cuts found on the tyre. There were signs of mud on the tyres.

Deflated and damaged tyre (aircraft at parking bay)

/ rectification action. The information of the incident was communicated to the MCC / LMM and Base Manager. Both the wheels on LH Landing Gear were replaced as per Aircraft Maintenance Manual (AMM).

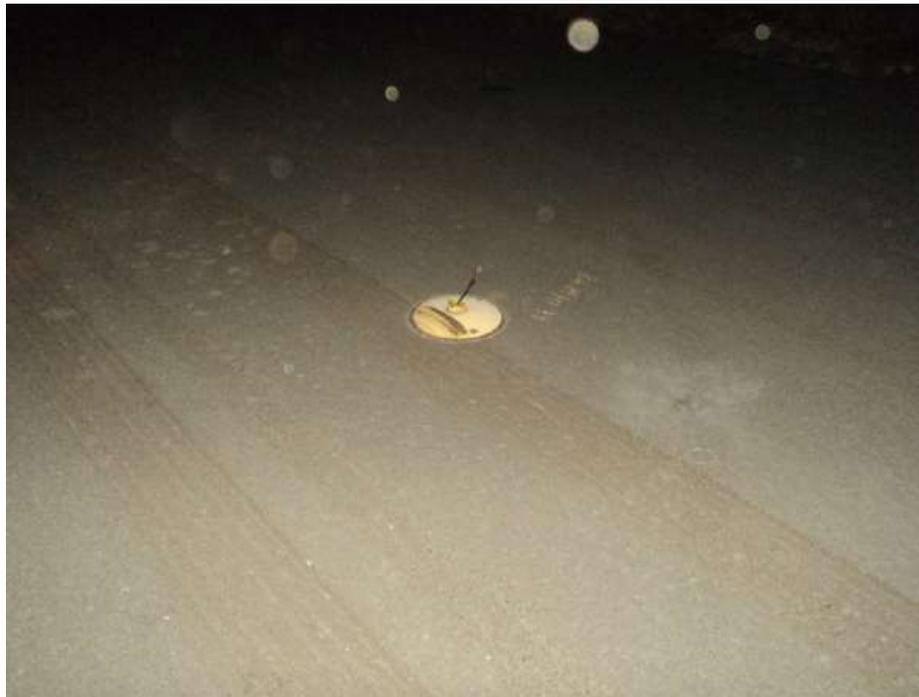
The flow of air traffic continued normally after the flight. Later, the SMC Controller requested ATC that Follow Me jeep wanted to carry out routine inspection of Runway 27, which was permitted by ATC. Post the runway inspection the vehicle reported that 7 south side Runway 27 Edge Lights are broken between N7 and N8.

One of the damaged runway edge light

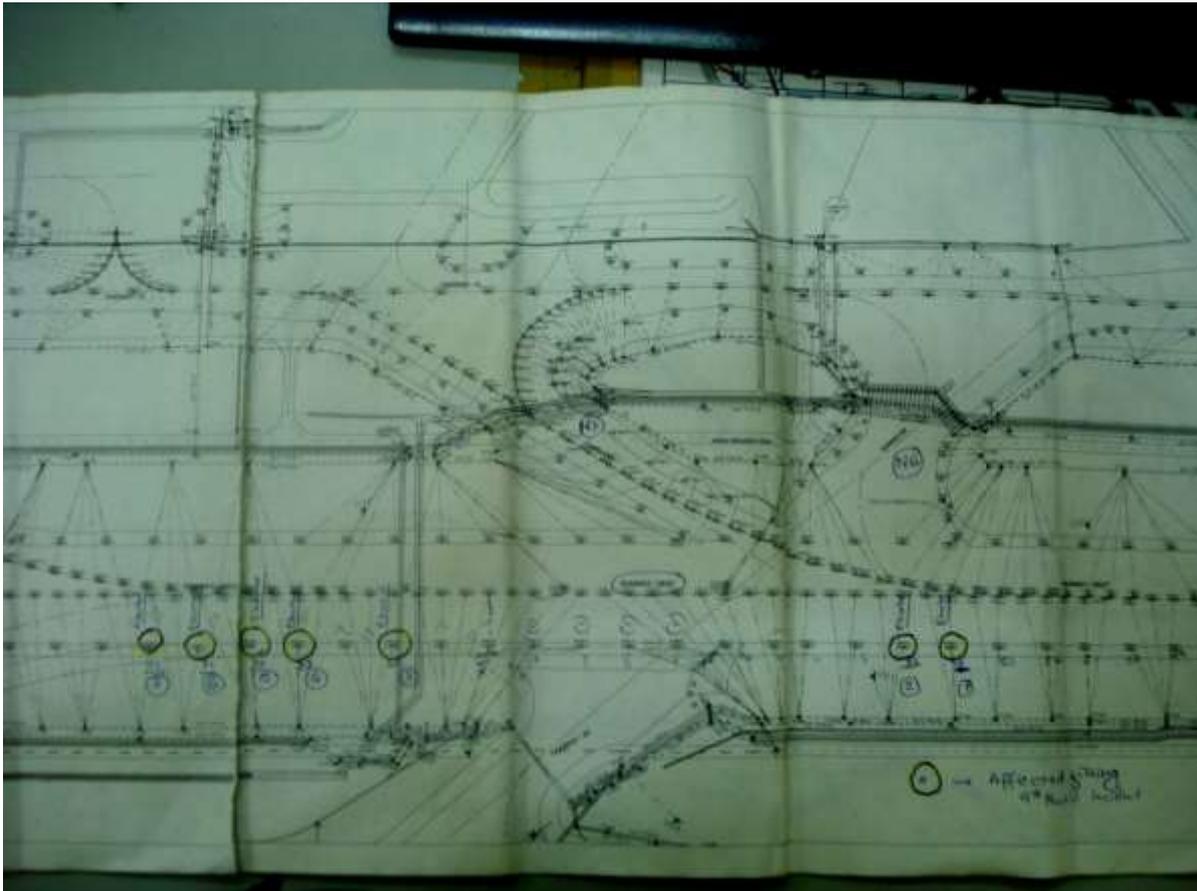
07 Runway Edge Lights on the left side of Runway 27 (encircled in the figure below) were broken.

7 damaged runway edge lights (encircled)

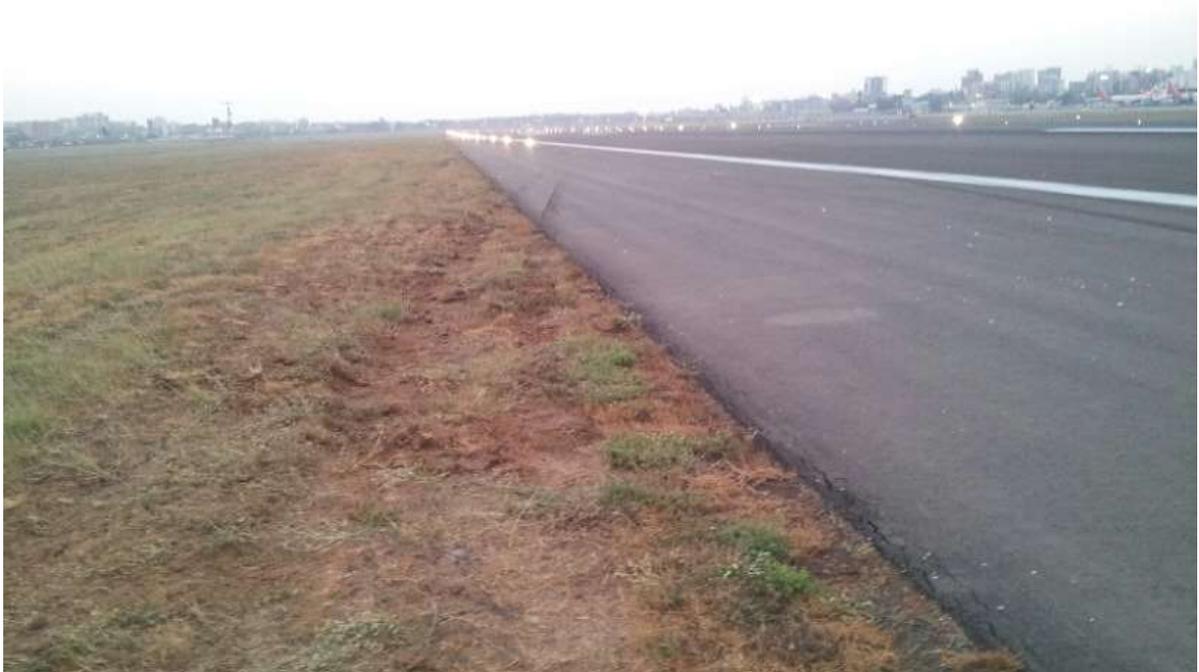
The Aircraft touchdown was in the touchdown zone slightly left of the runway centre line. No significant or abnormal marking of tyres was seen in touch-down zone. Thereafter ground marks indicate that the aircraft started veering further to the left at approximately 1600 meters from the threshold. The left deviation increased and the left main wheels reached the left shoulder up to a maximum deviation of 31.5 meter from the runway centreline. At this point two sequential runway edge lights were damaged.

The left main wheel after travelling for approx. 200 meters near the runway edge lights exited the paved surface and entered the soft ground on the left side breaking five runway edge lights in the process. The aircraft then was steered back on the runway and taxied to bay under its own power. During inspection, glass pieces were found on the main wheel and deep cuts found on the tyre. There were signs of mud on the sidewall indicating that the wheel had entered 'kutchha' after leaving the paved surface on the runway.

Tyre marks on the kutchha and runway

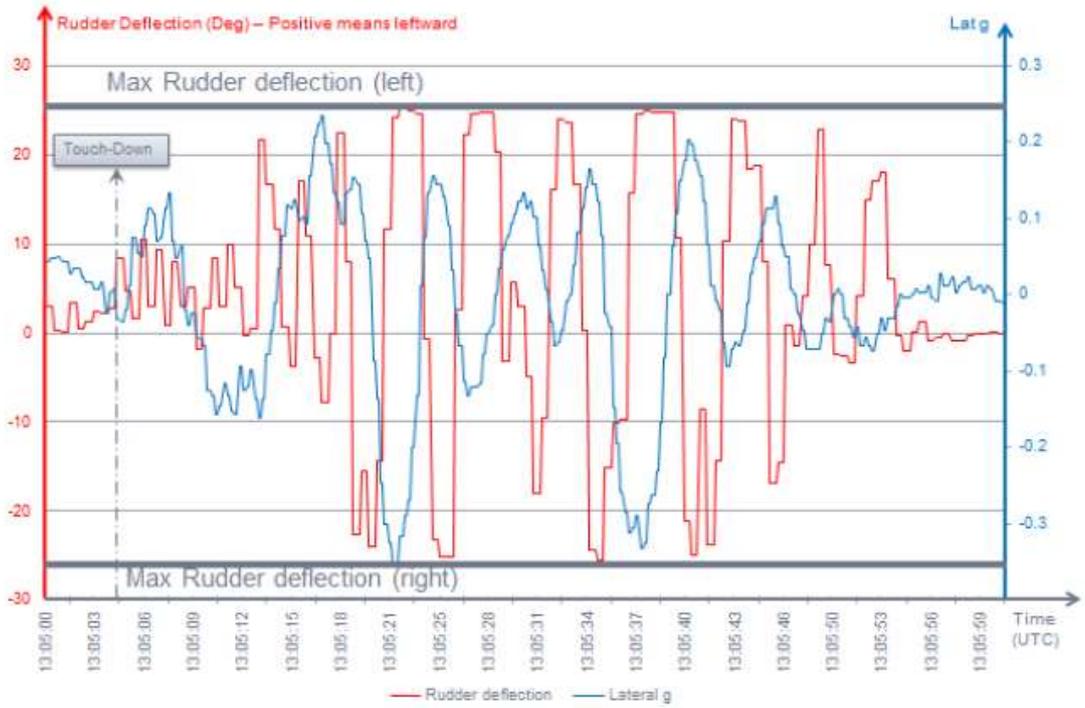
Rudder deflection versus Lateral g
 (Rudder deflections up to max left and right – Lateral g variation between -0.35g and +0.23g)

right sides. The LOC deviation increased to reach a maximum of 123mA (A/C on the left of the runway). During that time several brake pedal inputs were also applied on both sides. Improper use of the rudder by the Captain contributed to the incident.

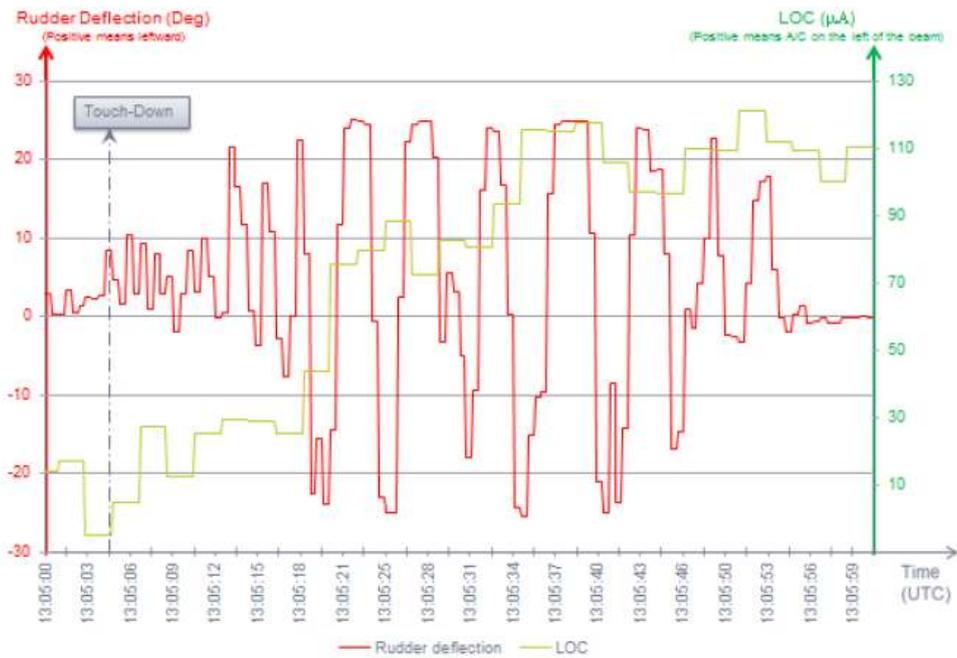
Rudder deflection versus LOC deviation
 (A/C on the left of the LOC beam)

up to the max left and right sides. The LOC deviation increased to reach a maximum of 123 (aircraft on the left of the runway). During that time several brake pedal inputs were also applied on both sides. The justification of the pilot that there were heavy cross winds could not be corroborated with other evidences. The Captain though was on controls but was unaware of the actions he was taking. He has deviated from the centerline and reached the extreme left which might have been due to loss of situational awareness.

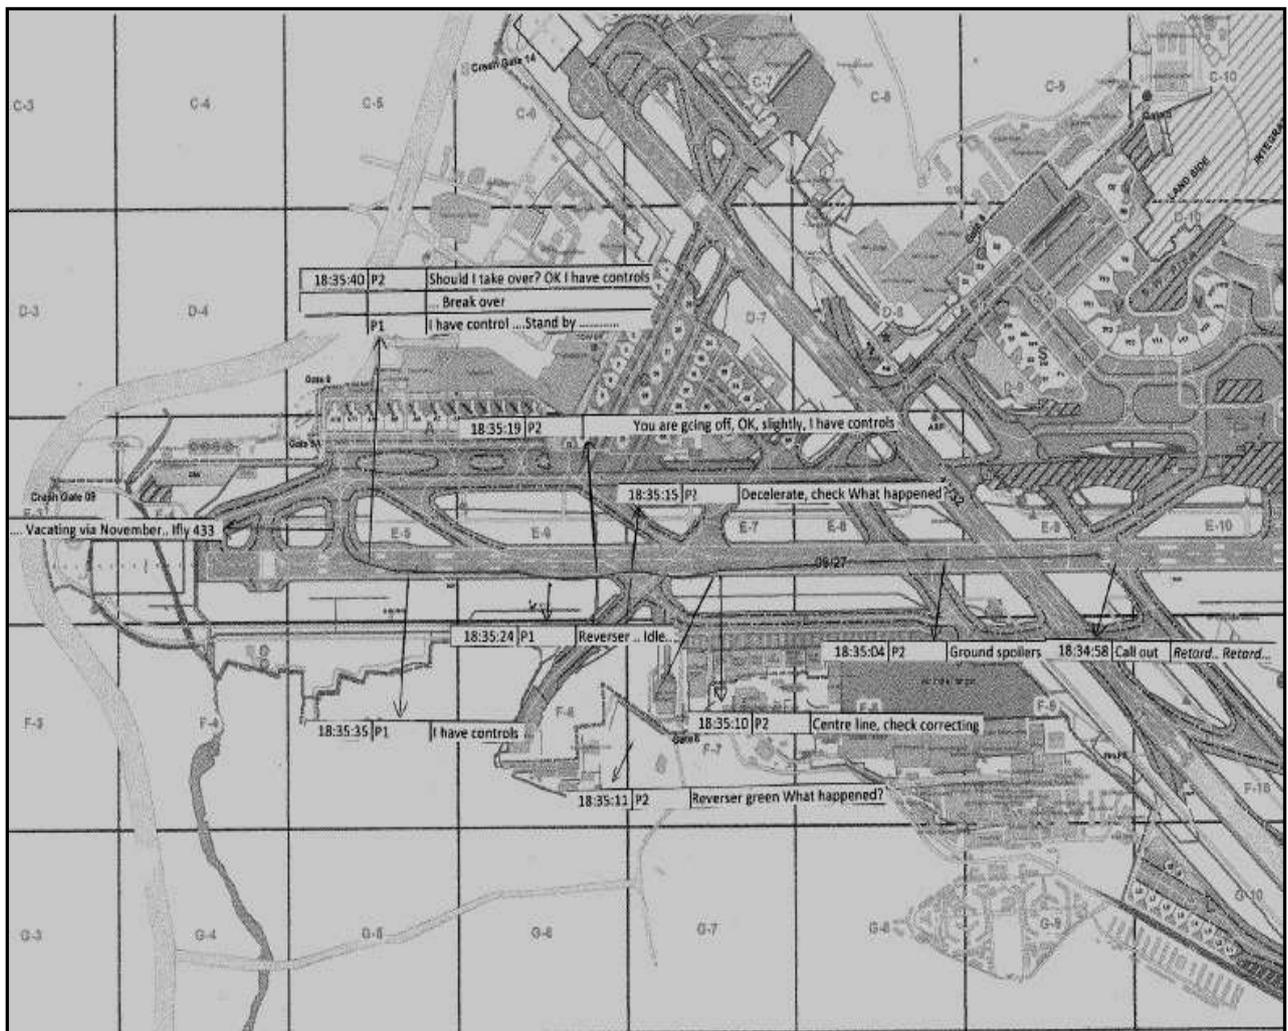
CVR readout superimposed on Airport map
