**FINAL REPORT**  
**OF SERIOUS INCIDENT OF RUNWAY INCURSION BETWEEN**  
**M/s GOAIR FLIGHT GOW336 AND INDIAN AIR FORCE FLIGHT VUDBL**  
**AT DELHI ON 02<sup>ND</sup> OCTOBER 2013.**

- 1. Aircraft**  
Type : A 320 (GoAir) and AN32 (IAF)  
Nationality : INDIAN  
Registration : VT-GOK (GoAir) and VUDBL (IAF)
- 2. Owner/ Operator :** GoAir and Indian Air Force

GoAir aircraft VT-GOK flight GOW 336 was given the departure clearance from runway 09.

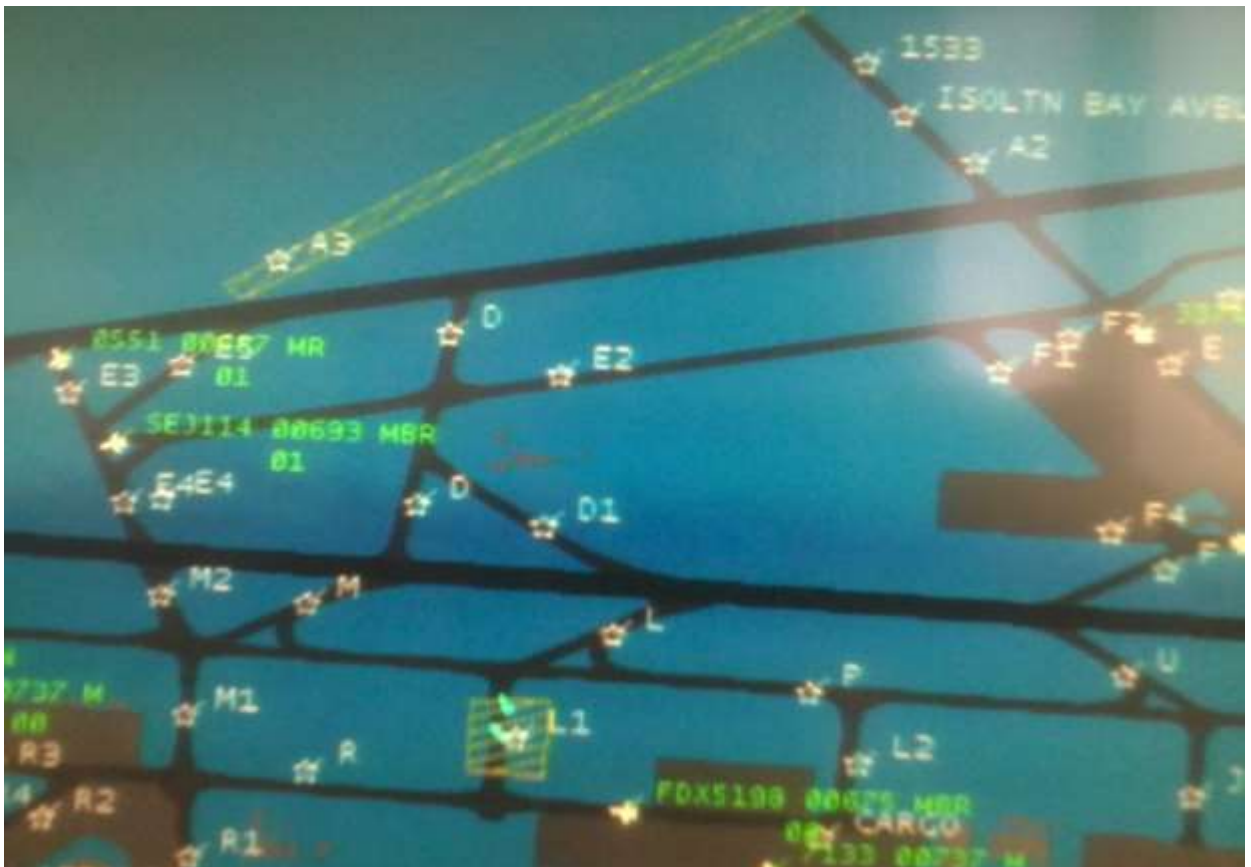
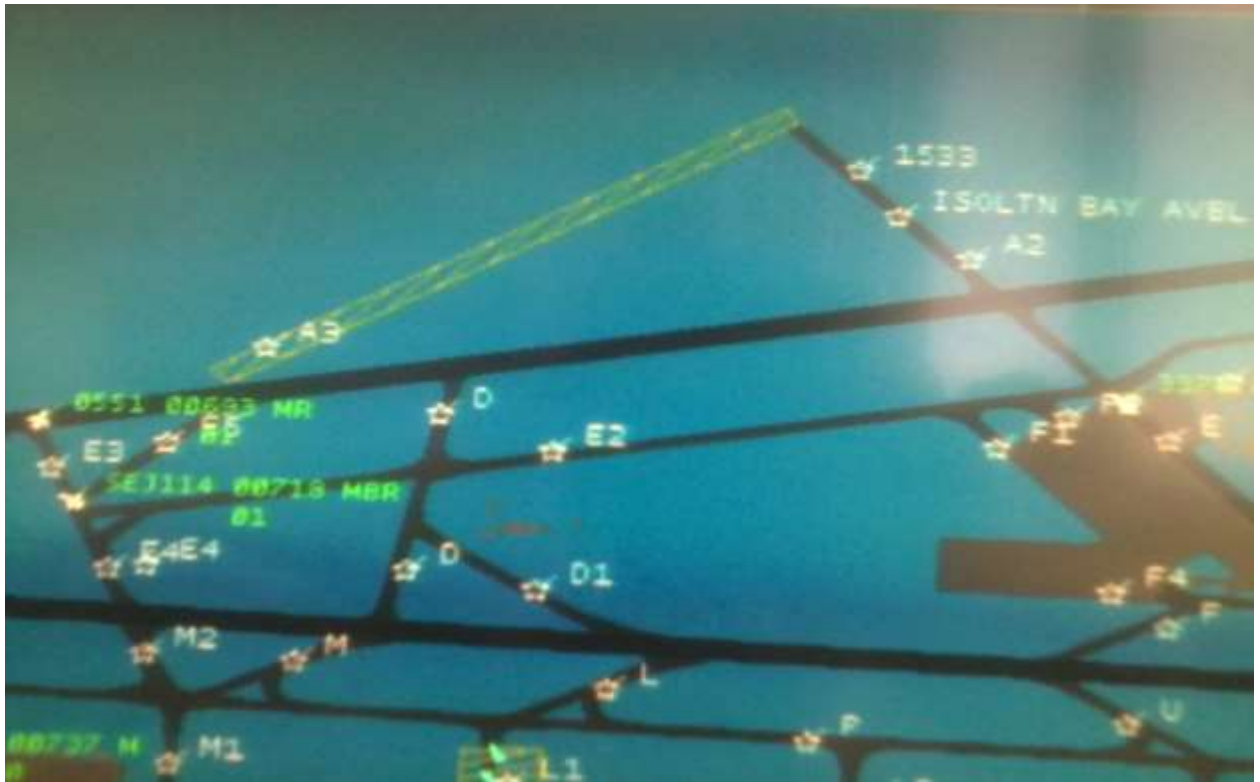
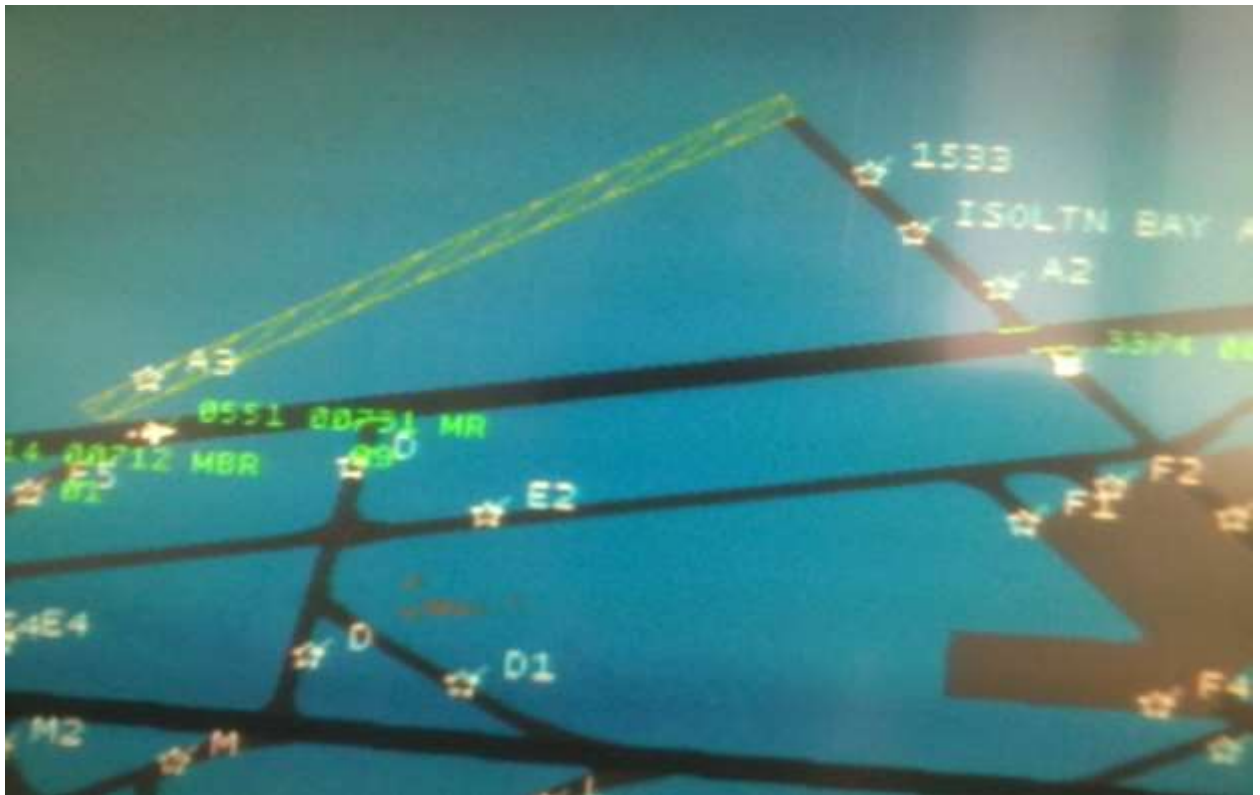
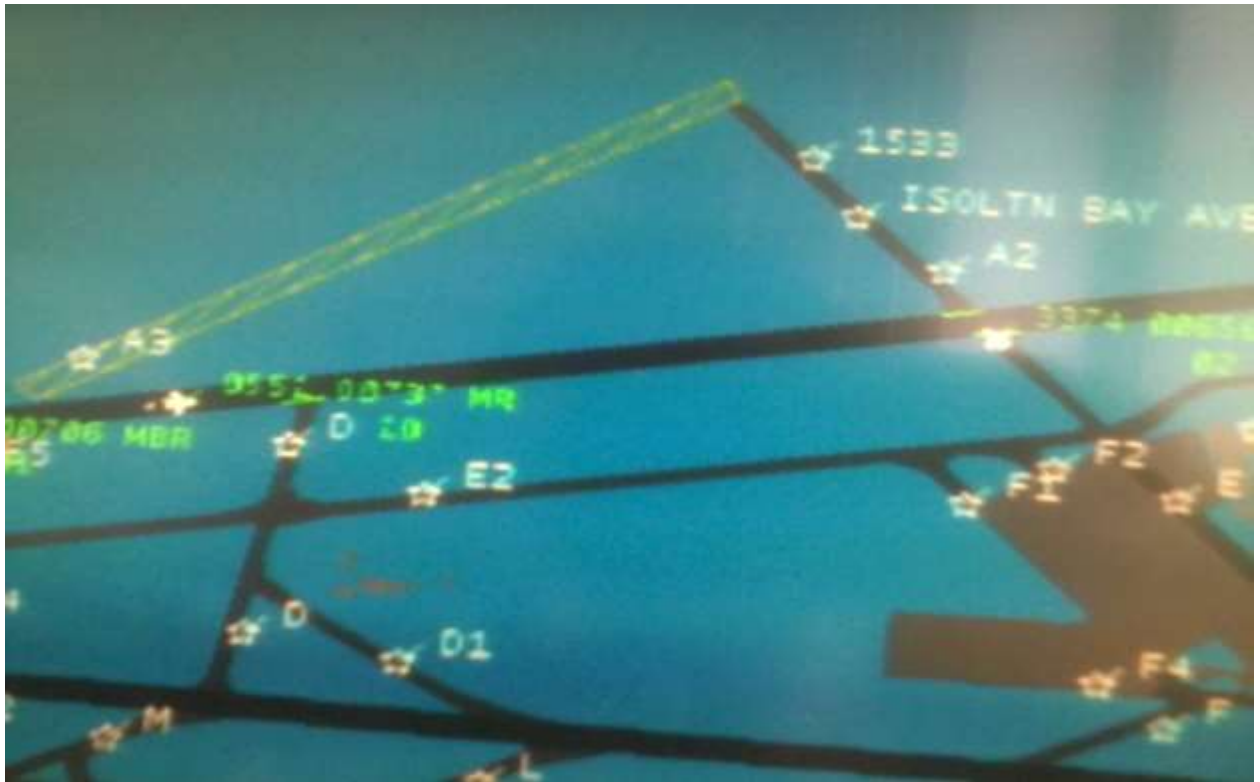
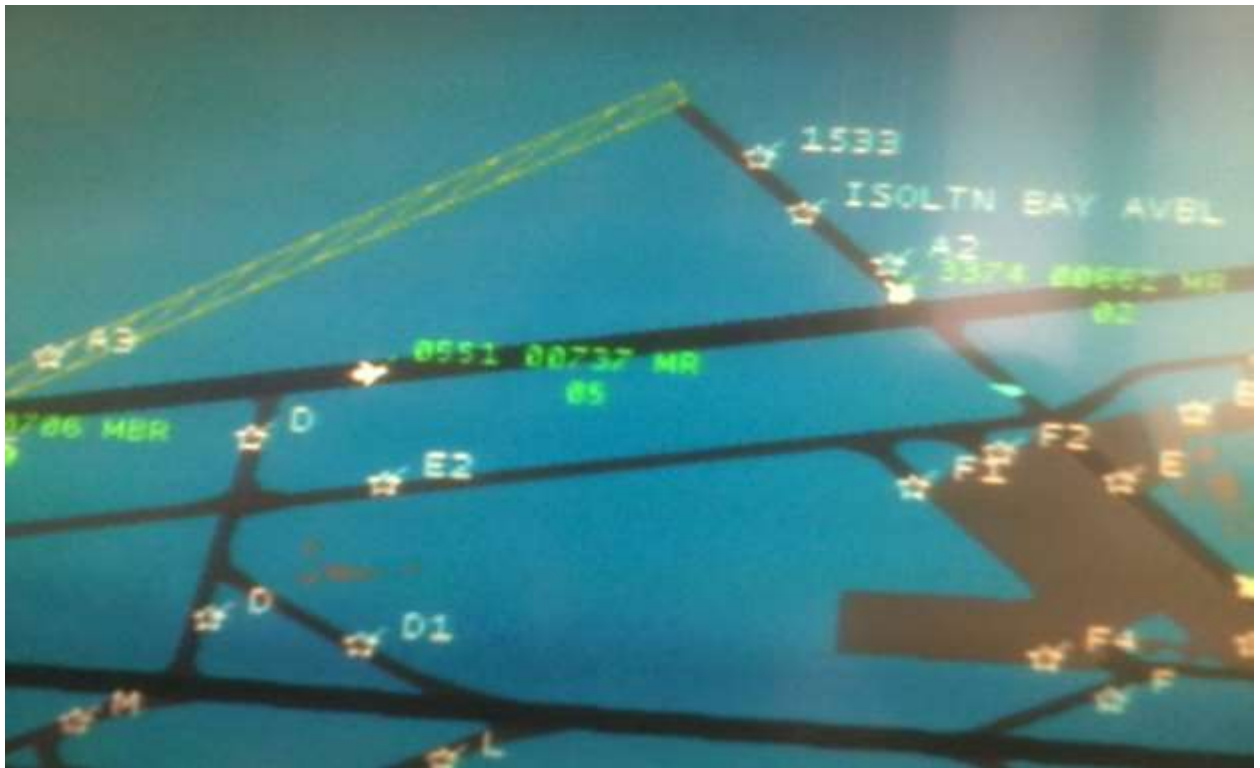
#### Radar picture of VUBDL (AN 32) IAF aircraft crossing Runway 09 from south to north
