Final Investigation Report on Accident to
M/s Transbharat Aviation Pvt. Ltd.
Cessna 152 aircraft VT-CAX on 20-03-2014
at Salon near Fursatganj Airfield, Raibareli

FINAL INVESTIGATION REPORT ON ACCIDENT TO M/s TRANSBHARAT AVIATION PVT. LTD. CESSNA-152 AIRCRAFT, VT- CAX AT SALON NEAR FURSATGANJ AIRFIELD, RAIBARELY, U.P. ON 20-3-2014

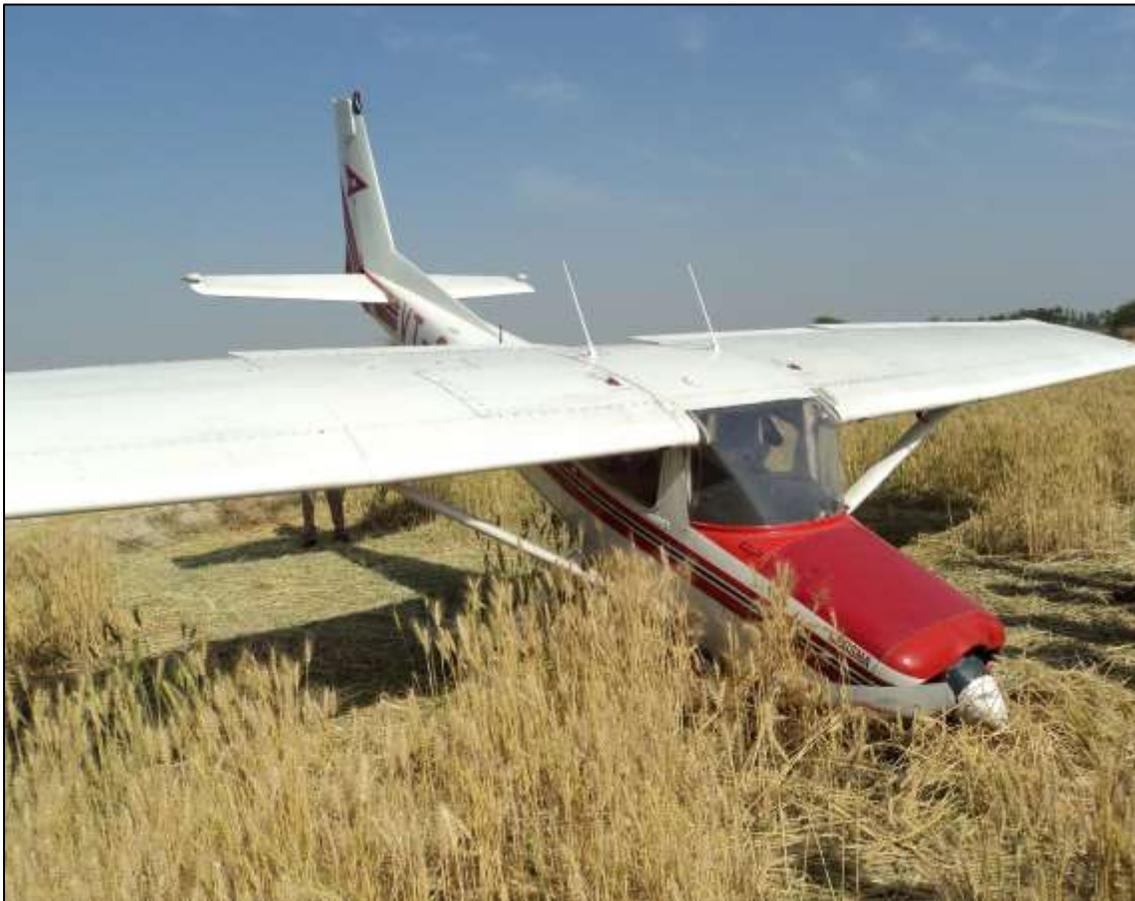
During examination of the wreckage at site, it was observed that the aircraft was lying in nose down upright condition. The wreckage was confined to one place indicating that there was no in-flight disintegration of the aircraft. One blade of Propeller had bent backward. Nose landing gear was bend backward from mounting and the Station No.0 (firewall) was damaged and pushed back toward cabin.

Final rest position of the aircraft in Nose Down condition.

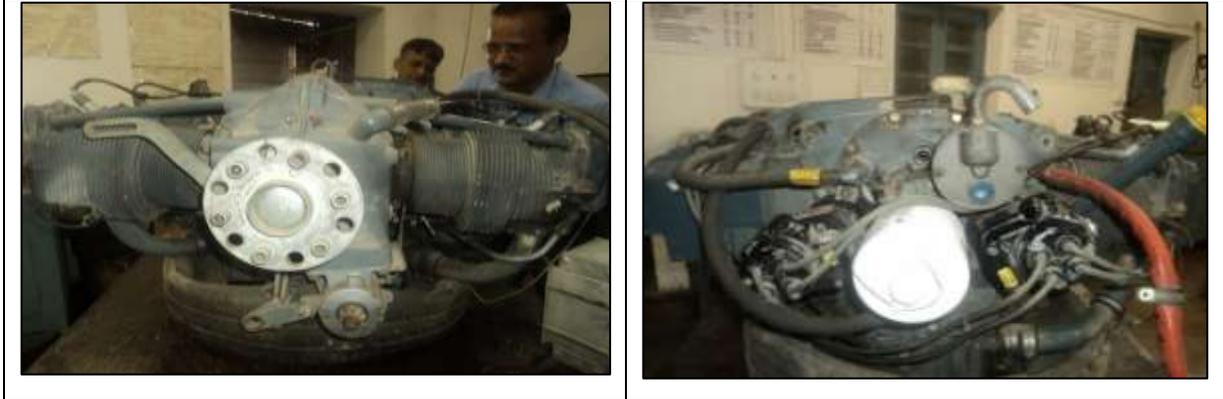
The engine was found Intact and no external damage observed. All the accessories were found installed and intact except the carburetor.

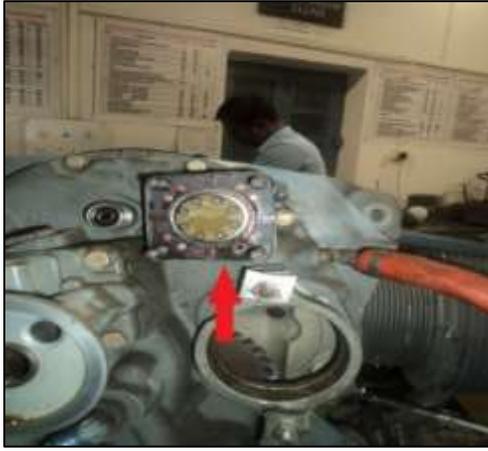
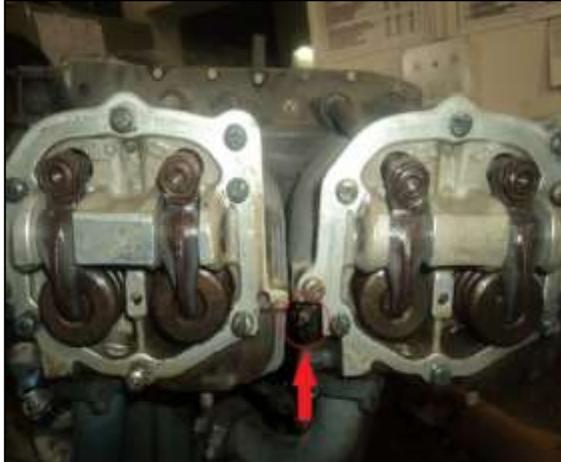
<p><i>Vacuum Pump Coupling found broken</i></p>	<p><i>Primer line Cylinder No. 01 found broken due impact.</i></p>

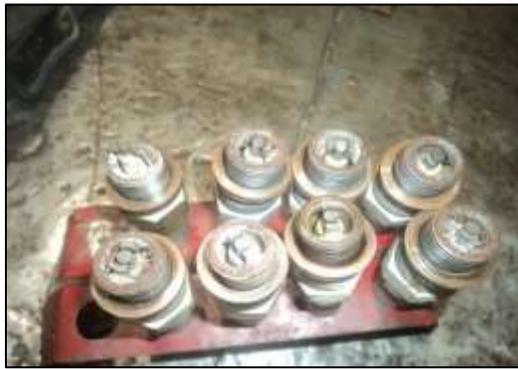
All Spark Plugs condition was found satisfactory.

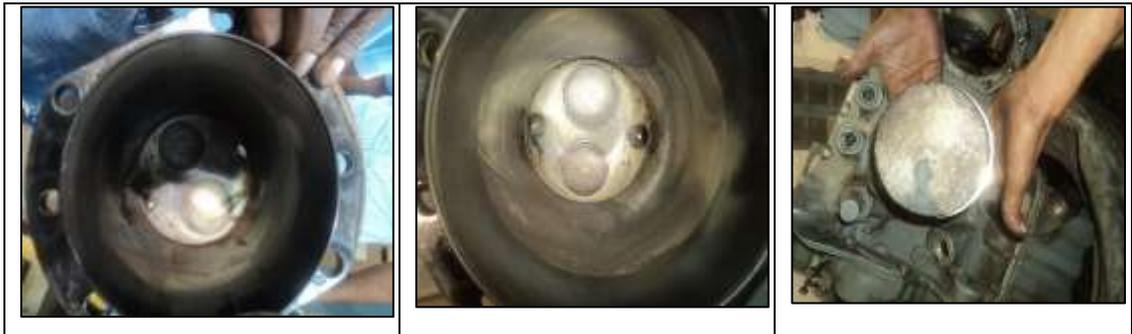
The condition of all Cylinders, pistons and its associated parts found satisfactory.

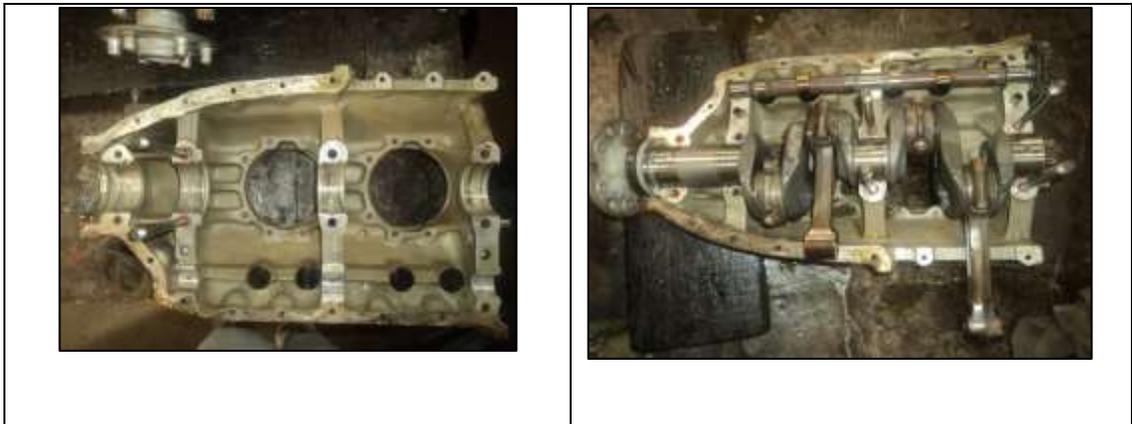
The condition of Crankcase, Crankshaft, Camshaft & Connecting Rods were found satisfactory.

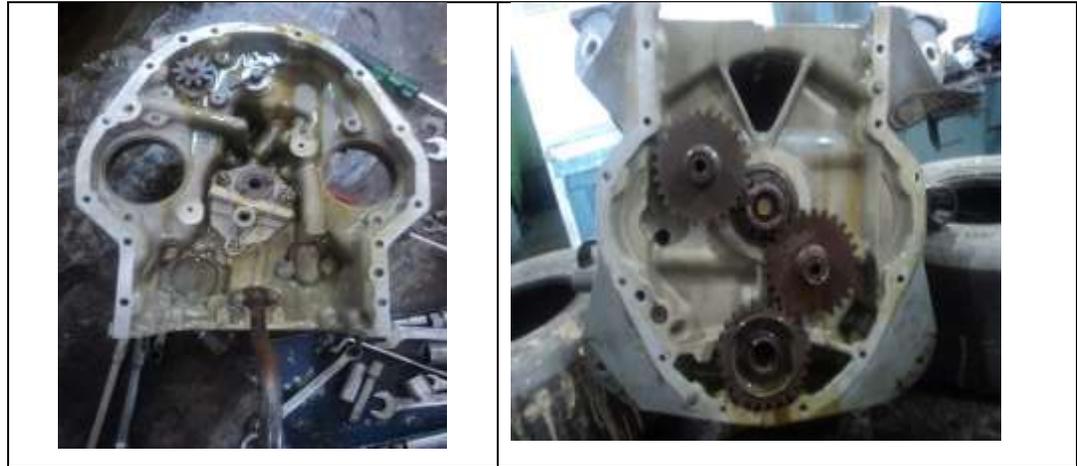
The condition of Oil Pump and housing, Tachometer drive, Vacuum pump drive, Crankshaft gear, Camshaft Gear and Magnetos drive gears were found intact. No damage observed.

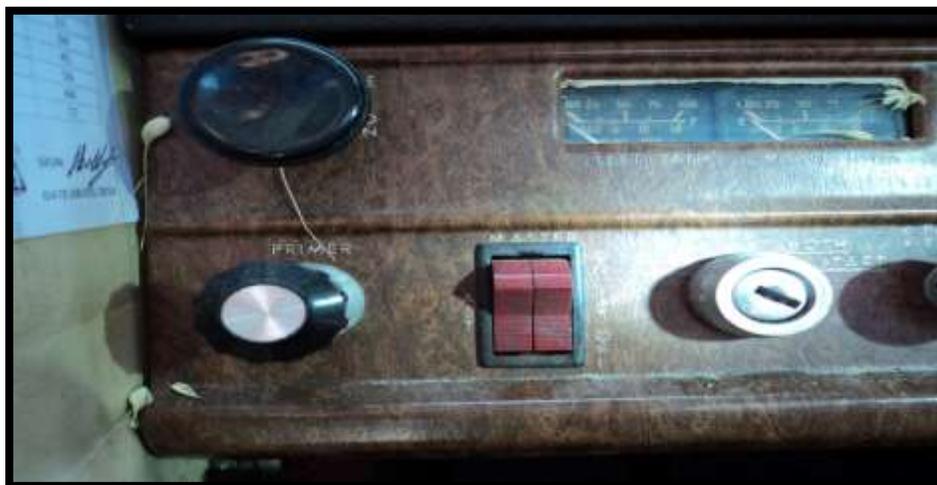
Fuel Quantity Indicator of VT- CAX

Scrutiny of the Tech log revealed that there was no defect reported on the aircraft before the accident flight. The defect register shows no defect from 11-08-2012 to 22-02-2014. However as per PIC, during flight left fuel quantity gauge was showing correct reading but right fuel quantity gauge was not showing correct reading.

During flight left fuel quantity gauge was showing correct reading and but right fuel quantity gauge was not showing correct reading.

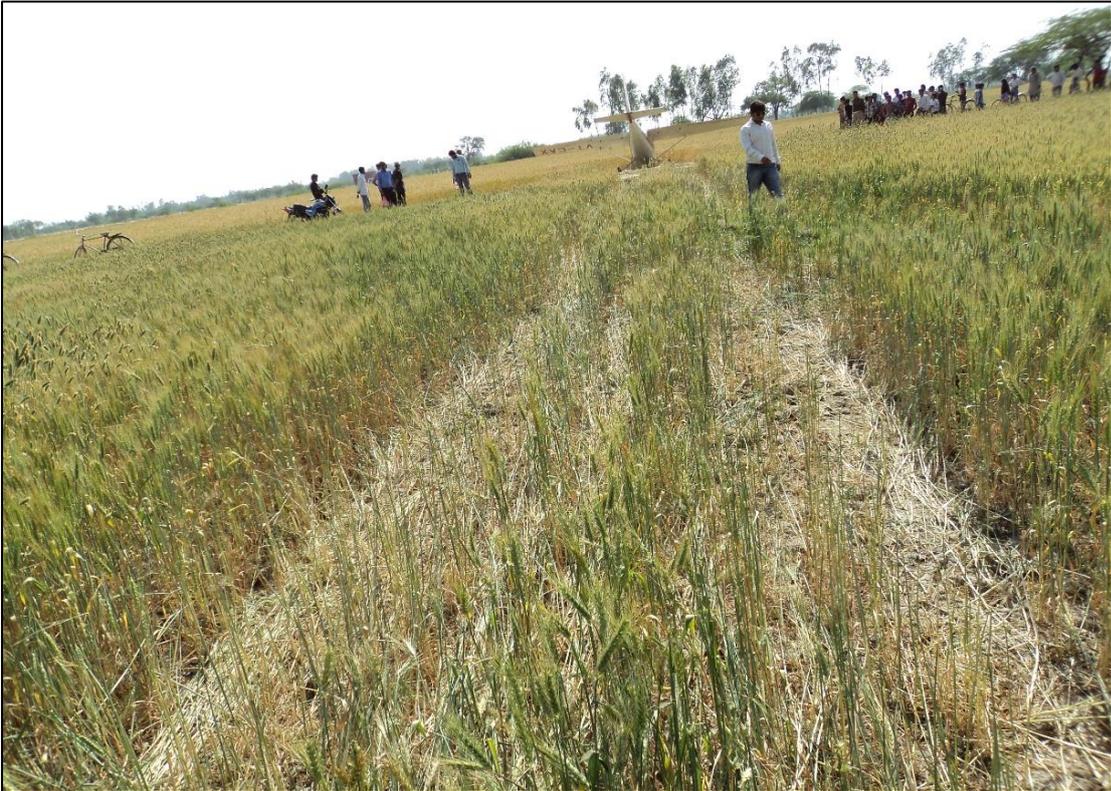
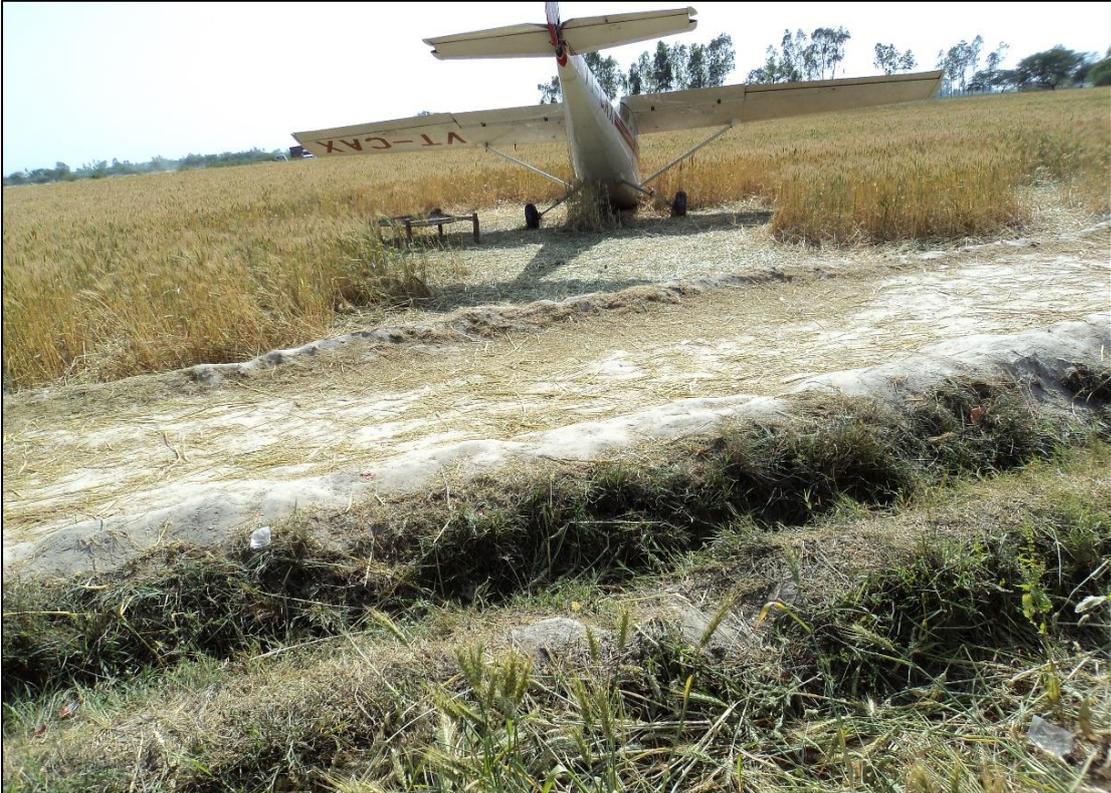
1.12.1. During forced landing the aircraft moved around 100 meters before hitting the mud- bund as visible by the wheel marks.

GROUND MARKS & TOPPLING OF AIRCRAFT ON NOSE

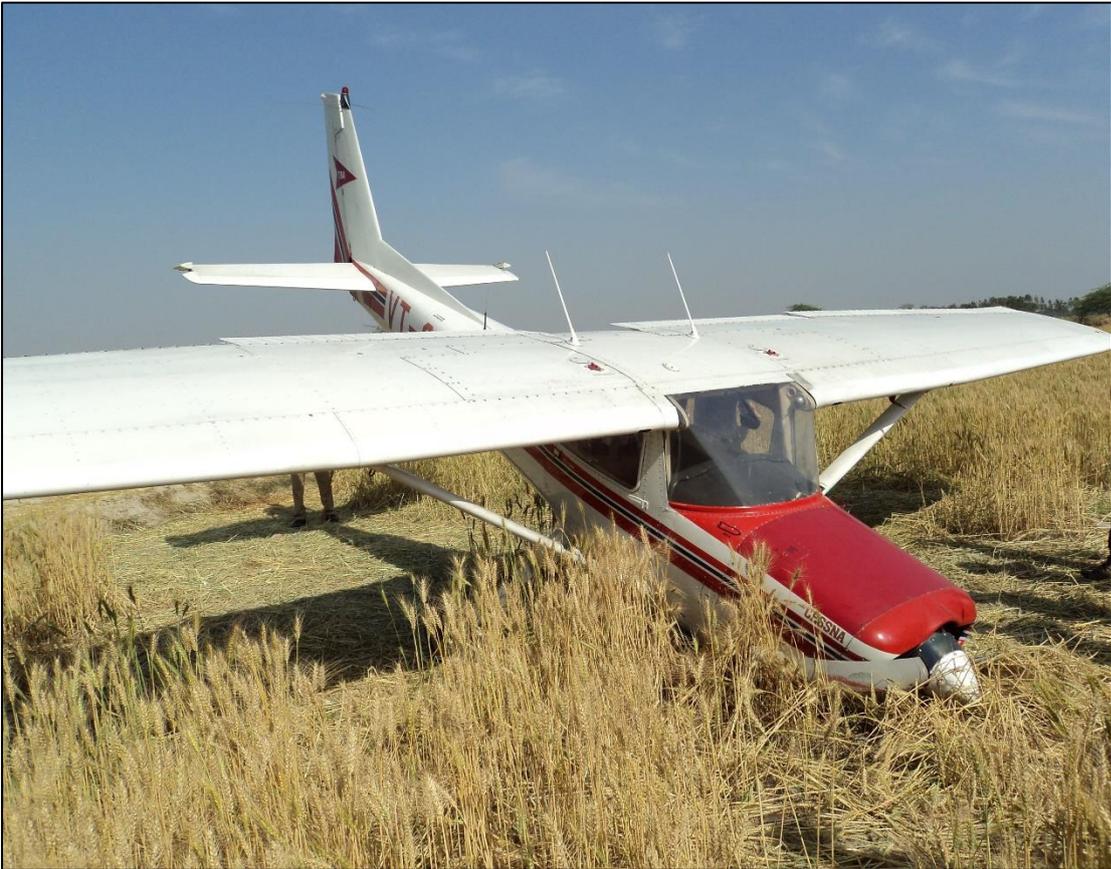
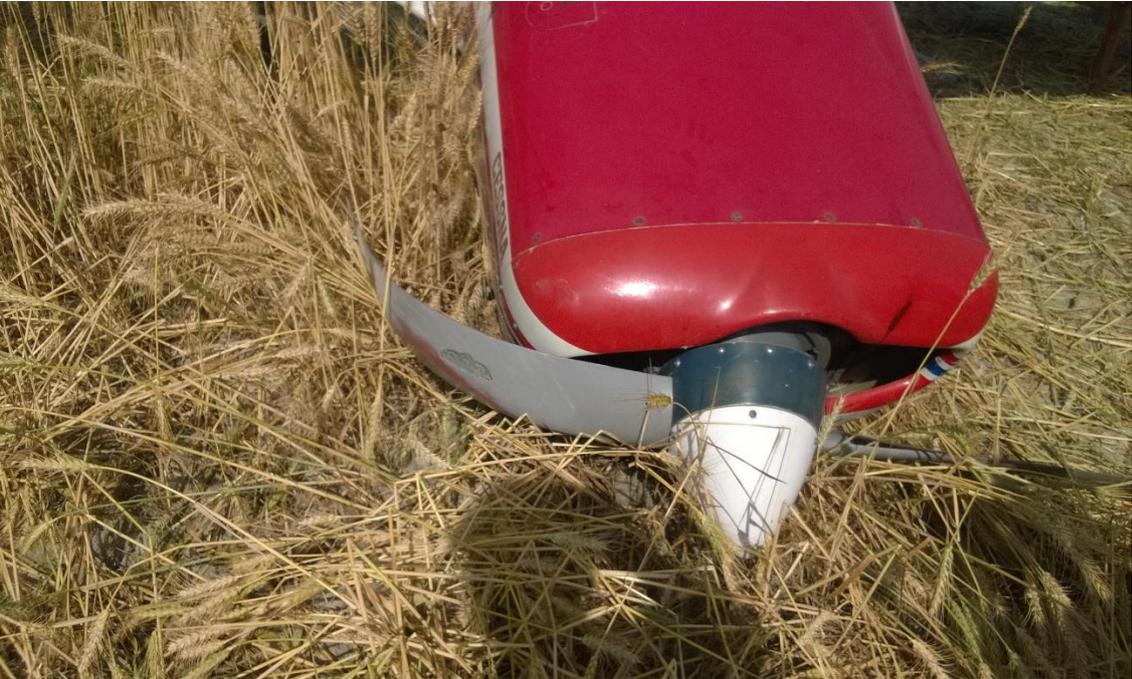
DAMAGE TO PROPELLER

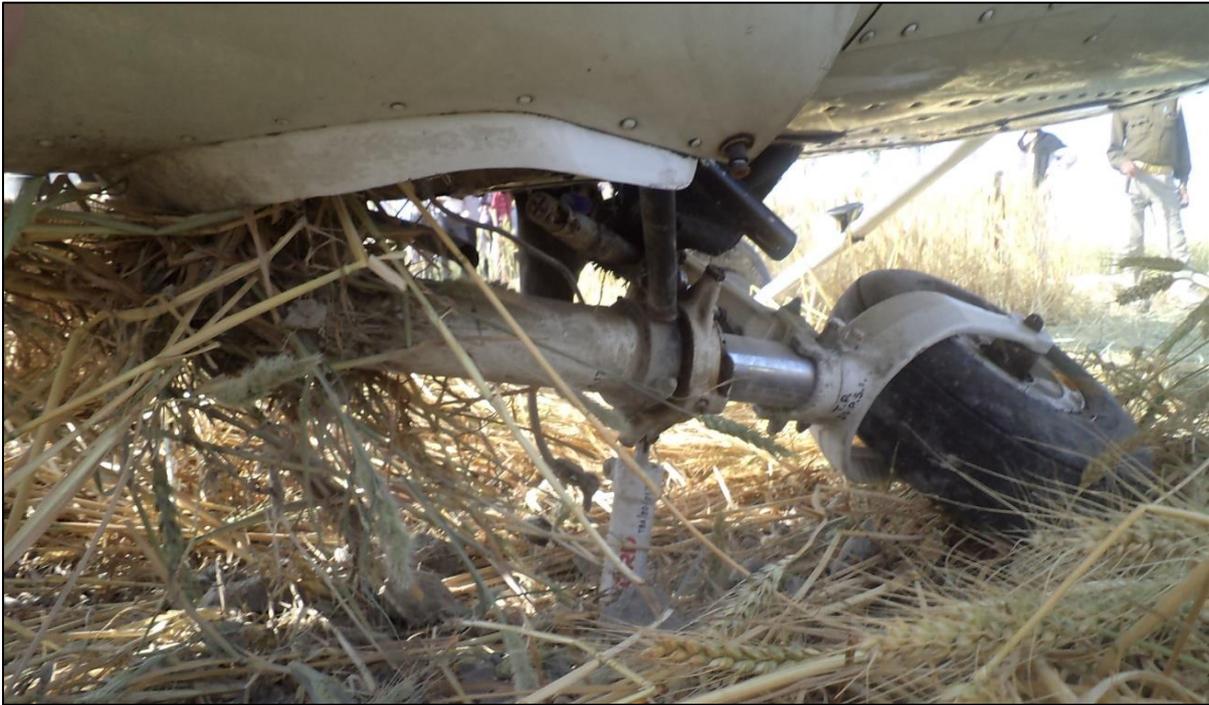
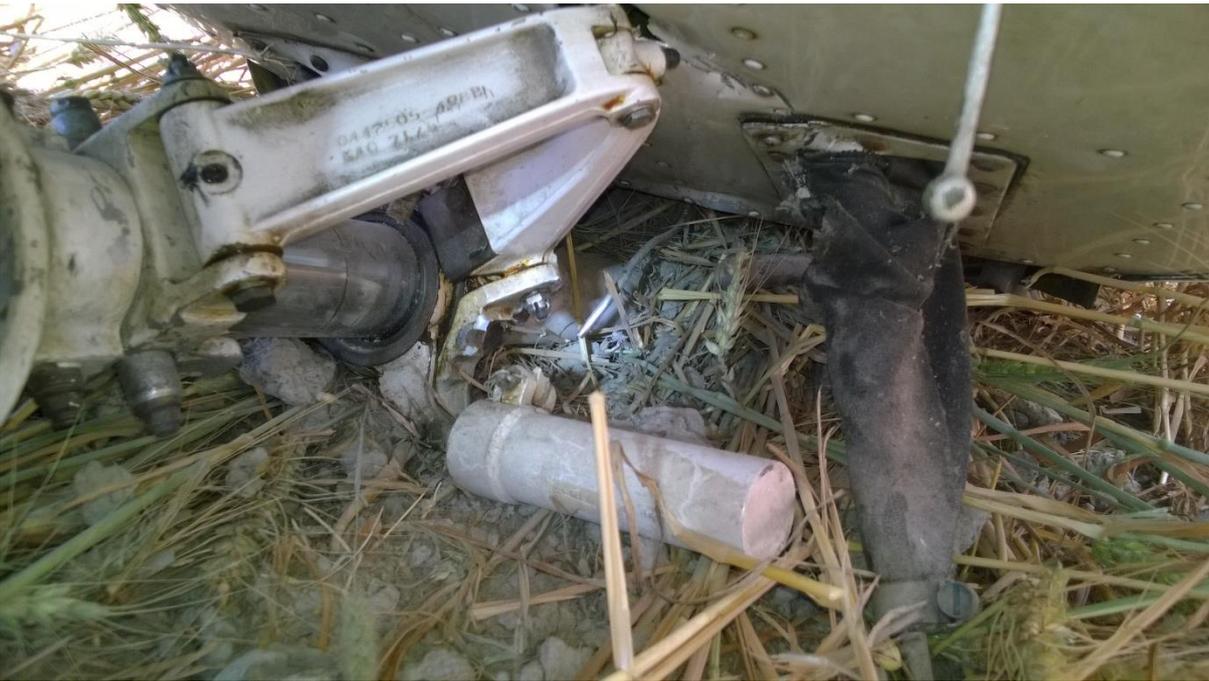
DAMAGE TO NOSE LANDING GEAR

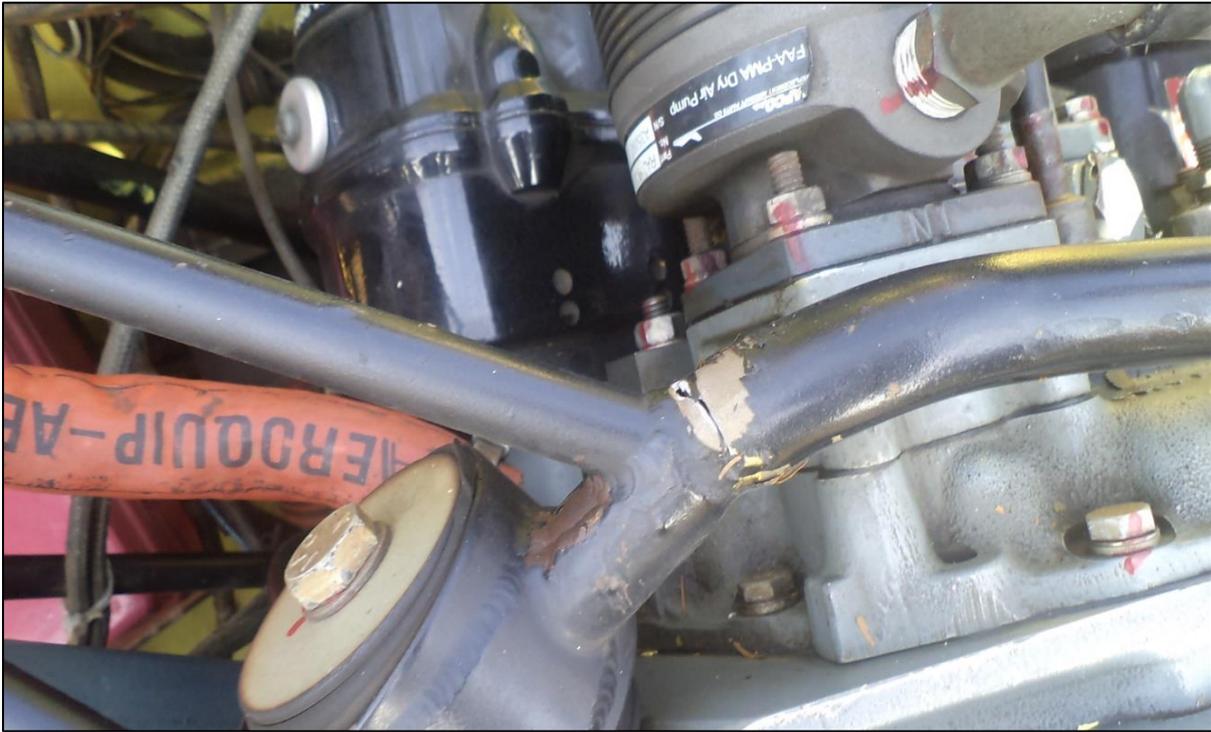
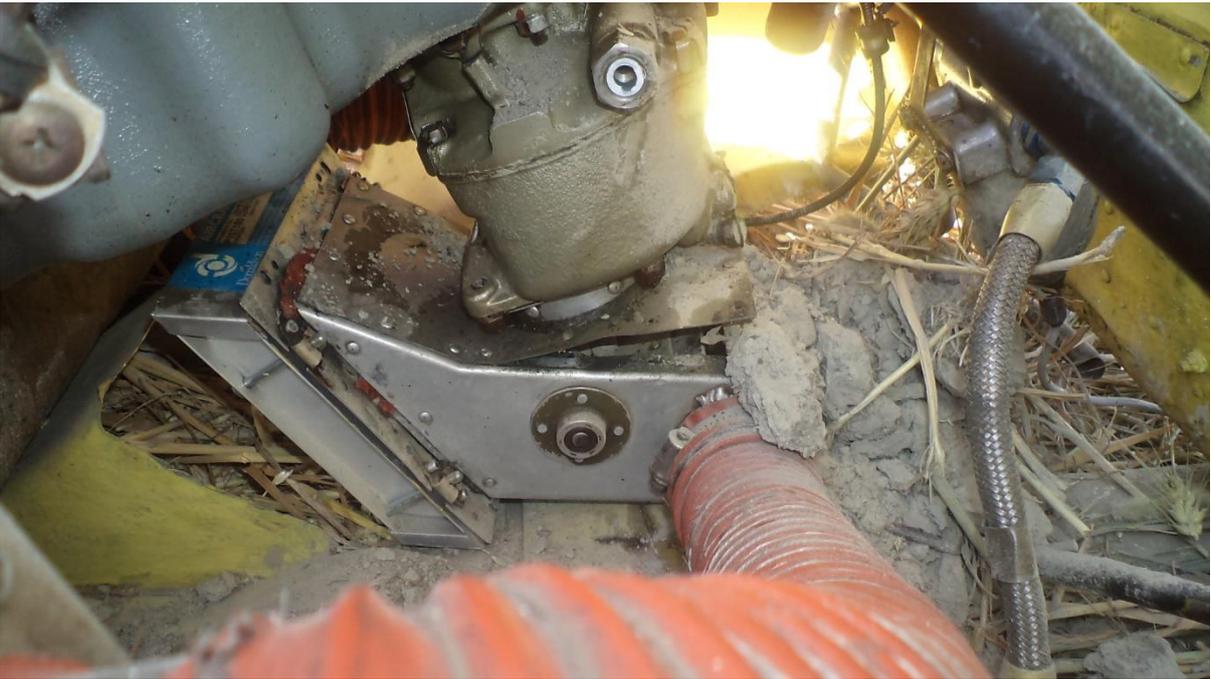
DAMAGES TO ENGINE & ENGINE MOUNT

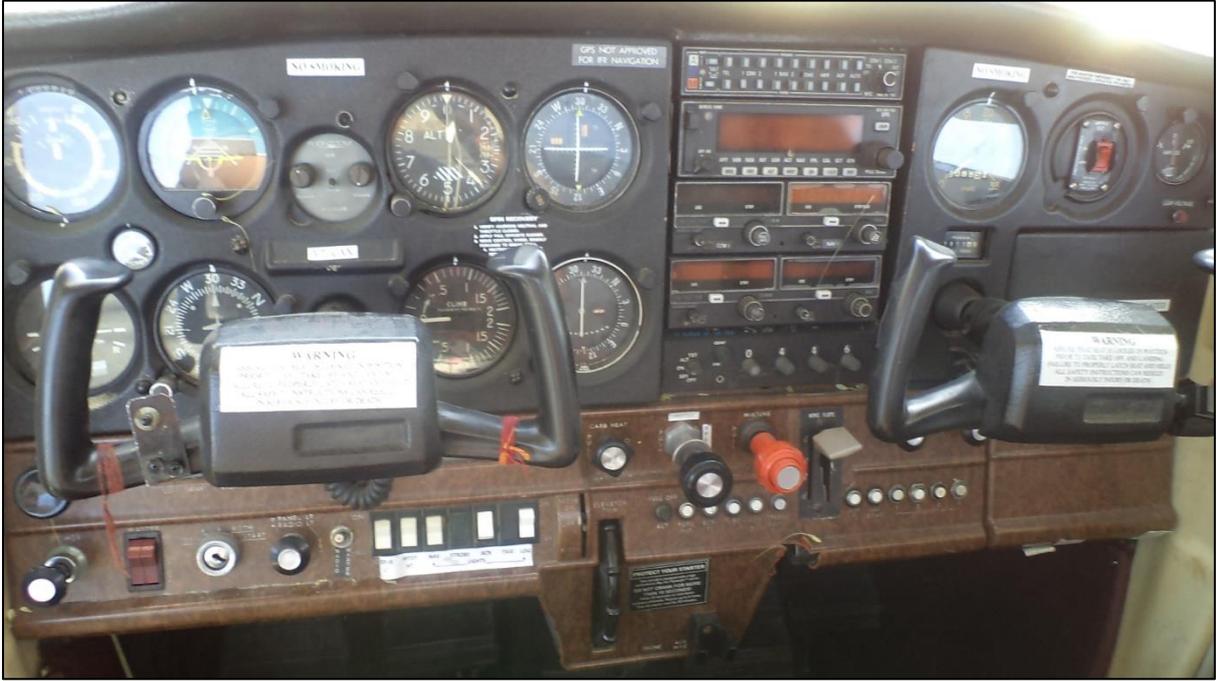
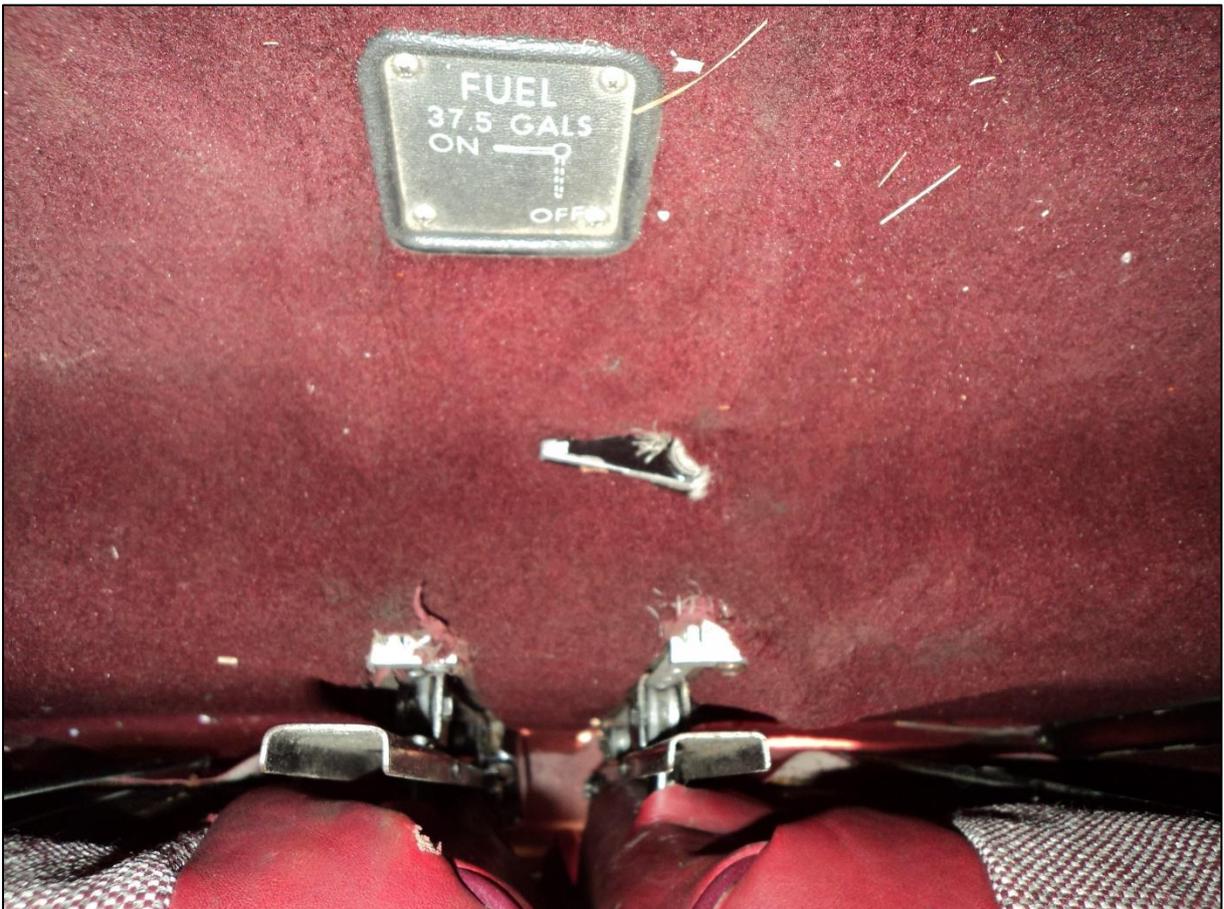
1.12.2. In the cockpit, the throttle levers were found to be in the forward position and the mixture was full rich and the flaps were in up position. Fuel shutoff valve was found in ON position.

POSITION OF THROTTLE, MIXTURE CONTROL, FLAP LEVER & FUEL COCK
