**FINAL REPORT ON ACCIDENT TO M/s DECCAN AVIAION PVT, LTD., PC-12/45 AIRCRAFT VT-DAR AT GUWAHATI ON 28-11-2014**

| 7. Date & Time of Accident | : 28 <sup>th</sup> Nov 2014, 13:21 UTC |
| 13. Type of Accident | : Bounced Landing |

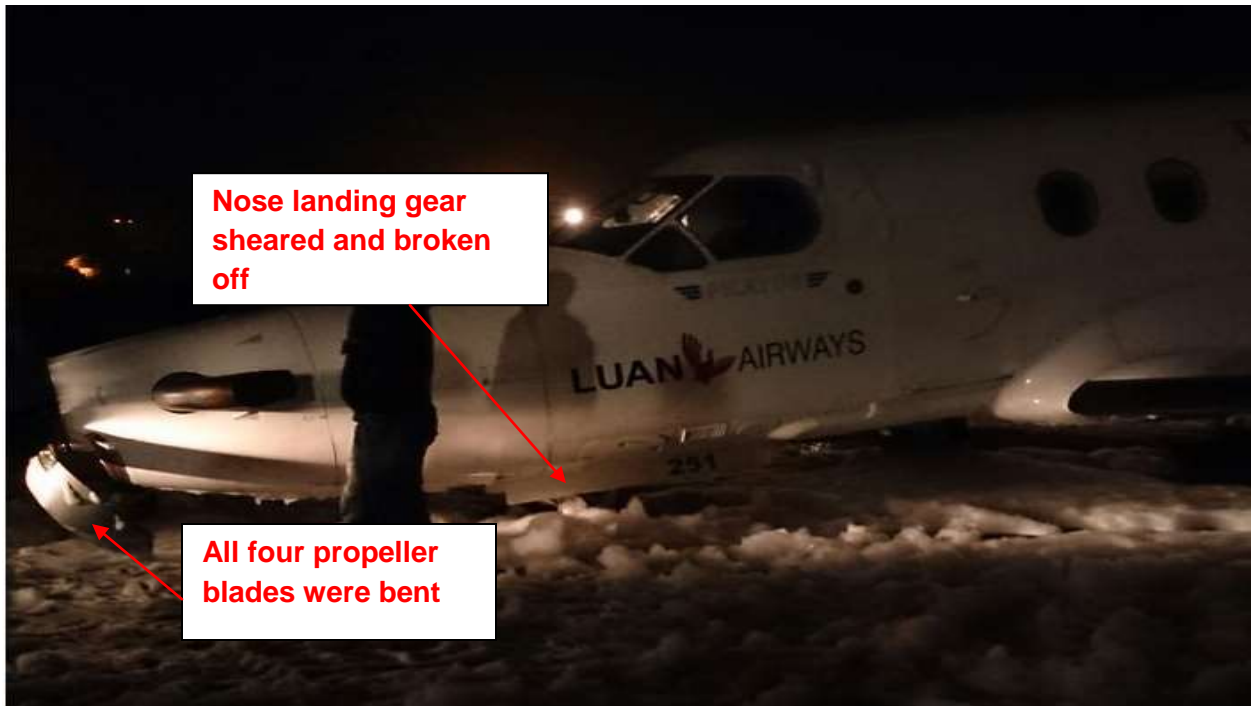
1. After the impact the Nose wheel sheared from the shock absorber along with the fork assembly.
2. All the four propeller blades hit the runway surface and got bent from the middle and the tips had worn off due to friction on the runway.
3. With the engine impact on the runway, the Engine fuel pump and FCU had broken off from its mounting and the bolts shear off after the impact.
4. Generator 2 assembly housing broken due to heavy impact.
5. Starter / Generator cooling duct has struck on the TCV cover causing bending it.
6. Left flap inboard trailing edge skin got minor damage.

**Final resting position of the aircraft on the runway with nose landing gear broken off**

7. The fuel condition lever were found stuck at ground idle position as FCU had broken and came out from its original position.
8. Crack and kinks were found on frame number 12.
9. Wrinkle on the skin found on both side nose gear doors.
10. Cracks visible on starter generator mounting.
11. The RH NLG door was damaged.
12. Following parts of nose landing gear found broken-
  - a) Fork broken from both sides.
  - b) Torque link broken from middle and bottom joint.
  - c) Spring strut broken from both ends and found on runway.
  - d) Drag link bottom linkage broken form middle.

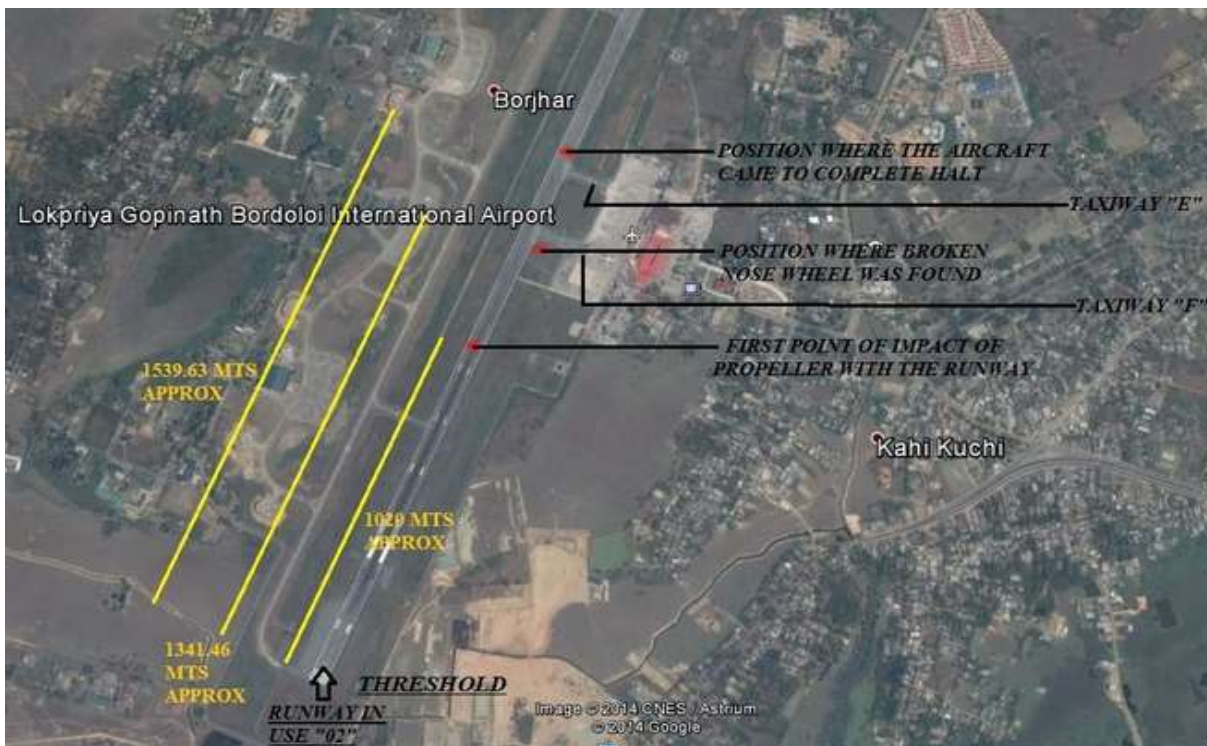
**Figure: Location of aircraft and parts on the runway after landing.**

During landing the aircraft bounced twice on its main landing gear and on the third time the aircraft impacted on its nose landing gear. The impact was such that the nose gear sheared off from its attachment point and the bend backward.

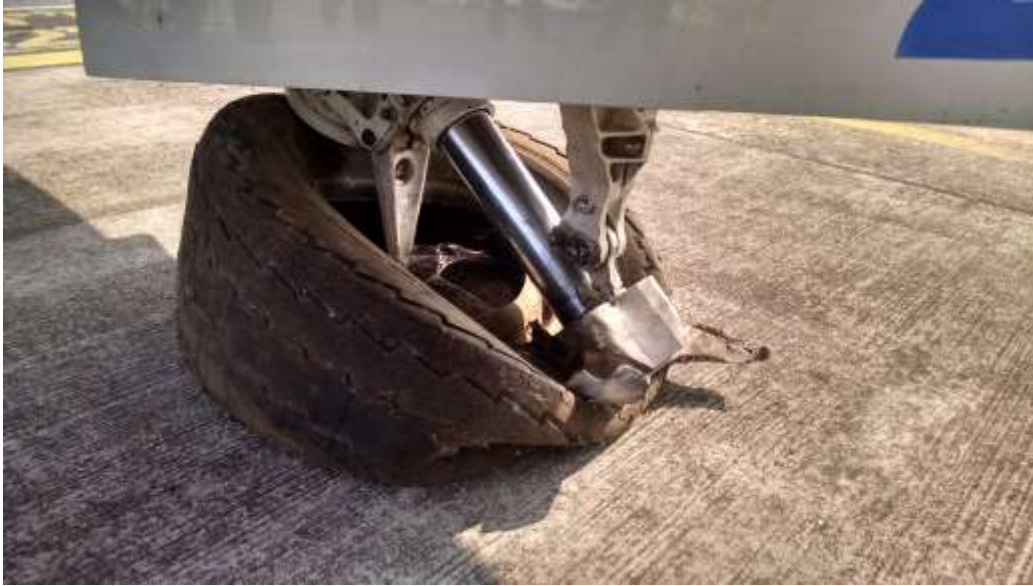
**NOSE LANDING GEAR BENT BACKWARD**

The nose wheel also got detached from the wheel assembly, and the propellers came in contact with the runway surface as it is evident with the propeller marks on the runway surface. After the nose wheel detached from the hub the oleo of the nose gear came in contact with the runway surface as it is evident from the deep gouge marks on the runway surface and also on the nose landing gear.

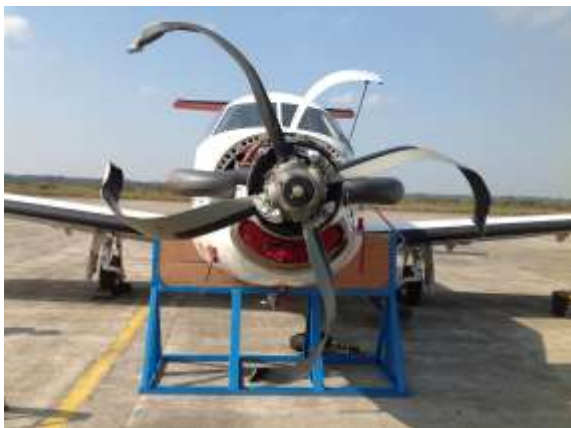
**BENT PROPELLER BLADES**

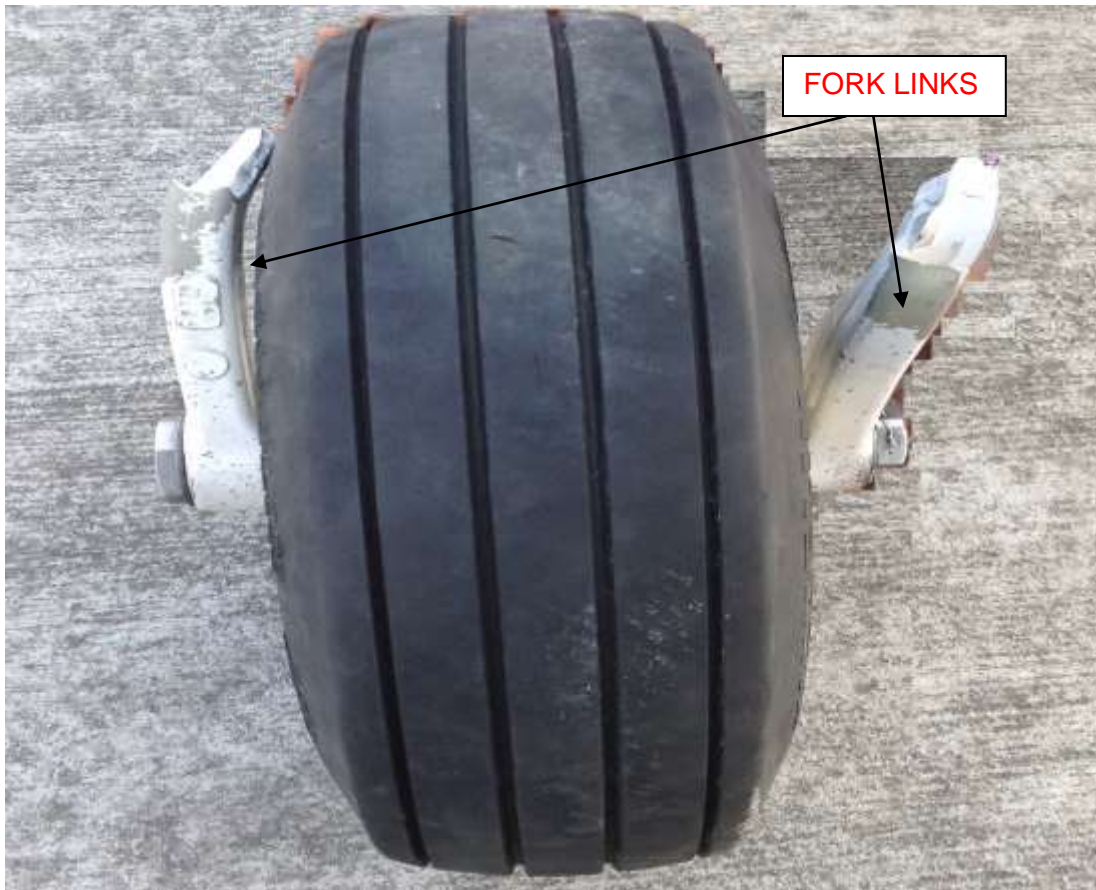
The intensity of the impact on the nose gear on the runway was so strong that both the fork link of the nose wheel broke due to impact on the runway. The nose wheel went away and the propeller hit the runway surface at about 1020 metres from threshold.

**BOTH THE FORK LINKS BROKE DUE IMPACT**

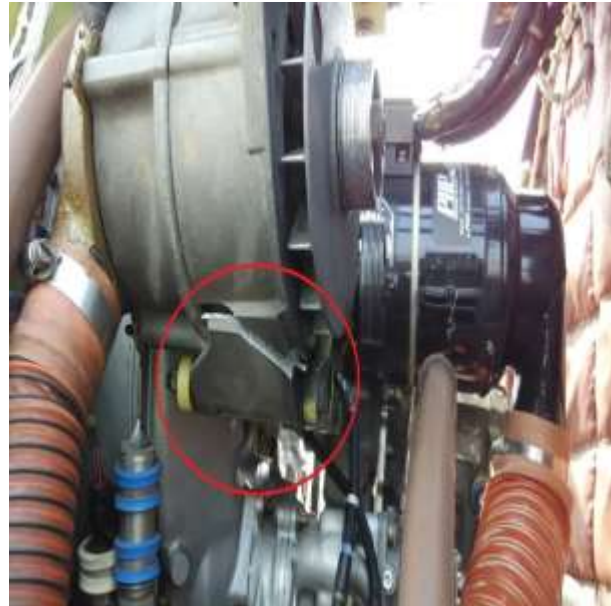
**Generator casing rupture due impact**

During subsequent inspection it was observed that the AC generator mounted on the engine its cast iron casing had cracked at two locations and also the aircraft frame number 12 had cracked due impact. The hydraulic fluid lines had ruptured and the hydraulic fluid had leaked and spread on the runway surface.

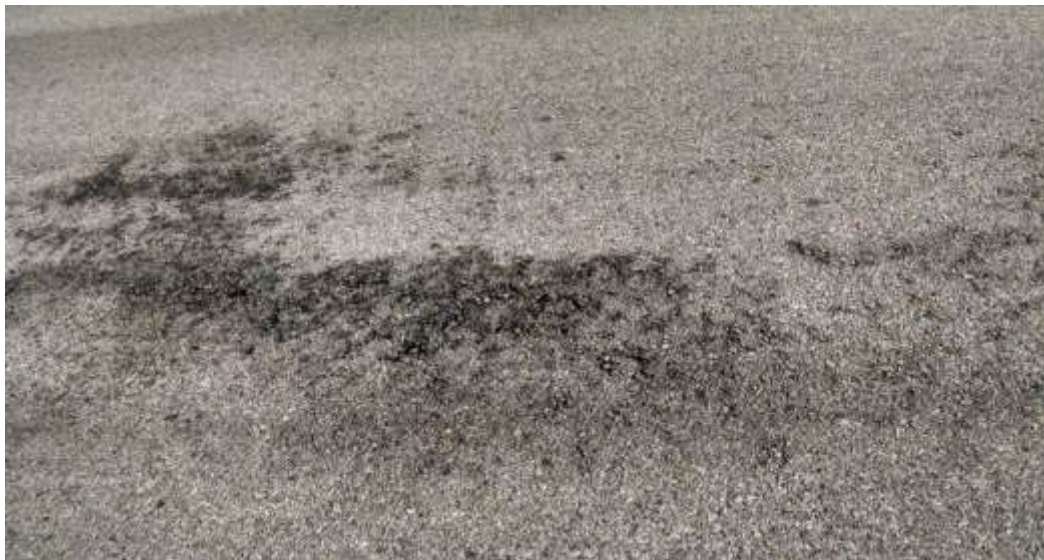
**Hydraulic leakage on the runway surface**

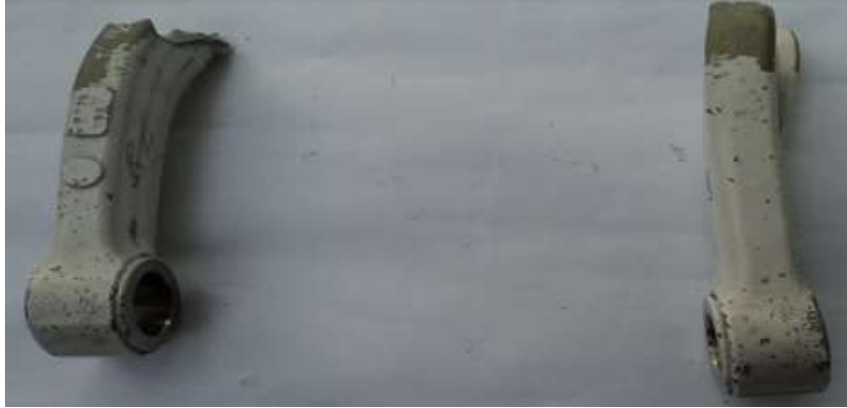
**Left and Right fork:-** Left & right fork were examined on the microscope. The left fork was found twisted and the fracture surface was observed to be slant & fibrous. On the other end, bore (Inner diameter) and face condition were found satisfactory. Right fork was also found twisted with fracture surface having slant and fibrous appearance.

**Figure shows nose wheel fork (right and left) parts**

The presence of slant and fibrous fracture surface along with twisting features on the left and right fork indicate that the components have failed under overload conditions. Presence of dull and fibrous appearance on the fracture surface of remaining failed parts i.e. link torque upper and lower part, spring pack assembly & drag link assembly and bearing rod end of spring strut also indicates failure due to overload.

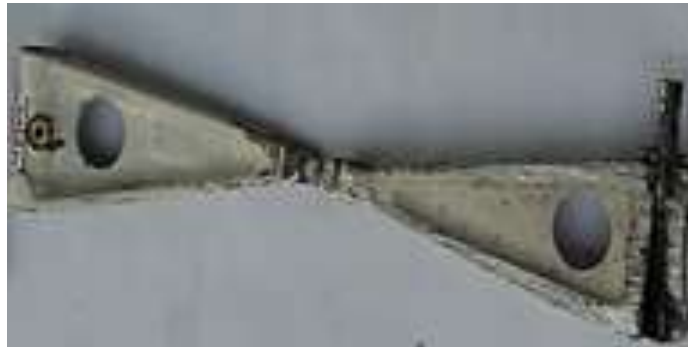
Link torque upper and lower part Fracture surfaces of both the parts are found dull and fibrous.

**Figure shows lower and upper part of torque link**

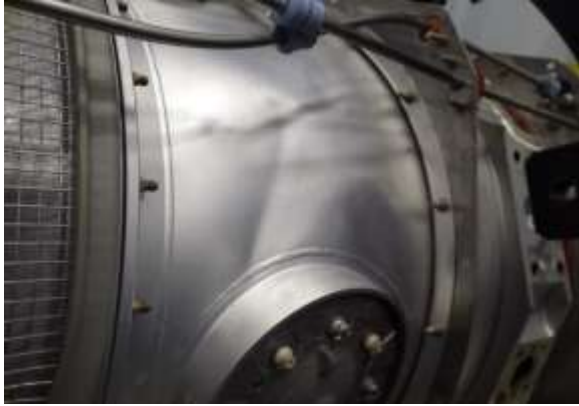
**Buckling found at the GG case.**

Damage observed to the GG case and AGB housing were because of the sudden stoppage. Light rubbing at the PT blades tip, CT blades tip and compressor were also because of the sudden stoppage.

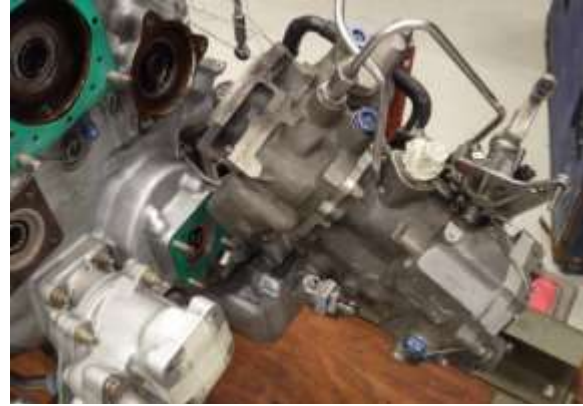
**The AGB fuel pump pad was found with broken studs. Engine teared down.**

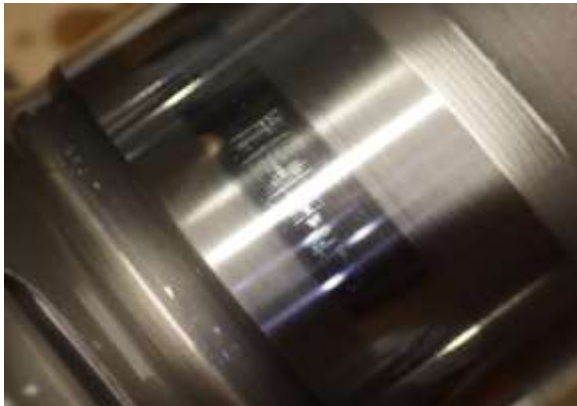
**Scores were observed on the 2nd stage carrier at #5 bearing journal.**

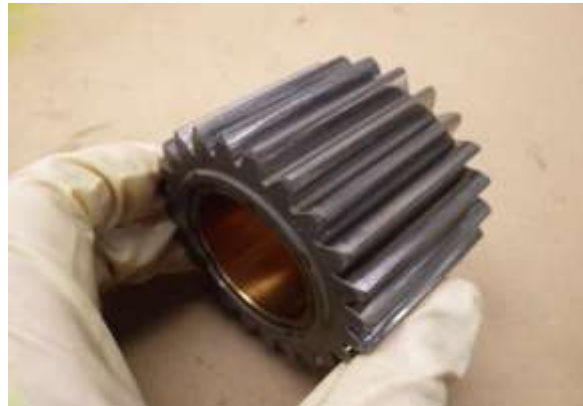
**Light wear was observed at the 2nd stage planet gears teeth**

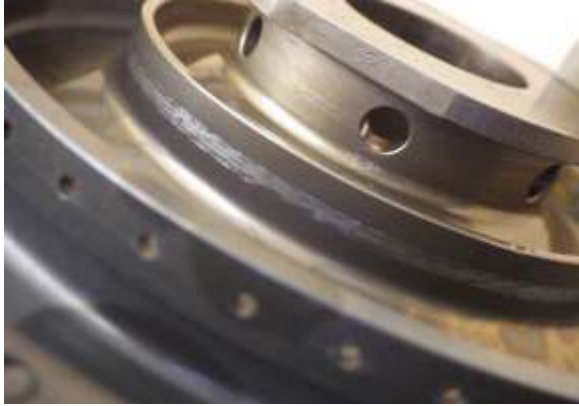
**Rubbing at the 1st and 2nd stage PT blades and discs.**

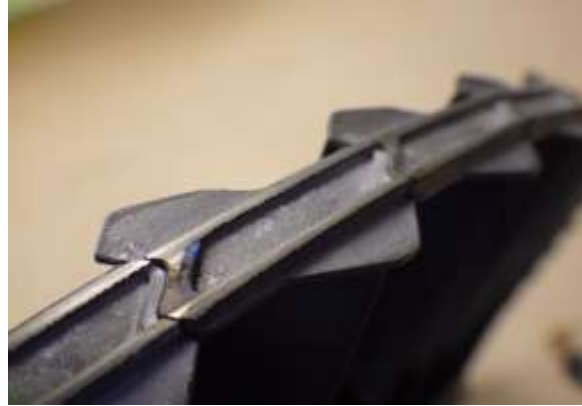
**Rubbing at the 1st and 2nd stage PT blades and vanes**

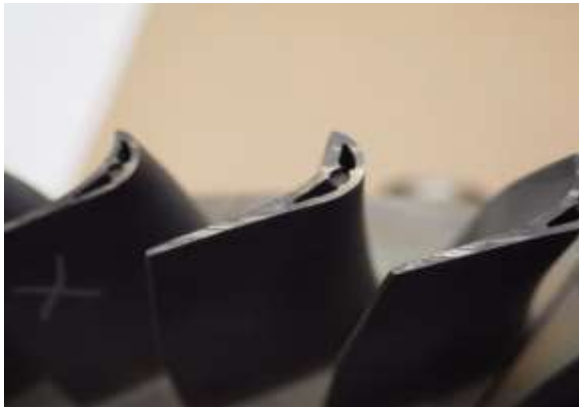
**Rubbing observed at the CT blades tip. The inner and outer liner exhibited normal wear.**

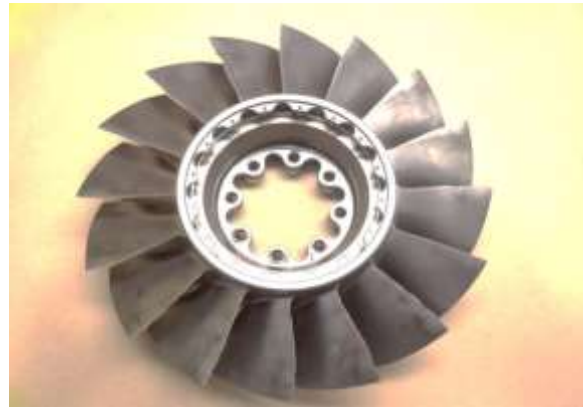
**1st stage compressor rotor found with light FOD.**

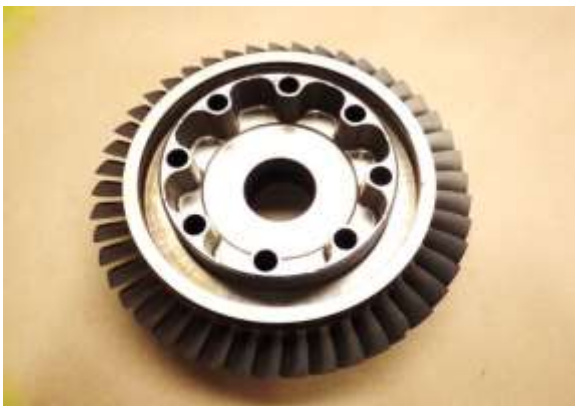
**4th stage compressor rotor was found in normal condition (previous cut-back observed) The compressor stator were found with normal wear.**

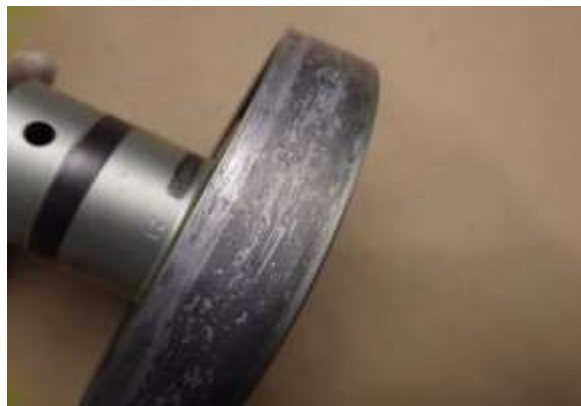
**Light rubbing at the rear compressor stub shaft**

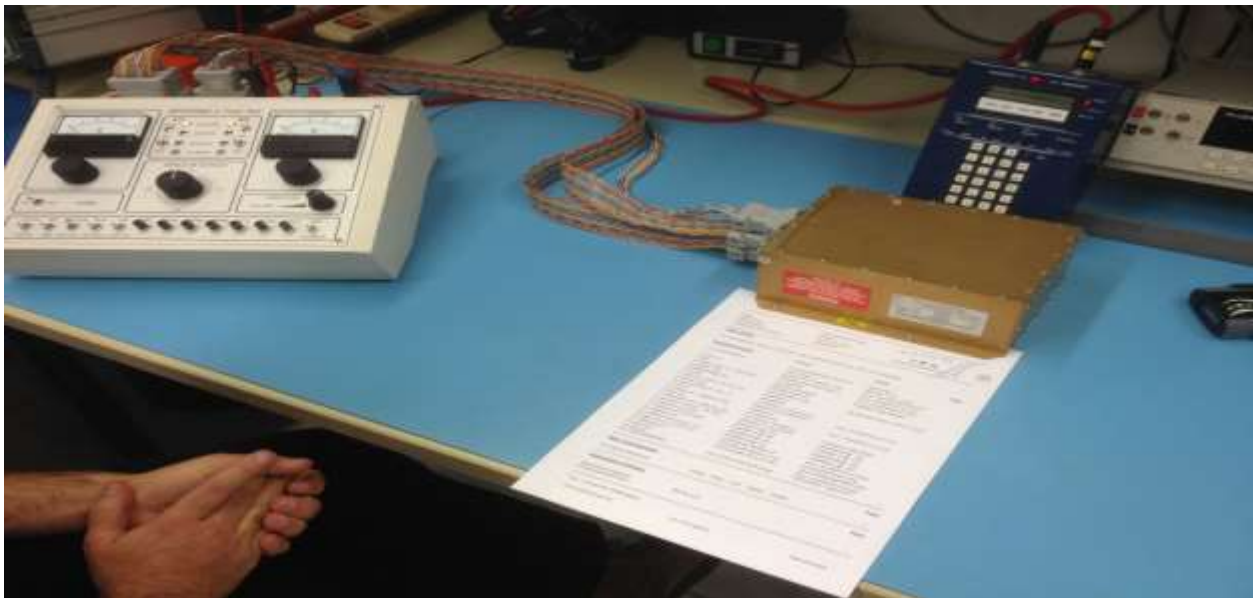
Acceptance Test Procedure of stick pusher computer was carried out. A total of 25 test steps were successfully completed. No errors were detected during test.

**The Test equipment Stick Pusher was used to run a full Factory Acceptance Test**

Since the Stick Pusher Warning Generator (SPWG) showed correct functions and no error at all, it can be assumed that it performed correctly in the aircraft as well.
