**GOVERNMENT OF INDIA
MINISTRY OF CIVIL AVIATION**

**FINAL INVESTIGATION REPORT ON ACCIDENT
TO AIR INDIA AIRBUS A-320 AIRCRAFT VT-ESH
AT JAIPUR ON 05.01.2014**

**AIRCRAFT ACCIDENT INVESTIGATION BUREAU
SAFDARJUNG AIRPORT
NEW DELHI – 110003**

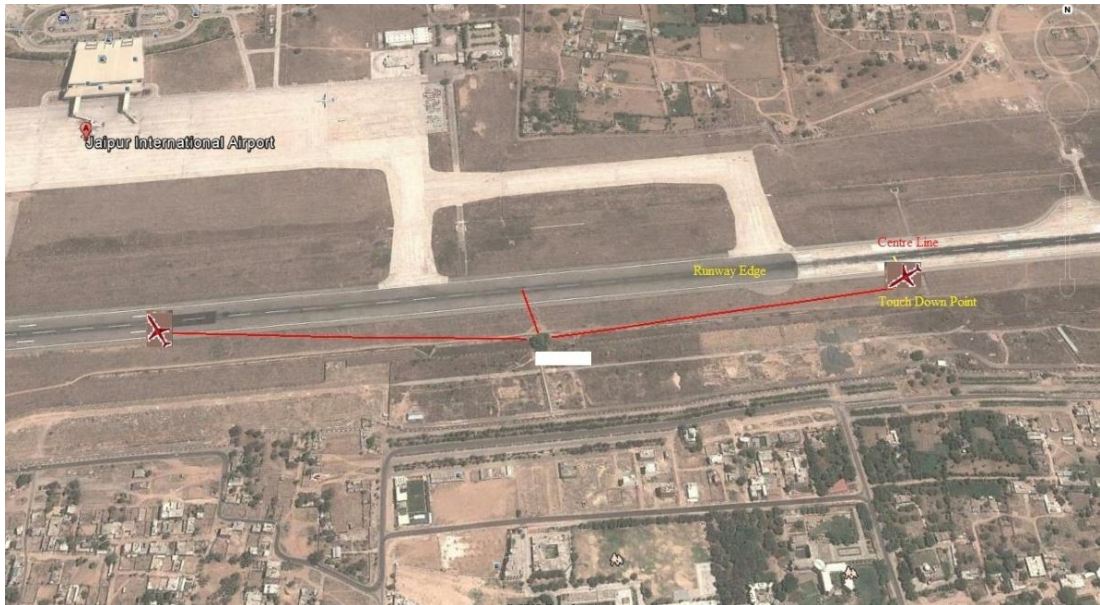
The aircraft continued to roll/ skid on the unpaved surface and during this period the left wing impacted trees causing damage to the left wing. Thereafter aircraft turned right and entered the runway finally coming to a halt on the LH side of runway. There was no fire.

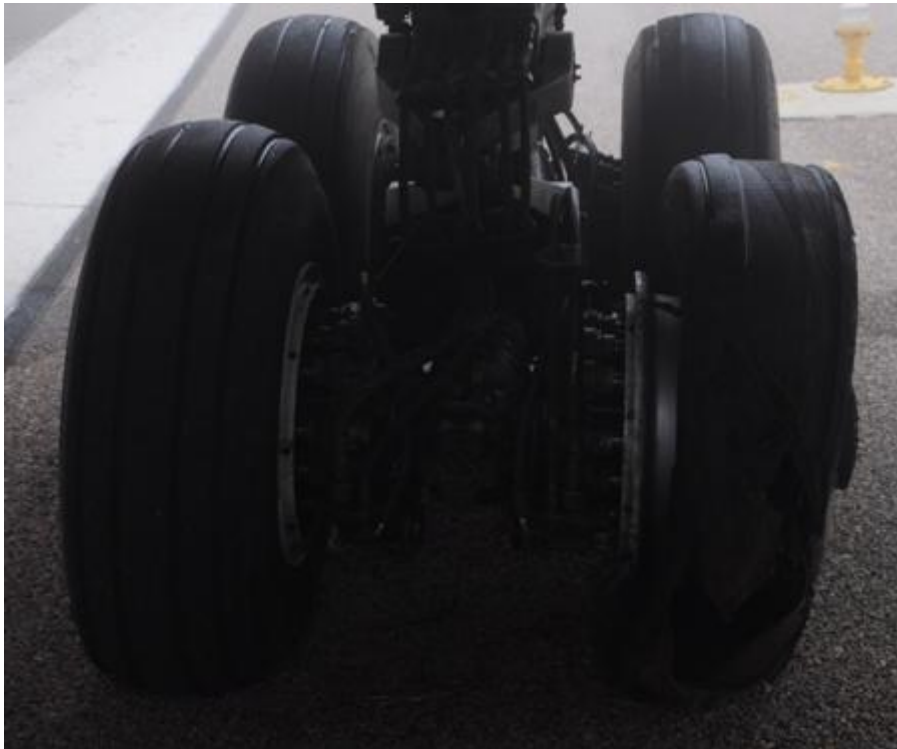
The aircraft had touched on the left side of the runway on soft ground. There was no damage to the aircraft on its first impact with the soft ground. The aircraft had rolled and then the left wheel had gone over the drain boundary area. The left main wheels got de-capped / damaged during this roll over/ skidding and during final stoppage with application of brakes.

Thereafter the aircraft turned right but at the same time hit trees wherein the left wing leading edge structure got damaged from rib 23 onwards. Outboard wing spar box including upper skin, lower skin, front spar, rear spar and ribs got sheared off from a distance of about 5 ft from the wing tip.

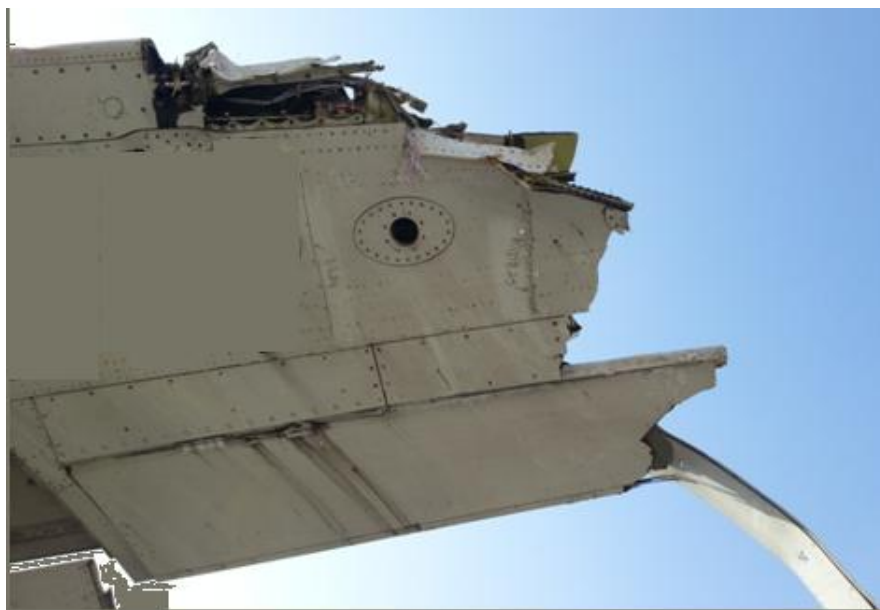
- Wing tip and wing tip fence area sheared off and found in drain.

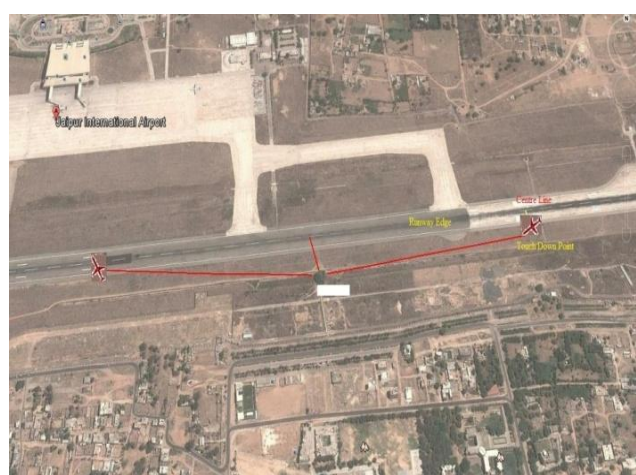
The PIC disengaged the auto-pilot at 200 feet. At 75 feet RA on the longitudinal axis, the Captain applied two successive back stick inputs (5.5° and 7°). The pitch increased up to 5.5° . On the lateral axis, aircraft was aligned with runway axis, left roll was commanded on captain stick leading left roll to increase. In the meantime, a progressive right rudder pedal input was applied.

The decision of PIC to disengage the autopilot was the last inappropriate act which caused the aircraft to deviate to left from localiser resulting in the aircraft landing (with both landing gears) on the soft ground.
